HAMLET OF PAULATUK

Sewage and Solid Waste Disposal Facilities

Abandonment and Restoration Plan

November 29, 2017

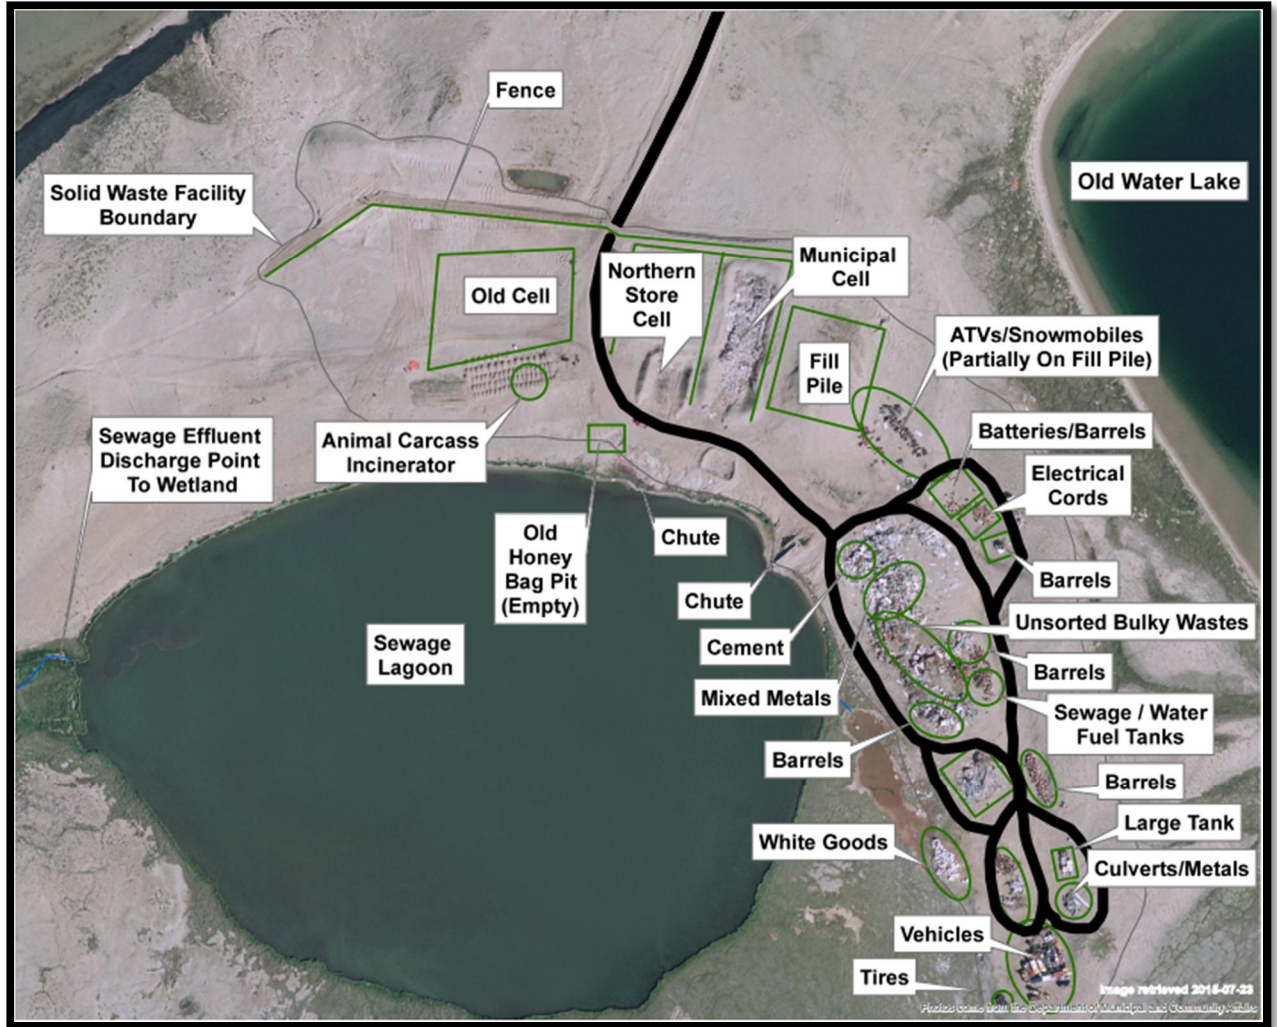
All materials are currently being stored and sorted above ground as shown in Figure 3. Several landfill cells within the current facility boundaries have been developed for general household waste to the west of the access road and have been filled in and covered. Final cover of these cells was completed in 2014. The specific design for the cap and cover of these completed cells on site could not be determined. It is known that neither cell was constructed with an engineered leachate collection system. Based on the May 27, 2015 site visit, the ground surface over these capped cells is flat to grade.

Historical site photos have shown the presence of standing water in the areas of old, capped cells. The same areas did not show any evidence of standing water during the July 2017 site visit, however, it is not known if this is due to seasonal variations in surface water or if the standing water issue has been effectively addressed. If standing water remains an issue, it may infiltrate the landfill caps and get into the waste below causing leachate issues from the landfill cells into the wastewater lagoon. Since the site is very close to sea level and underlain by permafrost it is not expected that this leachate will contaminate groundwater supplies, but the potential to contaminate the sewage lagoon as it drains into the Darnley Bay is a concern. It is recommended that the old landfill cell areas to the west of the access road be monitored for standing water throughout the year. If water is detected, these areas should be tested, drained to an appropriate location (if contaminated, drained to a holding pond for further treatment) and the low lying areas filled and graded to ensure proper drainage away from the landfill cells and the sewage lagoon.

There is a chain link fence around part of the site perimeter to catch any windblown waste material. The fence has been damaged and is falling down to the east of the facility entrance, where the fencing was installed in sand. This section is currently undergoing reconstruction, and should be monitored once completed to ensure it remains upright and functional. Future damage should be addressed promptly to manage windblown litter.

Figure 3: Active Sewage and Solid Waste Disposal Facilities Site Plan

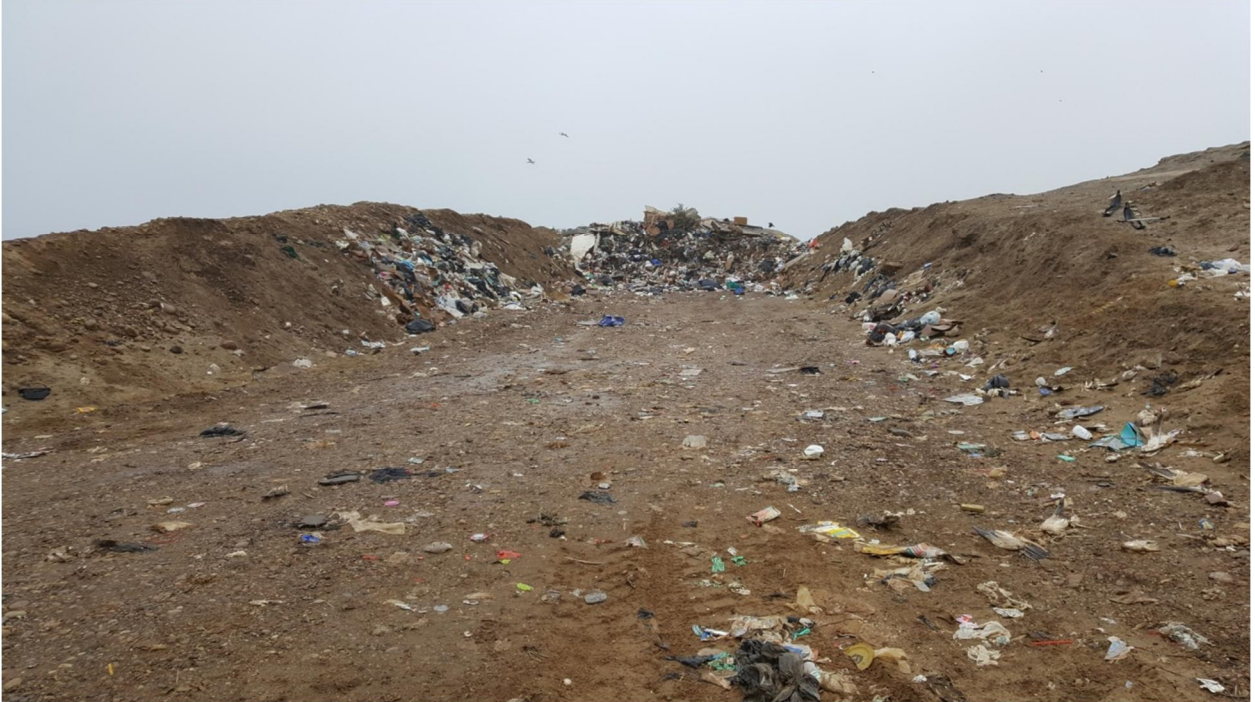
The general municipal waste storage area includes a variety of different types of waste including household waste, beverage containers, paper/cardboard, miscellaneous plastics, as well as smaller pieces of scrap metal, rubber and scrap wood, as shown in Figure 4. Since the closure of the landfill cells originally designed for the facility in 2014, general municipal waste has been disposed of in a cell to the east side of the access road which has an estimated capacity of 800 m³. The community currently produces approximately 550 m³ of non-compacted solid waste each year (200 m³ of compacted waste), based on generation rates specific to the Hamlet. The municipal solid waste cell is surrounded by a berm to help mitigate wind sweeping waste out of the cell.

This cell is covered by overburden periodically to prevent odour, wind, and pest issues. Overburden should be applied on a regular basis when waste is collected, delivered, and compacted into the cell as per the *Hamlet of Paulatuk Solid Waste Disposal Facilities Operations and Maintenance Plan* (SWDF O&M Plan). The lack of regular overburden application presents many hazards including attracting nuisance animals. Current management practices may also lead to a potential fire hazard. Piling waste in excess of the 2 m recommended by the *Guidelines for the Planning, Design, Operation and Maintenance of Modified Solid Waste Sites* may lead to increased temperatures within the waste pile which can cause smoldering and burning of waste. If the general municipal waste were to catch fire, the fumes would be hazardous to community members downwind. Waste should be managed as per the SWDF O&M Manual to lessen the chance for fire.

Figure 4: Municipal Solid Waste Cell

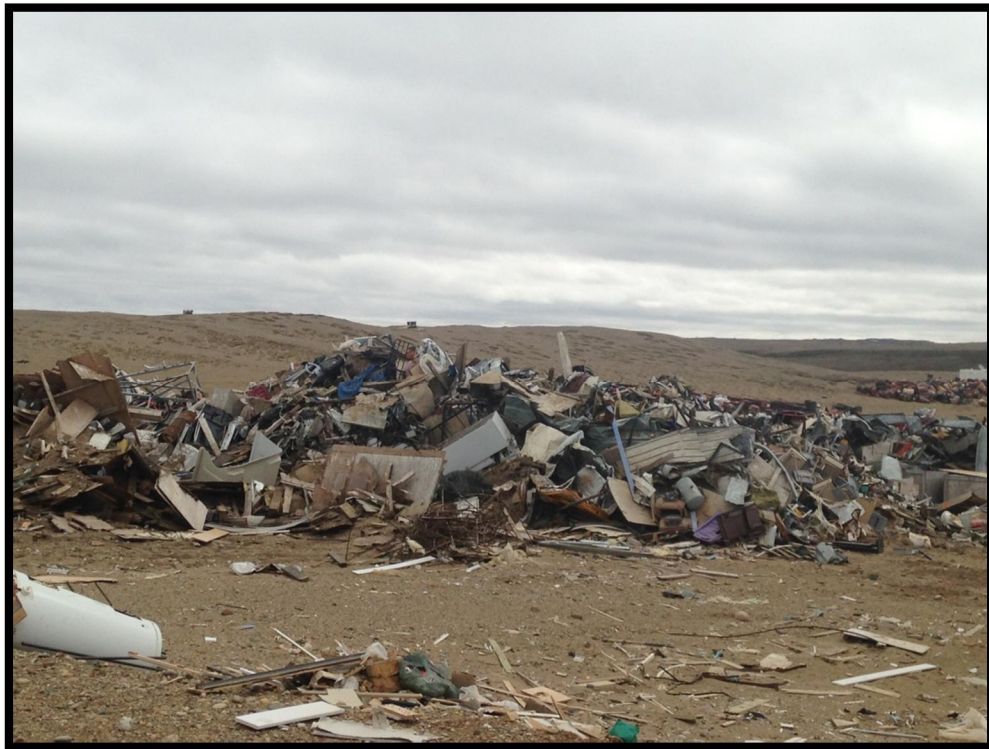
The majority of the area to the northeast of the sewage lagoon is occupied by unsorted bulky waste that has not been properly processed into its component categories (Figure 5). This area contains white goods (fridges, freezers, washing machines, furnaces, hot water tanks, etc.), construction waste, mixed metal, household furniture, vehicle components, and other large waste items. Many of the white goods and other products have not been properly processed to remove hazardous components such as mercury temperature switches and hazardous refrigerants.

Figure 5: Unsorted Bulky Waste

Construction waste products should be sorted by Hamlet staff and recoverable materials made available for reuse by community residents. Particularly wood products and metal fixtures should be stored in a manner that protects them from further damage and avoids safety hazards to residents when combing through the materials.

Clean, non-recoverable wood products that have not been painted, stained or otherwise treated should be sorted for burning. Any disposal by burning is subject to the conditions of the Municipal Solid Wastes Suitable for Open Burning guidelines from the Department of Environment and Natural Resources (Environmental Protection Division, 1993). Conditions for burning include, but are not limited to, applying the principles of reduce, reuse, recycle, burning in a controlled manner when conditions are favourable (no or low wind blowing away from the community), receiving applicable permits and abiding by permit conditions, removal of all non-burnable material, and compliance with any other site specific conditions. Treated wood products can be broken down and included in the general municipal waste disposal. Metal products should be sorted to remove any hazardous materials and stockpiled to ship south for recycling and recovery.

The scrap metal content in the unsorted bulky waste area should be sorted and stockpiled with the construction scrap metal to ship south for recycling and recovery. Household furniture and other large, non-hazardous, non-recoverable items removed from the unsorted bulky waste area should be broken down to increase compaction and disposed of in the general household waste area.

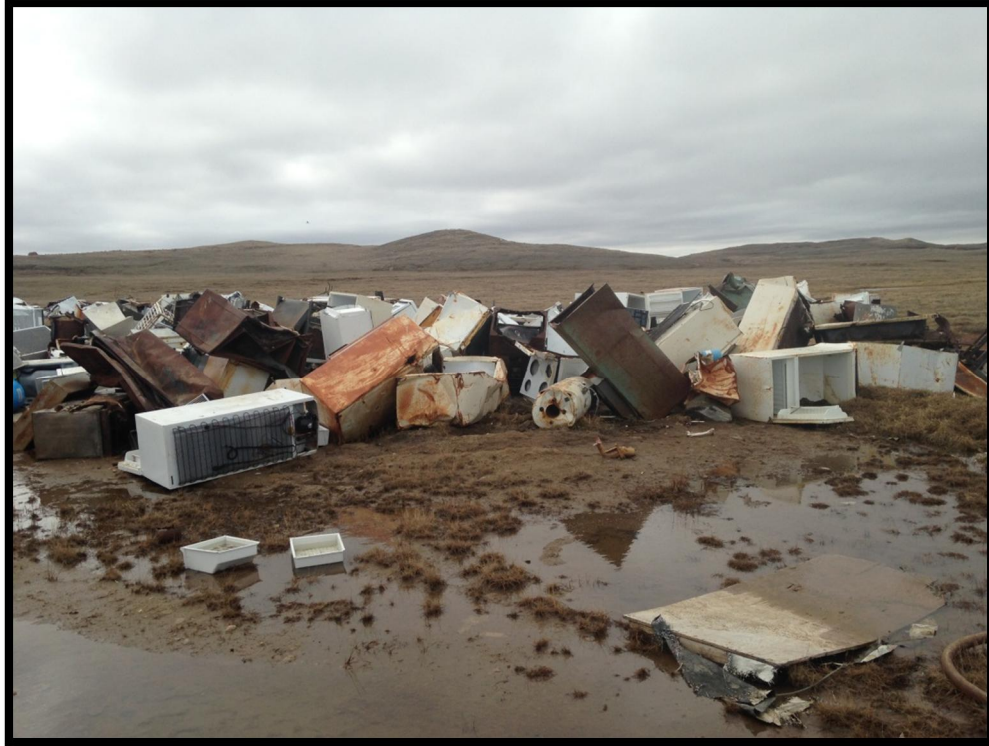
In addition to the white goods that are in the unsorted bulky waste area, some have been sorted and are stored in a designated area to the west of the unsorted bulky waste area (Figure 6). White goods typically include large household appliances such as washing machines, dryers, freezers, fridges, stoves and hot water tanks. These products often have hazardous components such as mercury switches and refrigerants which must be removed and properly disposed of before the metal and other components can be recovered. Many of the white goods currently stored in the designated areas have not been adequately stripped of hazardous components, something that should be completed promptly for all white goods stored in the solid waste disposal facility.

Figure 6: White Goods Storage and Sorting Area

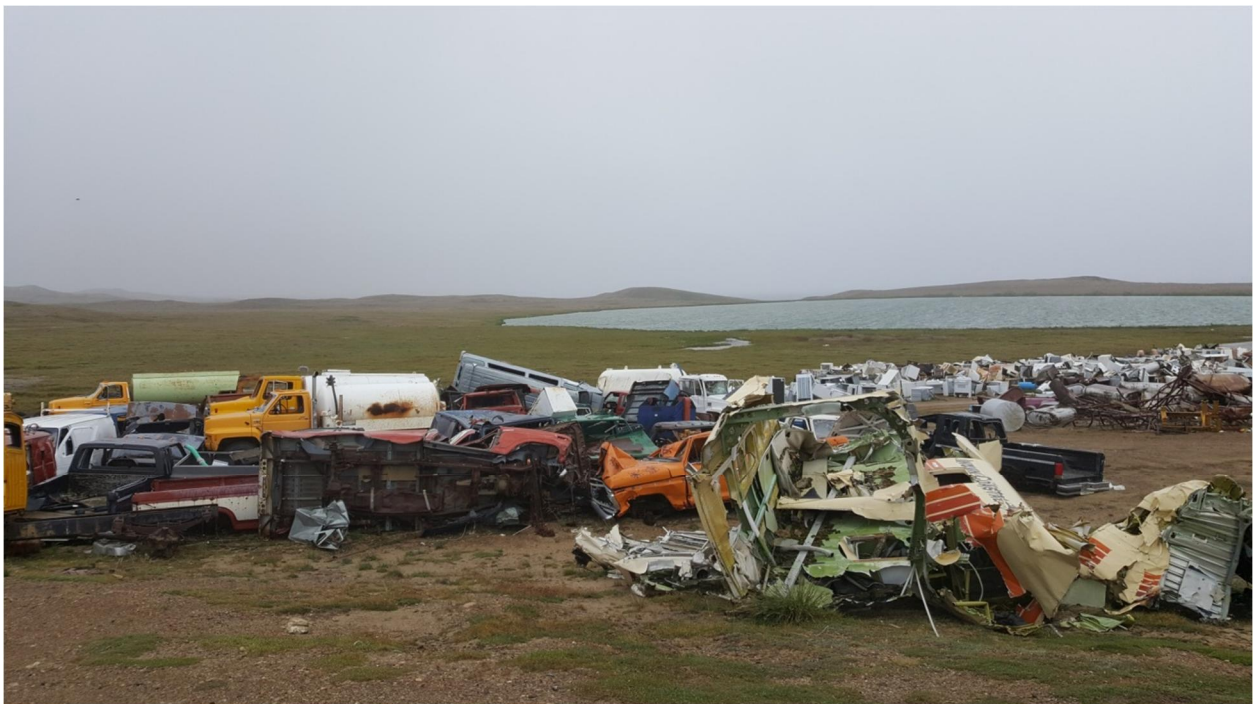
There are currently numerous end-of-life vehicles (ELVs) and used tires stored in a designated area to the west of the mixed bulky waste area. As discussed in the SWDF O&M Plan, the ELVs should have all hazardous components stripped including batteries, refrigerants, fuel, oils, antifreeze, windshield washer fluid, and other lubricants. Procedures for stockpiling and disposing of these hazardous materials are detailed in the SWDF O&M Plan. Once all hazardous materials are adequately recovered, ELVs should be stored in a manner that allows for parts recovery by community residents in order to reuse components as required and available. Once adequate storage space is no longer available for stockpiling ELVs, Hamlet staff should arrange to have vehicles shipped to a proper recycling facility for further dismantling and disposal. In addition to passenger vehicles, there are several graders and tanker/vacuum trucks stored in the ELV area of the solid waste disposal facility. The Hamlet should contact the manufacturer of the various vehicles or metal recyclers that specialize in large equipment recycling to determine how best to dismantle them to ship south.

Figure 7: End of Life Vehicle Storage Area

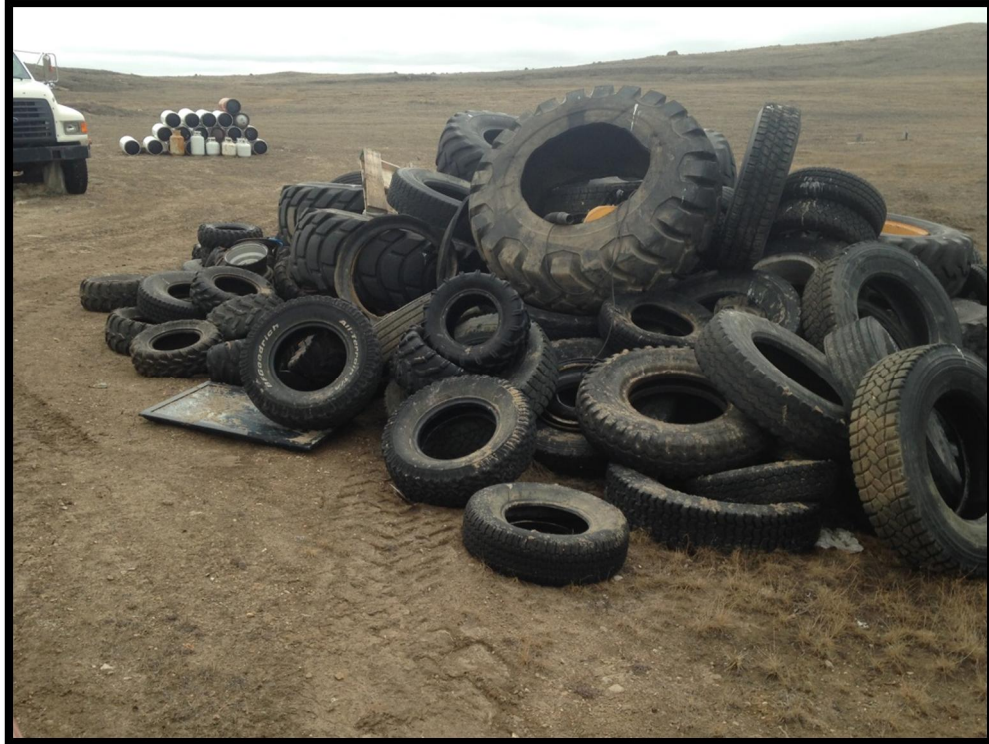
As discussed in the SWDF O&M Plan, used vehicle tires are not considered hazardous and can be stored above ground in a manner allowing for recovery by community residents as required and available. However, tires are susceptible to fire, which produces hazardous fumes so care must be taken to store tires far from ignition sources. Tires should also be stored to limit the amount of water collected in the tires. Standing water in tires can provide a breeding ground for insects. Once the quantity of tires surpasses available storage space, arrangements should be made to ship stockpiled tires south for recycling at a properly equipped facility. Photographs of the ELV and tire storage areas are shown in Figure 7 and Figure 8.

Figure 8: Used Tire Storage Area

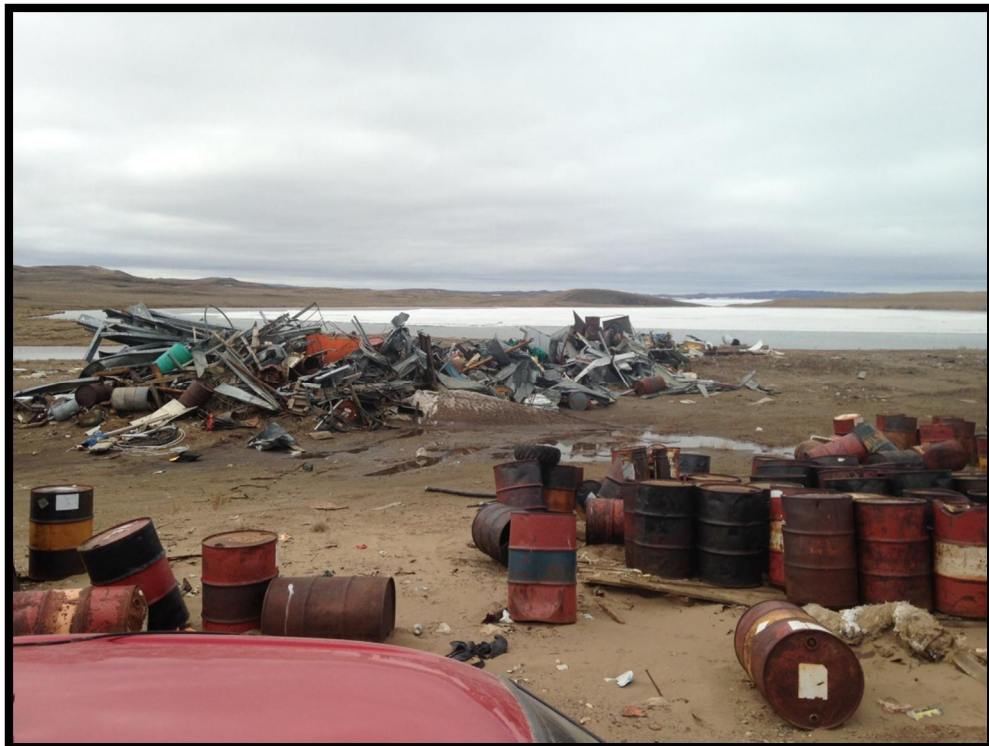
In addition to the metal found in the unsorted bulky waste area, some metals have been sorted and stored separately in an area to the west of the bulky waste area. Materials stored in this area include scrap construction metal, old corrugated steel pipe culverts and old fuel tanks (Figure 9). There are also several locations throughout the bulky waste area where used metal barrels are stored (Figure 10). It is not known if all of these barrels have been properly cleaned or if they are still contaminated by hazardous waste. If they have not been properly cleaned out, the Hamlet should make arrangements to have an environmental contractor clean them out, as described in the SWDF O&M Plan, so that they can be properly crushed and shipped south for material recovery. This should be completed promptly to prevent any residual fluids in the barrels from contaminating the surrounding site. Barrels that need to be cleaned should be stored upright in a lined area to prevent the migration of any leaking fluids into soils and water on site. Once cleaned, barrels should be crushed and transported off site promptly.

Figure 9: Mixed Metals Pile

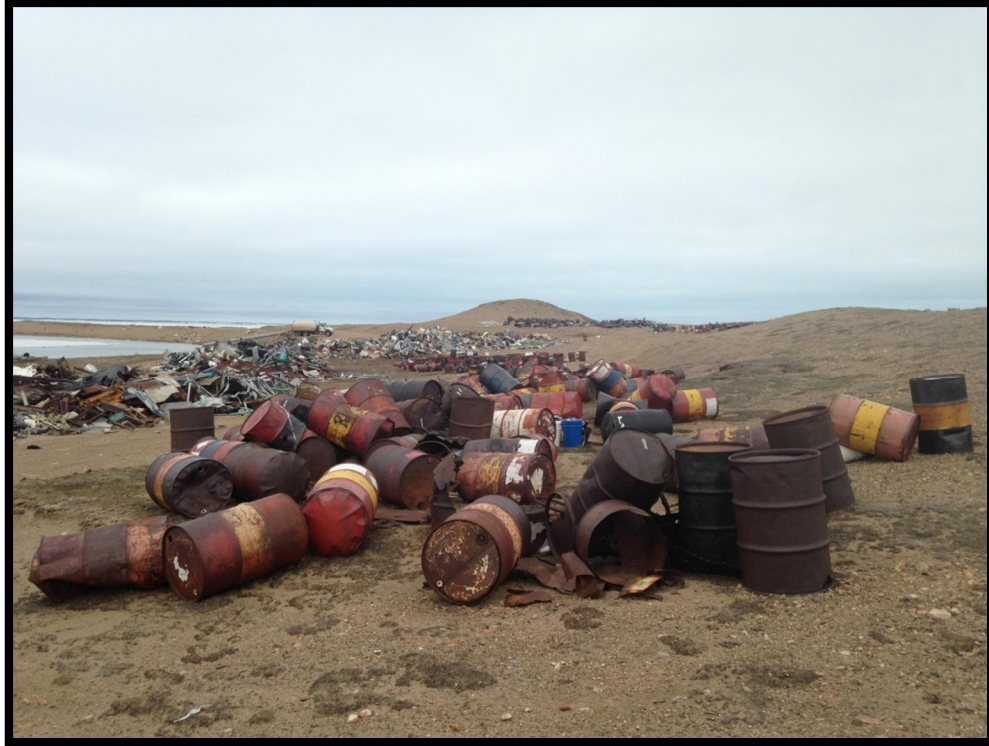
Figure 10: Used Barrels Storage

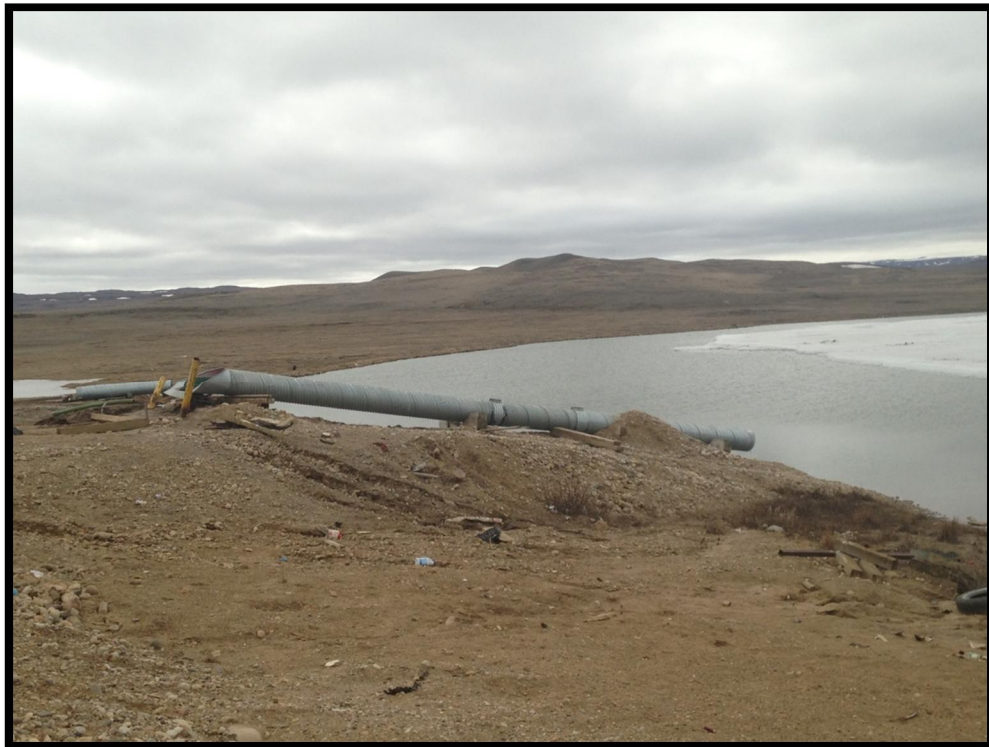
Figure 11: Sewage Disposal Facilities Discharge Chute

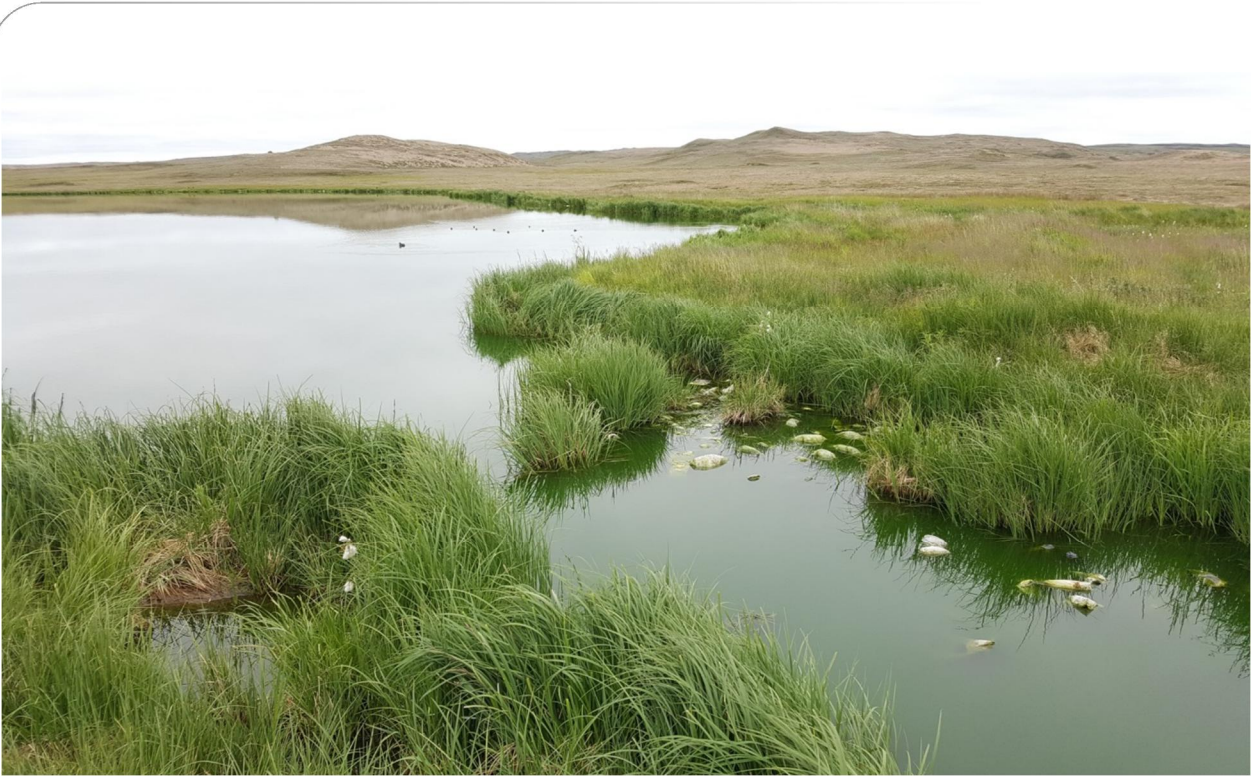
The 2009 water licence renewal application (Dillon Consulting, 2009) reported that the overflowing of the lagoon occurs periodically, particularly in the spring during runoff and periods of heavy precipitation. It was reported that there are holes/tunnels along the perimeter of the lagoon that cause particular overflowing issues. This concern was highlighted again during the 2017 site visit. The lagoon does not have an engineered berm surrounding the perimeter. The truck discharge area is built up upon a mound but it does not offer any overflow containment since the mound does not extend past the discharge.

Figure 12: Sewage Lagoon Discharge to Wetland

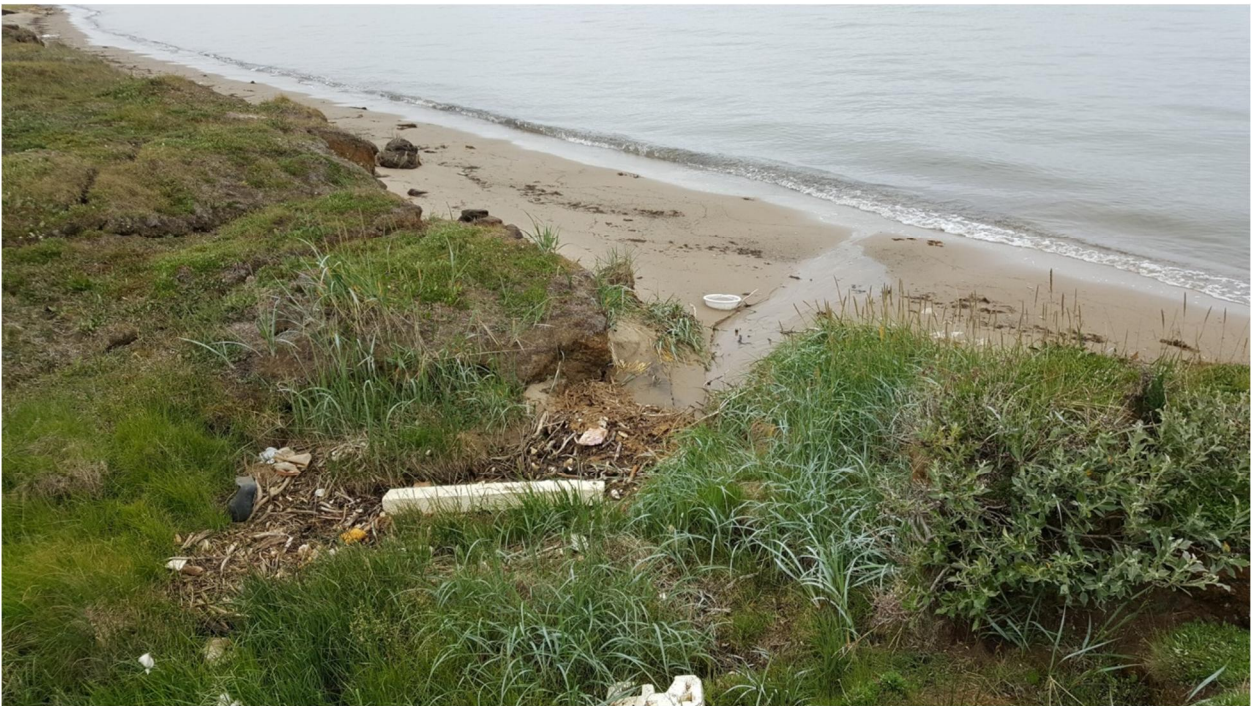
Figure 13: Wetland Discharge to Darnley Bay
