MUNICIPAL WATER USE INSPECTION FORM

DATE:	September 30, 2004	COMPANY REP:	Eugene Pascal - SAO
LICENSEE:	Hamlet of Aklavik	LICENCE #:	N3L3-0570

LIST OF FIGURES FOR WATER LICENCE INSPECTION REPORT

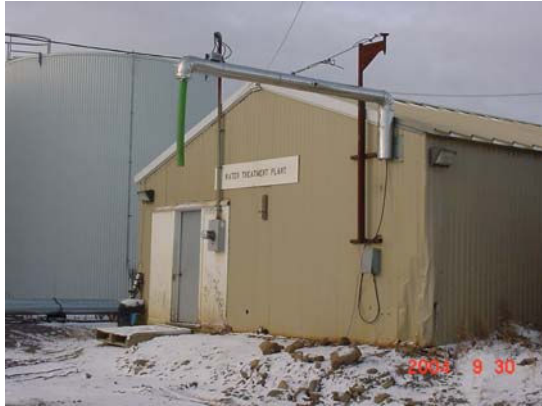
Figure 1. Water Supply. Water Intake and Treatment Building

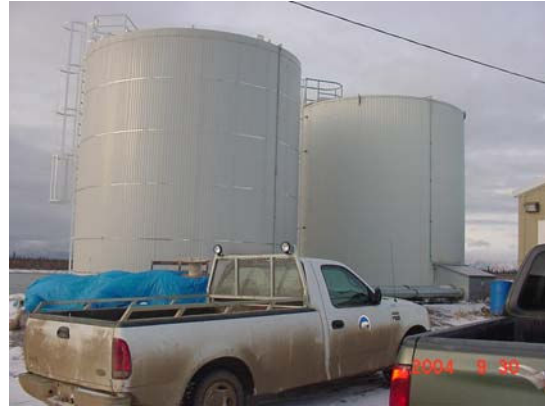
Figure 2. Water Supply. Water Storage tanks.

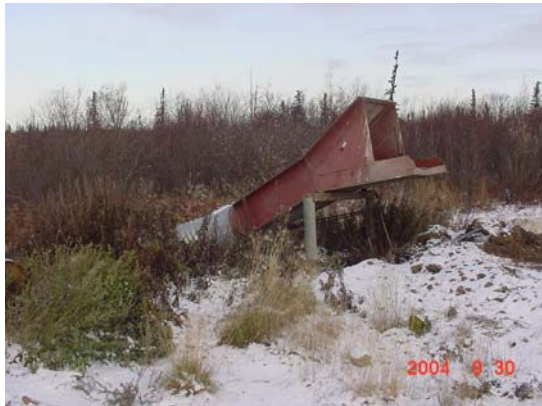
Figure 3. Waste Disposal. Sewage Lagoon pump-out shoot.

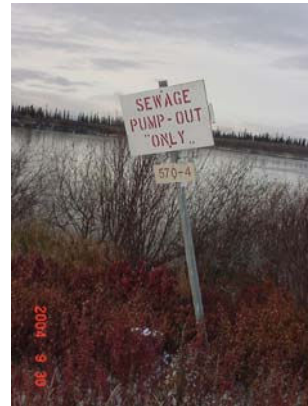
Samples Collected (Hamlet)	-SAO indicated that samples are taken in the spring and fall at SNP 570-3.		
(DIAND)	-Samples collected at 570-4 (Sewage Lagoon Inflow)(Figure 4). -Raw Water sample collected inside Water Treatment building (Figure 1) -All results pending		
Signs Posted: SNP	-SNP station 570-4 is posted (figure 4) but is not listed in the Water Licence. Only one SNP Station 570-3 required and is for the point of outflow from the sewage lagoon. Upon consultation with the SAO this SNP site is only accessible by boat (open water months) and is posted.	Warning	ID Signs posted but no direct Warnings seen.
Records & Reporting:	-2004 Annual Reports not completed. Hamlet was reminded that the report was due March 31, 2004. -2003 Annual Report did not include SNP data and is therefore incomplete. Please ensure that all sections of Annual Report requirements as indicated in Part A, section 3 (a through e) are addressed. -O & M Plan was due December 30, 1999. The latest O & M Plan currently at this office is dated 1985 and was produced by AESL of Alberta. This Plan was approved in 1995 by the NWT Water Board.

Figure 4. Waste Disposal. Sewage Lagoon Sign and SNP 570-4 station.

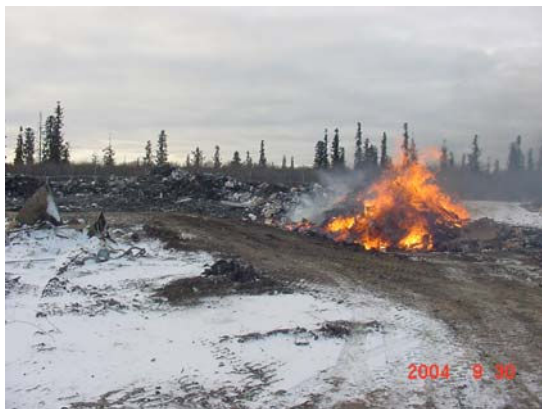
- Currently only 2-3 people still using the honey bag pit located at the SWDS. Sign Posted
- Open burning was occurring during the inspection (Figure 5). Material mainly consisted of wood debris but did contain minor amounts of other garbage (domestic).
- Currently understood that waste volume measurements (Part A, section 6) are monitored by the truckload.
- Facilities are posted and identified.
- SAO indicated that a screen was installed at the outflow of the sewage lagoon (Part B3).

Figure 5. Waste Disposal. SWDS domestic waste disposal area.

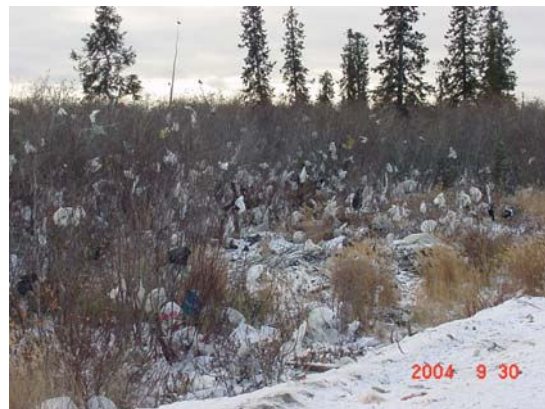
2. Considerable wind blow debris escaping (especially plastic bags) from the Solid Waste Disposal Site (SWDS)(Figure 6).
3. Poor segregation of waste at the SWDS (figure 8). Please ensure designated and identified areas exist for public guidance. The signs should include not limited to domestic waste, waste tires, waste appliances, bulky metal wastes, waste wood, snowmobiles, empty drums, etc.

Figure 6. Waste Disposal. SWDS. To the south of the domestic waste disposal area.

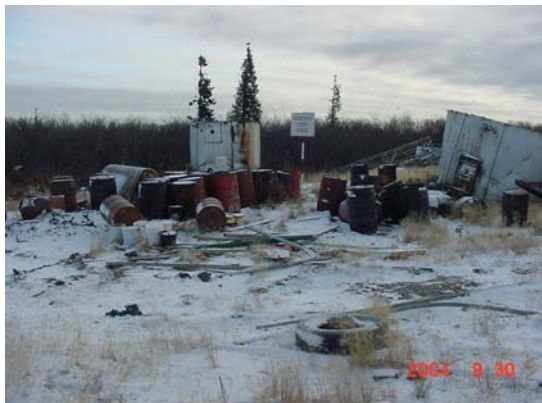
5. Sign for hazardous wastes storage area reads "Dangerous Goods Buried"(figure 7). Consultation indicated that asbestos materials were buried to the north of the hazardous wastes storage area. It is my understanding that no other hazardous wastes have been buried at this location.

Figure 7. Waste Disposal. SWDS hazardous wastes disposal area.

6. No bermed (engineered) hazardous wastes disposal area. As with other communities these areas are becoming permanent storage areas. Please ensure efforts are made to dispose of this material appropriately. Long term storage of this material is not recommended.

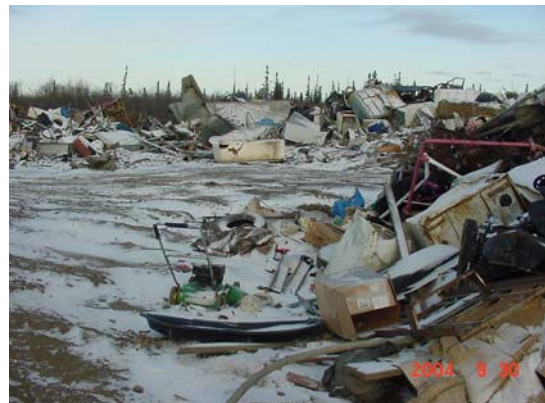
7. Bulky Metal Waste disposal Area, as indicated in the 2000 Inspection report, contains other wastes (batteries, tires, wood debris, etc).

Figure 8. Waste Disposal. SWDS bulky wastes disposal area.

4. Numerous lead acid batteries in and around the landfill (especially the bulky waste disposal area). This material should be segregated and stored in a designated area (i.e. the hazardous wastes storage area).
