## 2003 Hamlet of Tuktoyaktuk Annual Water Licence Report

Prepared by AECOM for the Hamlet of Tuktoyaktuk

### INAC Inspection Report

MUNICIPAL WATER USE INSPECTION FORM

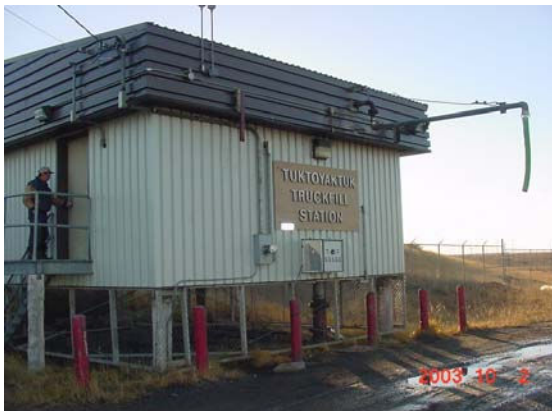
- Treatment Facility (Tuk. Truckfill Station) (figure 1) diesel fuel storage container (figure 2) has no double containment and has corroded transfer line (figure 3). In addition the transfer line is not protected. Careful inspection of the line and use of a double contained container should be considered. There is potential for a fuel spill. If fuel spill does occur fuel will travel south east and enter a pond approximately 25 m away. Currently this pond does not serve any particular use.
- Old 200 L drum (figure 2) should be removed and disposed of at an appropriate area.

**Figure 1.** Water Supply. Water treatment plant and transfer station

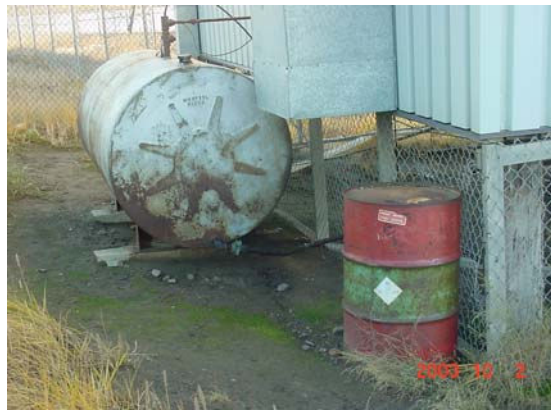
**Figure 2.** Water Supply. Fuel storage at water treatment plant.

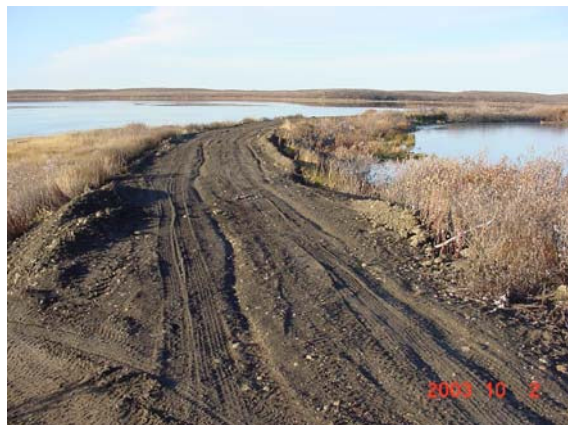
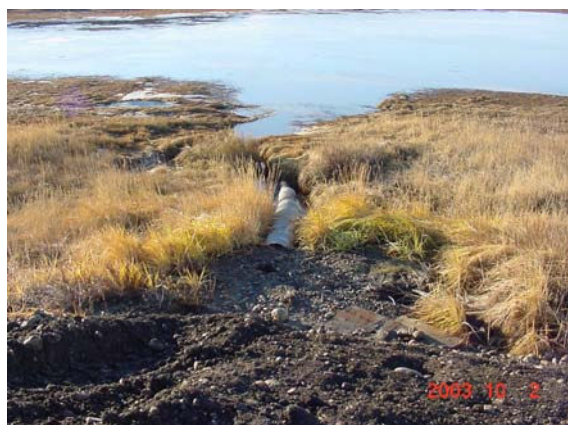
- Discharge of the Sewage Lagoon (figures 4-7) was requested on August 26, 2003. Approval of the discharge was rejected due to high pH levels that could potentially harm aquatic ecosystems (above pH 9). As per our letter dated October 22, 2003 fall emergency decant was authorized to maintain structural integrity of the containment berm (Figure 4,5) and thus Sewage Lagoon. All other parameters were sampled on time and met license effluent quality standards. After review of previous year’s analytical results this trend was not seen. In the future, industrial discharges to this lagoon will be discouraged until the Hamlet can meet their License Discharge criteria. As a note the Hamlet was diligent and made every effort, through sampling and delaying discharge, to meet discharge criteria.

**Figure 4.** Waste Disposal. Sewage lagoon (south west end) at containment berm.

**Figure 5.** Waste Disposal. Sewage lagoon (south west end) at containment berm.

**Figure 6.** Waste Disposal. Sewage lagoon (south west end) discharge location.

**Figure 7.** Waste Disposal. Sewage lagoon intake structure.

- Work was done to sewage lagoon containment berm this year (July). In general fill material was placed on berm to fix erosion that had occurred in previous years. Berm is now in good condition.

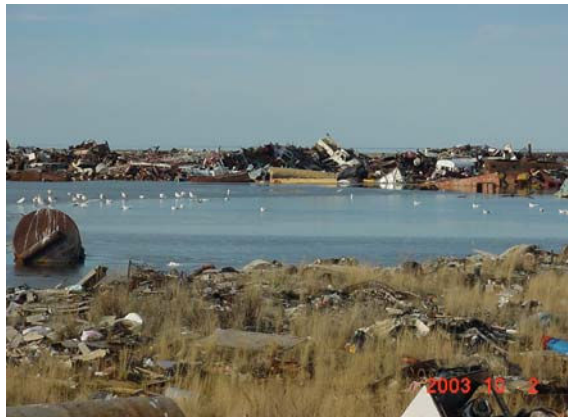
- Currently there is no disposal area for old lead acid batteries. This issue should be addressed.
- Oil and fluids in old vehicles disposed of at the metal waste storage area (figure 12, 13) are not drained and removed. It is a matter of time before this material escapes causing contamination of ground and/or surface water.

**Figure 12.** Waste Disposal. Landfill north west view with metal waste storage area in background.

**Figure 13.** Waste Disposal. Landfill east view with metal wastes storage area in background.

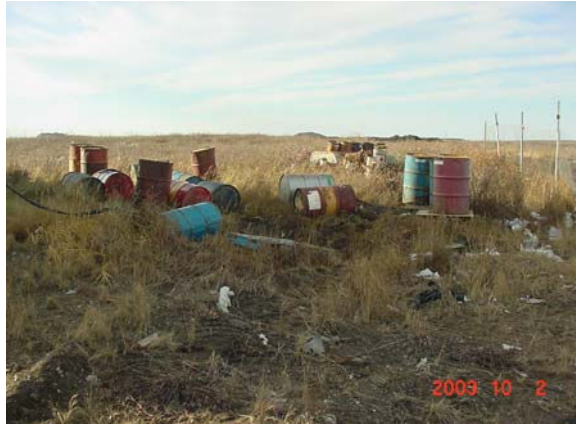
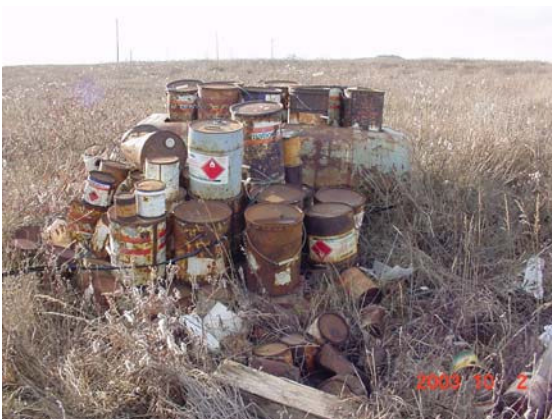
- Fence around the SWDS needs repair. There are various areas that show damage.
- Like many communities the waste oil and hazardous materials area (Figure 14, 15) are becoming permanent storage areas. It is recommended that every effort be made to dispose of these materials at a certified disposal facility. Long term/permanent storage of this material is not recommended. It is only a matter of time before spills occur and this becomes a liability. It is understood that there is a plan to dispose of this material at Grubens. However, there is no timeline. Plans should be made to address this issue and should be addressed in the O&M Plan.

- Hazardous waste storage area (figure 14, 15) needs to be designed appropriately.

**Figure 14.** Waste Disposal. Landfill waste oil and hazardous wastes area.

**Figure 15.** Waste Disposal. Landfill waste oil and hazardous wastes area.

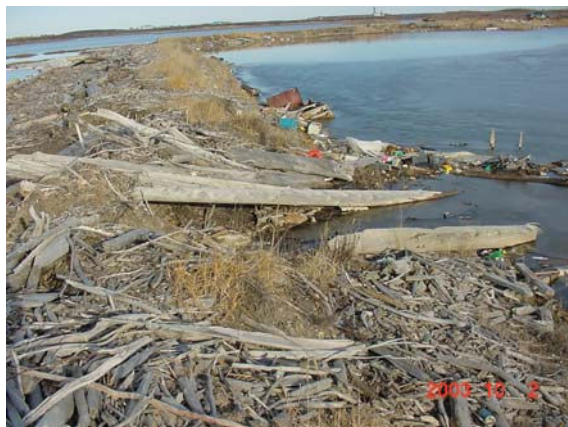
8. Solid waste Disposal Site (SWDS) North West containment berm (figure 16) needs repair. This is an area of potential failure. As indicated during the inspection there are plans to fix the berm at this location.
9. O&M plan was submitted in September 2001. Upon consultation with the board this plan has not been accepted because of outstanding information required by the Hamlet.

**Figure 16.** Waste Disposal. Landfill north west containment berm.
