# 2005 Hamlet of Tuktoyaktuk Annual Water Licence Report

Prepared by AECOM for the Hamlet of Tuktoyaktuk

## MUNICIPAL WATER LICENCE INSPECTION REPORT

DATE:	July 5, 2005	COMPANY REP:	Dave Krengnektak (Acting Foreman)
LICENSEE:	Incorporated Hamlet of Tuktoyaktuk	LICENCE #:	N7L3-0714 (Renewal)

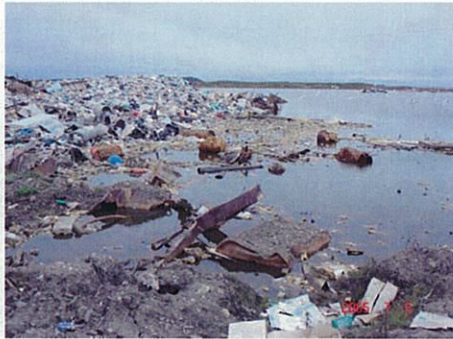
1. As indicated in the 2003 and 2004 Inspection Reports the old/historic Solid Waste Disposal Facilities (SWDF) waste oil and hazardous materials area (Figure 10-12) are becoming permanent storage areas. It is recommended that every effort be made to dispose of these materials at a certified disposal facility. Long term/permanent storage of this material is not recommended. As indicated in the 2004 Inspection Report it is only a matter of time before spills occur. This in fact is now the case as various materials in and around the area have escaped included a large area where pooled oil was found (figure 12). Lastly, it seems that there is no designated area for these materials. It is assumed that these materials are being deposited in the domestic garbage disposal area which eventually make their way to the SWDF Lagoon (figure 9)

**Figure 9. Waste Disposal.** SWDF general south view.

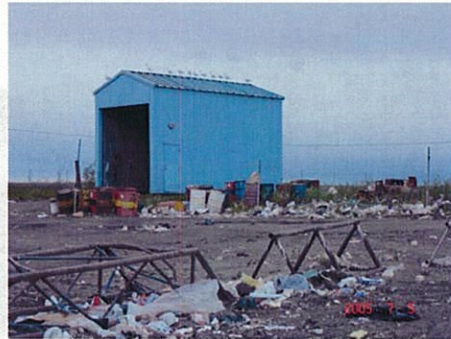
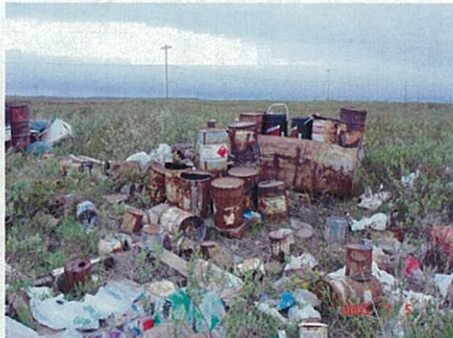
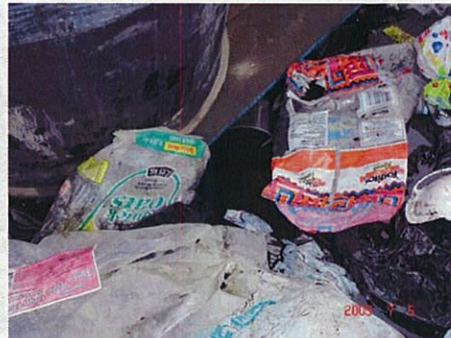
**Figure 10. Waste Disposal.** SWDF waste oil and hazardous wastes area.

**Figure 11. Waste Disposal.** SWDF waste oil and hazardous wastes area.

**Figure 12. Waste Disposal.** SWDF waste oil and hazardous wastes area and pooled/spilled oil.

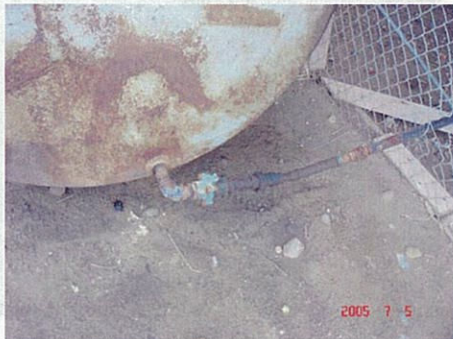
1. As indicated in the 2003 & 2004 Inspection Report there is a small fuel spill at water treatment plant (figure 13). Fuel tank and distribution/conveyance lines badly corroded.

- The Hamlet is aware of the poor condition of this tank and the distribution lines both in 2003 and 2004.

**Figure 13. Fuel Storage.** Fuel storage at water treatment plant.

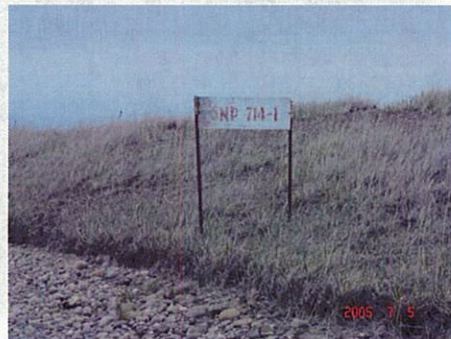
1. SNP 0714-1 needs to be re-painted (figure 14).
2. SNP 0714-2 & 3 signs (figures 15&16 respectively) posted but should be relocated. Please see SNP, concern 1 in the 2004 Inspection Report.

**Figure 14. SNP.** SNP 0714-1 Water Reservoir.

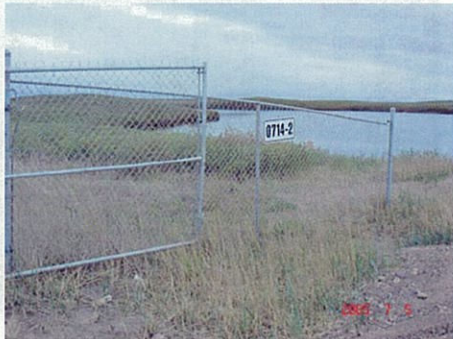
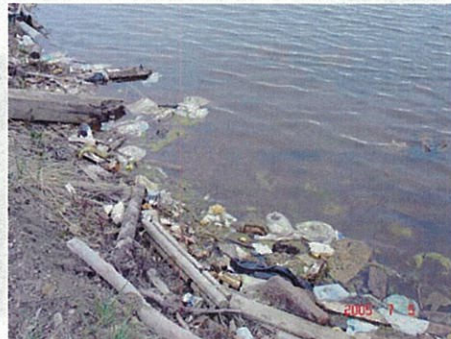
**Figure 15. SNP.** SNP 0714-2 Effluent Discharge structure at the Sewage Lagoon.

**Figure 16. SNP.** SNP 0714-3 at North east Solid Waste Lagoon.

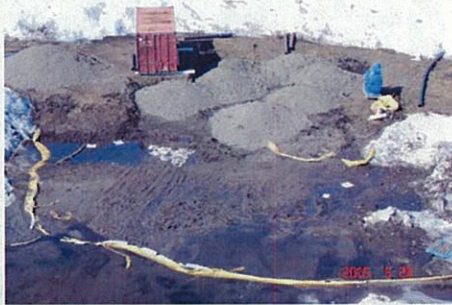
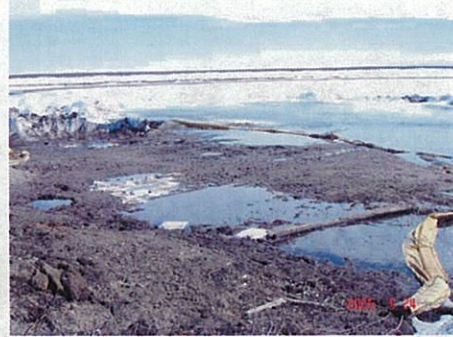
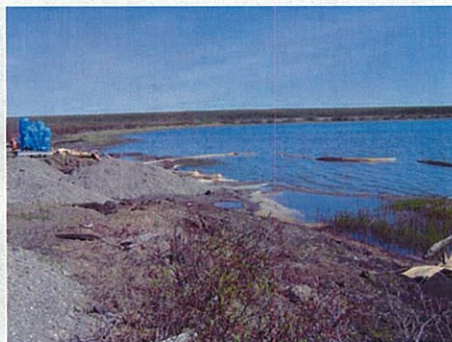
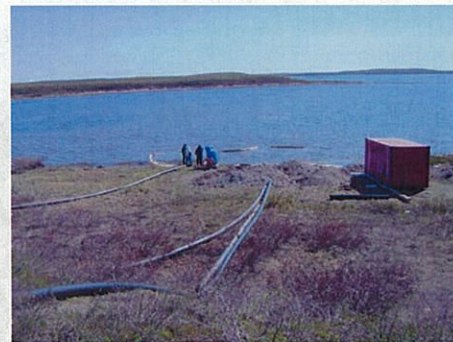
1. Spill 04-572 clean up still in progress (figure 1-4).
2. Bag of chemical above the doorwell and should be stored in appropriate area (figure 5).
3. Water meter at the time of inspection did not work.
4. Relating to spill 04-572 pumping facilities at Kudlak Lake (figure 1) and water treatment facility (figure 13) are unacceptable. Specifically this relates to fuel storage and Spill 04-572 which has still not been cleaned up and remediated.

**Figure 1. Water Supply.** Kudlak Lake 050524 spill 04-572. Investigation Pending.

**Figure 2. Water Supply.** Kudlak Lake 050524 spill 04-572. Investigation Pending.

**Figure 3. Water Supply.** Kudlak Lake 050628 spill 04-572. Investigation Pending.

**Figure 4. Water Supply.** Kudlak Lake 050628 spill 04-572. Investigation Pending.

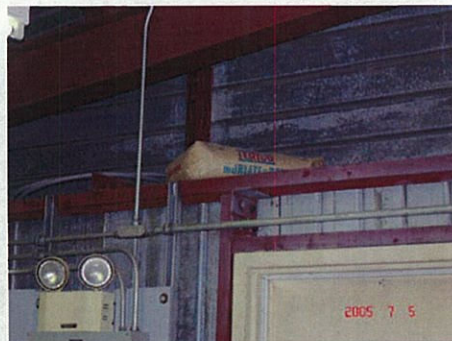
**Figure 5. Water Supply.** Water Treatment Building.

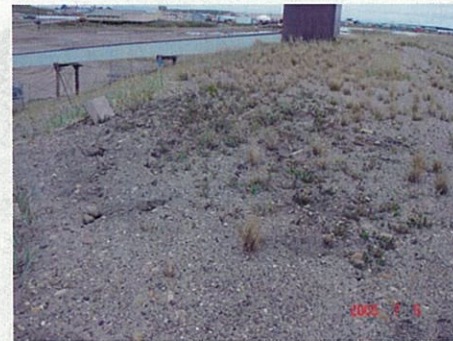
**Figure 6. Water Supply.** Water Reservoir.

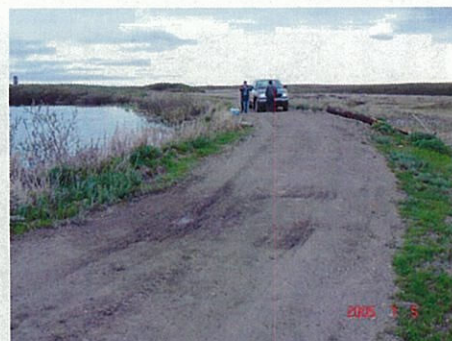
- No leaks found at the Sewage and SWDF Lagoon containment berms.
- No decant from Sewage Lagoon after the last inspection period. The last decant occurred in October 2004. An assessment will be made in the next Inspection Report. The 2004 Inspection report indicated high pH levels above MAC criteria.

**Figure 7. Waste Disposal.** Sewage Lagoon containment berm.

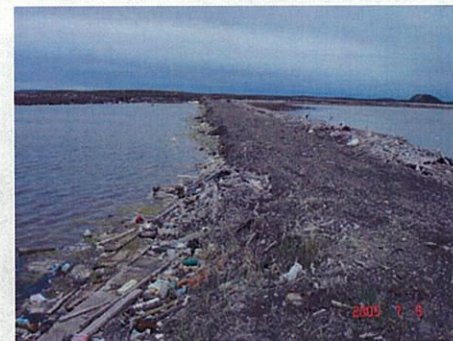
**Figure 8. Waste Disposal.** SWDF Lagoon containment berm.
