Hamlet of Tuktoyaktuk

Background Report for Water Licence Renewal (2015)

AECOM

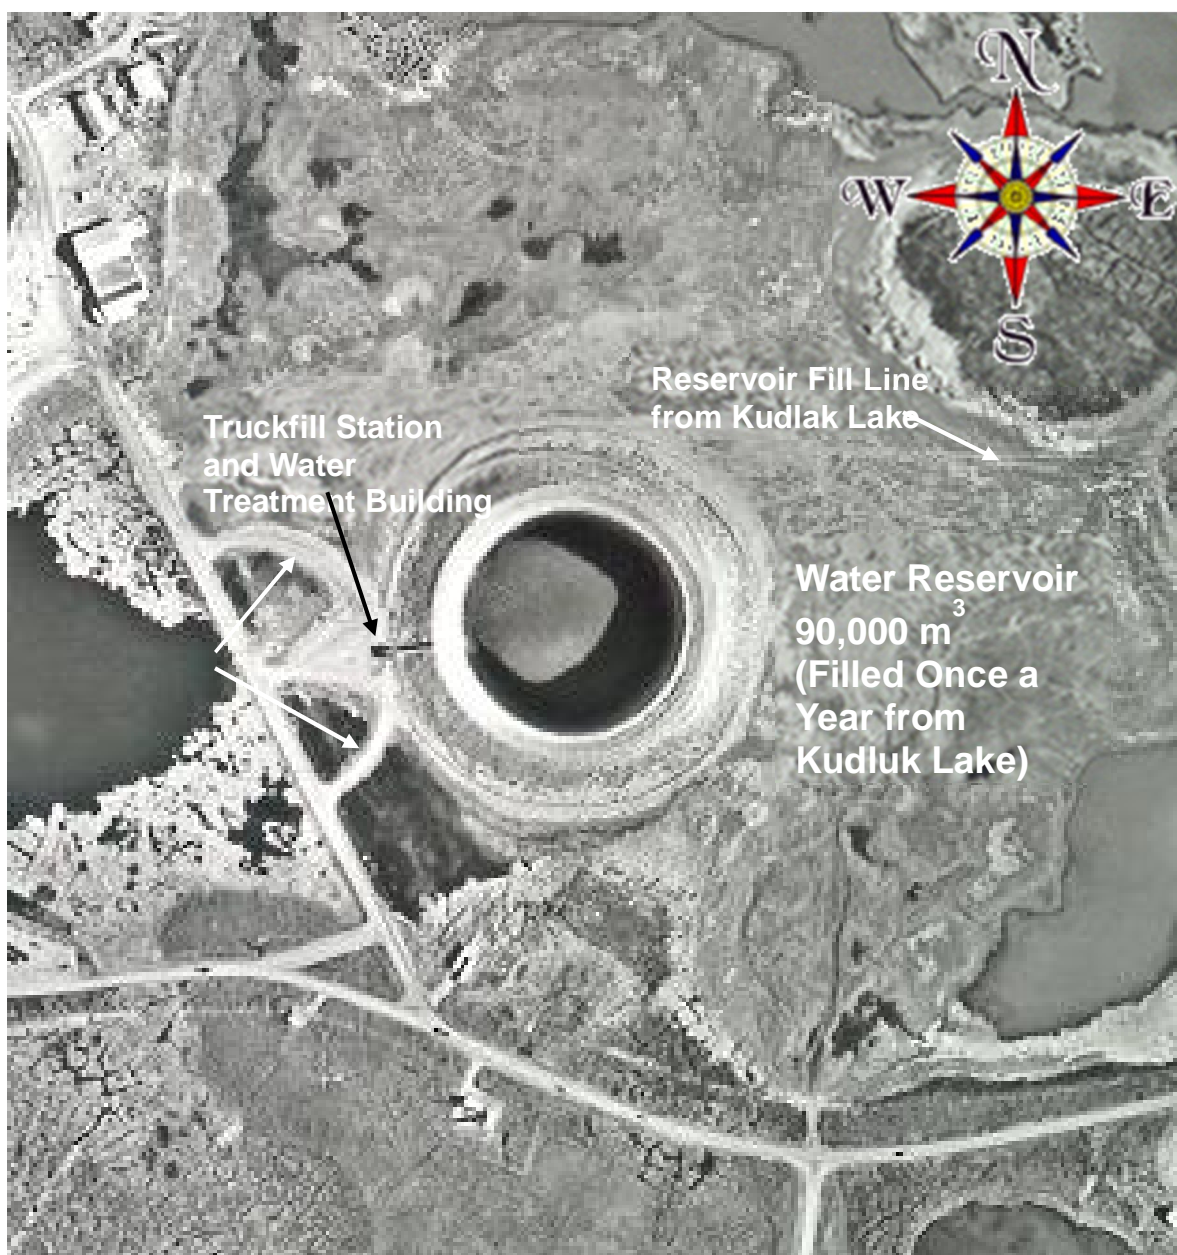
Figure 2. Water Supply Site Plan

See **Figure 2** for the water supply site plan and **Figure 3** for water supply photographs.

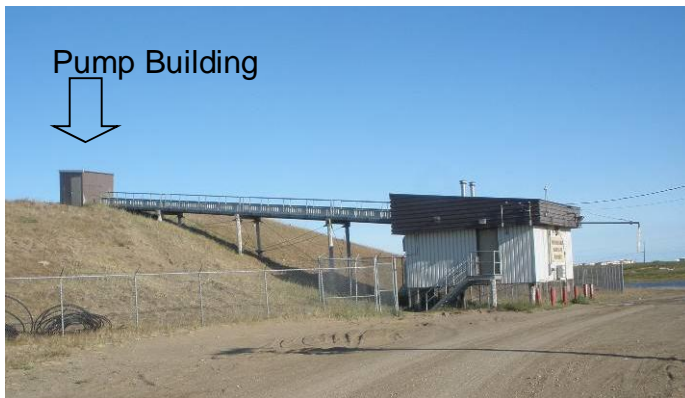
**Water Reservoir**

The water reservoir, built in 1984, is an earth structure with a capacity of approximately 90,300 m³. The reservoir characteristics are presented in **Table 2** below.

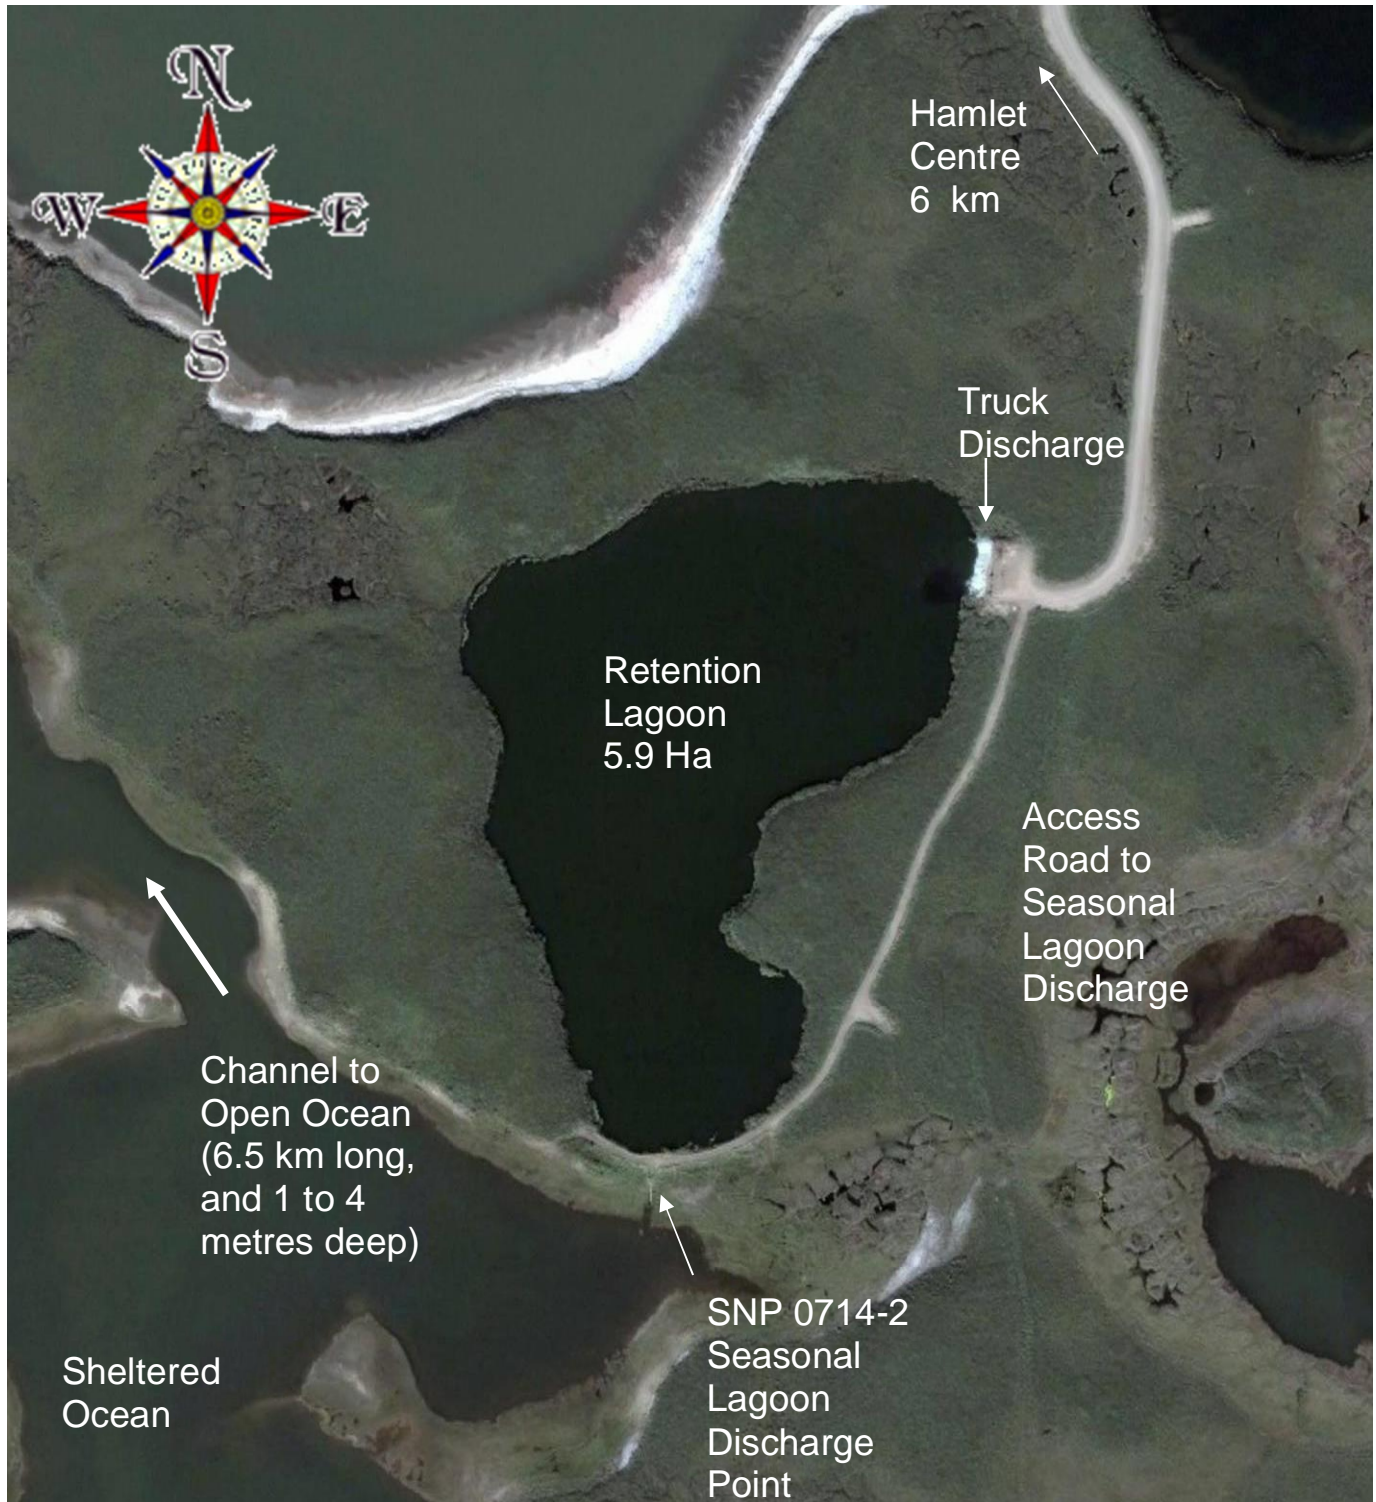
Figure 4. Sewage Lagoon Site Plan

Tuktoyaktuk's sewage is collected using trucked pumpout services. The sewage is treated at a sewage lagoon, shown in **Figures 4 and 5**, which is located approximately 3.9 km due south of the Airport Terminal Building.

The Hamlet's sewage lagoon is located approximately 5.8 km due south from the Hamlet Office, or 3.9 km south of the Airport Terminal Building, and 1.5 km southwest of the Reindeer Point subdivision.

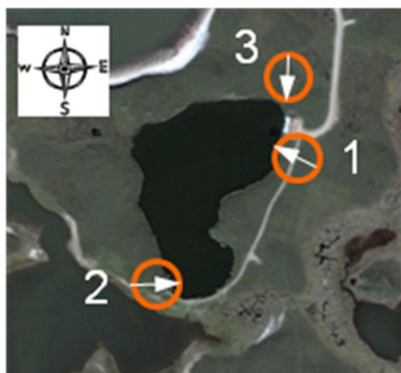
View 3 – Discharge Structure in 2009

The dispersion structures at the sewage lagoon consist of a timber retaining wall and a metal ramp from the base of the retaining wall into the lagoon. The metal ramp provides a means of effluent dispersion into the lagoon and provides erosion protection to the retaining wall.

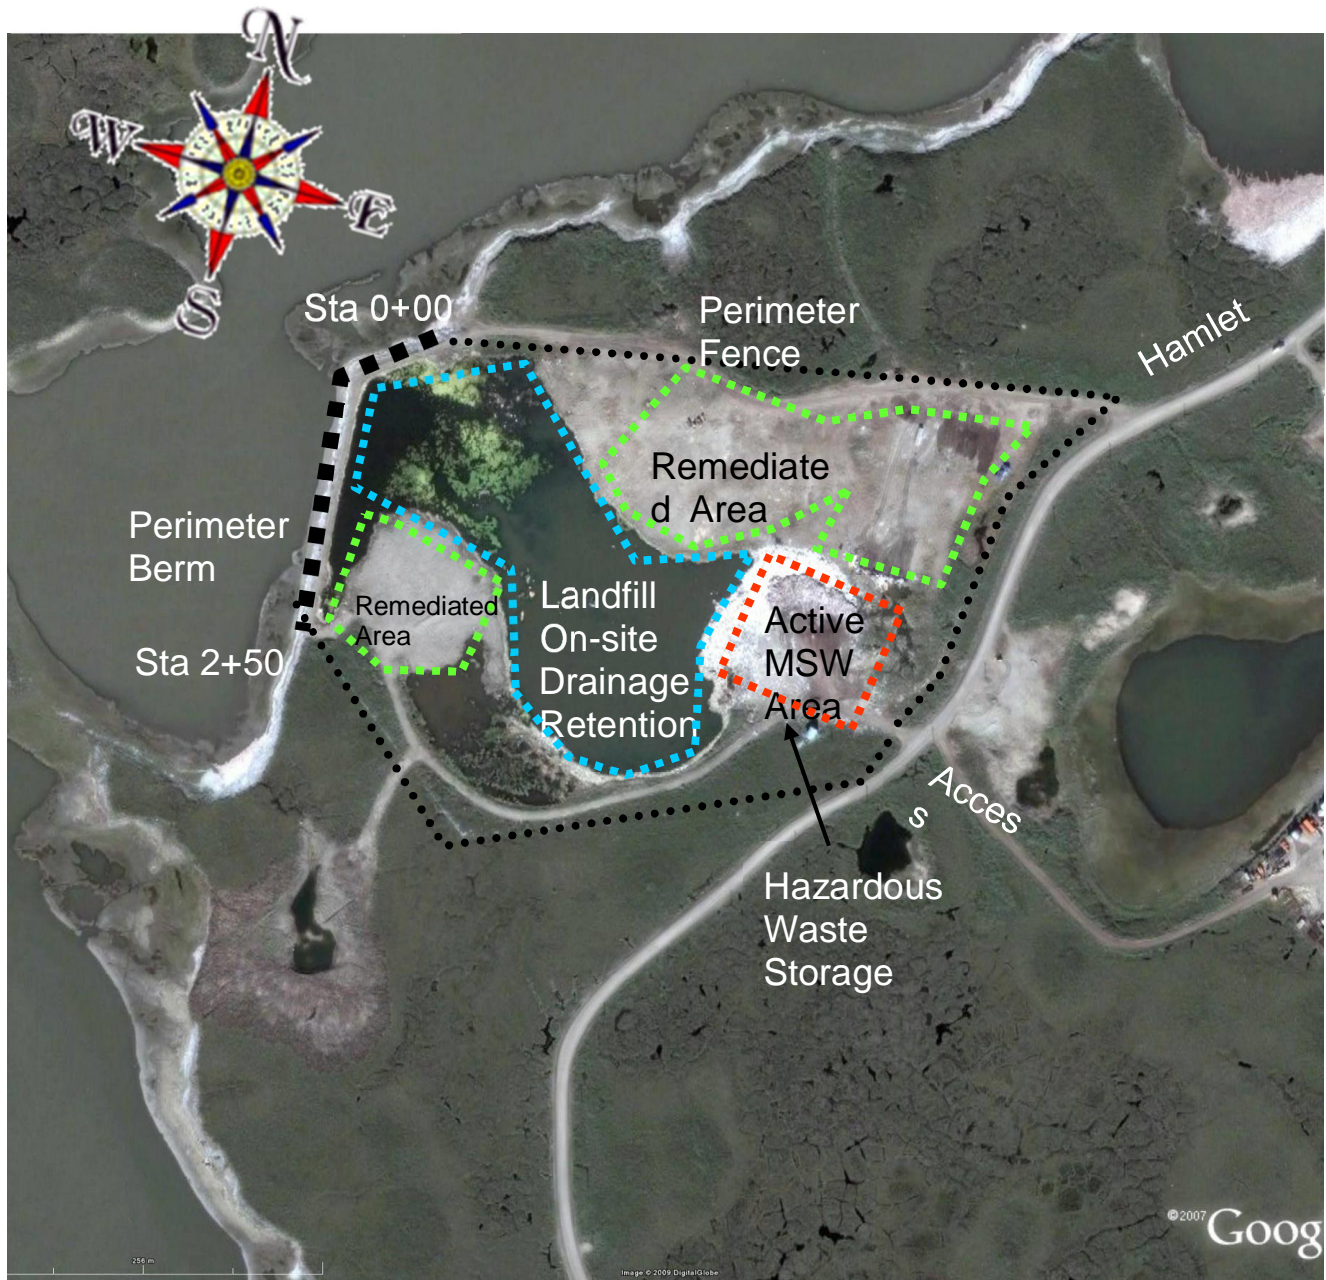
Figure 6. Landfill Site Plan

Tuktoyaktuk's solid waste is collected by truck and transported to the solid waste landfill, approximately 3 km south of the Hamlet. The landfill site consists of the following components:

- Perimeter fence and access roads to landfill areas
- Active municipal waste disposal area (east area)
- Bulky waste disposal area (south area)
- Remediated disposal areas
- On-site drainage retention system.

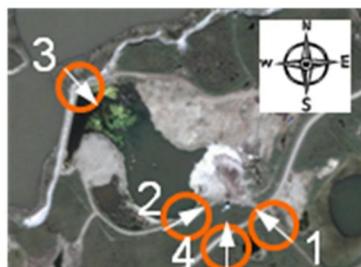
**View 3: Perimeter berm**

Most of the surface area of the Solid Waste Disposal facility is covered by a lagoon containing surface runoff from the landfill. The surface runoff lagoon is retained by a 250 m long gravel and clay berm on the eastern edge of the landfill site.

The berm does not have any discharge control structure, so drainage continually accumulates. The perimeter berm also prevents the ingress of the ocean.

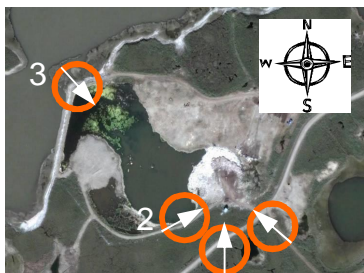
**View 4: Active Municipal Solid Waste (MSW) Area in 2009**

The municipal waste area occupies an area approximately 70 m wide and 50 m long. The landfill is operated with limited compaction and limited cover.
