SEWAGE LAGOON DISCHARGE ASSESMENT
TUKTOYAKTUK, NT

Government of the Northwest Territories
Department of Municipal and Community Affairs

February 2005
IEG Project 5727-04

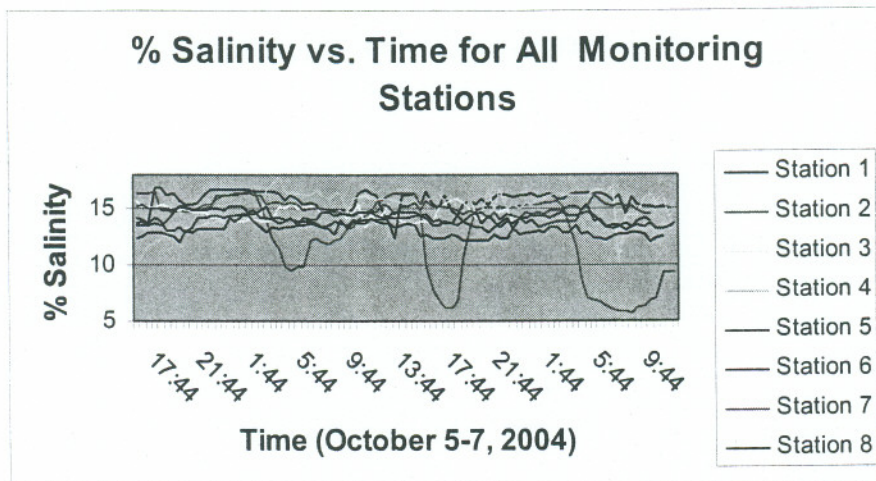
Figure 1 Plume Delineation, Station Summary

The following is a comparison graph of the salinity versus time for all eight stations throughout the entire discharge process. It can be clearly seen the only station influenced by the discharge is station 2. The salinity at station 2 decreased shortly after the pump started pumping and returned to background levels approximately 2 hours after the pump stopped pumping. The following are observations of when the pump was either on or off during the study.

- Pump started at approximately 18:30 October 5th
- October 6th
 - Pump is off at 9:00
 - Pump is on at 11:00
 - Pump is off at 14:45
 - Pump is on at 16:00
 - Pump is on at 19:00

- Pump is off at 21:30
- October 7th, pumping started again at approximately 10:00

- The data correlates to when the pump was on/off. During the operation of the pump salinity dropped to a low of 6.5% and returned to background levels within 2 hours of the pump turning off.

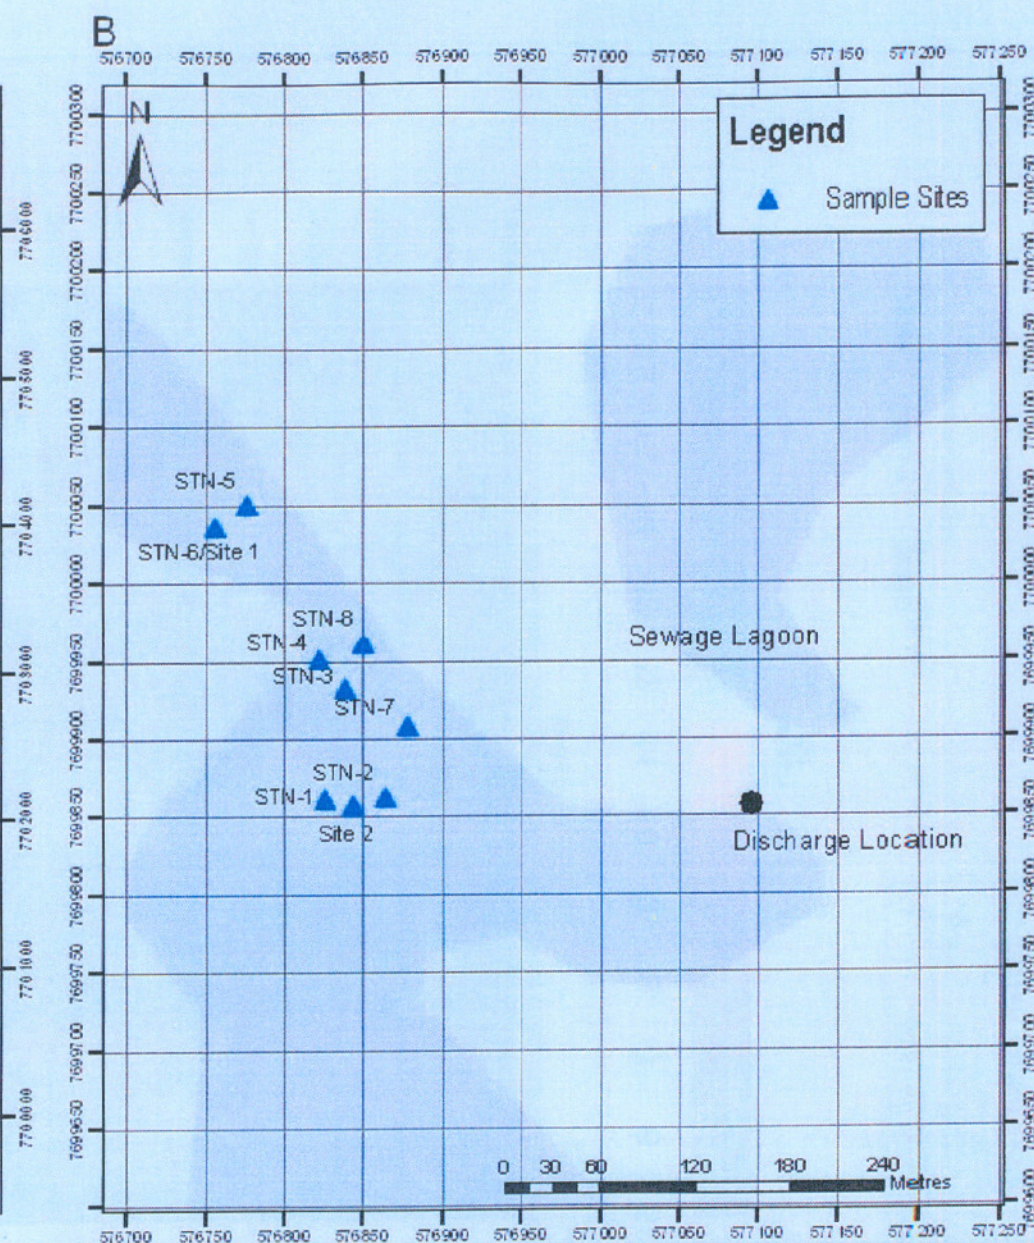
DEPT OF MUNICIPAL & COMMUNITY AFFAIRS - GNWT
 Tuktoyaktuk Sewage Lagoon - Discharge Monitoring Program
 Data Collected October 6, 2004 datum: NAD 83

Tuktoyaktuk Sewage Lagoon Study Site

All three site locations are indicated on Figure 1 in Appendix A.

The location of the eight probes was limited by the area of open water, the locations of the meter stations are identified in Figure 1, Appendix A. The average depth of the water at all eight stations was 0.75 m and the average depth of the probes was 0.6 m

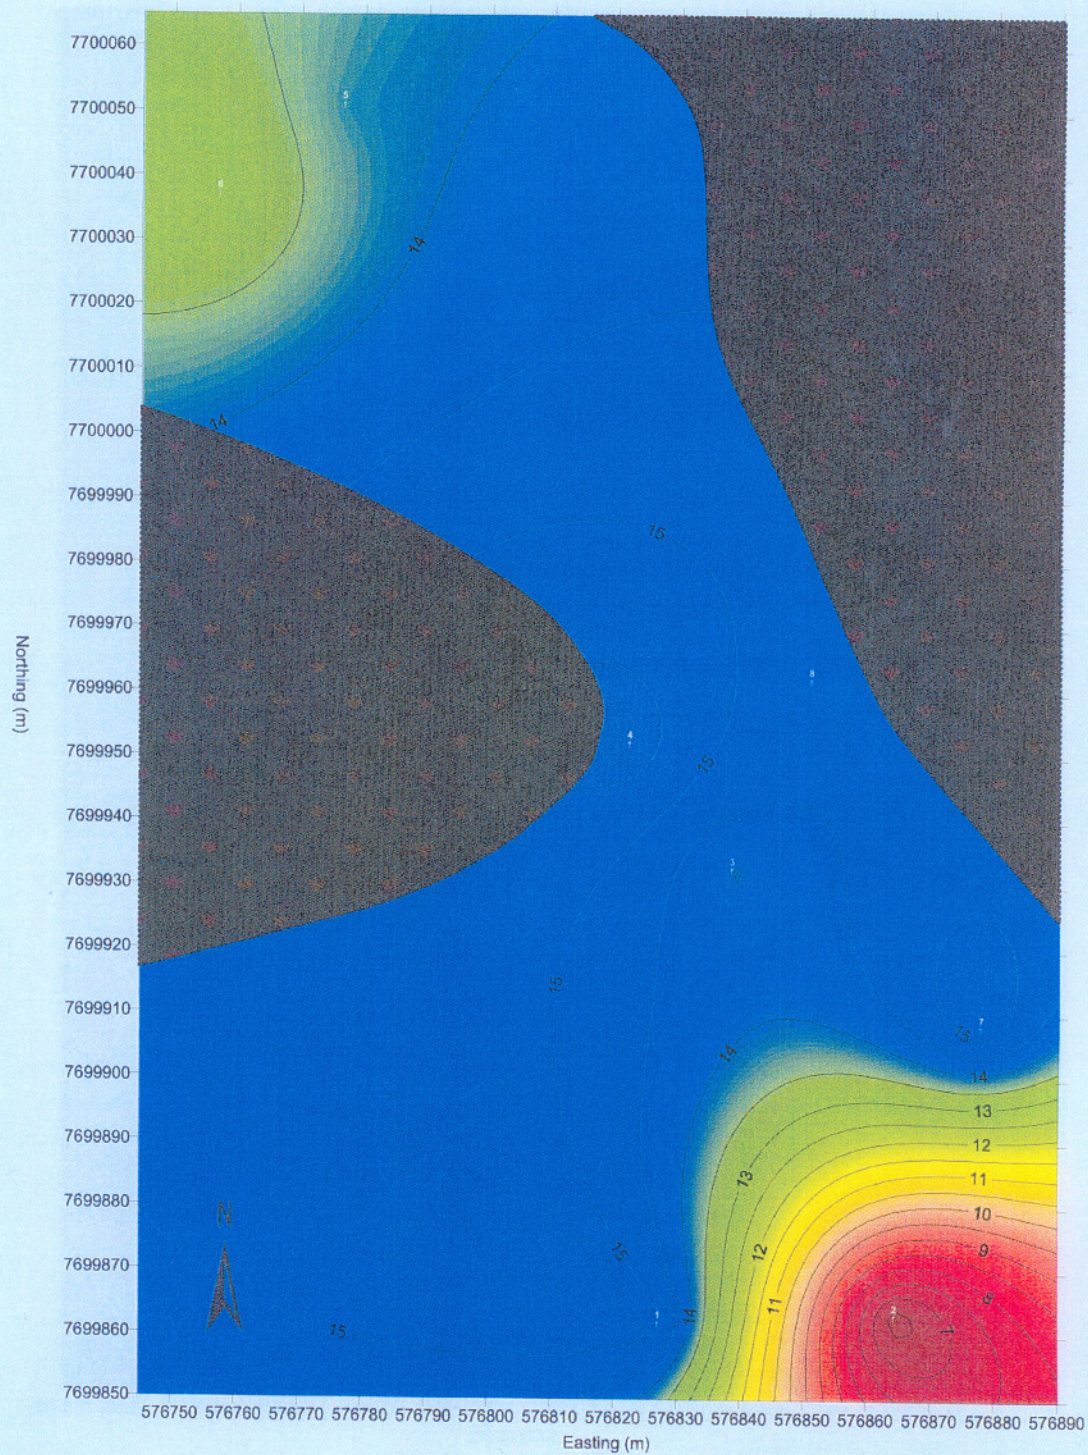
Project 5727-04 November 16, 2004 Figure 3

INUVIALUIT LAND ADMINISTRATION
Tuktoyaktuk Sewage Lagoon
Discharge Monitoring Program
Data Collected October 7, 2004
Positional data by GPS, NAD83 datum

SEAWATER SALINITY MAP (15:00-16:00)

To delineate the effluent plume salinity readings were used. As freshwater in the lagoon was pumped into the bay it mixed with salt water from the ocean and the salinity dropped. This was observed and recorded to produce Figures 2-4 which displays the size and extent of the effluent plume. Figure 2 shows the receiving water before the discharge, figure 3 shows the extent of the plume during discharge and figure 4 shows the plume a few hours after the pump shut off before it was started again, representing the salinity in the receiving water after discharge.

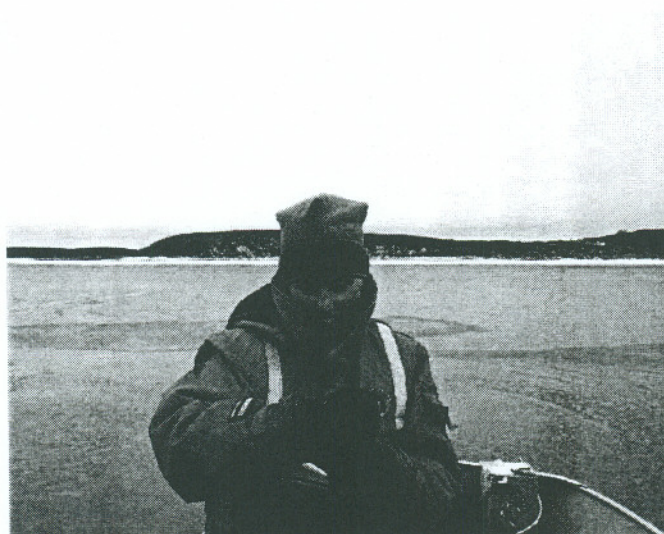
| Date: 10/4/04 | Location: Discharge Inlet | Direction: South |
| Description: Sarah Dando, IEG recording observations | | |

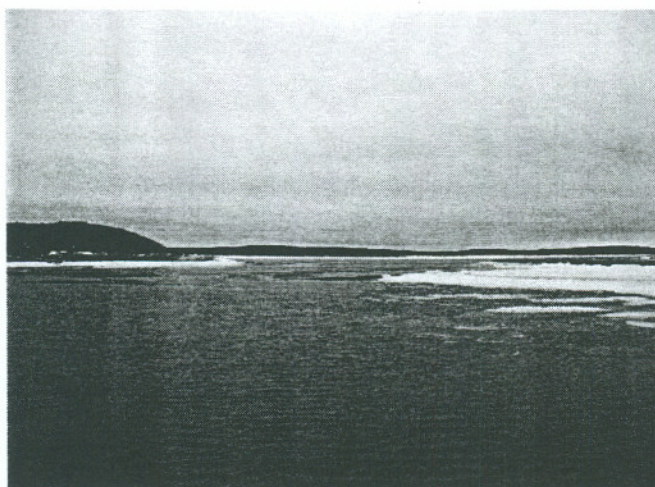
| Date: 10/4/04 | Location: Discharge Inlet | Direction: North |
| Description: Discharge Inlet leading to Kugmallit Bay | | |

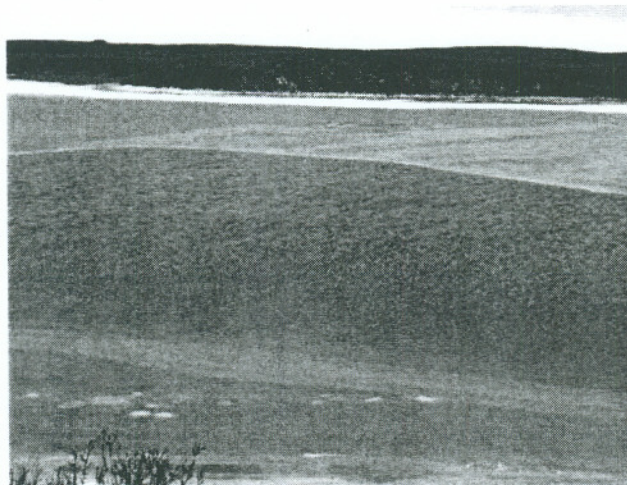
| Date: 10/4/04 | Location: Discharge Inlet | Direction: SW |
| Description: Discharge inlet taken from atop the hill | | |

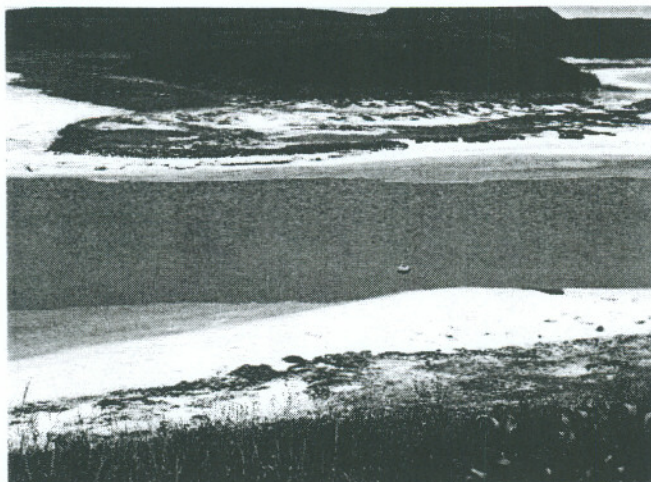
| Date: 10/4/04 | Location: Discharge Inlet | Direction: SW |
| Description: Portable Salinity Metre from atop the hill between the discharge inlet and the lagoon | | |

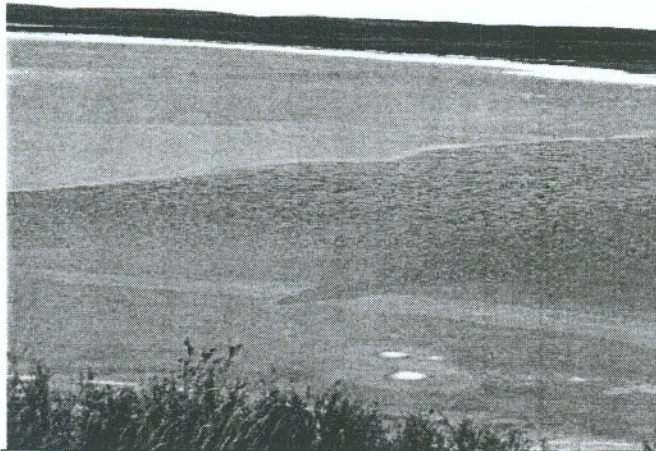
| Date: 10/4/04 | Location: Discharge Inlet | Direction: South |
| Description: Discharge inlet taken from atop the hill | | |

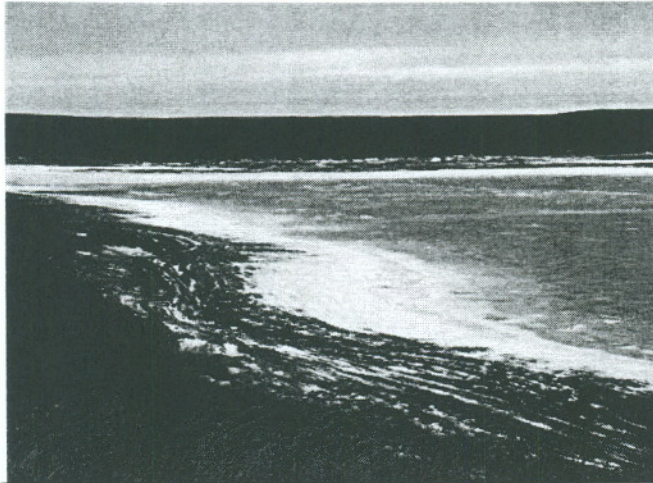
| Date: 10/4/04 | Location: Discharge Inlet | Direction: SE |
| Description: Access along beach and discharge inlet | | |

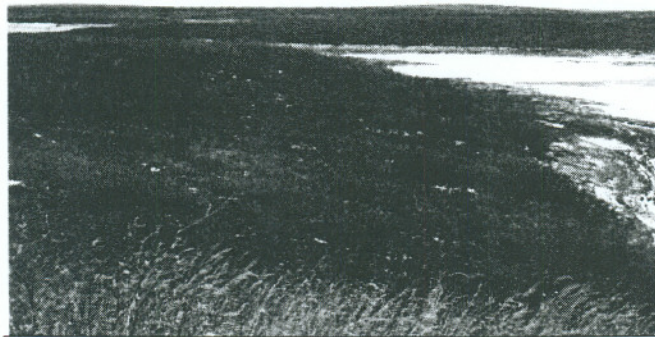
| Date: 10/4/04 | Location: Hill | Direction: SE |
| Description: Discharge, Inlet | | |

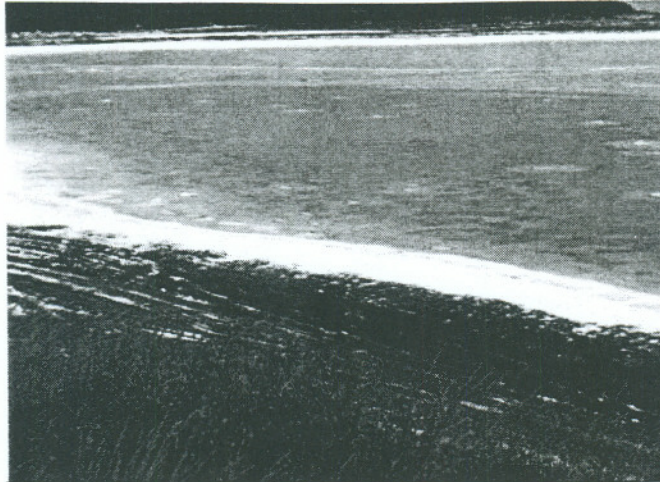
| Date: 10/4/04 | Location: Hill | Direction: SW |
| Description: Access along beach and Discharge inlet | | |

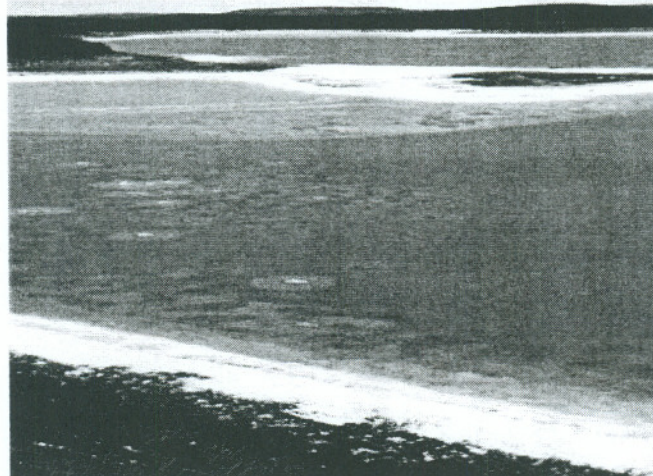
| Date: 10/4/04 | Location: Hill | Direction: SW |
| Description: Discharge Inlet | | |

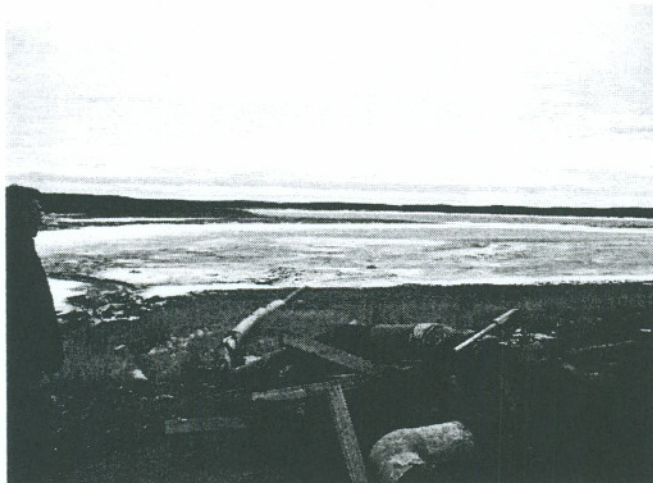
| Description: Discharge Pipe leading into discharge inlet | | |

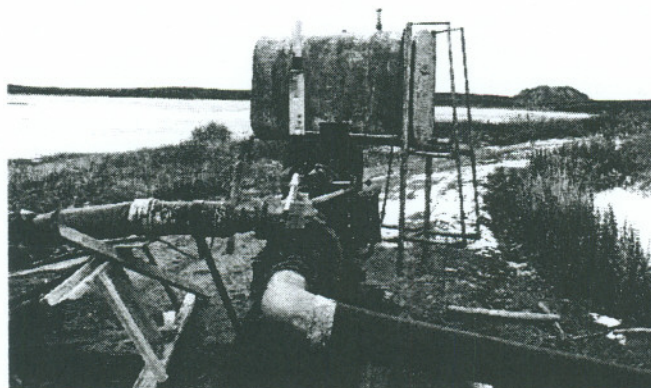
| Description: Pump station setup and standing fuel tank | | |

All municipal wastewater generated in the Hamlet of Tuktoyaktuk is collected by vacuum truck and transported to the municipal sewage lagoon located approximately 5.0 km from the community. The lagoon is a natural lake, approximately 5.9 ha in area. It has been modified with a perimeter berm at the south edge for retention purposes. The lagoon is discharged to an adjacent ocean inlet once a year in the fall. A temporary pump is set up on top of the berm to accomplish the discharge.
