**Part A
A Class B Water License
Application to Support the
1998/99 Construction Program
for the Town of Inuvik Gas
Project**

***An Application submitted to the
NWT Water Board***

Part B Creek Crossing Application for the Ikhil to Inuvik Gas Transmission Line

Creek Crossing Application for the Ikhil to Inuvik Gas Transmission Line

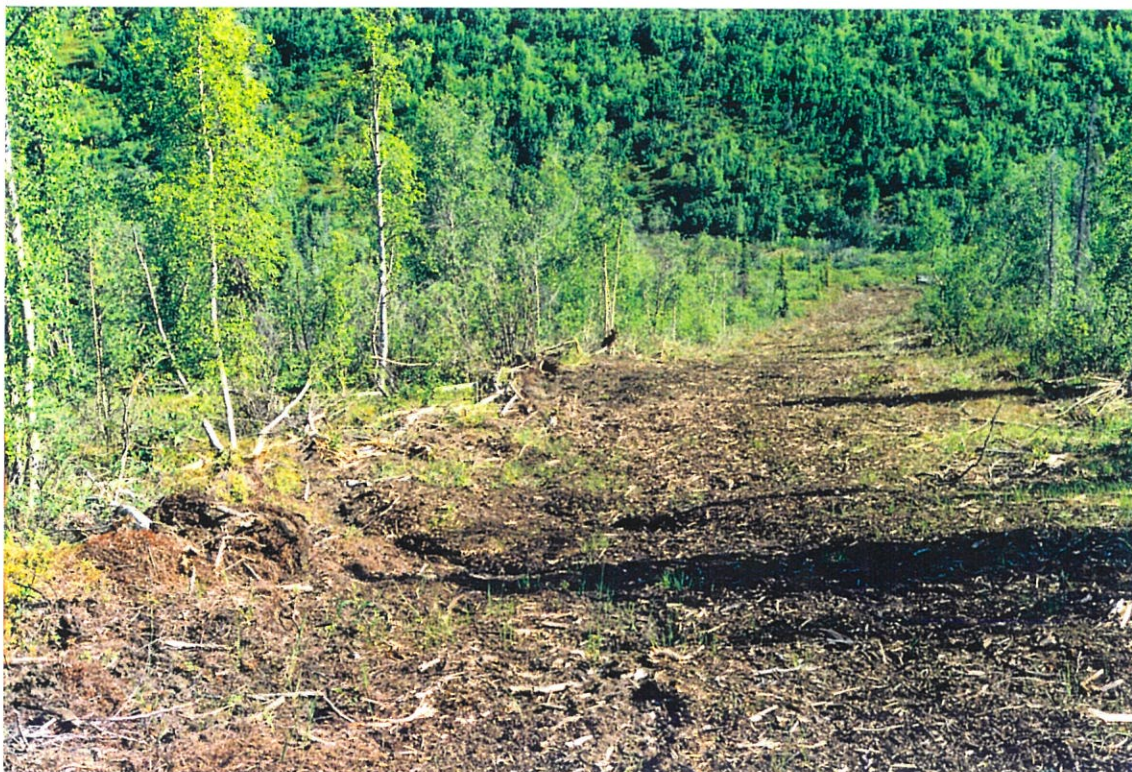
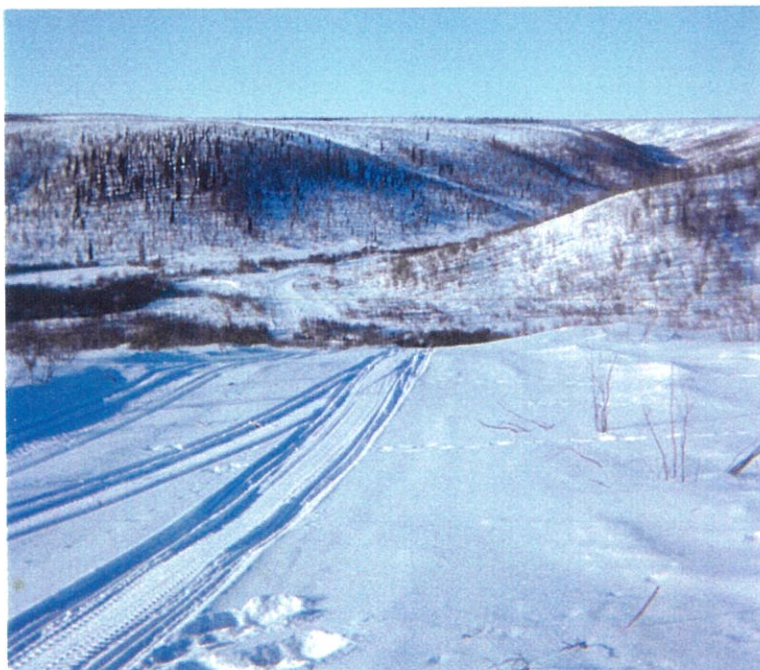
Figure 2 - Douglas Creek Ravine

Figure 3 - Douglas Creek Ravine

The Douglas Creek Ravine and Creek crossing is located at approximately kilometer post 26+380. Pictures of the ravine and creek crossing are shown in Figures 2 and 3. An elevated crossing of the ravine and creek is proposed in order to mitigate potential slope instability and to minimize environmental disturbance to the creek.

The above ground crossing of the creek is located downstream of the confluence of Douglas Creek and a tributary to Douglas Creek. The above ground crossing, will prevent most disturbances to the banks and the creek. The pipeline would be insulated and placed on pile supports approximately 8 feet above the ground. Schematic diagrams are provided in Appendix B. As shown in the drawings the pipeline will span the creek. Piles supporting the pipeline will be placed on either side of the creek.

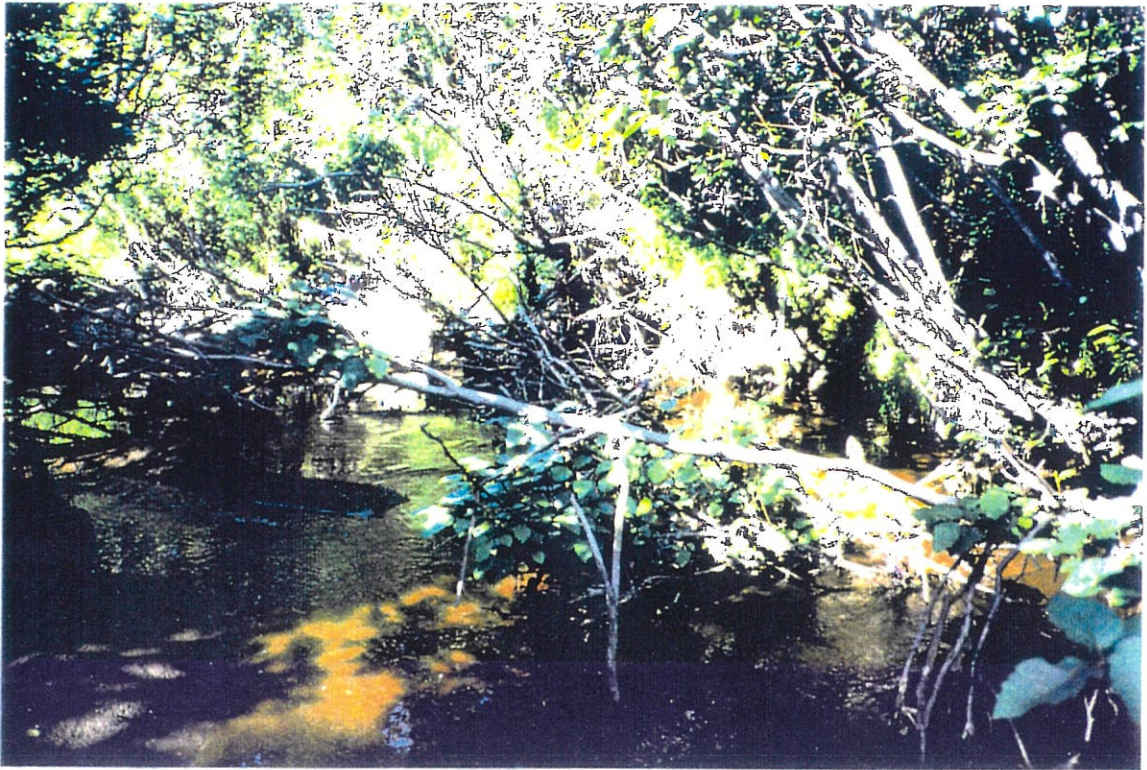
↑ Photograph 17 Class 3 run (R3) on Douglas Creek, upstream of proposed crossing site.

Douglas Creek originates from a series of small lakes on the open tundra, then enters a well-defined drainage approximately 5 km upstream of the proposed crossing. The creek flows through a mixedwood community, dominated by whitebarked birches (*Betula papyrifera*) and white spruce (*Picea glauca*), and riparian shrubs such as alder (*Alnus crispa*) and willow (*Salix* spp). Douglas Creek is a tributary to the Mackenzie River, which it enters approximately 7 km downstream of the proposed crossing. Douglas Creek is a meandering, occasionally confined watercourse with a neutral channel of moderate width to depth ratio (Photos 17-19).

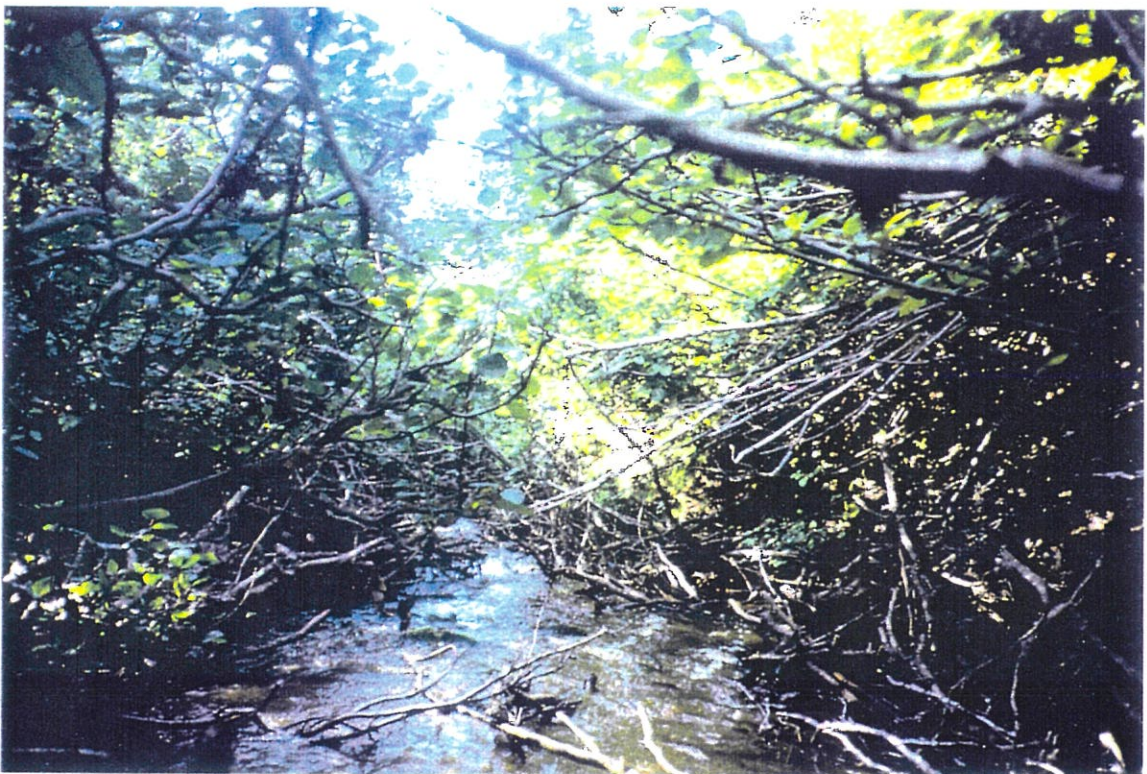
↑ Photograph 18 Proposed crossing location on Douglas Creek. Riffle/boulder garden (RF/BG) channel unit.

Douglas Creek was assessed at one location at the proposed crossing. Douglas Creek had a defined channel with an average width of 4.1 m. Discharge was measured at 0.131 m³/s just downstream of the proposed crossing. Substrate at the crossing site was 50% gravel and sand with some cobble and small boulders. The creek banks were slightly undercut and moderately unstable, with slumping banks in some areas. There was abundant overhead vegetation and

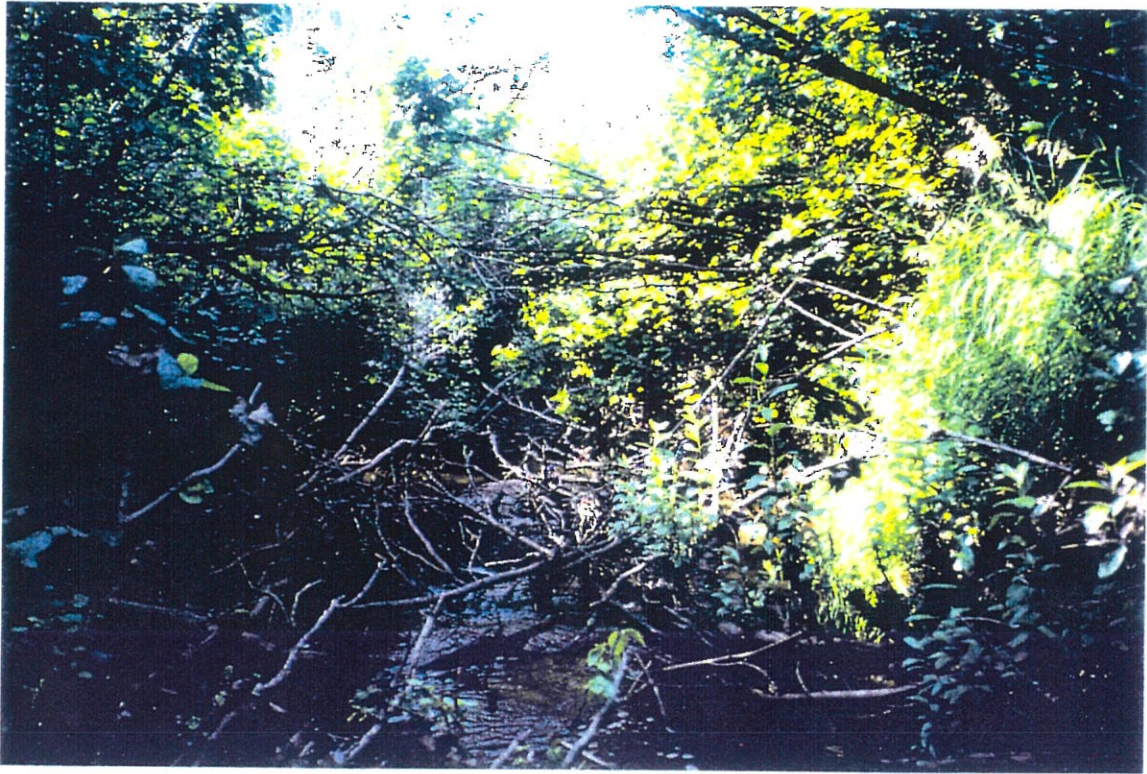
Photograph 19 Downstream of proposed crossing site, class 3 run (R3). Excellent overhanging shrub cover.

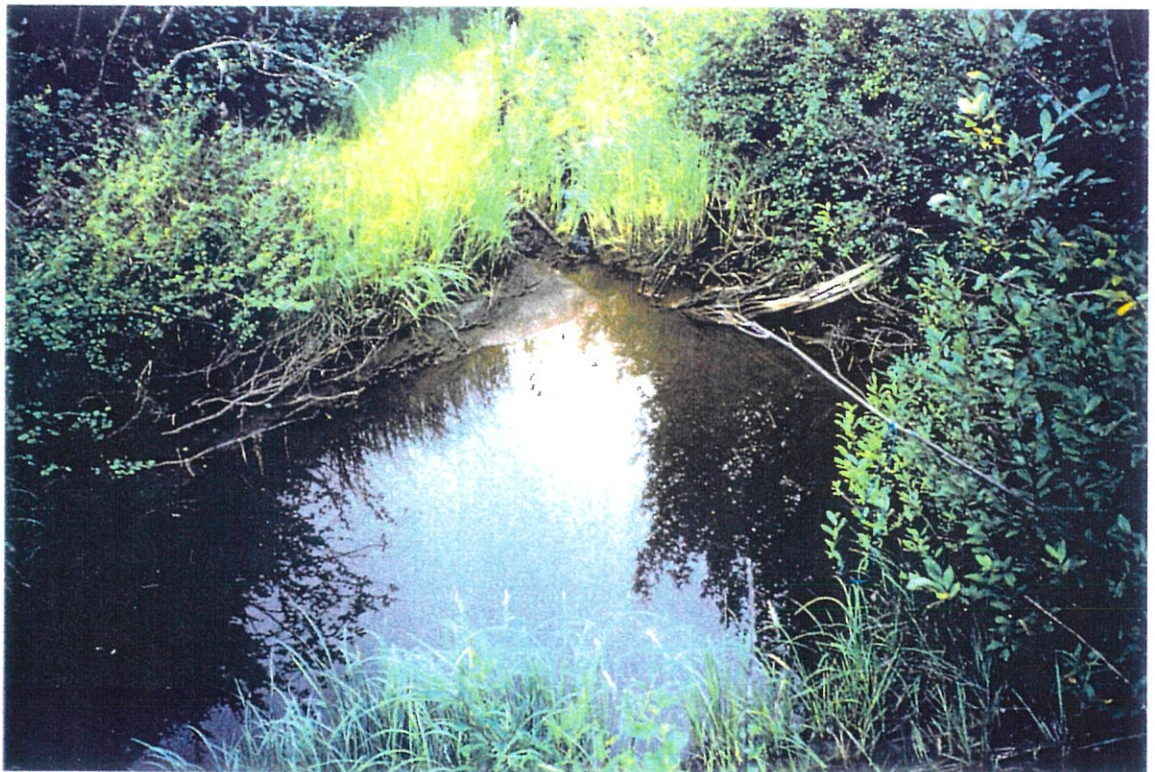
↑ Photograph 21 Class 3 pool (P3) at the proposed crossing site on the tributary to Douglas Creek.

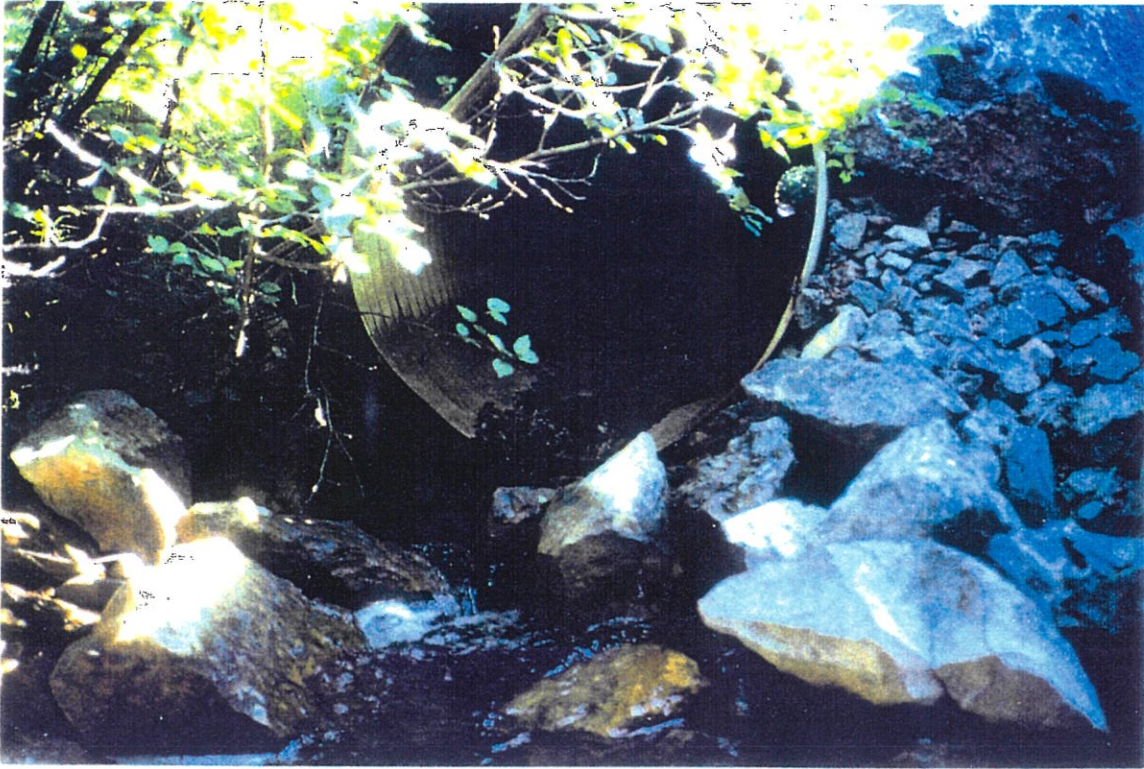
Photograph 22 Deteriorated culvert downstream of proposed crossing at an unnamed tributary, Km Post 44 + 200.

Though habitat was variable within the creek it is unlikely to support fish species. Where Navy Road crossed the tributary there were two culverts for low and high water levels. The lower of the two culverts was almost entirely disintegrated, presumably due to the low pH levels (3.0) in the water. The low pH values most likely contributed to the deterioration of a culvert along a road crossing (Photo 22). In addition, a scour pool below the culvert formed a significant barrier to upstream fish movement. There is insufficient water and lack of pools to support overwintering fish.

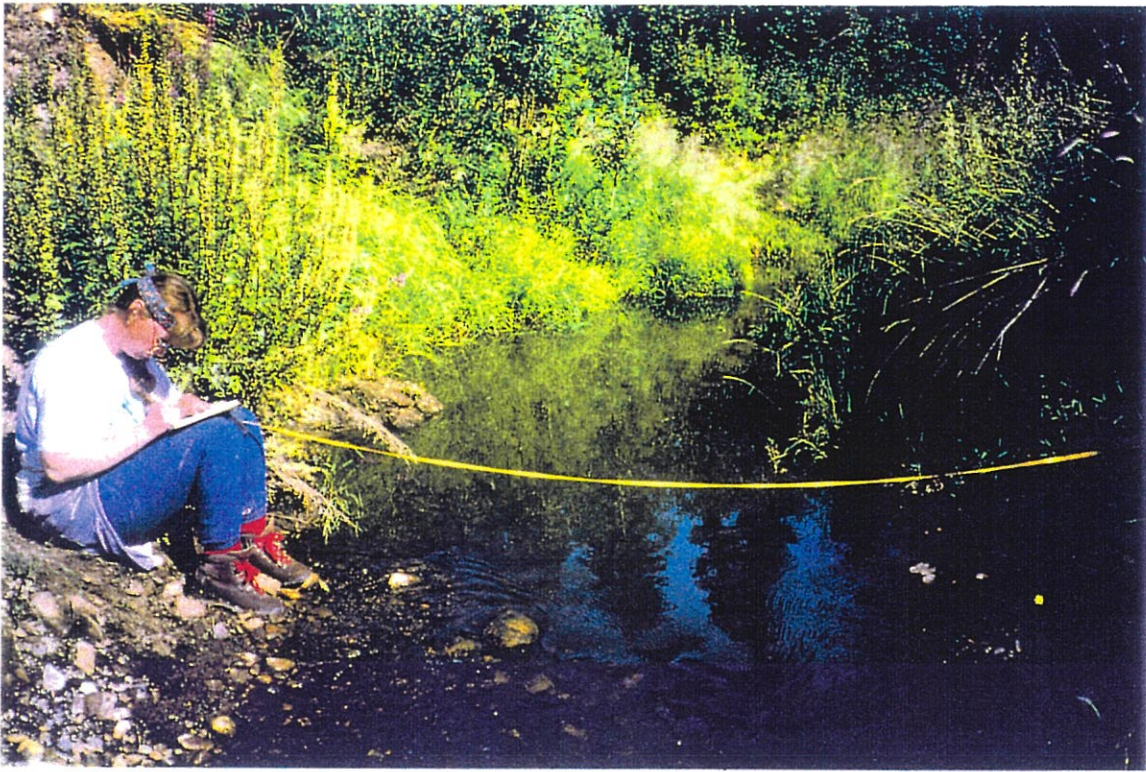
↑ Photograph 23 Discharge site upstream of proposed crossing on a unnamed tributary, Km Post 46 + 400.

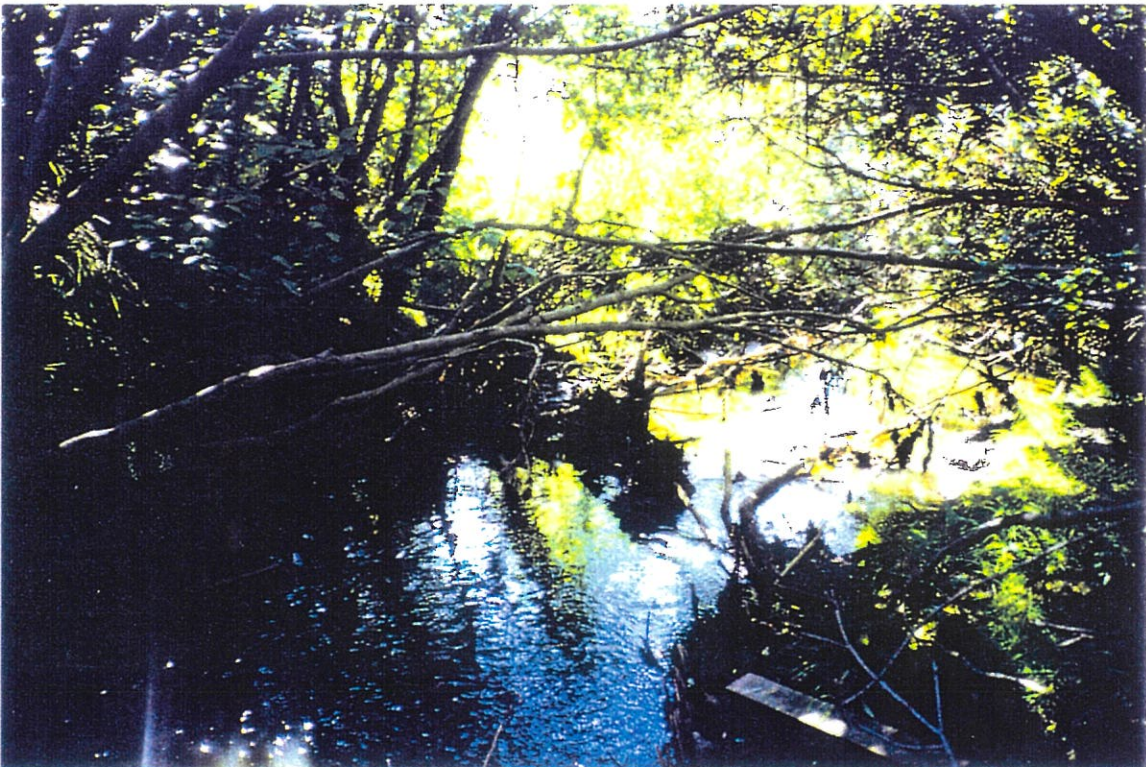
↑ Photograph 24 Looking downstream of the proposed crossing at the unnamed tributary, Km Post 46 + 400.

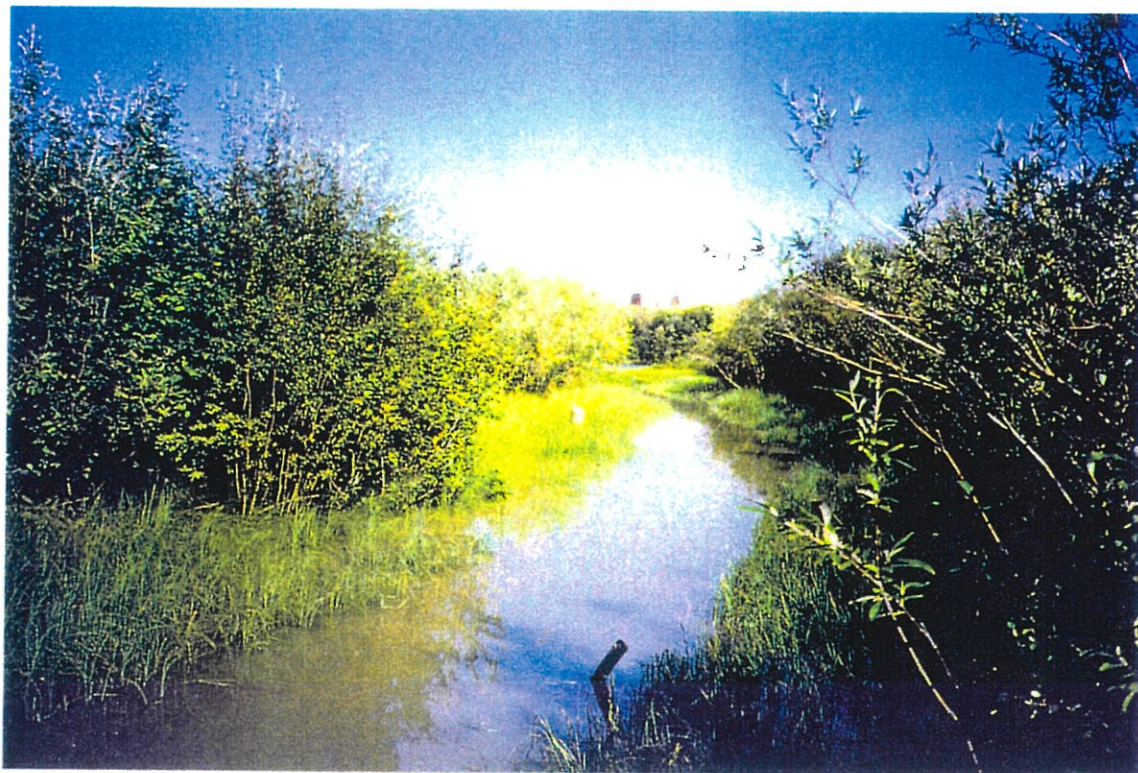
↑ Photograph 25 Looking upstream from the proposed crossing along the outlet from Twin Lakes, Km Post 47 + 815.

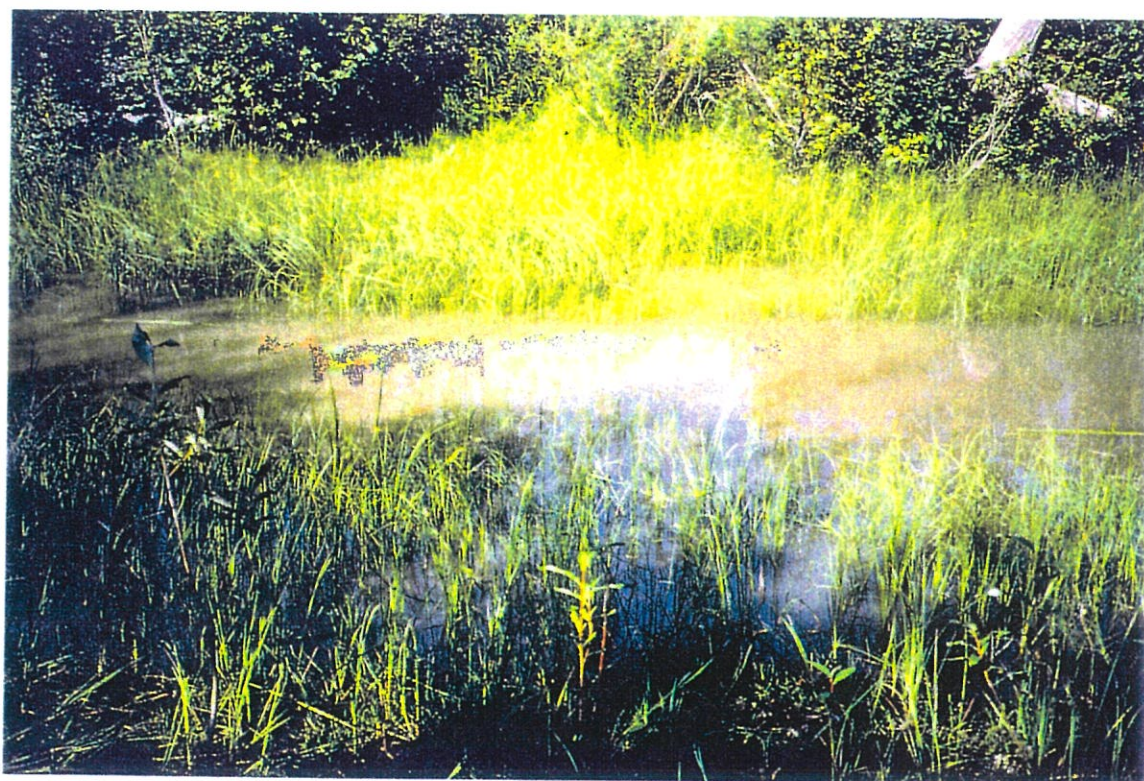
↑ Photograph 26 Looking across the outlet channel from Twin Lakes at the proposed crossing site, Km Post 47 + 815.

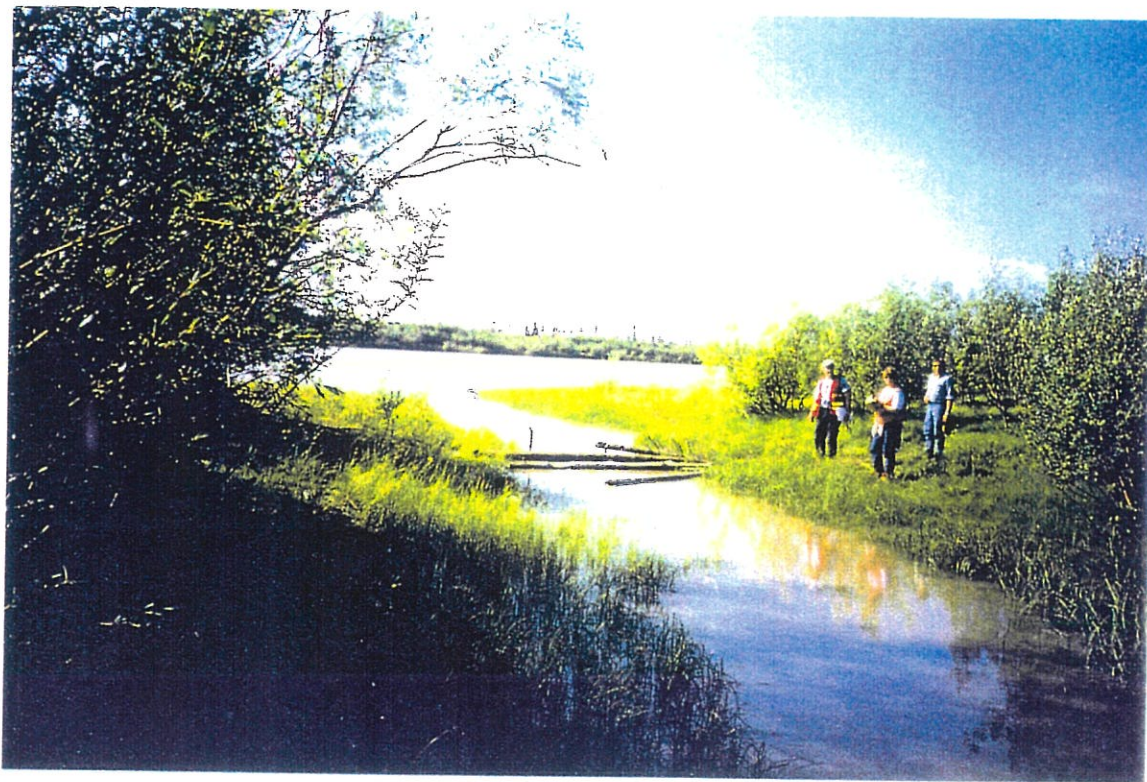
Photograph 27

Twin Lakes outlet with the confluence of the East Channel of the Mackenzie River,
Km Post 47 + 815.
