RE: Municipal Water Licence (N7L3-1531)

WATER LICENCE INSPECTION FORM

DATE:	August 28, 2007	COMPANY REP:	James Harry – Asst. Foreman
LICENCEE:	Hamlet of Sachs Harbour	LICENCE #:	N7L3-1531

WATER LICENCE INSPECTION REPORT Pg. 2
(Continued)

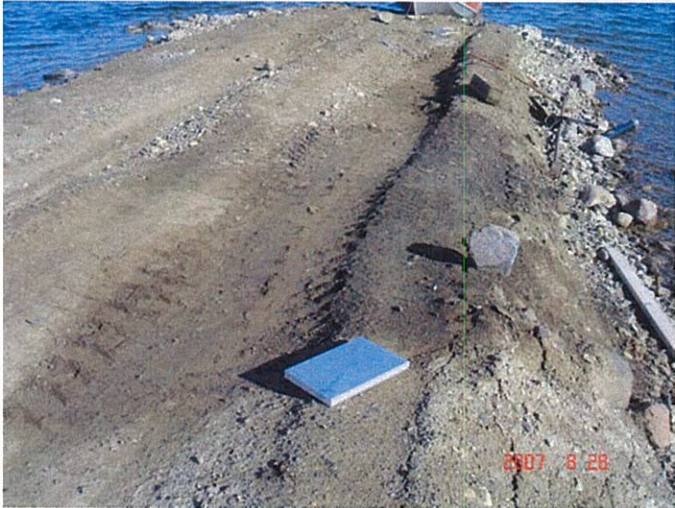
1. Large hydrocarbon stain on the intake ramp that goes into Water Lake. This contaminated soil needs to be removed as this soil is among the water supply. There has been a gradual accumulation of hydrocarbons from leaking equipment. The equipment needs to be repaired to prevent further leakage and potential contamination of the Hamlet's water supply(see Figure 1).
2. Water usage according to available Hamlet records is more than currently allotted in the Water Licence. The Hamlet of Sachs Harbour needs to apply for an amendment to the Water Licence from the Northwest Territories Water Board to increase the quantity of water that can be used.

Figure 1
Large hydrocarbon stain on intake ramp at Water Lake.

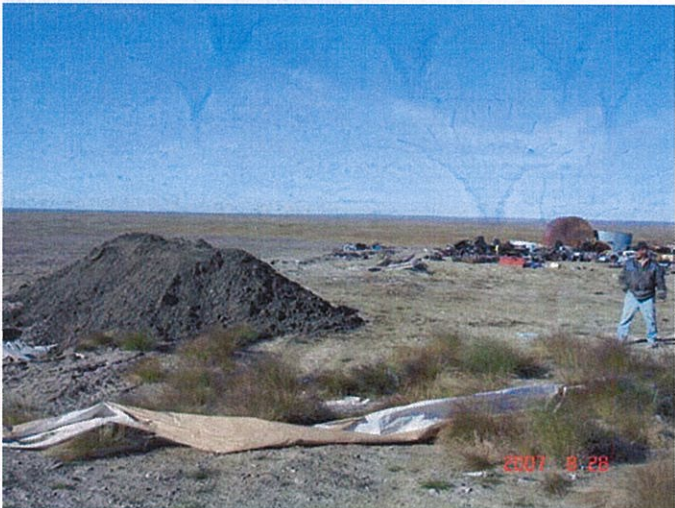
4. At the time of inspection contaminated soil was being transported to the Solid Waste Disposal Facility(SWDF). The pile of contaminated soil was from an excavation of a spill that had occurred in the Hamlet. The presence of contaminated soil at the SWDF occurred as a modification without notification of the Northwest Territories Water Board. The presence of contaminated soil at the SWDF without proper containment is unacceptable and could lead to further contamination. The Hamlet needs to comply with the Water Licence Part E: Conditions Applying to Modifications and provide proper containment for the contaminated soil(see Figures 2 and 3).

Figure 2
Contaminated soil pile from the excavation with no visible containment at Solid Waste Disposal Facility.

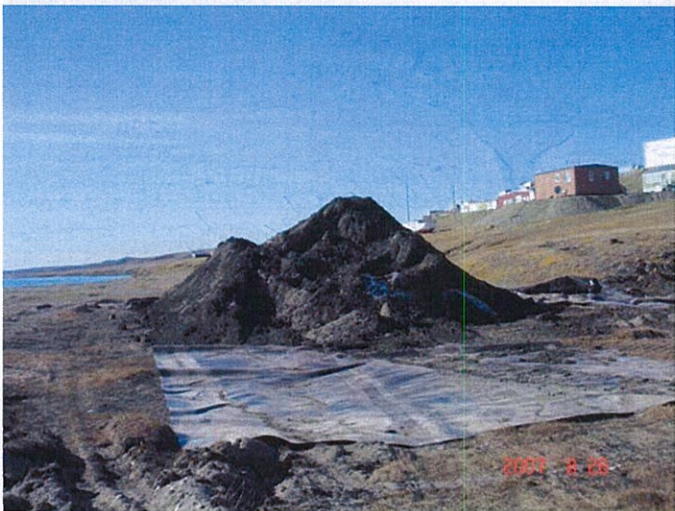
Figure 3
Contaminated soil pile with visible geotextile liner at the excavation site.

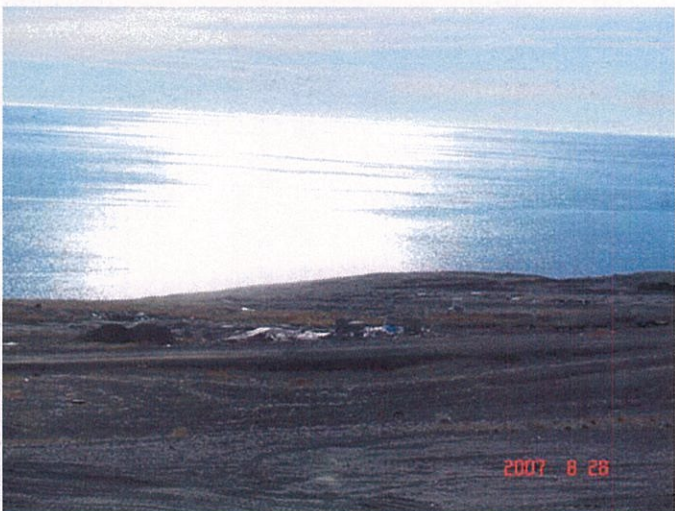
- There is no evidence that the Sewage Lagoon is discharging
- Waste oil – Hamlet has a waste oil burner
- Batteries are collected then shipped out
- Area surrounding the SWDF has recently been cleaned up of windblown debris
- There are still materials at the old SWDF site and are being moved to the new SWDF. According to files this process of Abandonment and Restoration of the old SWDF has been occurring for some time(see Figure 4).

Figure 4
Old Solid Waste Disposal Facility site. Material still being moved to new SWDF site.
