RE: Municipal Water Licence (N7L3-1531)

WATER LICENCE INSPECTION FORM

DATE:	September 28, 2009	COMPANY REP:	Adella Carpenter Acting SAO
LICENCEE:	Hamlet of Sachs Harbour	LICENCE #:	N7L3-1531

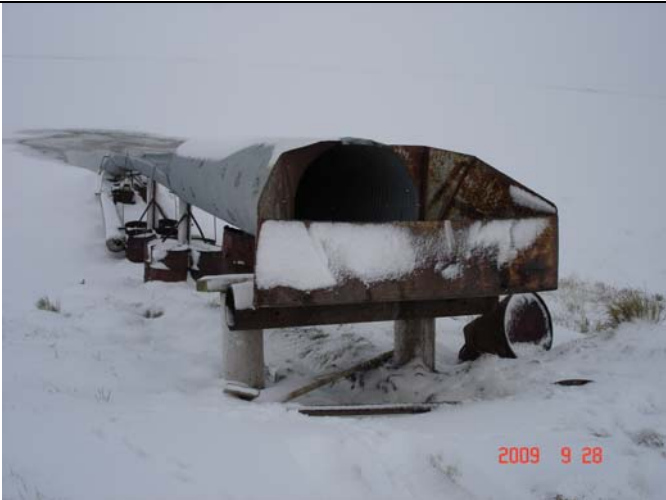
Figure 1

- Discharge Quality is unknown as the Hamlet has not collected any water samples.
- Erosion is present around the sewage discharge chute at the Sewage Disposal Facility(SDF). Continued maintenance is needed to prevent further erosion and subsequent damage to the sewage discharge chute. Ensure the truck tire stop/barricade is maintained. (see Figure 1)

Erosion still present at the sewage discharge chute.

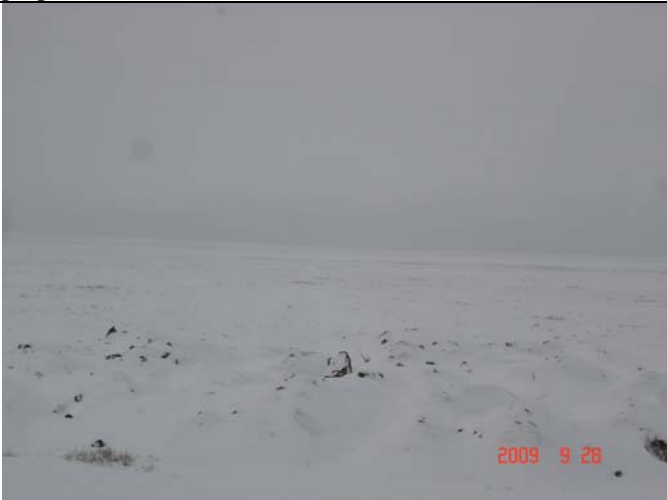
Figure 2

- Contaminated soil from an old POL tank farm spill on the beach in front of the Hamlet has been excavated by Biogenie S.R.D.C. Inc and deposited at the Solid Waste Disposal Facility(SWDF). There needs to be a geotextile/liner under the contaminated soil pile with a berm to minimize the potential for migration of contaminants into any waters. The presence of contaminated soil at the SWDF without proper containment is unacceptable and could lead to further contamination. The Hamlet needs to comply with Part D: Conditions Applying to Waste Disposal, Section 8 of the Water Licence and provide proper containment for the contaminated soil. (see Figures 2)

Contaminated soil pile at Solid Waste Disposal Facility needs proper containment.

Part D: Conditions Applying to Waste Disposal, Section 8,
“The Licensee shall contain all contaminated soil in such a manner as to minimize the potential for migration of contaminants into any Waters, to the satisfaction of an Inspector.”

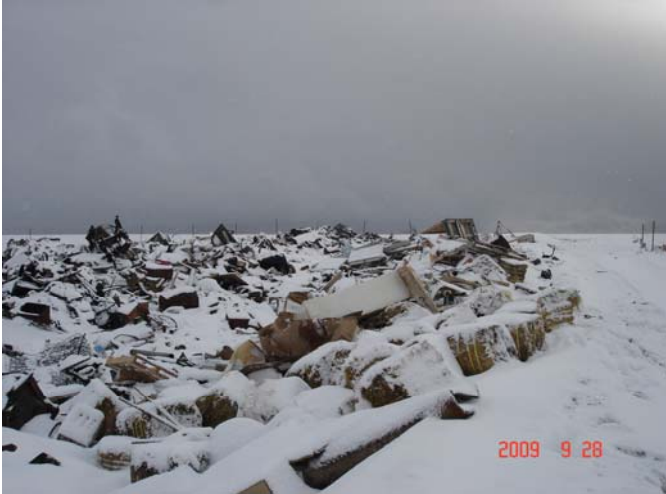
Figure 3

- There is evidence that burning of non-segregated Municipal Solid Waste (MSW) is still occurring. Burning of non-segregated MSW remains an unacceptable option for the management of MSW. Compliance is required with Part D: Conditions Applying to Waste Disposal, Section 10 of the Water Licence, in accordance with the guideline Municipal Solid Wastes Suitable for Open Burning, developed by the GNWT Department of Environment and Natural Resources (Please see enclosed document). Wastes that are conditionally suitable for open burning are paper products, paperboard packaging and untreated wood wastes. (see Figure 3)

Evidence that the burning of non-segregated Municipal Solid Waste is still occurring.

During the inspection it was evident that the burning of solid waste has occurred. Open burning of non-segregated Municipal Solid Waste (MSW) remains an unacceptable option for the management of MSW. According to the GNWT Department of Environment and Natural Resources, MSW suitable for open burning are paper products, paperboard packaging and untreated wood wastes only. Enclosed is the document titled "Municipal Solid Wastes Suitable for Open Burning" for your reference.

Part D: Conditions Applying to Waste Disposal, Section 10,
“The Licensee shall not open burn solid or liquid Waste, with the exception of paper products, paperboard packaging and untreated wood in accordance with the guideline Municipal Solid Wastes Suitable for Open Burning, developed by the GNWT Department of Environment and Natural Resources.
