**RE: AUGUST 15, 2005 INSPECTION OF WATER LICENCE N7L3-1619
INCORPORATED HAMLET OF PAULATUK**

MUNICIPAL WATER LICENCE INSPECTION REPORT

DATE:	August 15, 2005	COMPANY REP:	Tom Caines (SAO)
LICENSEE:	Incorporated Hamlet of Paulatuk	LICENCE #:	N7L3-1619 (Renewal)

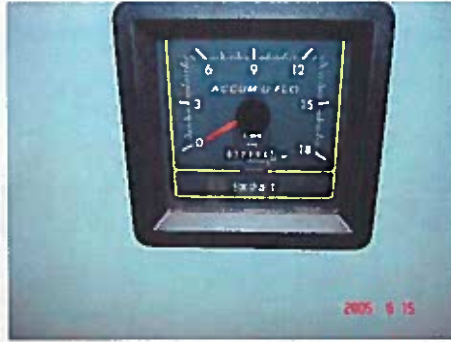
Figure 2. Water Supply. WSF water meter.

- No indication of leaks from fuel tank (figure 2).
- All meters and/or devices used to measure water seem to be in good working order (figure 2).
- Total water uptake from New Water Lake was 8033 m³ < permitted 10000 m³.

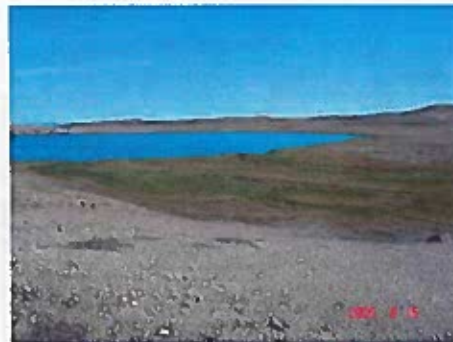
Figure 5. Waste Disposal. Sewage Disposal Facilities (SDF) Sewage Lagoon and SNP 1619-2.

Sewage	Sewage Treatment System (primary, secondary, or tertiary):		Primary coupled with rudimentary wetlands treatment.			
	Natural Water Body:	✓	Continuous Discharge (land or water):	✓		
	Seasonal Discharge:		Wetlands Treatment:	✓ (figure 5, 7)	Trench:

- The Sewage Lagoon is acting as a continuous discharge system with natural outflow as effluent slowly percolates through rudimentary wetlands (Figure 5, 7, 8) and to the Arctic Ocean (Darnley Bay (figure 7)). One area in the wetland discharge area was found to contain water (figure 8). In the spring there may be observable overland discharge from the Sewage Lagoon.
- No indication of floating sludge mats/algae mats in the Sewage Lagoon.
- Sewage Lagoon green in color at the time of inspection (figure 6).
- Part D2 – Please see first note.
- Part D3 – Freeboard at Sewage Lagoon does not apply as it is a natural Lake with no engineered berms/dykes.
- O&M Plan for the Sewage and SWDF was approved by the NWTWB on September 14, 2005.

1. SNP Signs not posted.
2. Please make note if overland discharge occurs in the spring months. If observed this effluent will require sampling as per SNP Part B1. No discharge was observed during this inspection (figure 5, 7, 8).

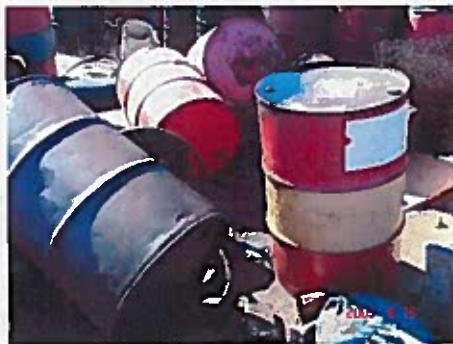
- Please note that burning waste at the Solid Waste Disposal Facilities (SWDF) is no longer permitted in the NWT. There was indication that this was still being conducted.
- Besides the domestic garbage disposal area (figure 16) there is poor to no segregation of waste at SWDF.
- Related to concern 2 above please ensure that the SWDF contains designated and identified areas pertaining to oil/hazardous wastes, waste batteries, waste appliances (washers/dryers), honey bag pit, metal wastes, skidoos/snowmobiles, waste wood, waste vehicles, etc..
- Currently no waste oil/hazardous wastes disposal area. Consequently, this material is located throughout the landfill (figure 11-15) with indication of many containers leaking (figure 15).
- As indicated in previous years Inspection Reports there is no sign identifying and warning the public of the SWDF and Sewage Disposal Facilities (SDF).

Figure 16. Waste Disposal. SWDF domestic garbage disposal area.
