**RE: Industrial Water Use N7L1-1762
CLASS B - INDUSTRIAL
Mackenzie River and Un-named Lake**

INDUSTRIAL WATER USE INSPECTION REPORT

LICENCE #:	N7L1-1762	EXPIRY DATE:	June 30, 2011
LICENCEE:	Shell Canada Limited	PREVIOUS INSPECTION:	January 19, 2005
COMPANY REP:	Randall Warren	INSPECTION DATE:	August 24, 2011

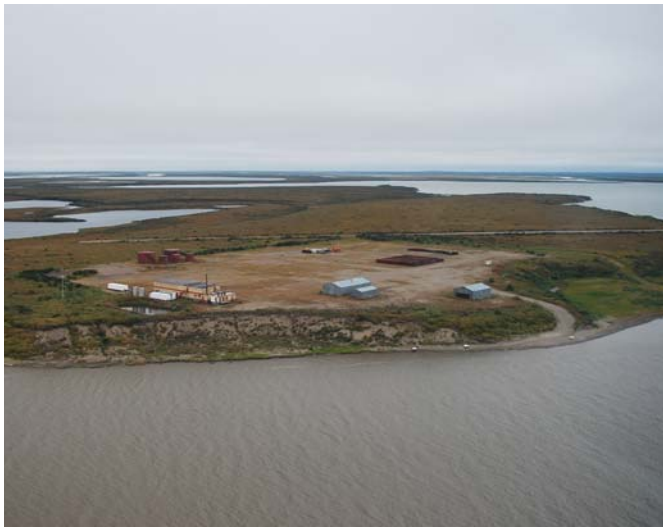
Figure 1
Aerial of Camp Farewell.

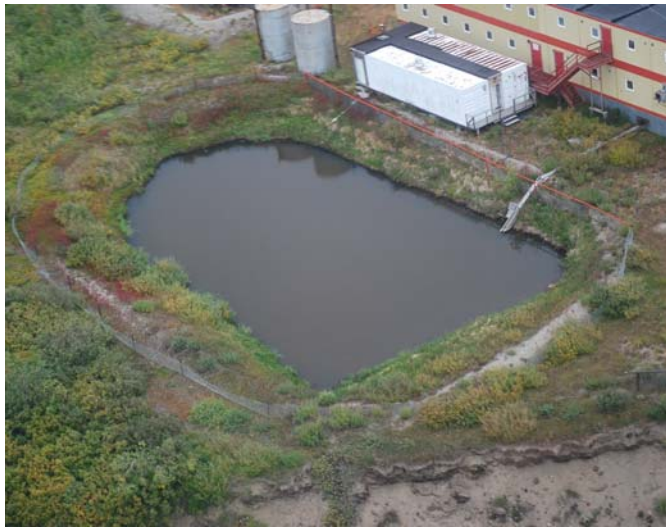
- Sewage lagoon freeboard was between 1.5–2.0 metres, acceptable according to Licence criteria.

Figure 2
Camp Farewell Sewage Lagoon

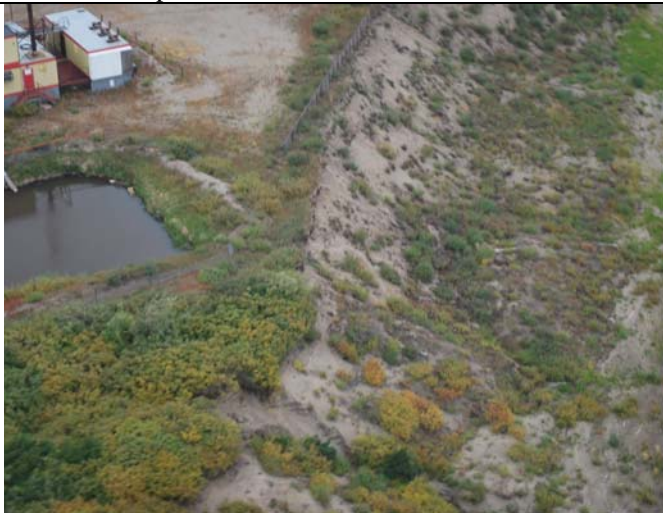
- River bank is eroding closer to the lagoon area 2-3 metres away (see Figure 3).

Figure 3
River bank is eroding closer to the lagoon area 2-3 metres away.

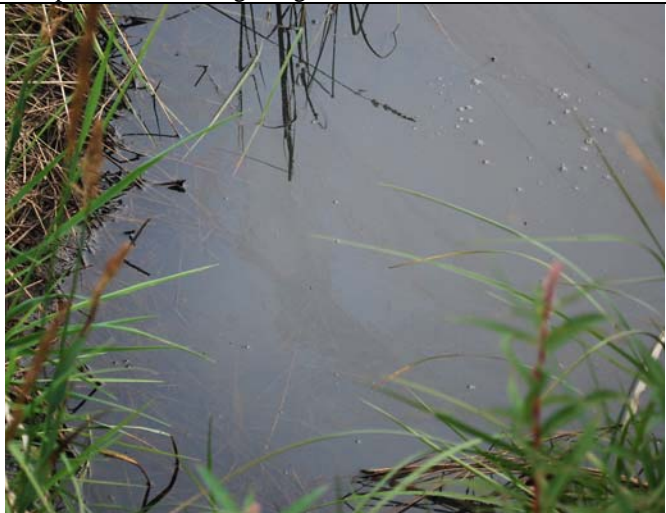
- Sheen present in camp sewage lagoon in corner closest to the river (see Figure 4). It is unknown if it is natural in origin. Subsequent lab analysis of lagoon water on September 20, 2011 by IEG Environmental was within the Water Licence Discharge Criteria which expired on June 30, 2011. Originally there had been an Oil and Grease result of 47 mg/L which was above the discharge criteria of 5 mg/L but when it was re-sampled on September 29, 2011, the result was <2 mg/L. Please note that a current Water Licence for Camp Farewell is needed in order for the sewage lagoon to be decanted.

Figure 4
Sheen present in camp sewage lagoon in corner/edge closest to the Mackenzie River.

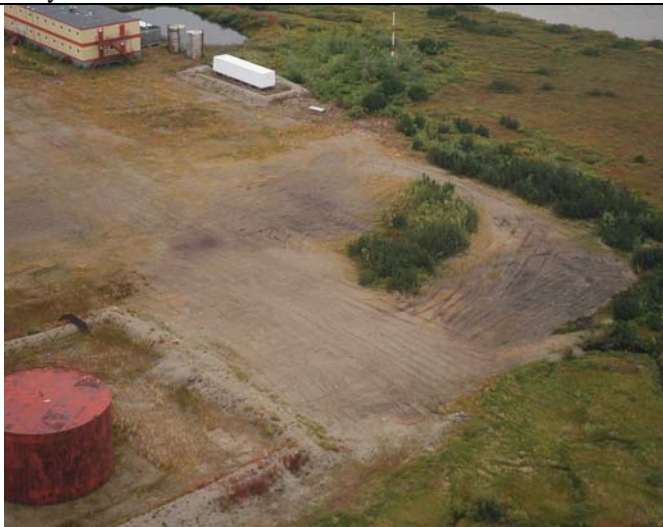
- Site is clean and organized.
- Maintenance activities were conducted at Camp Farewell from July 9, 2009 until at least August 7, 2009 based on notification from IEG Consultants Ltd (see Figure 6). Remediation work also occurred in the western corner of Camp Farewell just west and south of the bermed tank farm (see Figure 5). This was to remediate the hydrocarbon contaminated soil from the 1981 Dome/CanMar Spill.

Figure 5
Recent remediation in western corner of Camp Farewell just west and south of the bermed tank farm.

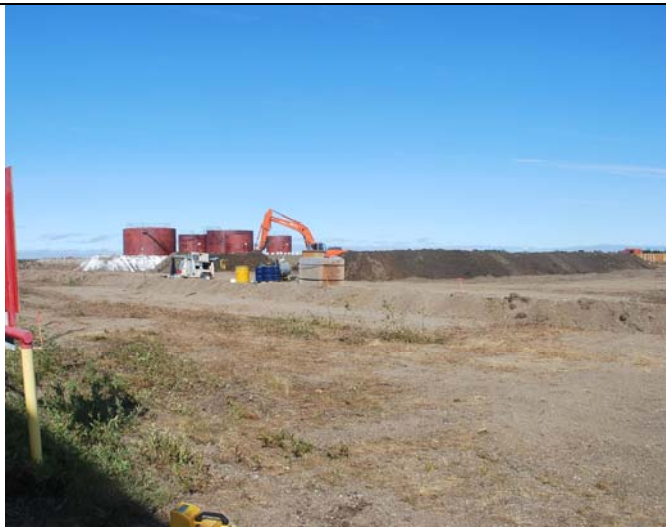
Figure 6
Maintenance activities at Camp Farewell during July-August of 2009, including remediation by the tank farm.
