**Re: Annual Monitoring Report for the Umiak N16 Sump, 2004
Licence N7L1-1797**

REPORT FOR THE ENCANA CORPORATION
UMIAK N-16 SUMP MONITORING PROGRAM

Water License: N7L1-1797

Year Reported: 2004

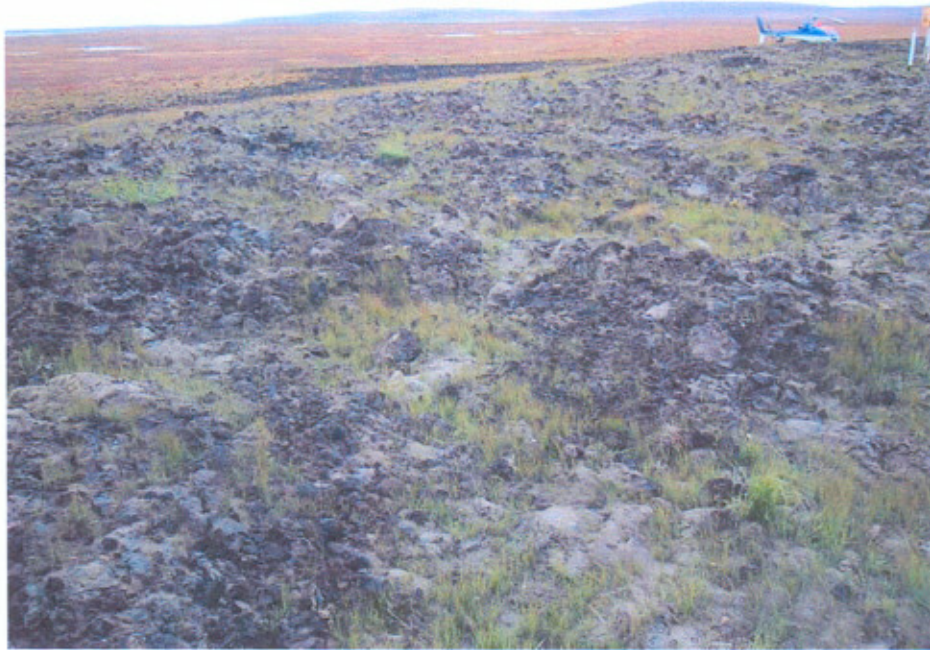
Plate 1. Sump surface showing vegetation re-growth (photo by Kavik-Axys)

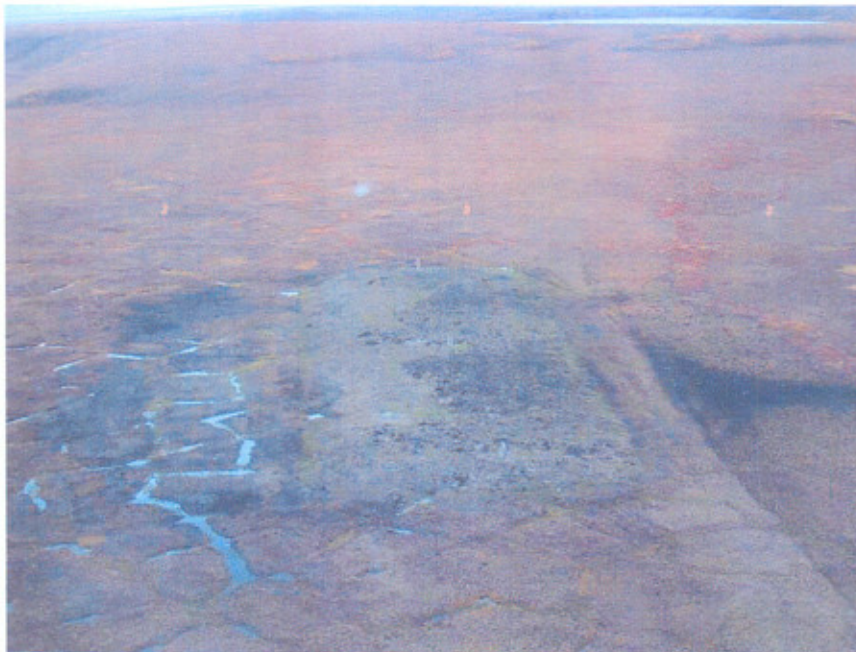
Plate 2. Aerial view of Umiak N16 sump (west end in foreground). Note thermistors down center axis of sump. (photo by Kavik-Axys)

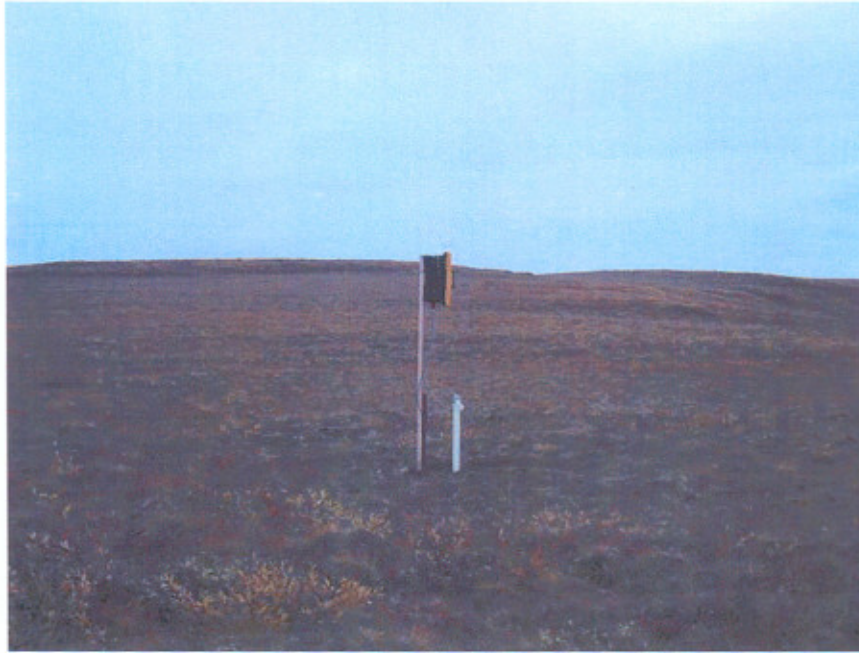
Plate 3. Control thermister adjacent to sump. (photo by Kavik-Axys)

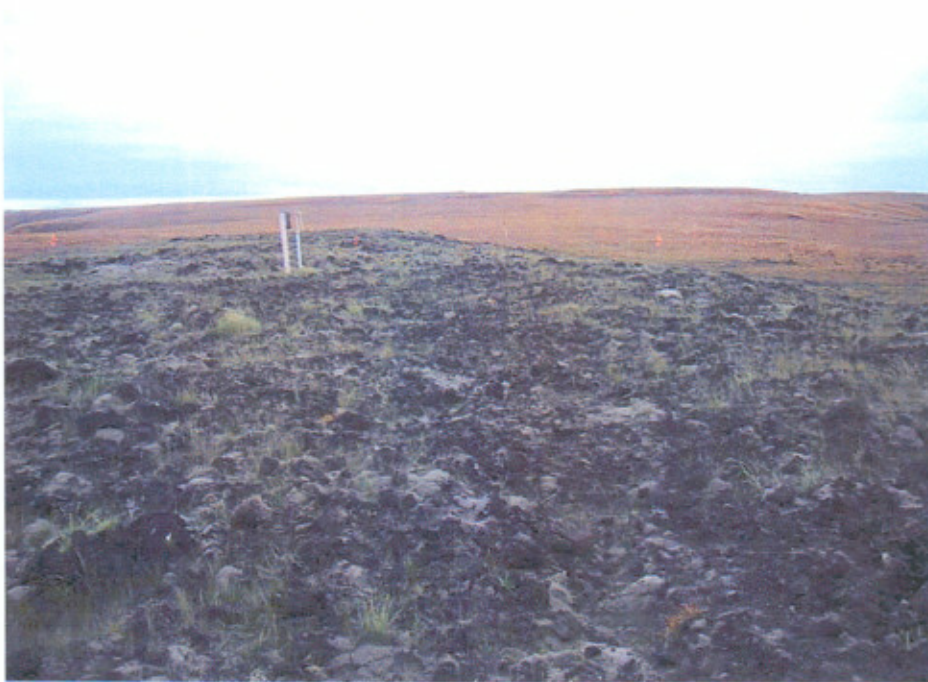
Plate 4. Surface view of sump. (photo by Kavik-Axys)

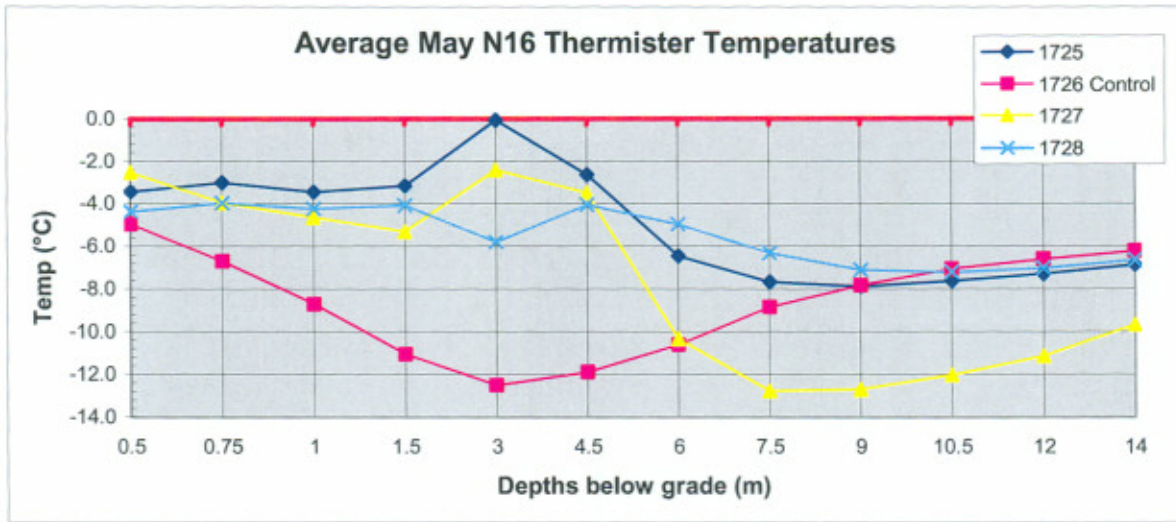
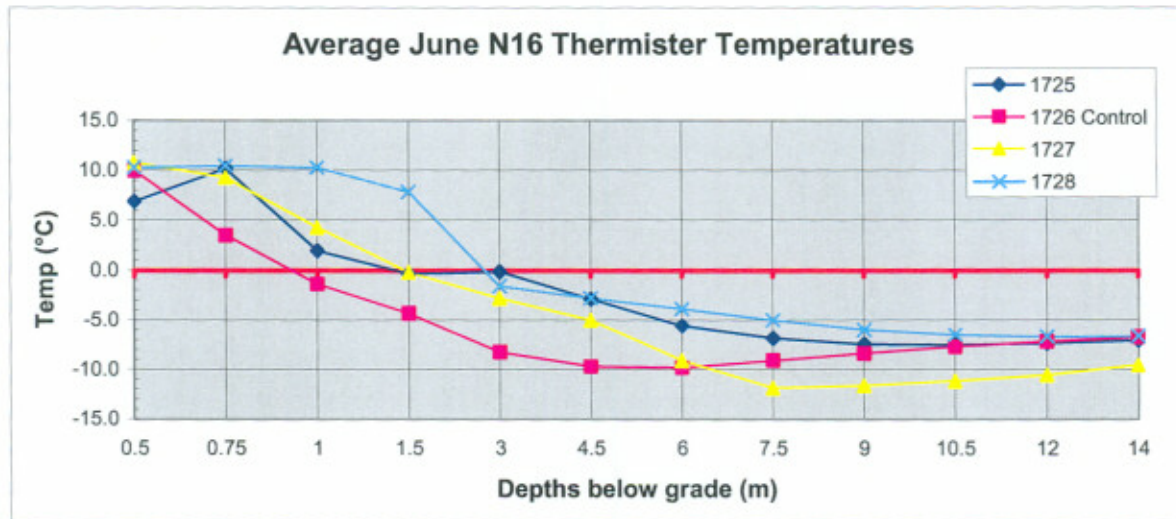
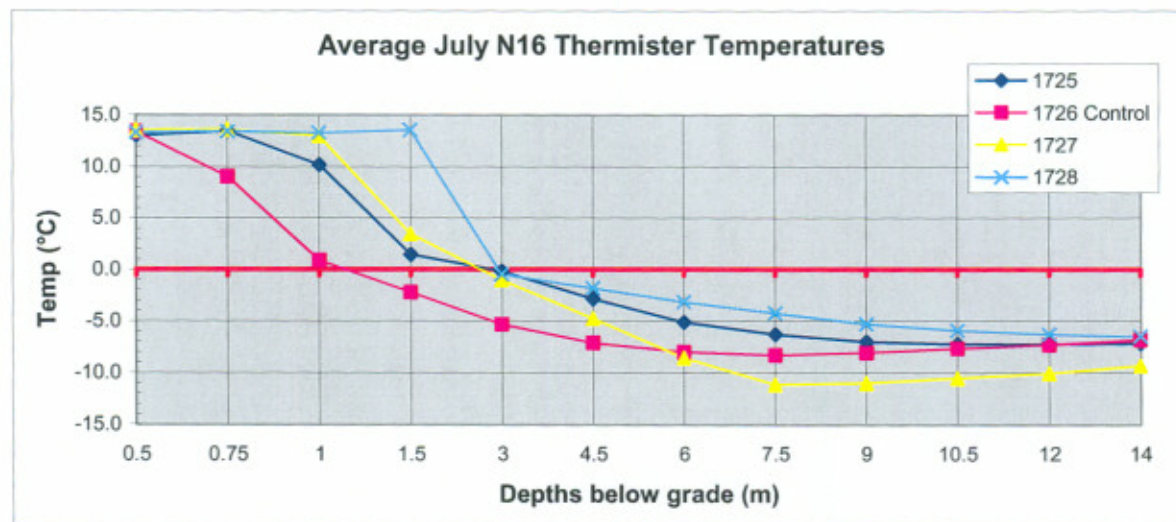
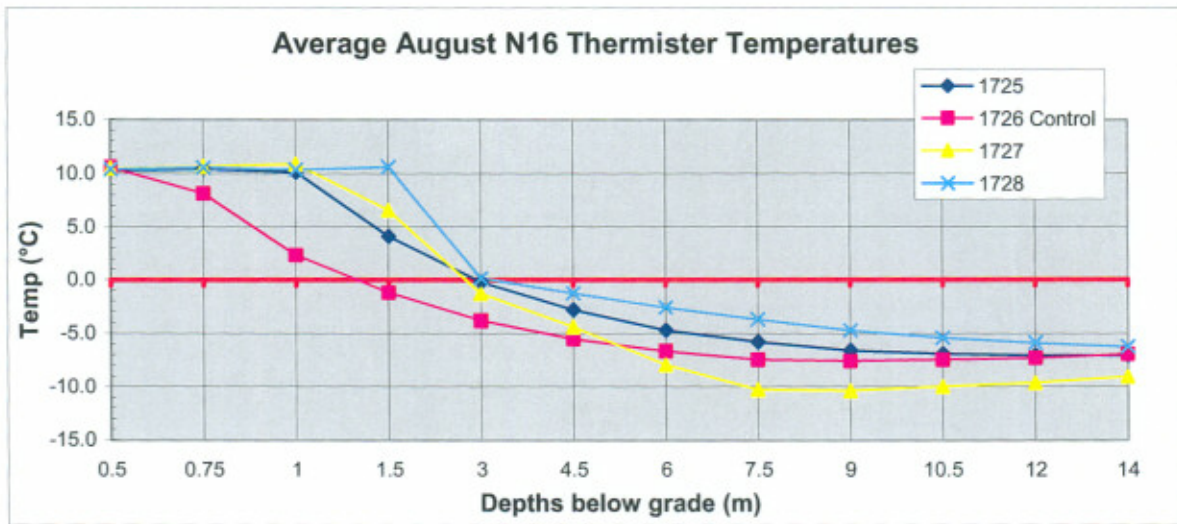
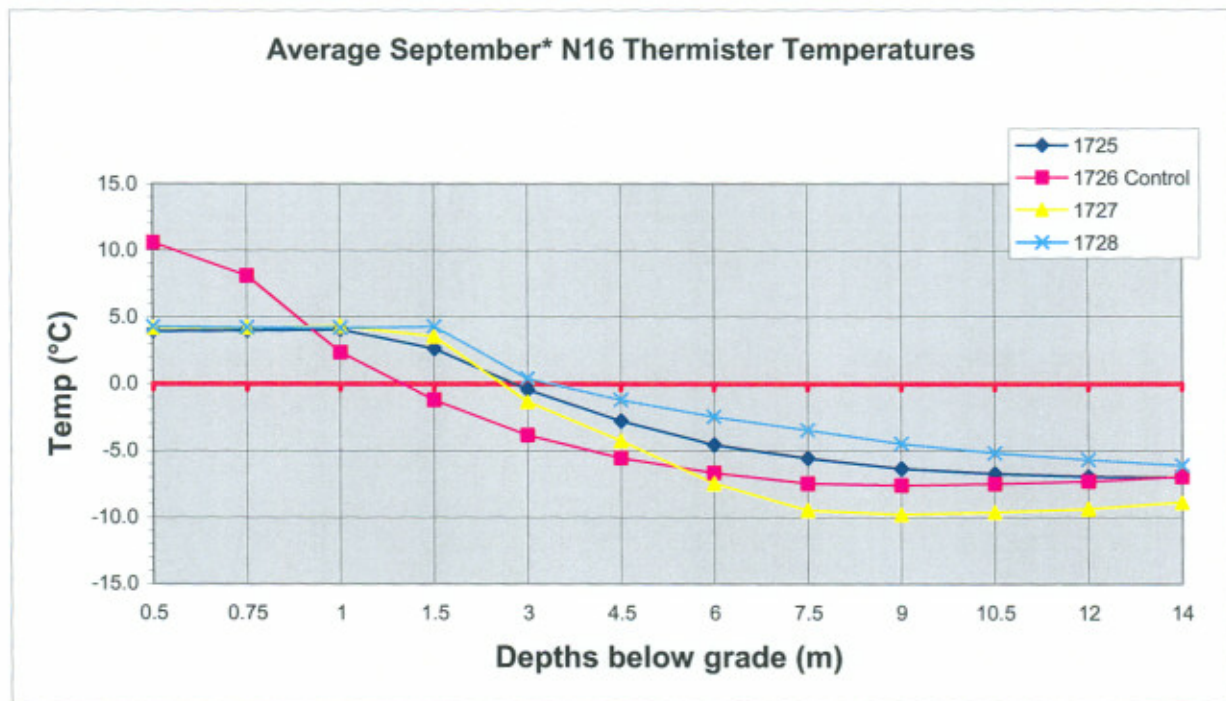
Visual observations made by Kavik-Axys, on 6 September 2004, indicate the sump surface has settled approximately 0.45 m since the initial sump construction. Support poles for in-sump thermisters were used to estimate the amount of surface settling. As a result of this settling, thermister depth readings must be adjusted – e.g., the thermister bead that originally measured temperatures at the 1 m depth now measures at 0.55 m depth. This should be considered when comparing data with the control thermister. Average monthly temperatures (recorded from 1 May to 6 September 2004) are provided below.

*Last temperature reading was September 6, 2004

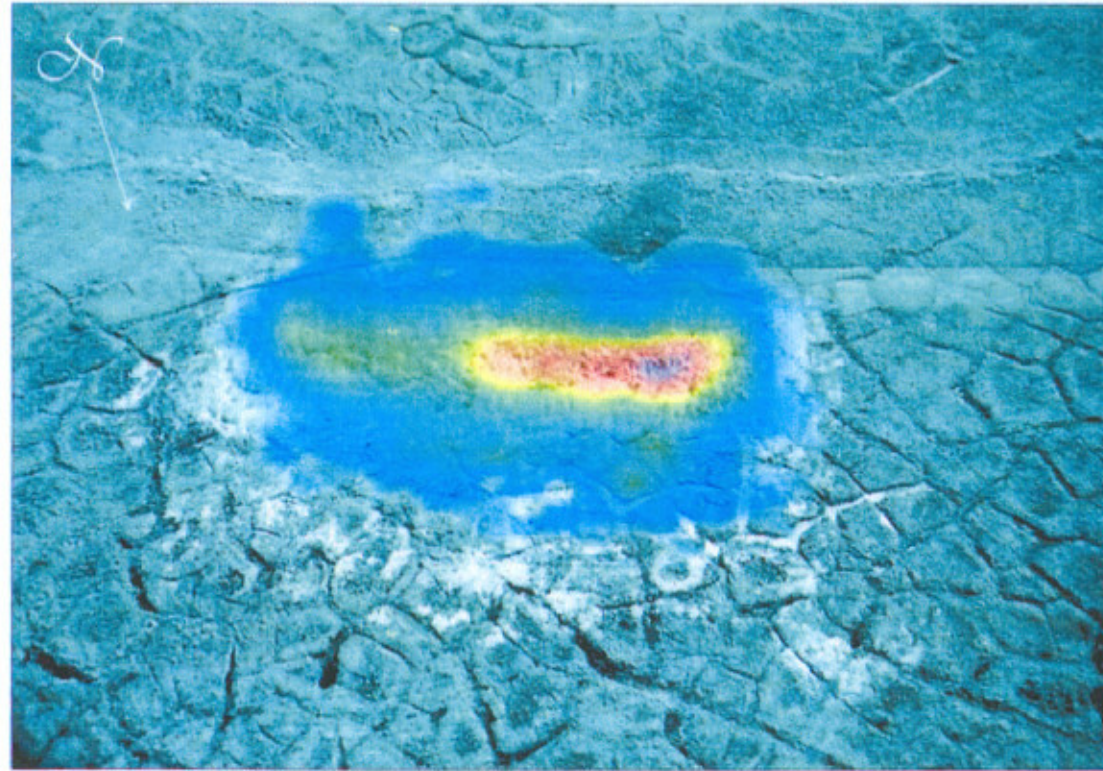
AERIAL PHOTOGRAPH & EM31 OVERLAY

THE OVERLAY ILLUSTRATES THE CORRELATION OF EM RESPONSES TO REGIONAL FEATURES. THE PROCESS OF MERGING EM DATA WITH THE AERIAL PHOTOGRAPH GENERATES FOCAL AND PERSPECTIVE DISTORTION.

GEOPHYSICAL INSTRUMENT: GEONICS EM31
MEASURED QUANTITIES: QUADRATURE IN MS/M

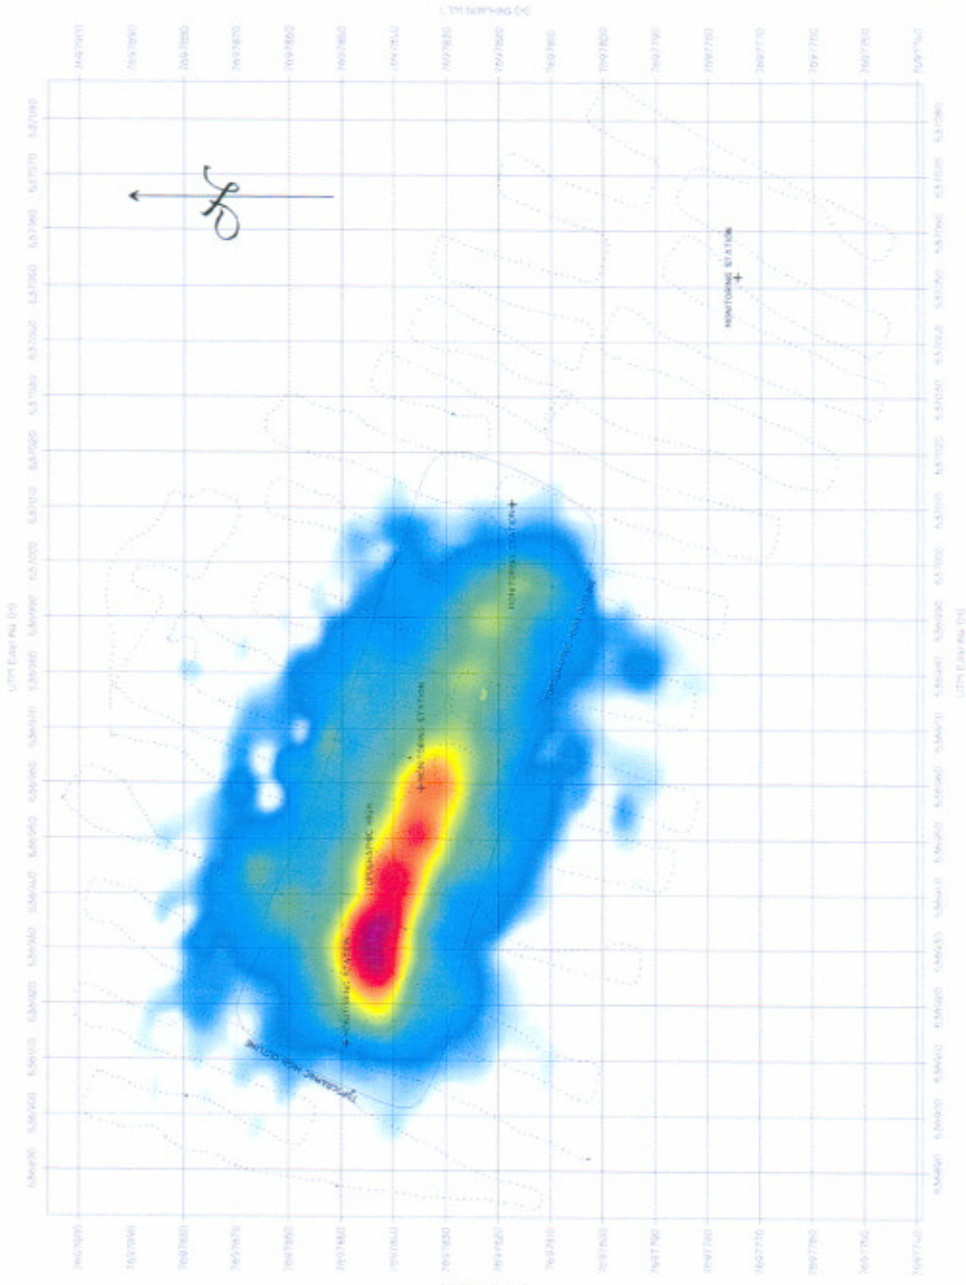
LATERAL CONDUCTIVITY DISTRIBUTION (EH31) & SITE FEATURES
 Linear 100 Year

On 18 August 2004, an electromagnetic (EM) survey was conducted using a Geonics EM31 to map the lateral extent of ion-contaminated regions using EM inductive forces. The EM31 readings approximated measurements of the initial 5 m of topsoil. Conductivity response trends using the EM31 suggest drilling wastes are concentrated along the central axis of the visible sump area, and there is no indication of lateral movement of sump fluids. An aerial photograph with the EM31 survey overlaid is attached, along with a map showing the lateral conductivity distribution.
