Umiak N-16 2012 Annual Sump Monitoring Report

For Submission to the
Northwest Territories Water Board
Under Water License N7L1-1797

November 2012

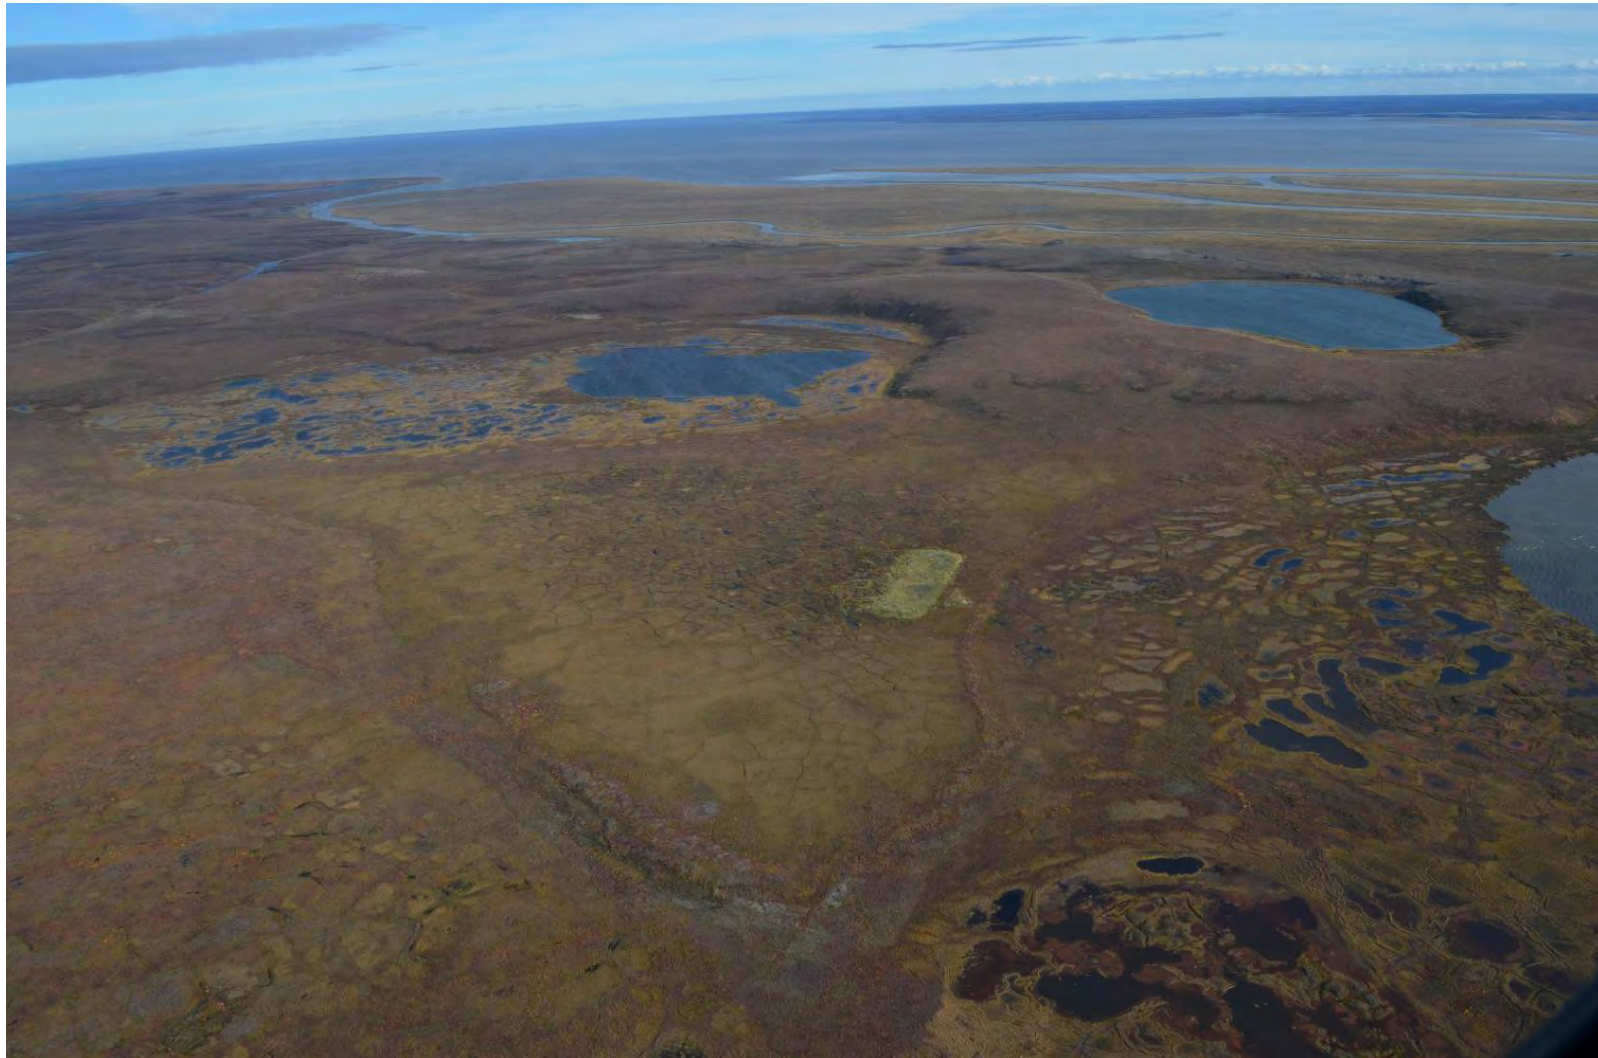
Photo 1: Aerial overview of Umiak N-16 sump on Richards Island (September 6, 2012)

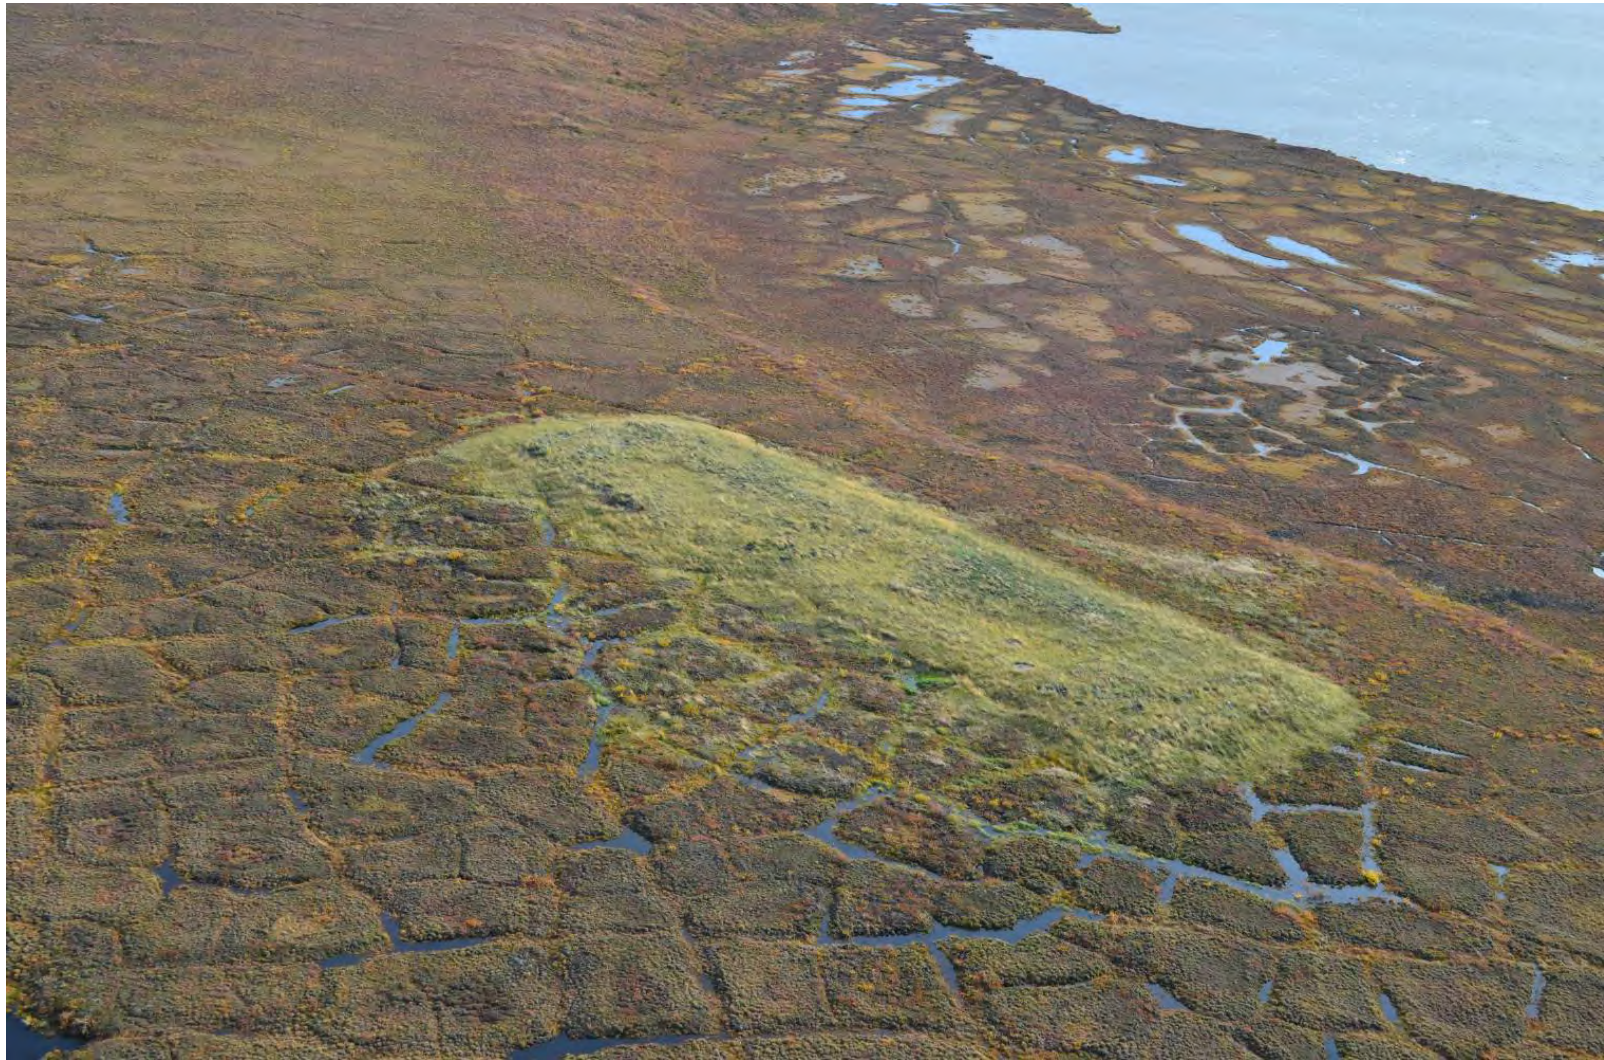
Photo 3: Aerial view of the sump cap from the northwest (September 6, 2012)

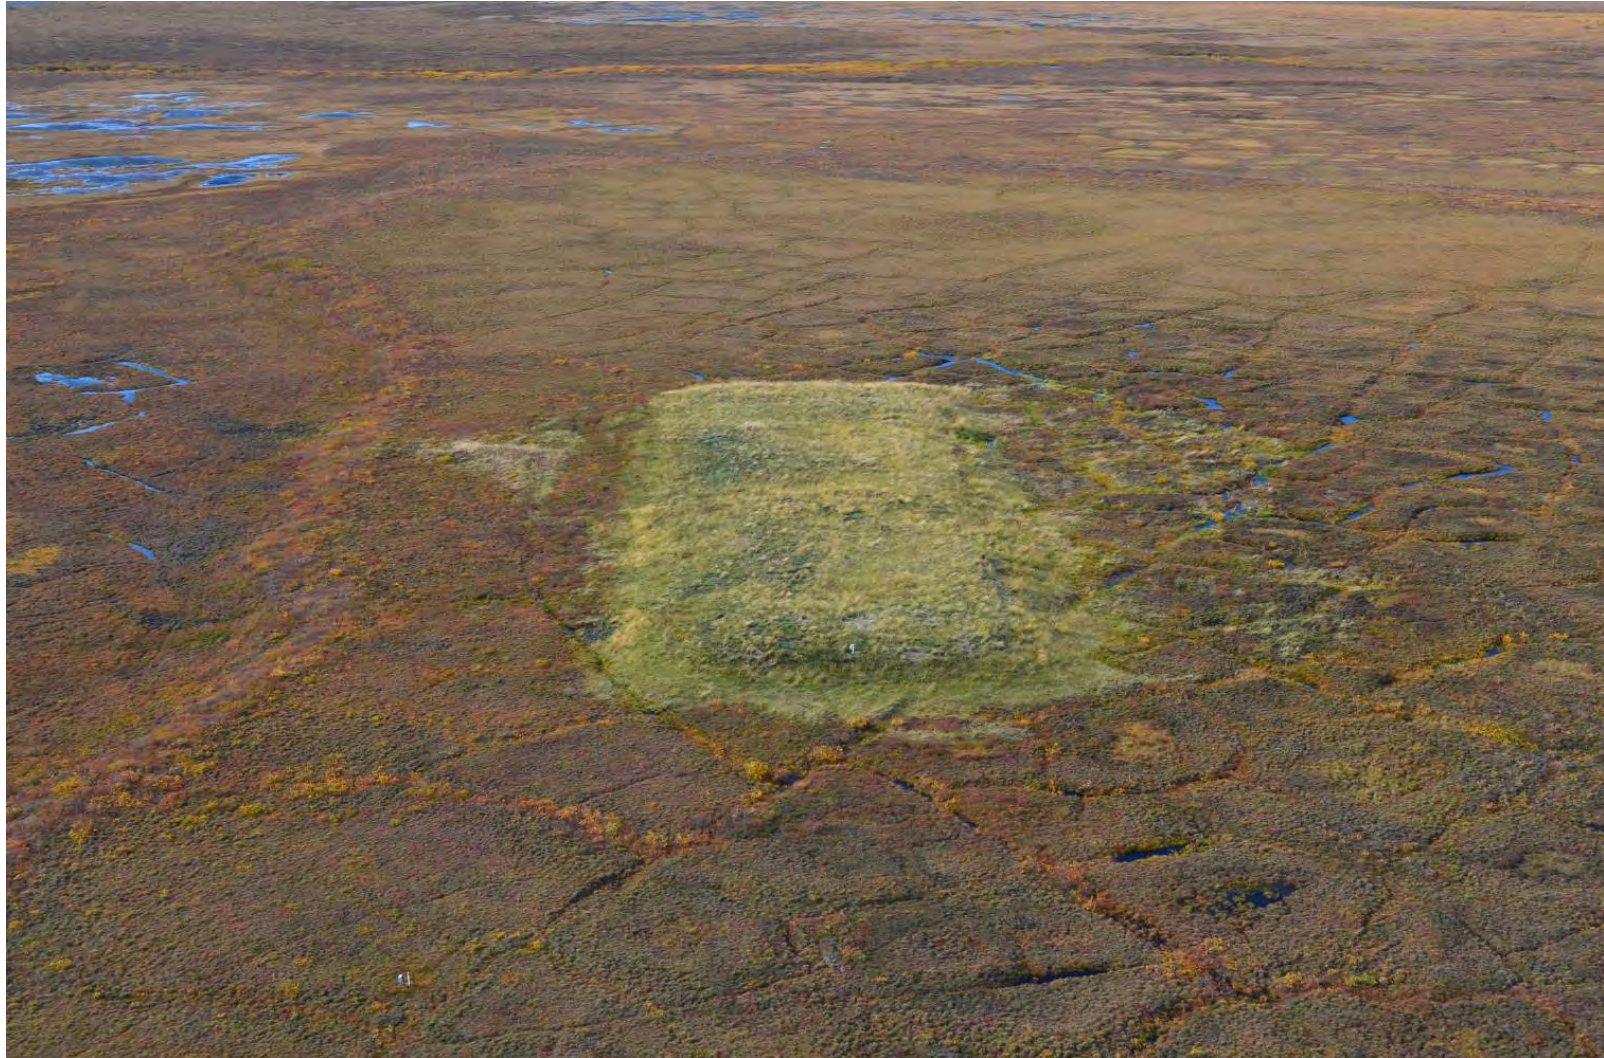
Photo 4: Aerial view of the sump cap from the east (September 6, 2012)

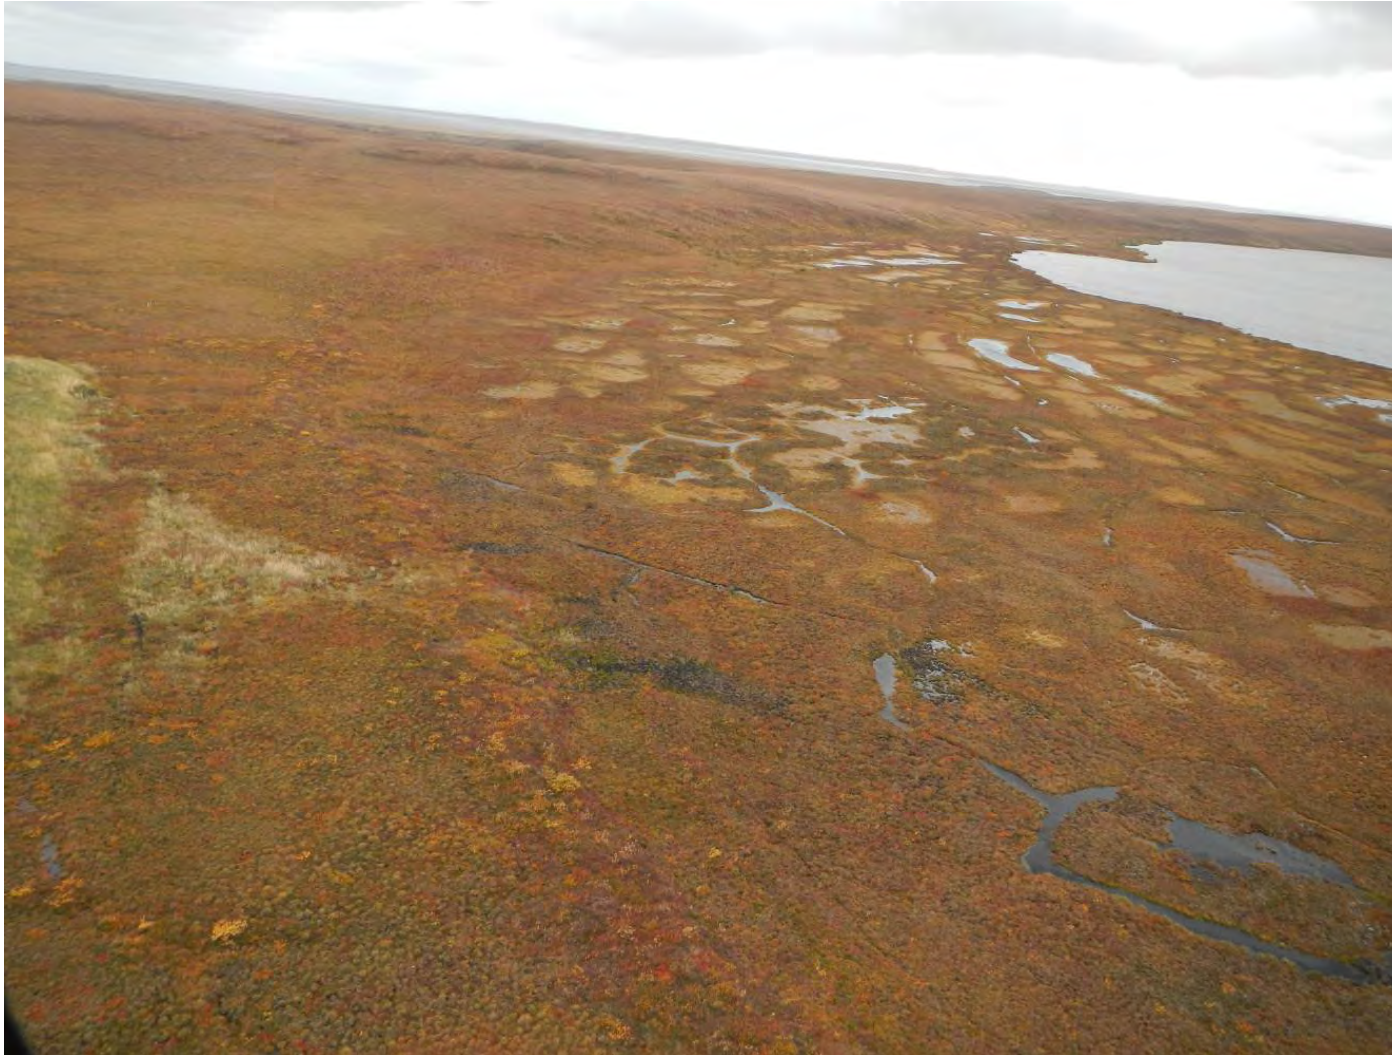
Elevated responses from the EM38 survey at the sump and extending beyond the perimeter of the sump cap indicate that there continues to be some ionic migration from the sump or sump cap into the surrounding area, which has been occurring since the initiation of monitoring program in 2004. The 2012 EM38 survey indicates that the overall extent of the apparent elevated conductivities south of the sump has increased compared to 2011. The increase in apparent conductivity may be a result of the saturated conditions surrounding the sump and the increased amount of surface water in 2012 compared to 2011 which has traditionally been insufficient to inundate the shallow active-layer. General precipitation in the region (Inuvik weather station) increased almost 50% in the 12 months prior to the site assessments in 2012 compared to 2011 (Environment Canada, 2012). Although the apparent conductivity levels appear to have increased since 2011, it is assumed to be a function of the overall level of saturation in the area and not a direct result of greater concentrations of ions inundating the area.

Photo 6: Aerial view of ion migration areas south of the sump (September 7, 2012)

1. Remediation of impacted areas surrounding the sump which should be carried out to minimize surface disturbance to the active-layer, vegetation and rooting zone whenever possible.

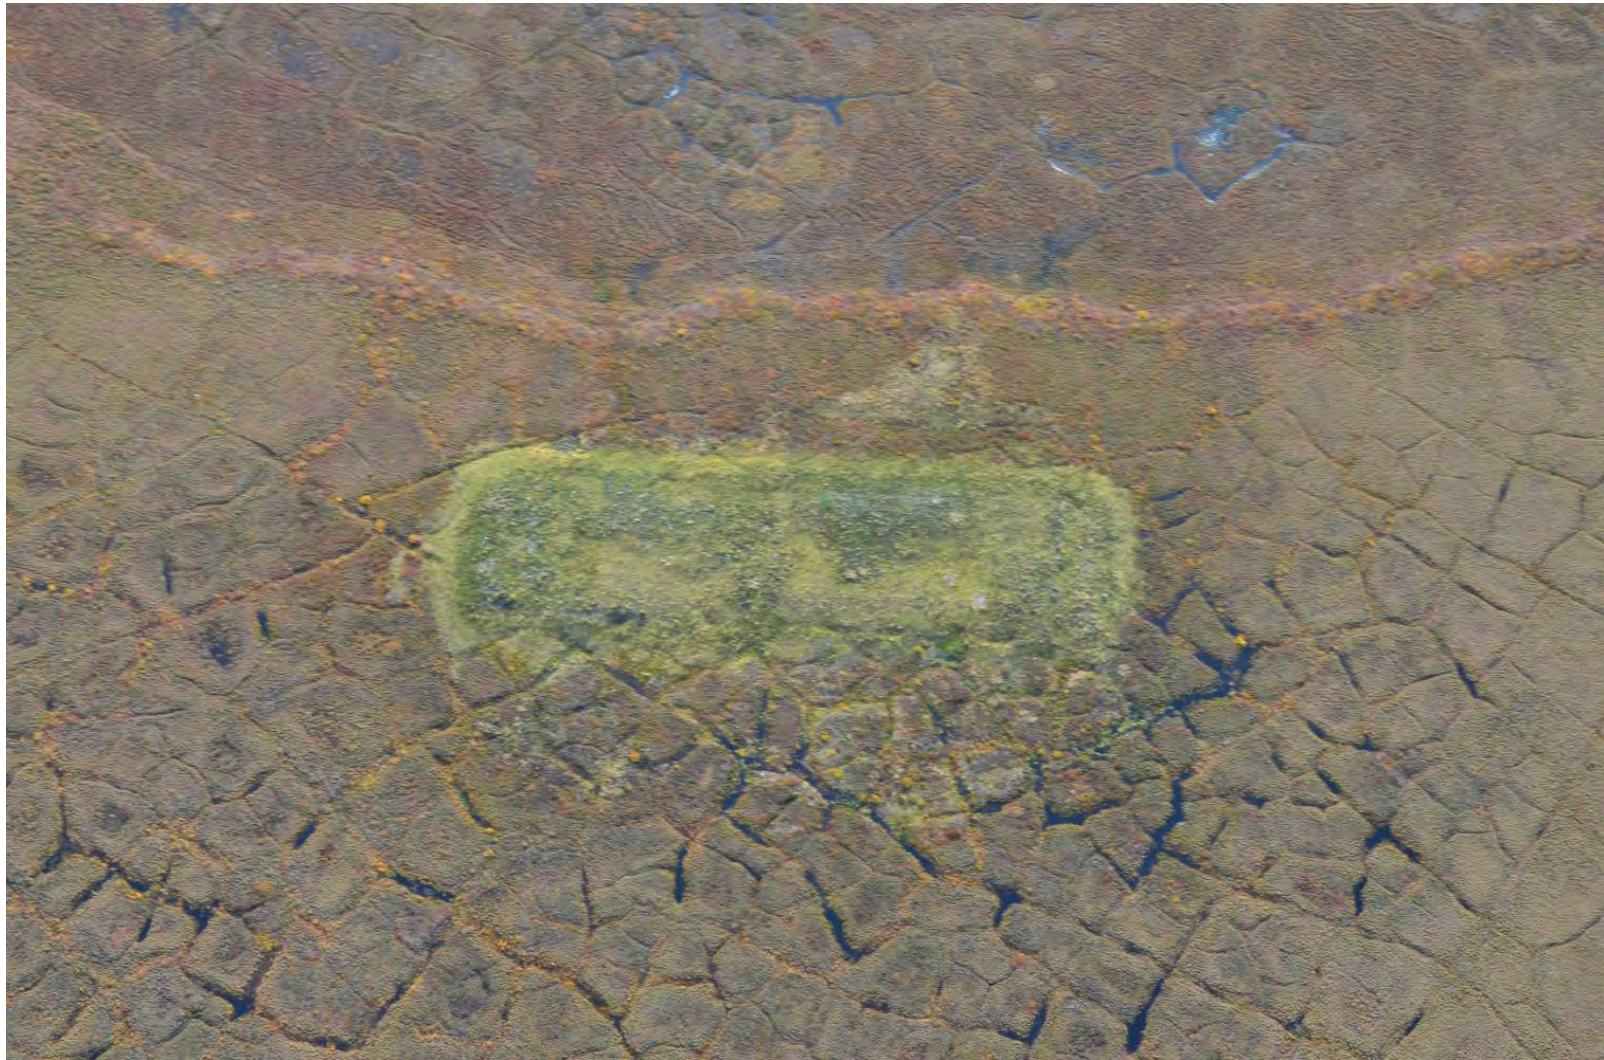
Visual assessments during 2012 revealed similar conditions to 2011 with no physical evidence of erosion, ponding, subsidence, stress or tension cracks on the surface of the sump cap. The sump cap was in good condition during the late summer site assessments on September 6 and 7, 2012.

Photo 7: Aerial view of sump cap directly from above (September 6, 2012)

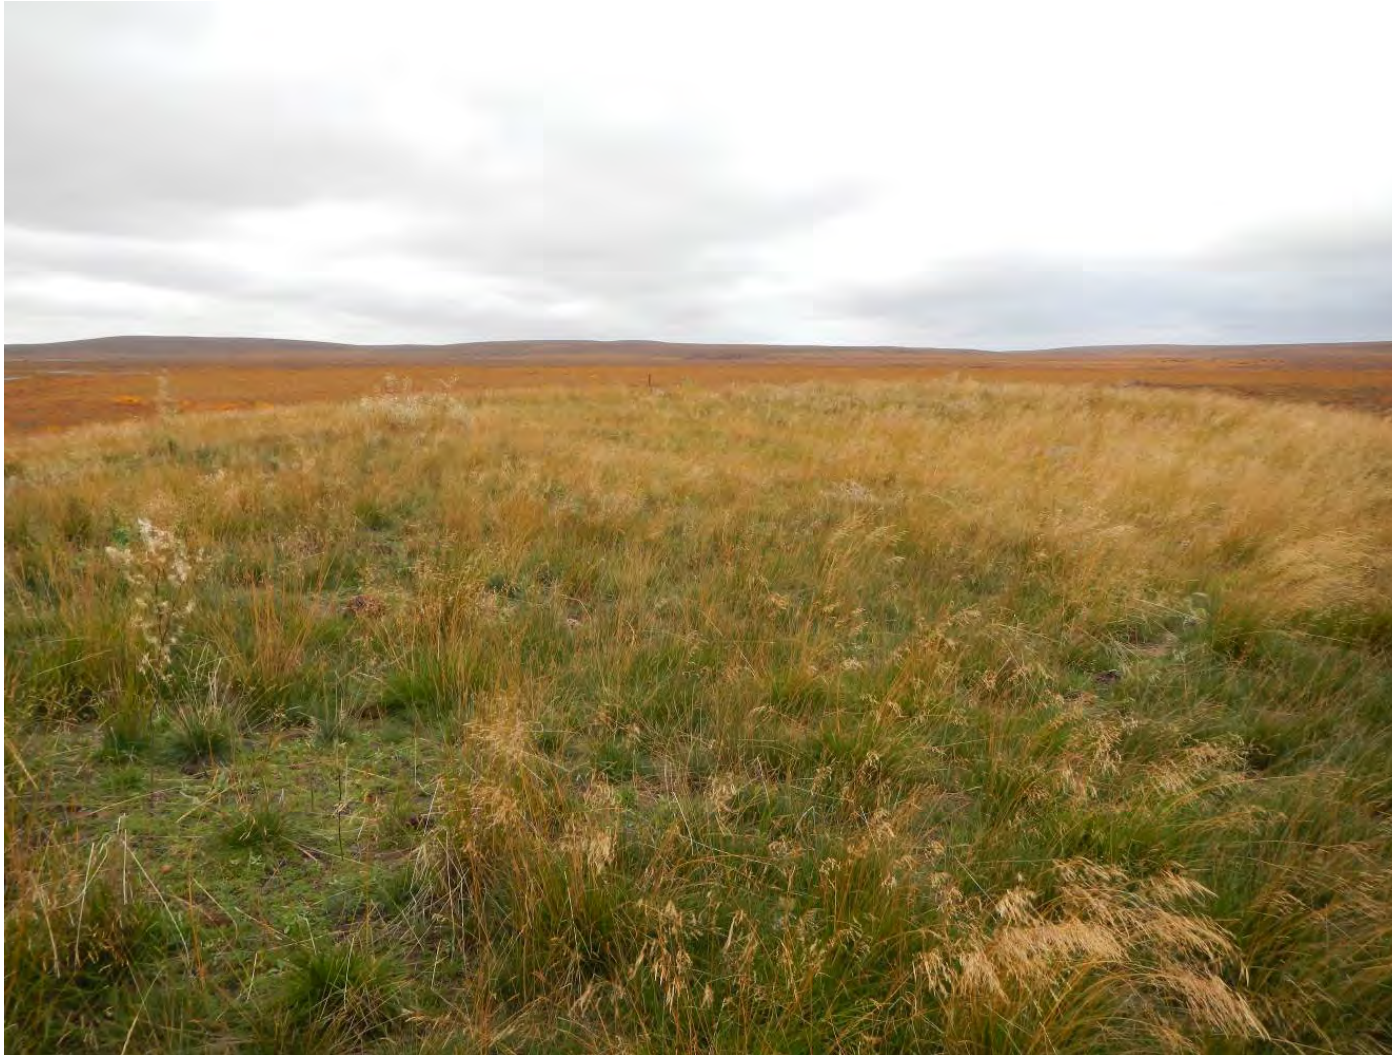
Vegetation on both the sump cap and the previously impacted area north of the sump cap (which was utilized for soil storage in winter 2004) was well established, in good health and self-propagating. There still remain a few small isolated bare patches on the sump cap which can be observed on the aerial photos in Appendix B. The sump cap should have enough vegetation growth to restrict either water or wind erosion from having a measured impact on the conditions of the sump cap.

Photo 8: Vegetation establishment on the sump cap (September 7, 2012)

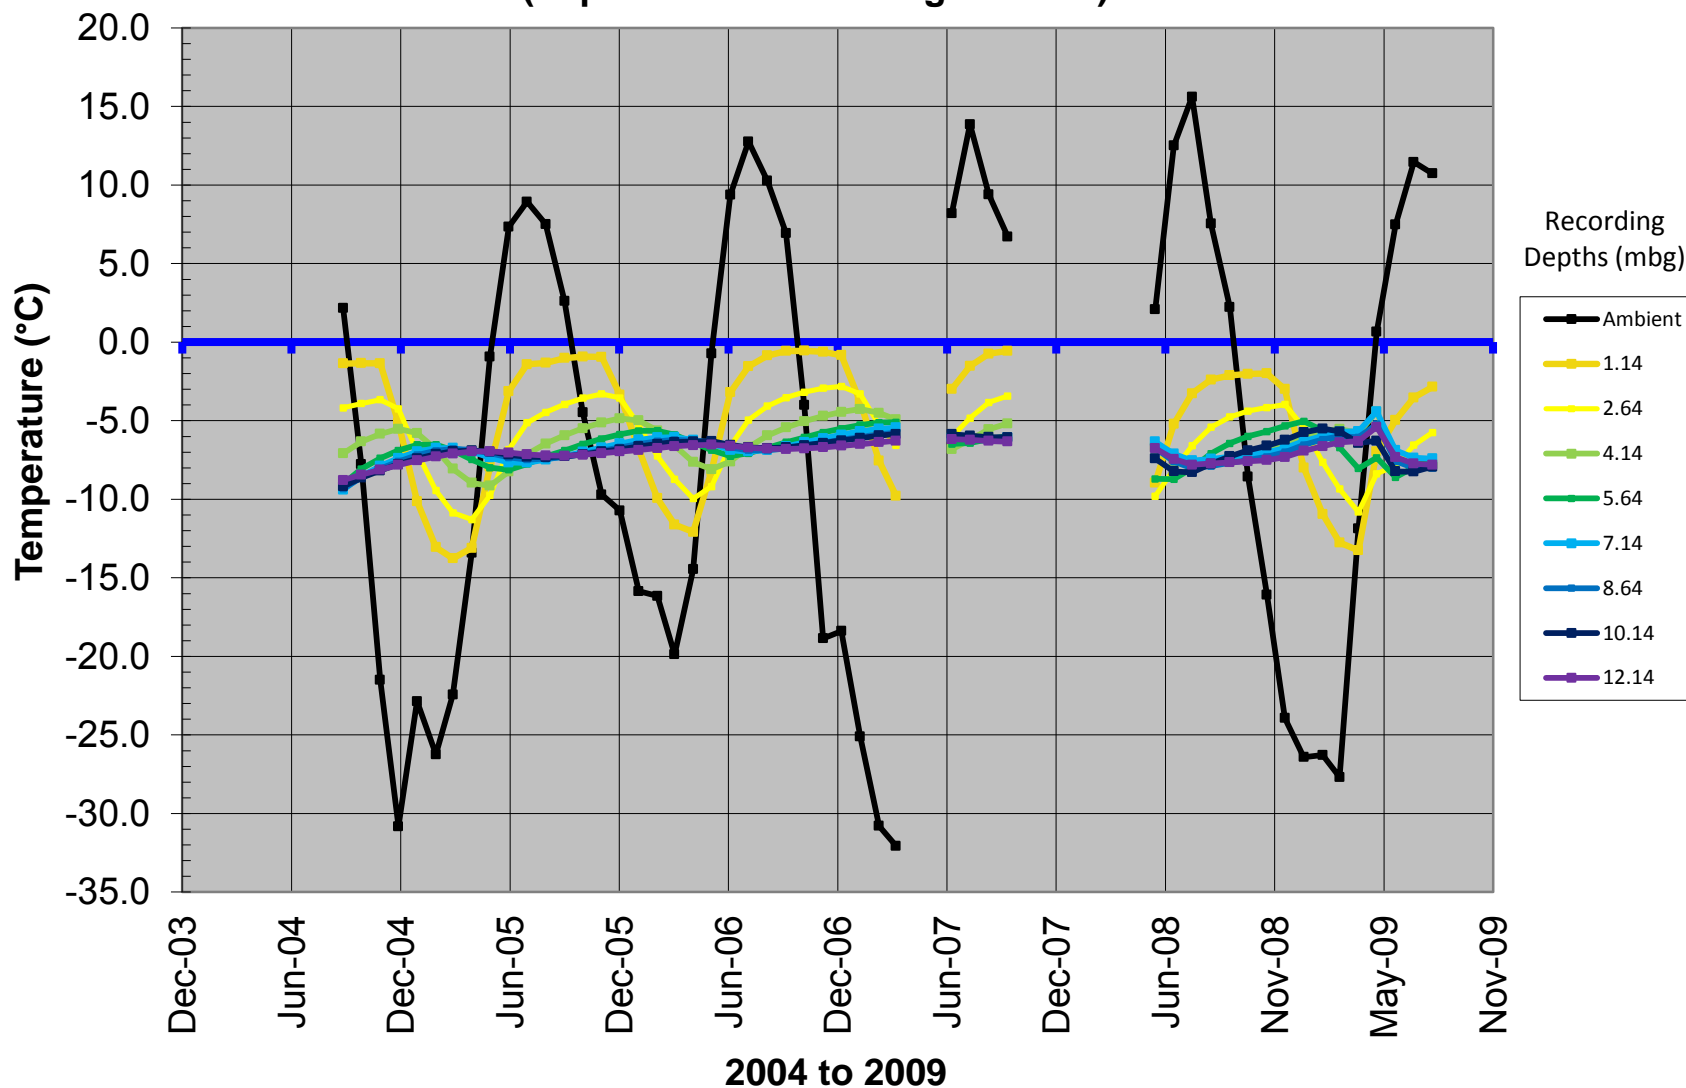
None of the thermisters registered temperatures above 0°C at the depths where drilling waste is contained (approximately 4.0 to 5.4 mbg). Generally, thermister strings located in the sump and in the control location have been logging equivalent temperatures at depths below 3 m (Appendix C).

**Figure C-3 - Thermister 1727 Average Monthly Ground Temperatures
(September 2004 to August 2009)**

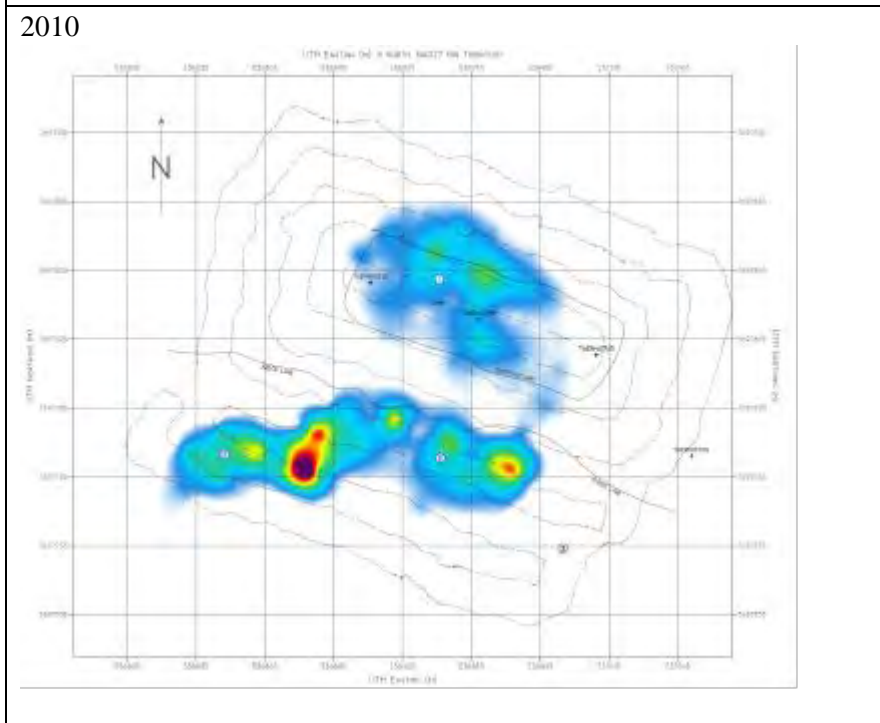
Figure E-2 2007 to 2012 EM31 Surveys

Results of the 2012 EM31 survey (0 mbg to 5 mbg) revealed that both the magnitude and extent of the apparent conductivities on the sump cap have increased from 2011. This is believed to be a function of the high influence of the apparent conductivity in the active-layer has on the EM31 survey results, since ionic migration within the permafrost would not otherwise be expected to vary by that magnitude from one year to the next.

Ground conductivity surveys were conducted in the thaw season to demonstrate the apparent spatial distribution of conductive materials (i.e., anions, cations, metals, etc.) at the sump cap. Changes in the distribution of such materials could be indicative of lateral migration of saline drilling fluids and potential problems with sump integrity (NWT Water Board, 2005). Historical data suggest that lateral migration may have occurred into a large topographical low area (approximately 120 x 40 m) south of the sump. The 2012 EM38 survey indicated that the plume of elevated apparent conductivity may have expanded compared to 2011, which is likely indicative of the more saturated conditions in 2012 compared to 2011. Of note, however, is that ECs in laboratory samples greatly decreased from 2011, as did concentrations of other major ions such as potassium and chloride, which suggests that the distribution of apparent conductivity may be a result of more abundant surface water or shallow active-layer groundwater south of the sump rather than an increase in ion migration. Although the level of surface water saturation increased during 2012, it does not appear to have extended significantly beyond the historical southwestern extent of the plume.
