REPORT FOR THE ENCANA CORPORATION UMIAK N-16 2006 SUMP MONITORING PROGRAM

Water Licence: N7L1-1797

Licencee: EnCana Corporation

Year Reported: 2006

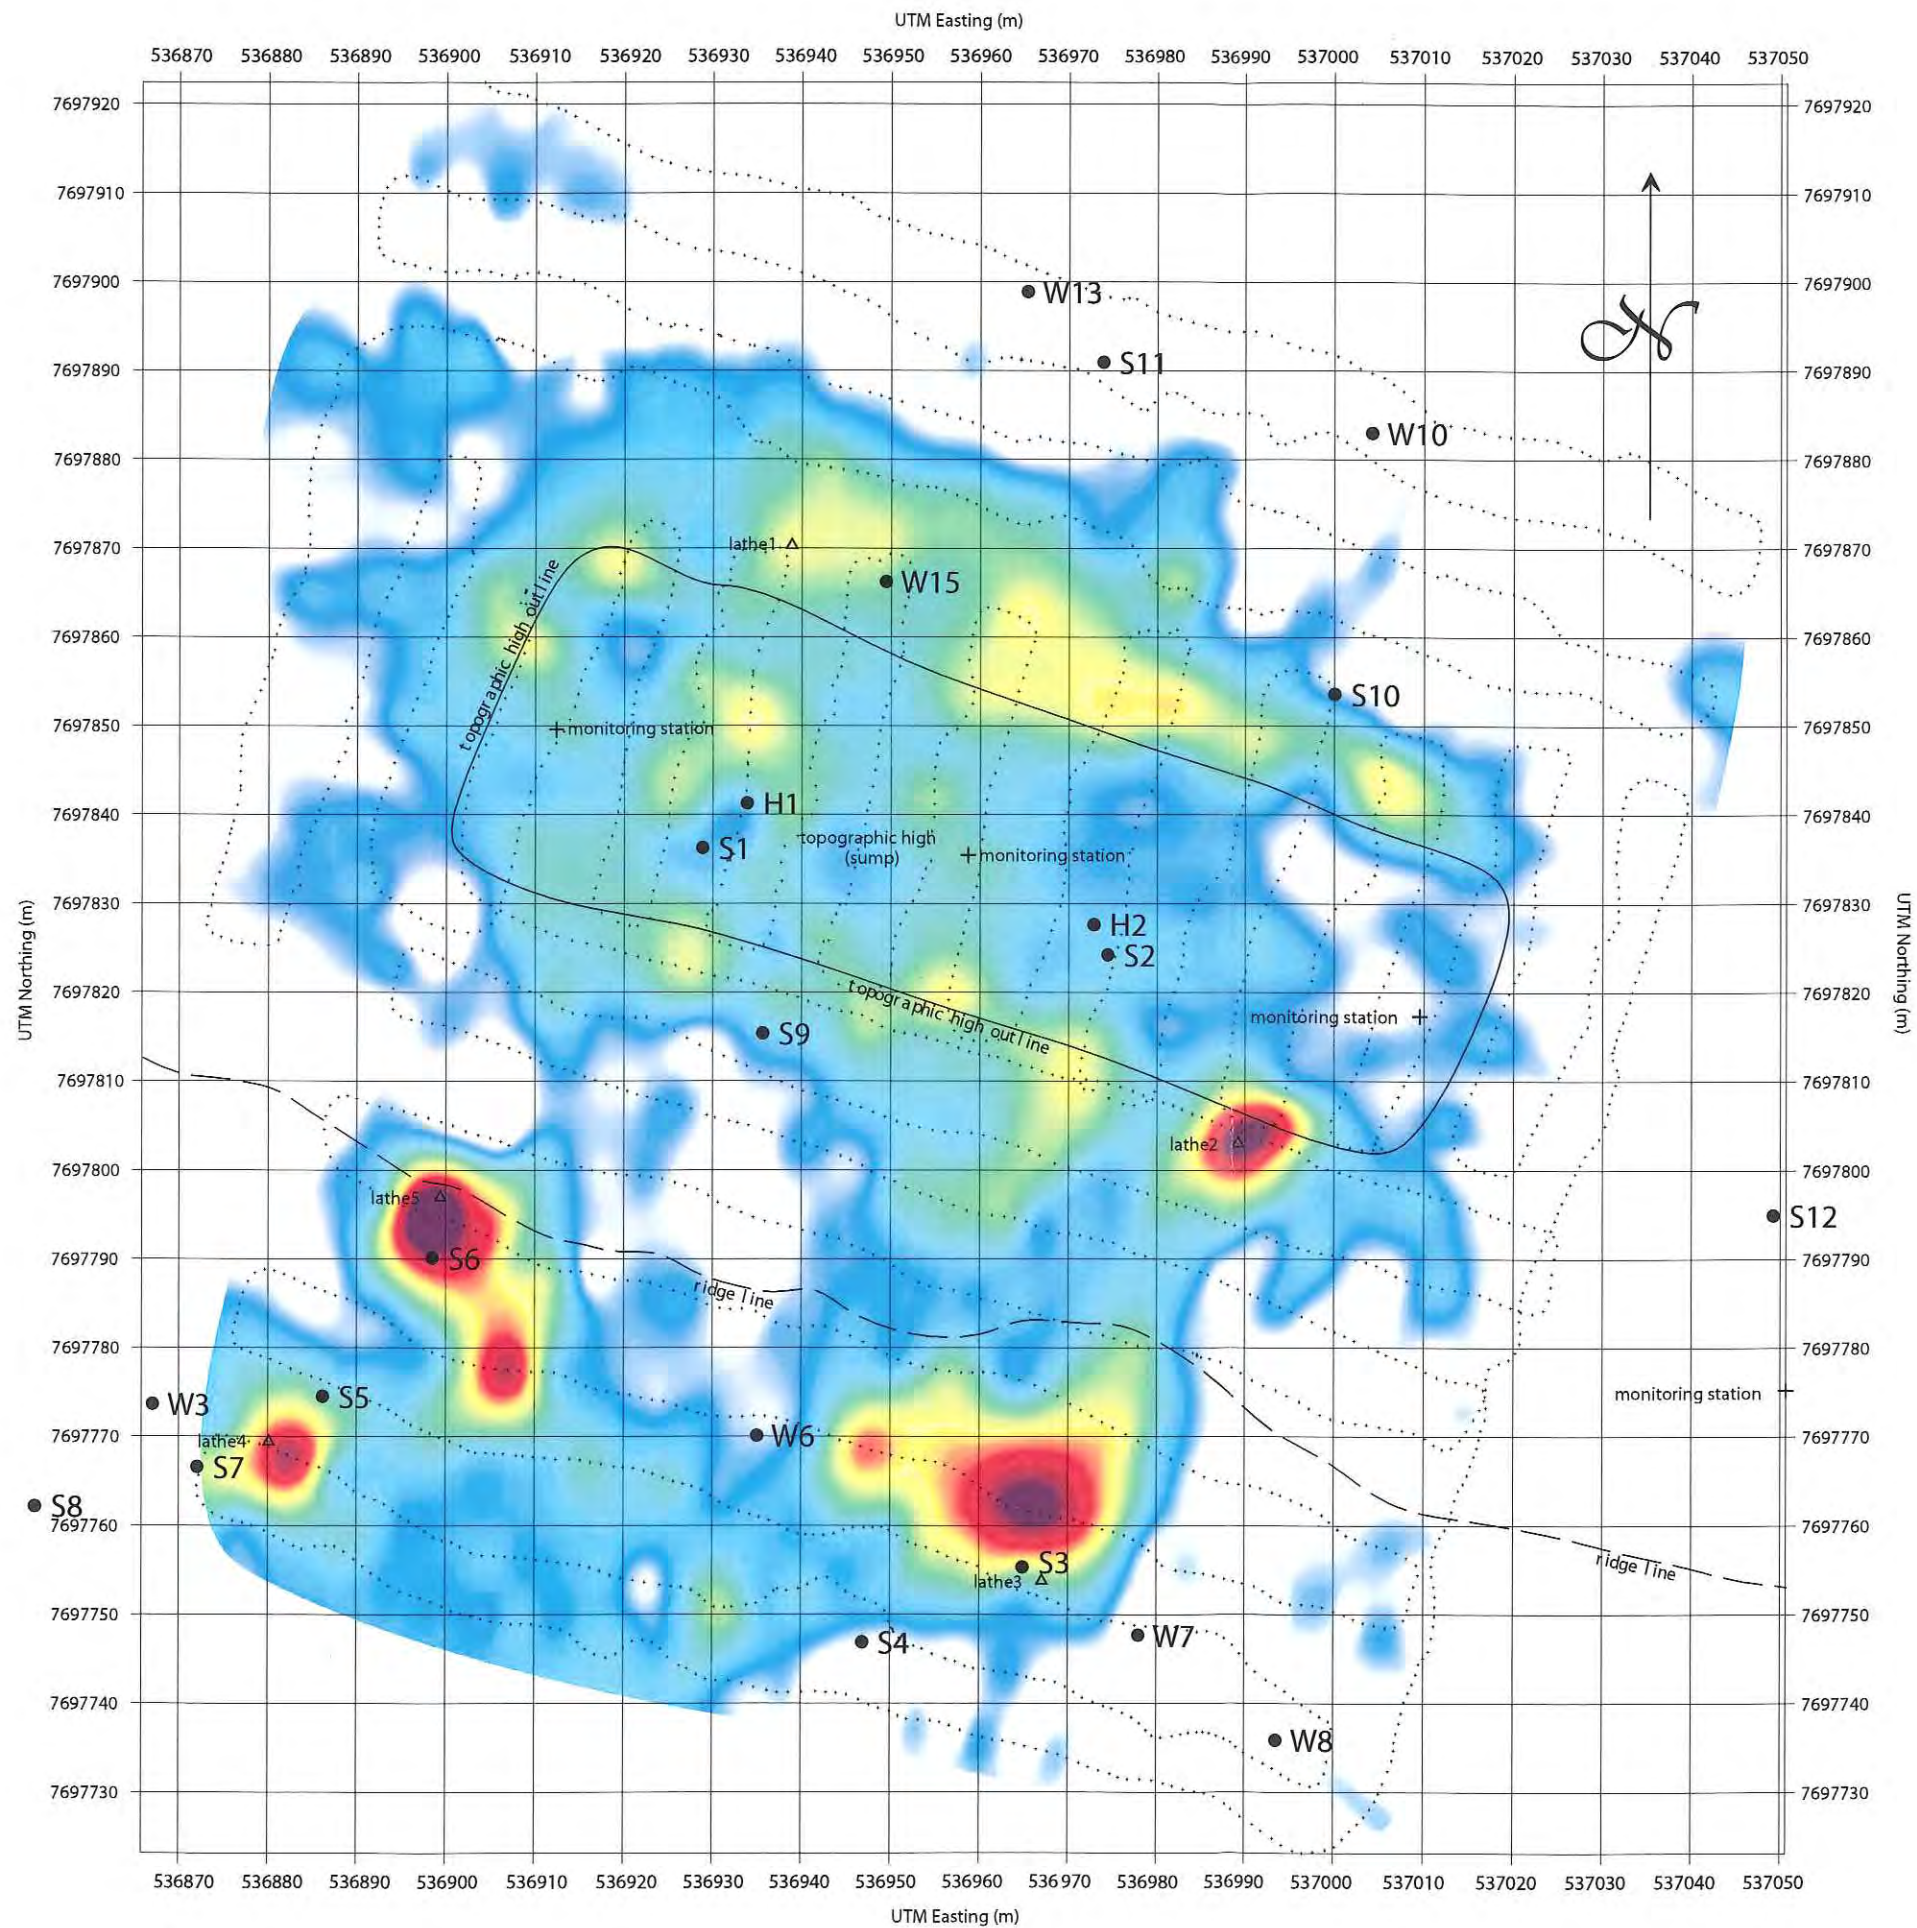
The colour image reveals the 'Apparent Conductivity Distribution' on site. The term 'Apparent Conductivity' implies that conductivity measurements do not linearly relate to actual soil conductivities.

The presented EM data should be used qualitatively to select targets for vertical (depth) geophysical profiling or soil sampling. Geophysical results are only conclusive after correlation to soil sample data (ground-truthing). The depth response of the electromagnetic (EM) field varies from surface to a unique depth, the 'skindepth' of that particular EM signal. The skindepth of any EM signal is strongly influenced by overall soil conductivity. Since soil conductivity varies randomly, the apparent conductivity distribution does not represent data from any particular depth.

Lateral Conductivity Distribution (EM38) & Site Features
Umiak N16 Sump

Results of the 2006 EM38 and EM31 surveys (Appendix D) showed decreasing response amplitudes along the axis of the sump as compared to the two previous years. As in previous years, drilling wastes appear to be concentrated in the western portion of the sump. The 2006 EM surveys indicate a wider dispersion of elevated conductivity around the sump; however, hot spots recorded in 2005 are slightly reduced in magnitude in 2006. Two new hot spots were identified this year in an area south west of the sump not surveyed in previous years.

Based on the 2005 and 2006 EM survey results, twelve (12) soil sample locations were chosen to characterize and delineate potential impacts from the sump (Figure 1). The salinity analysis revealed that soil samples N16-S6 and N16-S7, designed to investigate the high ionic anomalies southwest of the sump, have the highest concentrations of general salinity parameters. Sample N16-S7 was the only sample to have electrical conductivity concentrations that exceeded CCME guidelines. pH for all samples located off the sump cap (including background) had values that were not within the acceptable CCME guideline range, likely a response to naturally occurring low pH in the peaty substrate that surrounds the sump. All other samples were within CCME guidelines. Soil samples N16-S3, N16-S5 and N16-S9 were located to investigate other EM survey anomalies and migration paths on the south side of the sump. These samples had slightly elevated salinity parameters above background conditions. Generally, all the other samples on the south and north perimeter of the sump had values that approximate background conditions for the area.

Seven (7) water samples were obtained and forwarded to the lab for salinity analysis based on the results of the field screening (see Figure 1 for locations). There was no surface water observed on the cap of the sump. Water samples N16-W3, N16-W7 and N16-W8 were located to investigate anomalies identified in the EM survey on the south side of the sump. Water sample N16-W15 was located to delineate the northern extent of the anomalies identified in the EM survey. These samples had elevated electrical conductivity, potassium and chloride values. Water samples N16-W6 and N16-W13 approximated background conditions. The pH levels for four of the seven samples were not within acceptable CCME guidelines including the background sample, likely due to the acidic nature of the surrounding peatlands.

Results of the EM38 and EM31 surveys and the soil and water sampling program suggests that ionic concentrations have migrated from the sump into the adjacent areas. The EM38 survey showed elevated electrical conductivity responses extending north and south from the sump and appears to be concentrated in the lower topographical regions. Within these hotspots, elevated levels of potassium and chloride identified in the soil and water sampling program verified that these elevated anomalies likely originate from the sump. However, only one soil sample had elevated parameters that exceeded CCME guidelines that are not a result of background conditions (S16, with a conductivity reading of 7.44 dS/m, above CCME guideline of 2 dS/m).

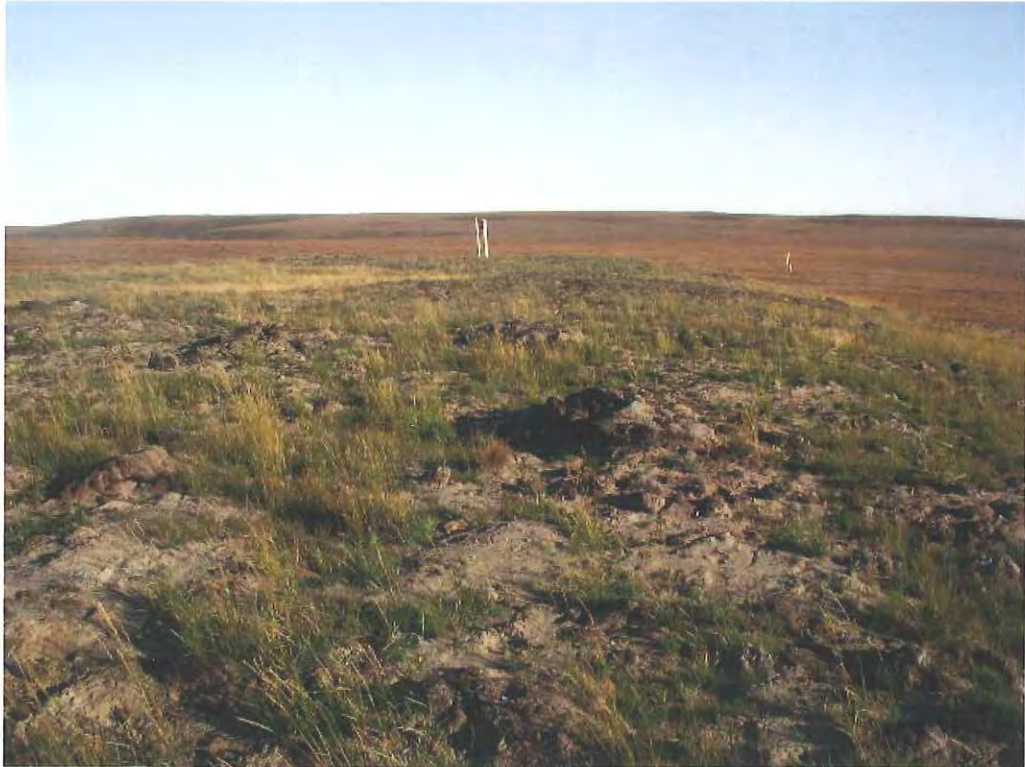
Visual assessments during 2006 revealed no evidence of ponding, erosion, stress, tension cracks on the cap or surface of the sump. There was no evidence of settling within the sump. Vegetation establishment on the sump cap has been moderate with clusters of vegetation growth (See Photo 1 in Appendix A). Vegetation surrounding the sump cap showed no visual signs of stress (Photo 2 in Appendix A). Permafrost depths were between 0.86 and 0.92 on the sump cap and ranged between 0.35 and 0.48 m in the areas adjacent to the sump (see depths of samples in Table 1). There was very little moisture contained in the active layer of the sump cap.

Photo 1: Vegetation establishment on the sump cap (September 16, 2006).

Revegetation has not fully covered the sump cap after three growing seasons since the initial reclamation. Revegetation has been sparse on the sump cap, limited to isolated clusters. Vegetation growth may be limited due to the coarse grain topsoil and lack of surface organics, limiting the moisture availability. Due to the coarse granular material composing the topsoil and the high wind potential, wind erosion may be a concern over the long-term management of the sump. However, significant wind erosion was not observed during the site visit.

Vegetation establishment has not been adequate to stabilize the cap of the sump and substantially inhibit the potential for erosion into the surrounding area. The sump cap should be fertilized and/or revegetated with an ENR approved seed mix as required in April-June 2007 in conjunction with the spring 2007 sump assessment and thermister download. Seed should be broadcast at the time of year when temperature and moisture regimes are at the optimum level to promote germination. Special care shall be taken to ensure seeds are buried in the sump cap and that the existing vegetation is not disturbed. Vegetation should be re-assessed during the fall 2007 site visit. If additional seeding is required, an ENR approved cover crop, designed to stabilize the cap during the short-term, have a finite life expectancy and be out competed by native vegetation should be considered.

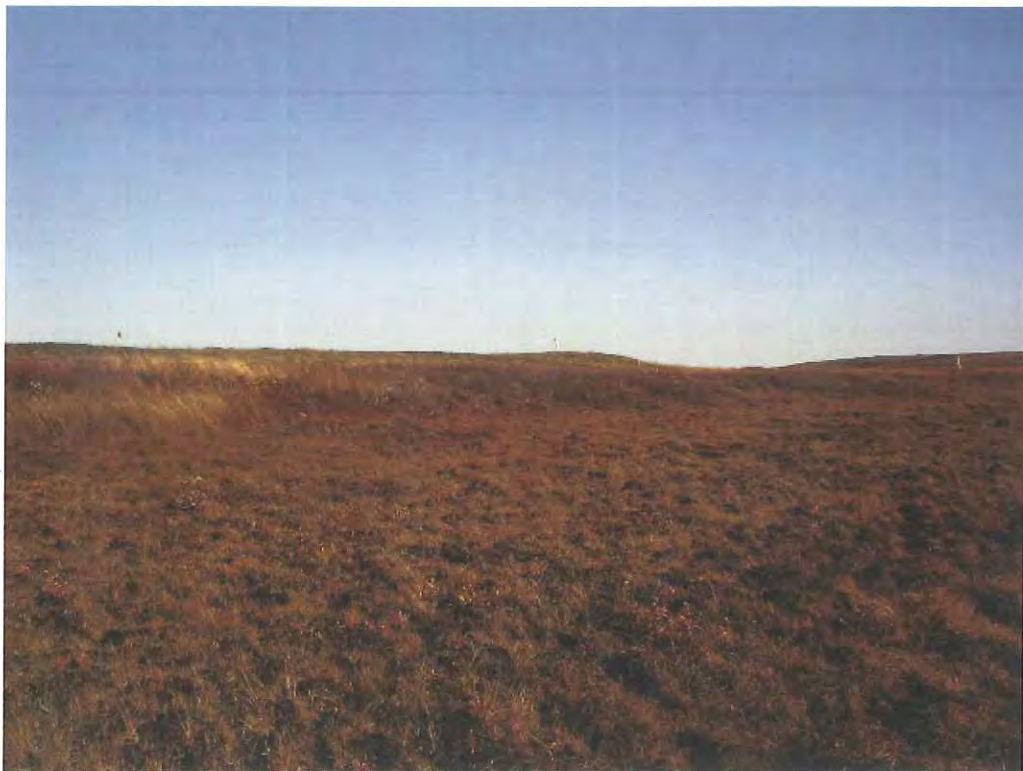
Photo 2: Representative photo of the general surrounding vegetation and ponding along the south perimeter of the sump (September 16, 2006).

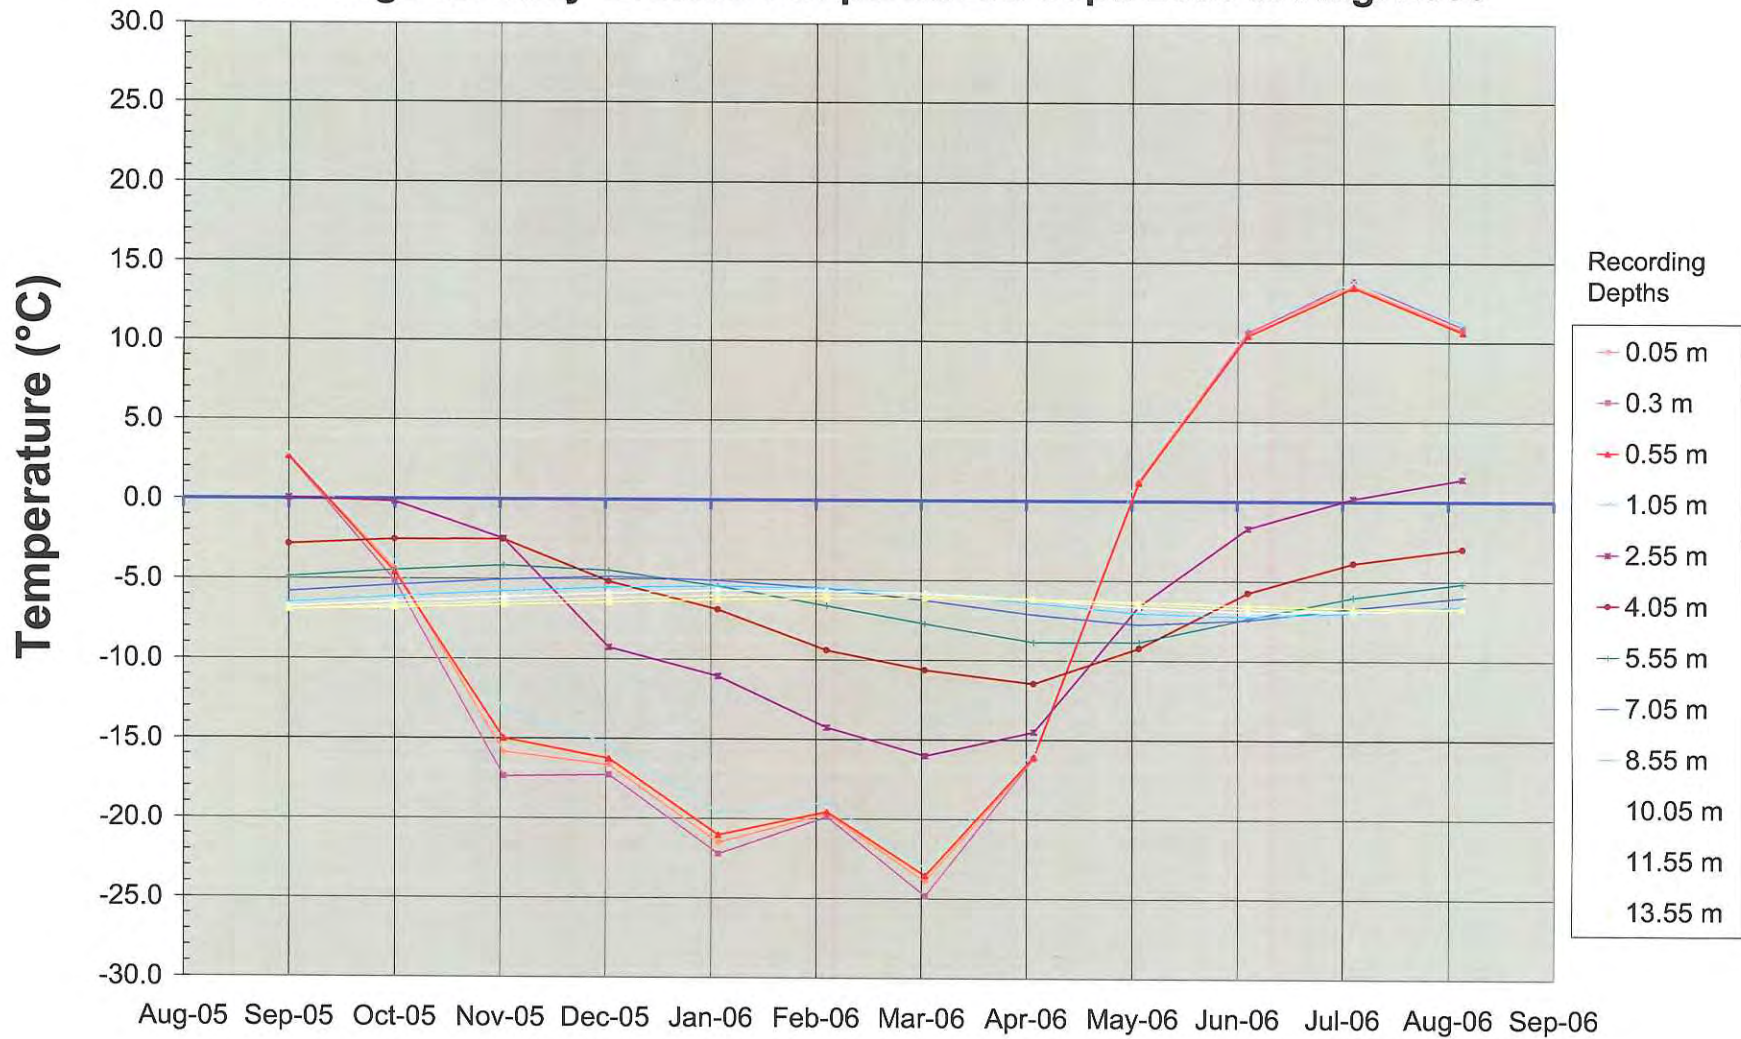
Umiak N16 - Thermister 1725
Average Monthly Ground Temperatures Sept. 2005 to Aug. 2006

Thermisters 1725 and 1727 located in the sump showed a greater degree of clustering of the temperatures in the active layer and shallow permafrost, between 0.00 m and 1.05 m than that of the control thermister (1726). Depths exceeding 4.0 m had temperature profiles between the control and the sump thermisters. Generally, the control thermister data reveals a greater degree of consistency in the thermal regime in the depths between 0.0 m and 4.5 m below grade.

Comparing the temperature graphs for each of the thermistors over the previous year, the temperature regime in the thermistors has appeared to be stabilized in the lower permafrost. In the active layer and the upper permafrost, there is a greater variability in the sequences of the graphs as the active layer in the sump is more sensitive to seasonal climatic variations than the control thermistor. This could be a result of the coarse grained nature of the sump cap and the limiting water retaining capability of the soil. Water has a much higher specific heat than air, allowing climate variations of the atmosphere to have a greater effect on the temperature in the soil of the sump cap than the water saturated organic horizons that surround the sump. In addition, the sump cap lacks an insulating organic layer at the surface allowing the cap to thaw and freeze more quickly and to a greater extent than the surrounding tundra, and resulting in an active layer that is considerably deeper than that of the surrounding area.

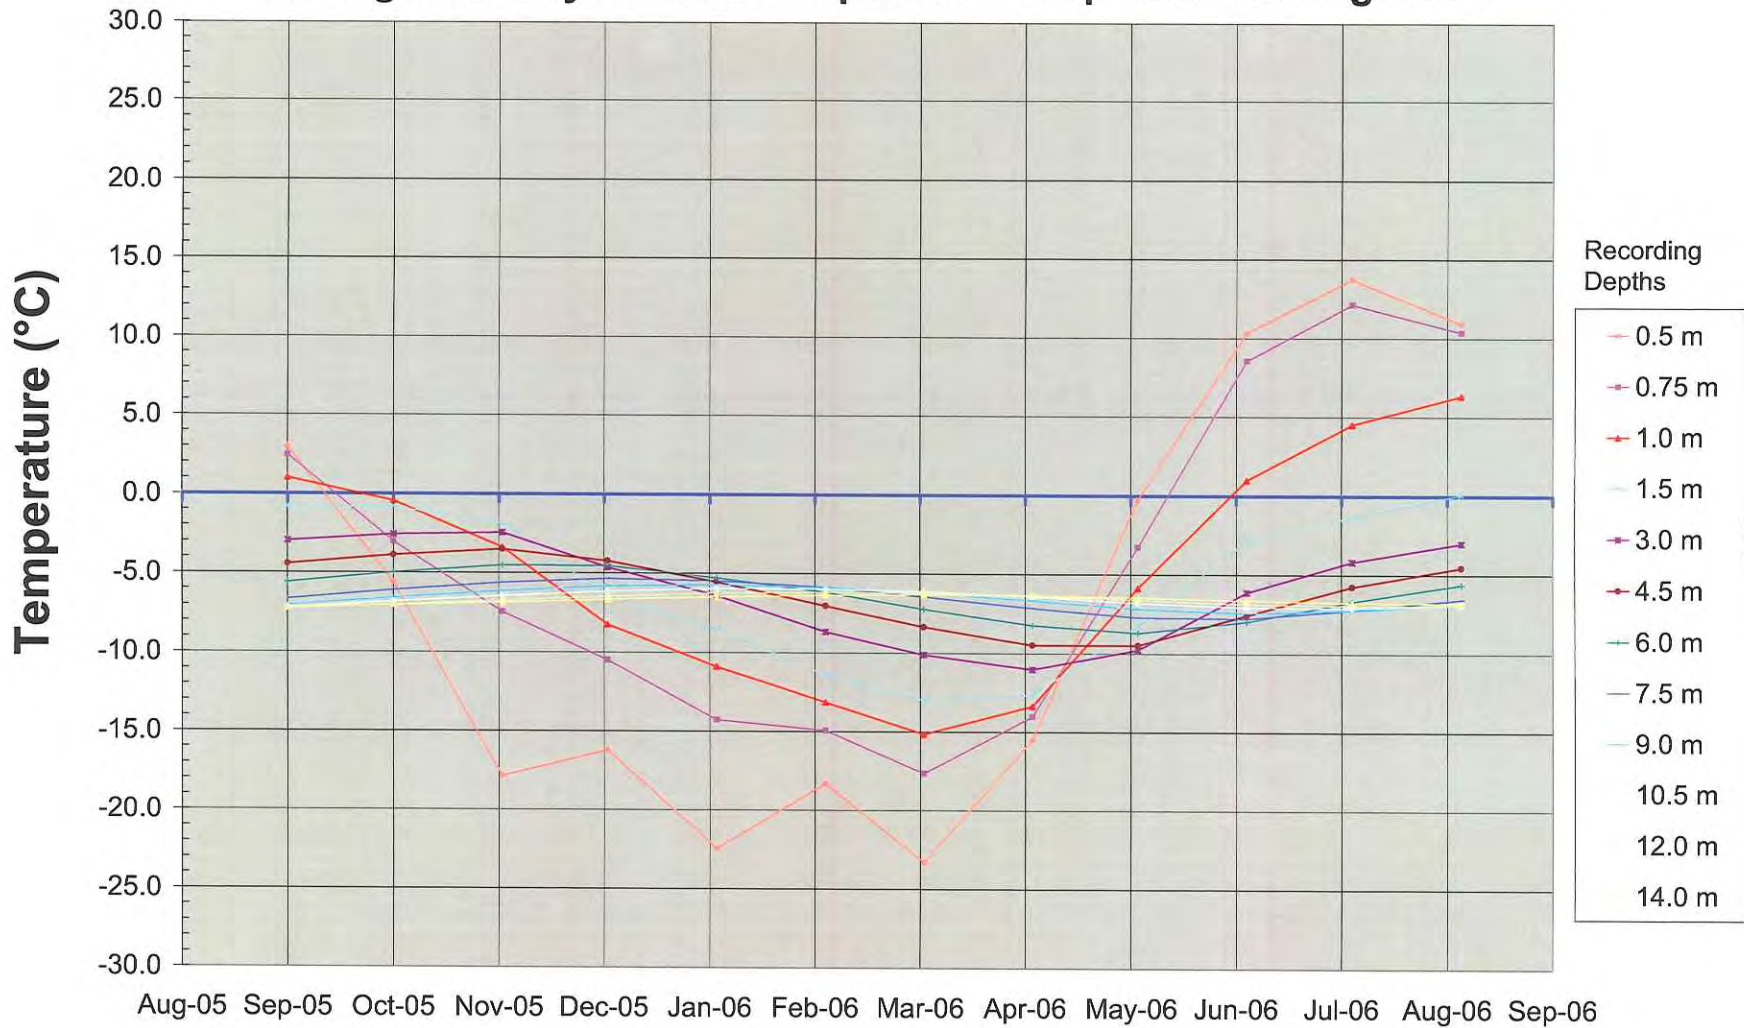
**Umiak N16 - Thermister 1726 (Control Thermister)
Average Monthly Ground Temperatures Sept. 2005 to Aug. 2006**
