**RE: INDUSTRIAL Water Use N7L1-1797
CLASS B – INDUSTRIAL
Burnt Lake/ Umiak N-16
Mackenzie River and various lakes**

INDUSTRIAL WATER USE INSPECTION REPORT

LICENCE #:	N7L1-1797, Burnt Lake/ Umiak N-16	EXPIRY DATE:	December 31, 2014
LICENCEE:	MGM Energy Corp.	PREVIOUS INSPECTION:	October 2, 2012
COMPANY REP:	Shirley Maaskant	INSPECTION DATE:	August 26, 2013

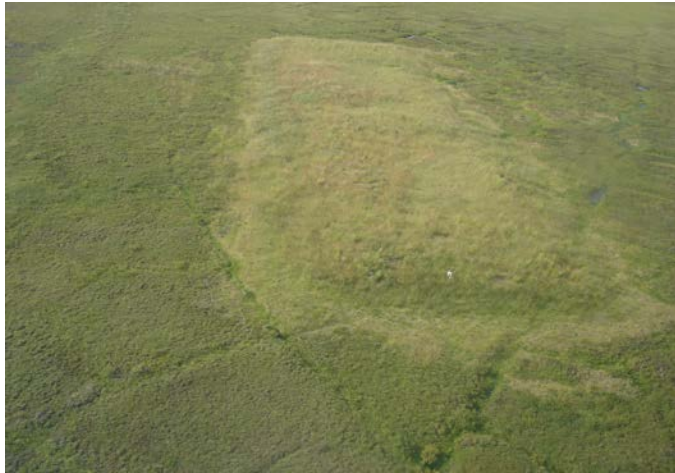
Figure 1
East side of sump with two very large intersecting polygon troughs.

- Greater prominent polygon line through east corner of sump.
- Good sloped sump and well drained.
- Polygons all integrating with sump and water present in some polygons. The presence of water ponding could affect the sump integrity. This polygon influence and water presence should continue to be monitored to ensure stability.

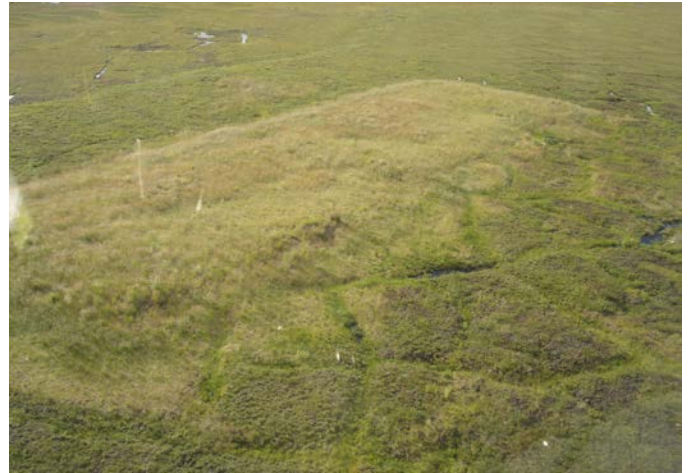
Figure 2
North side of sump with polygons integrating into side.

- Disturbance beyond the southside of the sump. It is thought there must have been some kind of disturbance such as where soil/overburden was piled during construction. There was enough of an impact that re-seeding of grass (similar to the sump) occurred.
- Thermistors still on site.
- Vegetation growth at 90-95%, well established.
- Polygons re-integrating into sump cap predominantly on northside of sump.

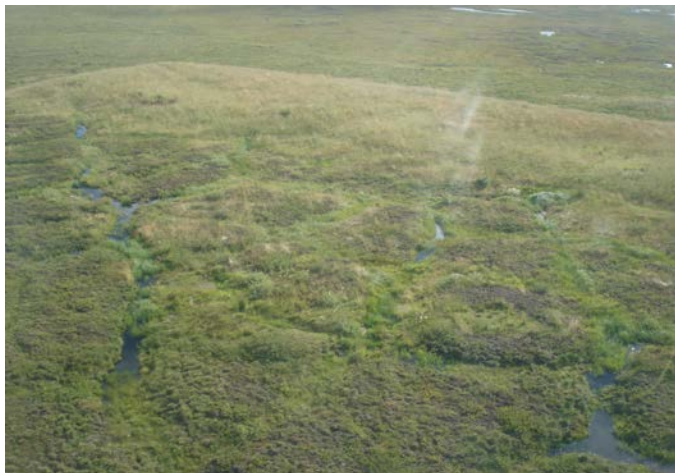
Figure 3
Water ponding in close proximity to sump on the northside of the sump.

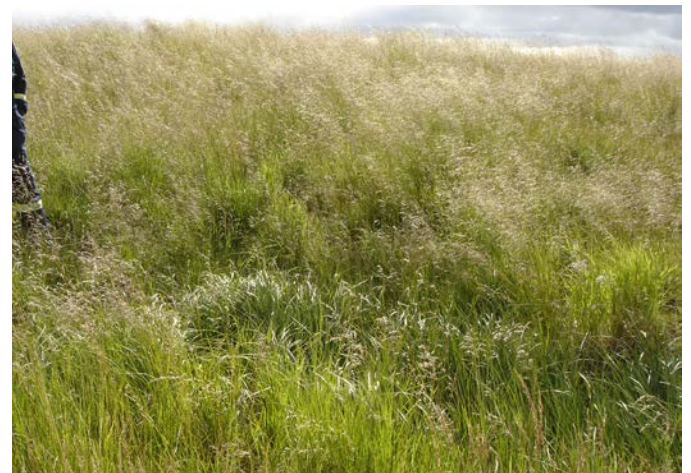
Figure 4
Deep polygon troughs along the northside of sump. Good thick and healthy vegetation cover.
