Public Works and Government Services Canada

Remediation Completion Report Johnson Point, Northwest Territories

AECOM

December 21, 2009

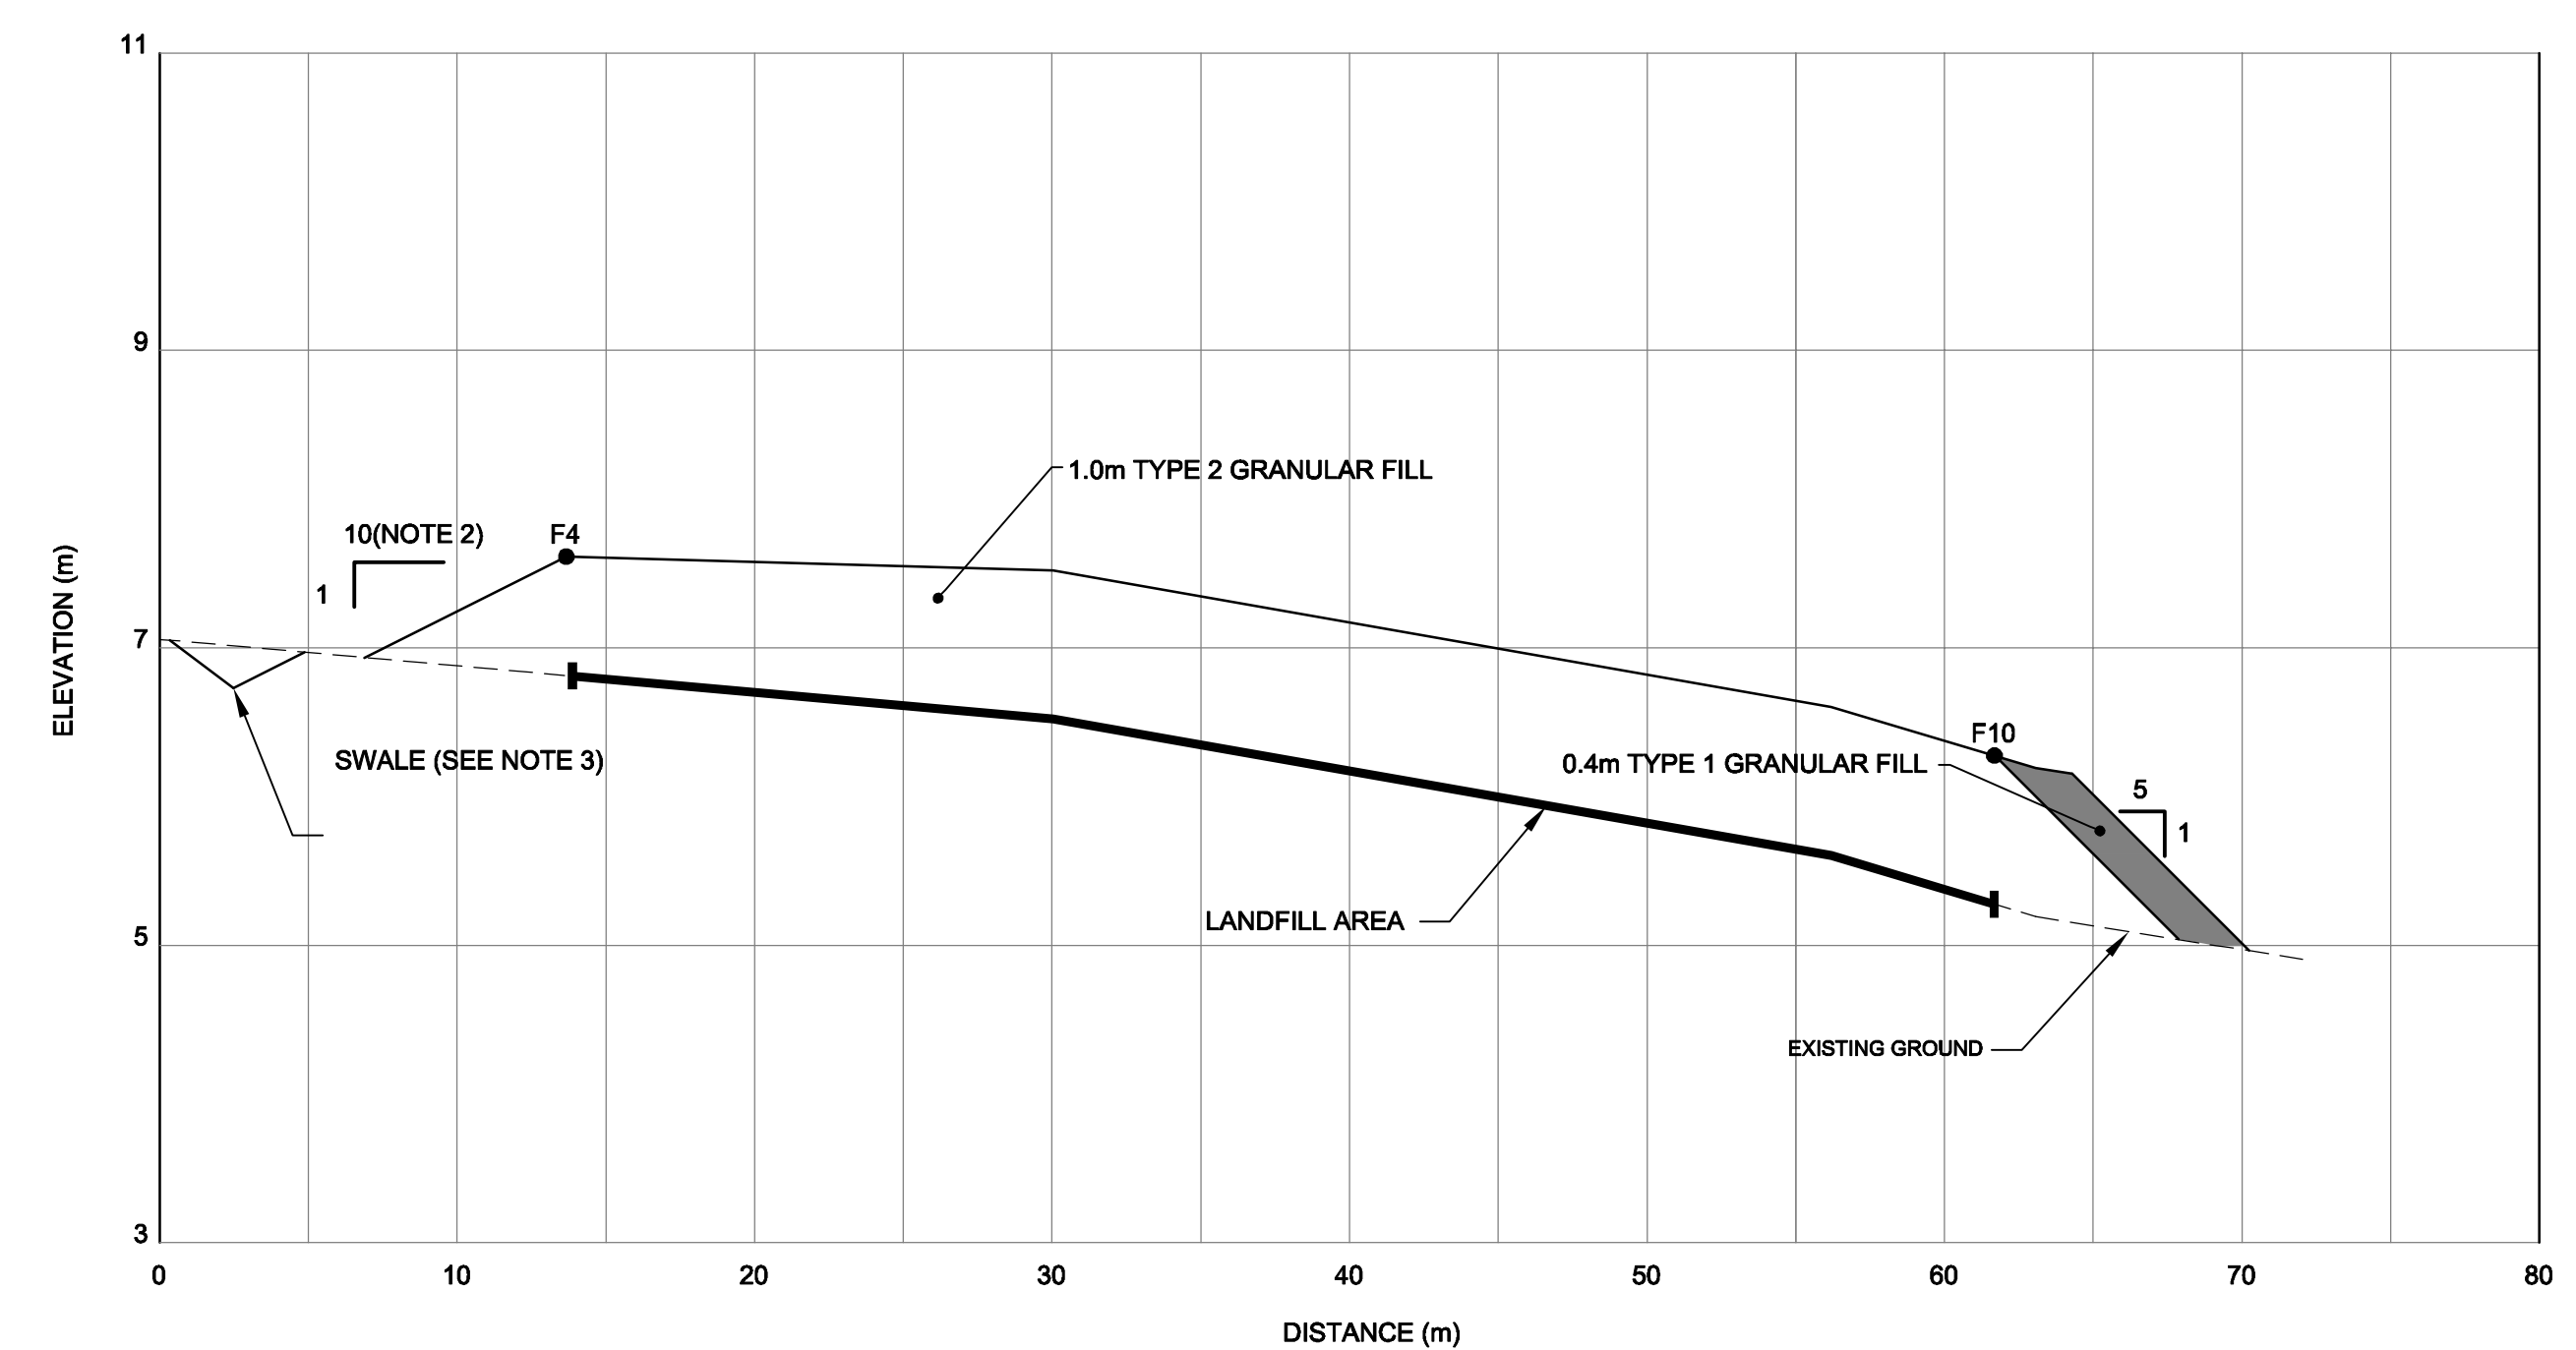
EXISTING LANDFILL A LOBE A REGRADE (TYPICAL SECTION)

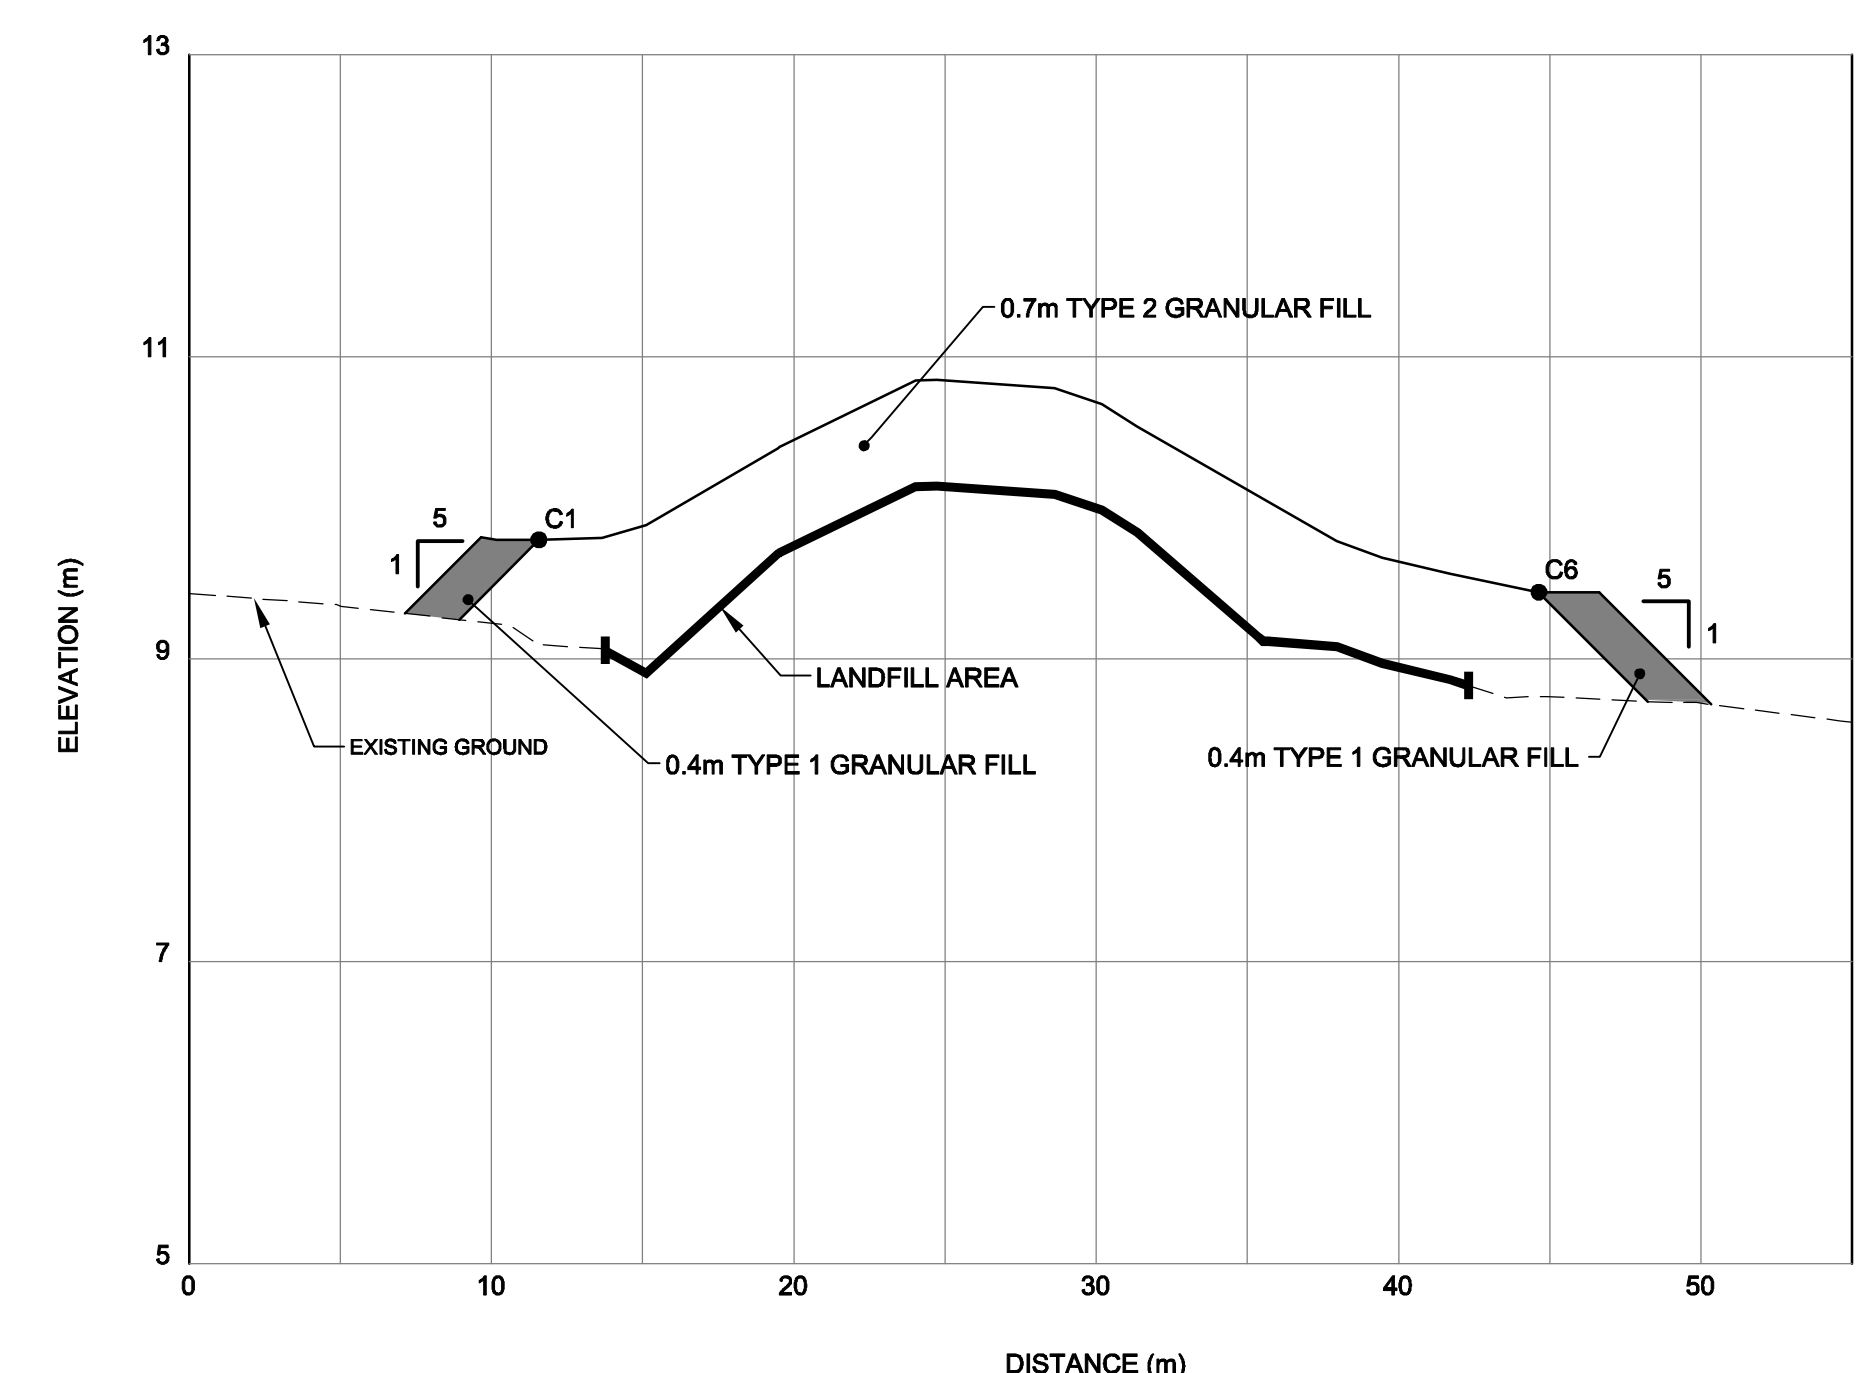
EXISTING LANDFILL B REGRADE (TYPICAL SECTION)

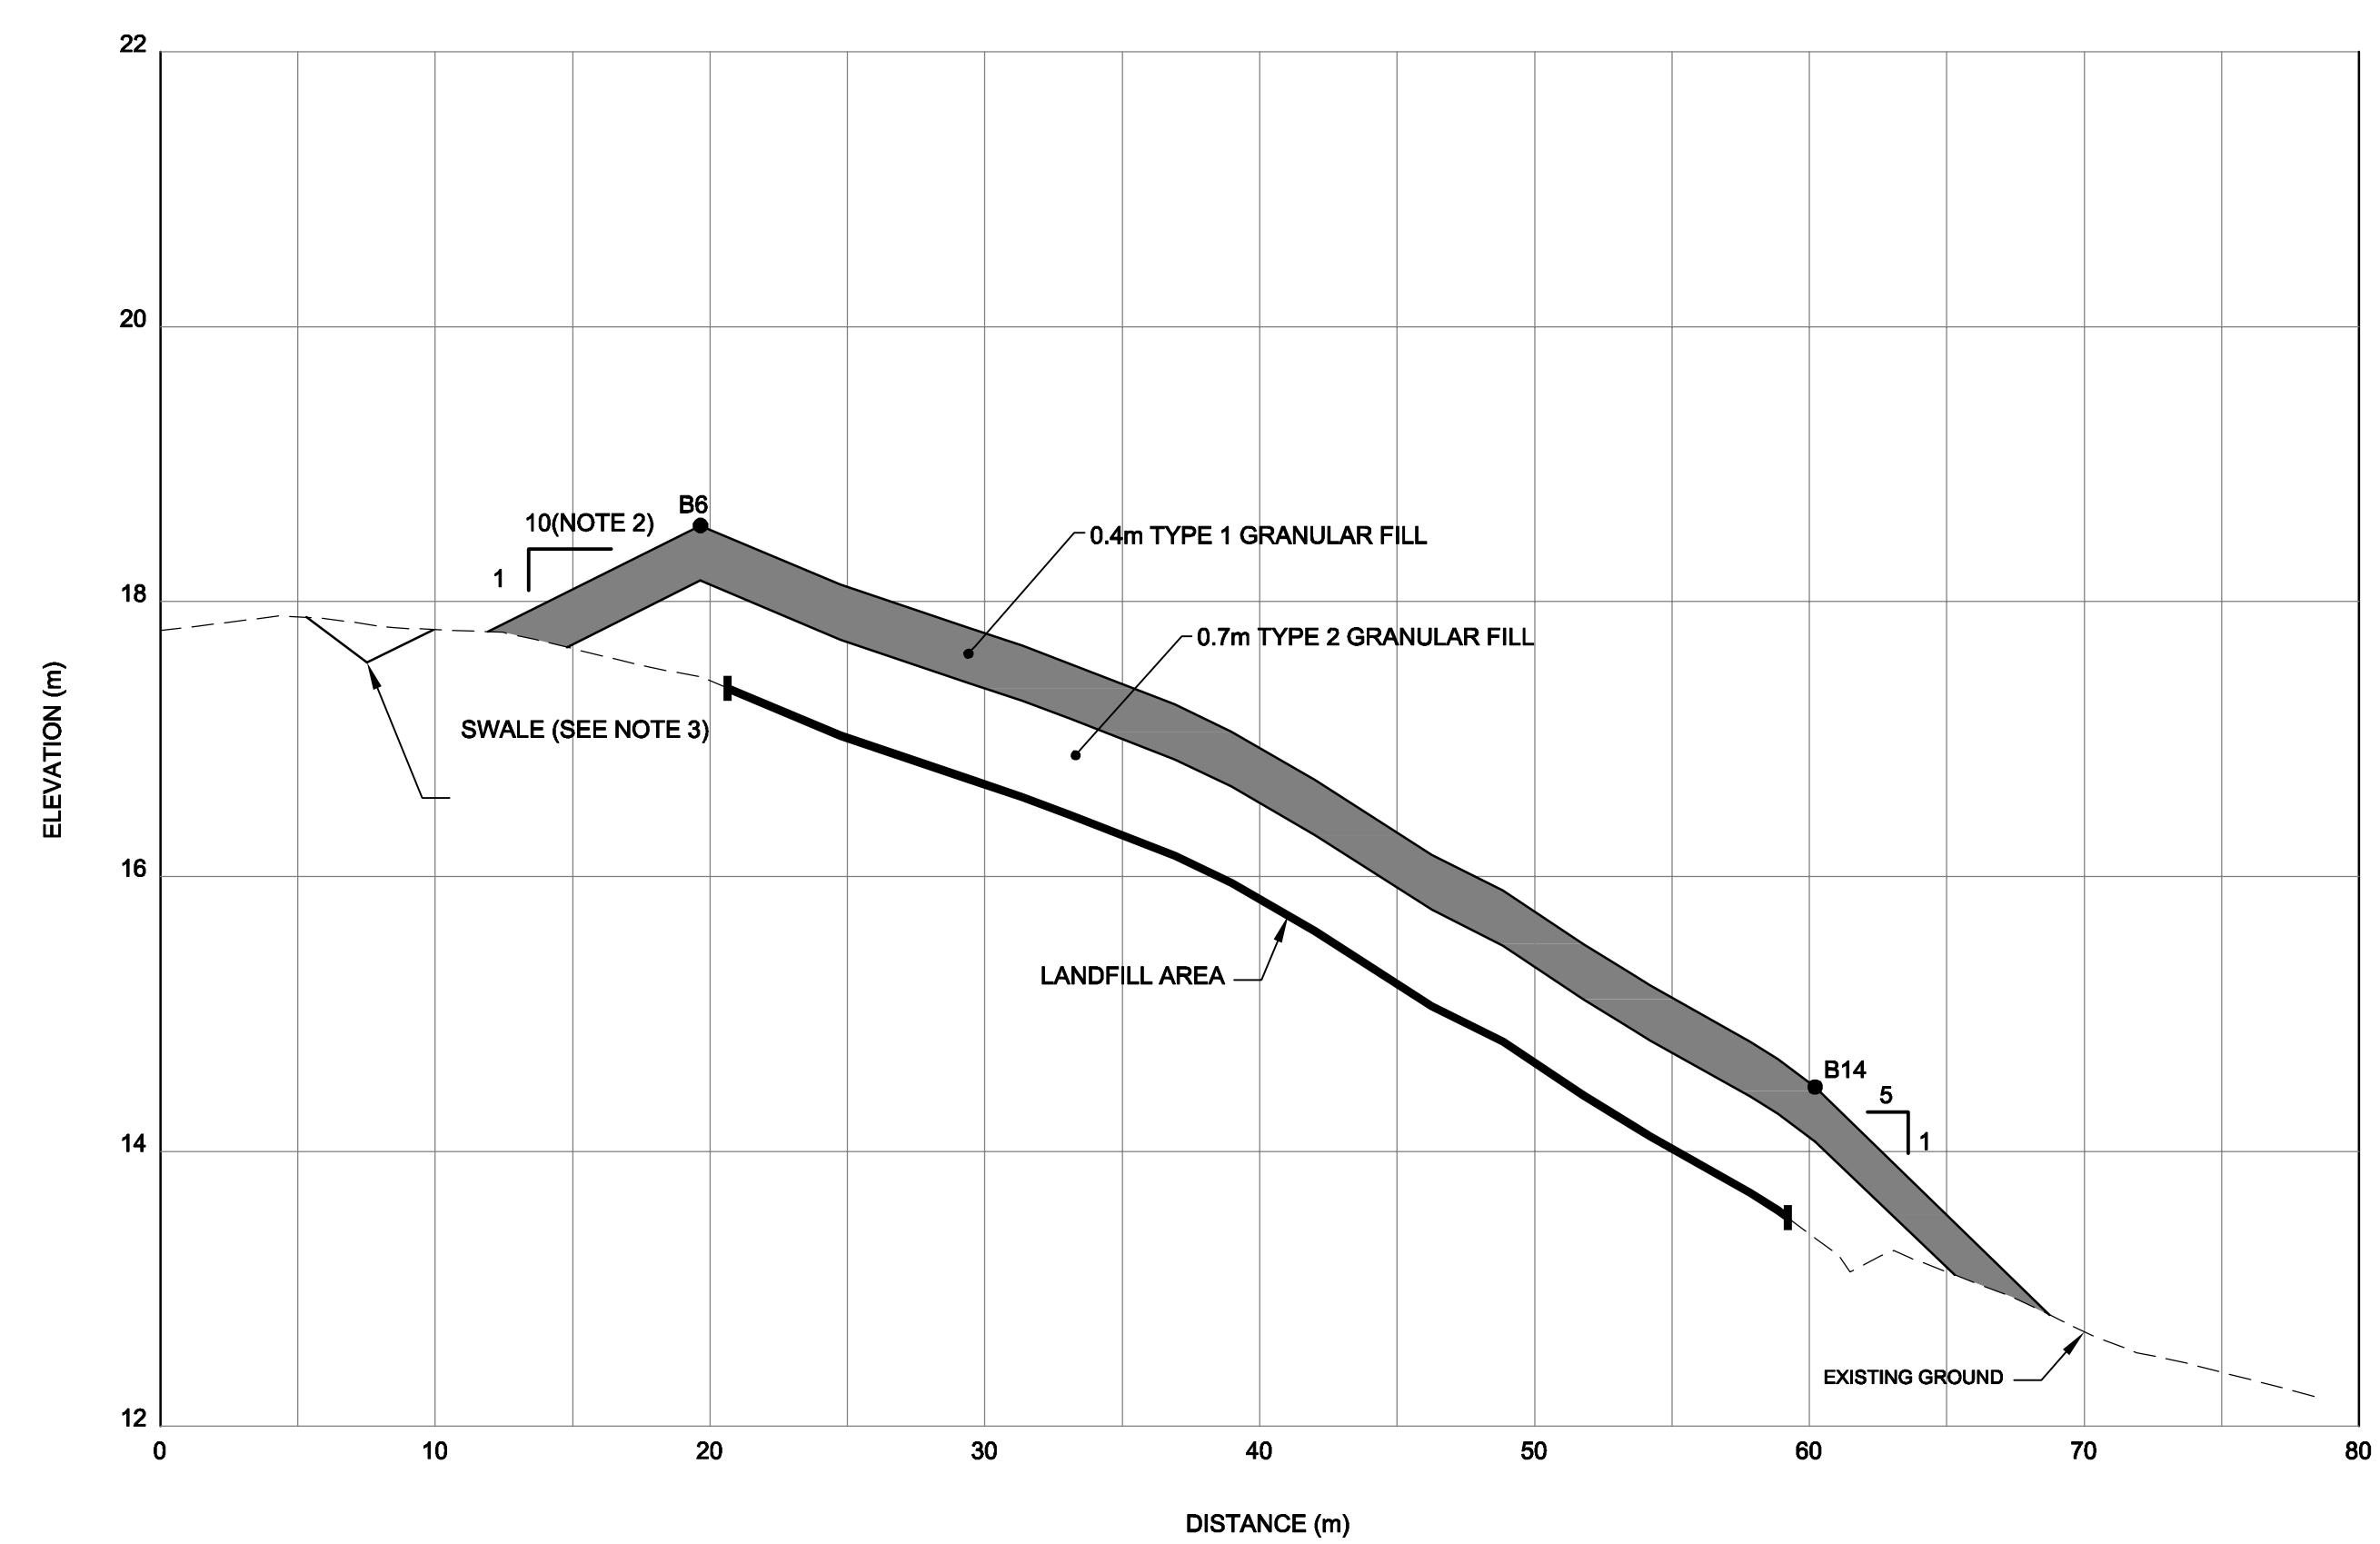
EXISTING LANDFILL C REGRADE (TYPICAL SECTION)

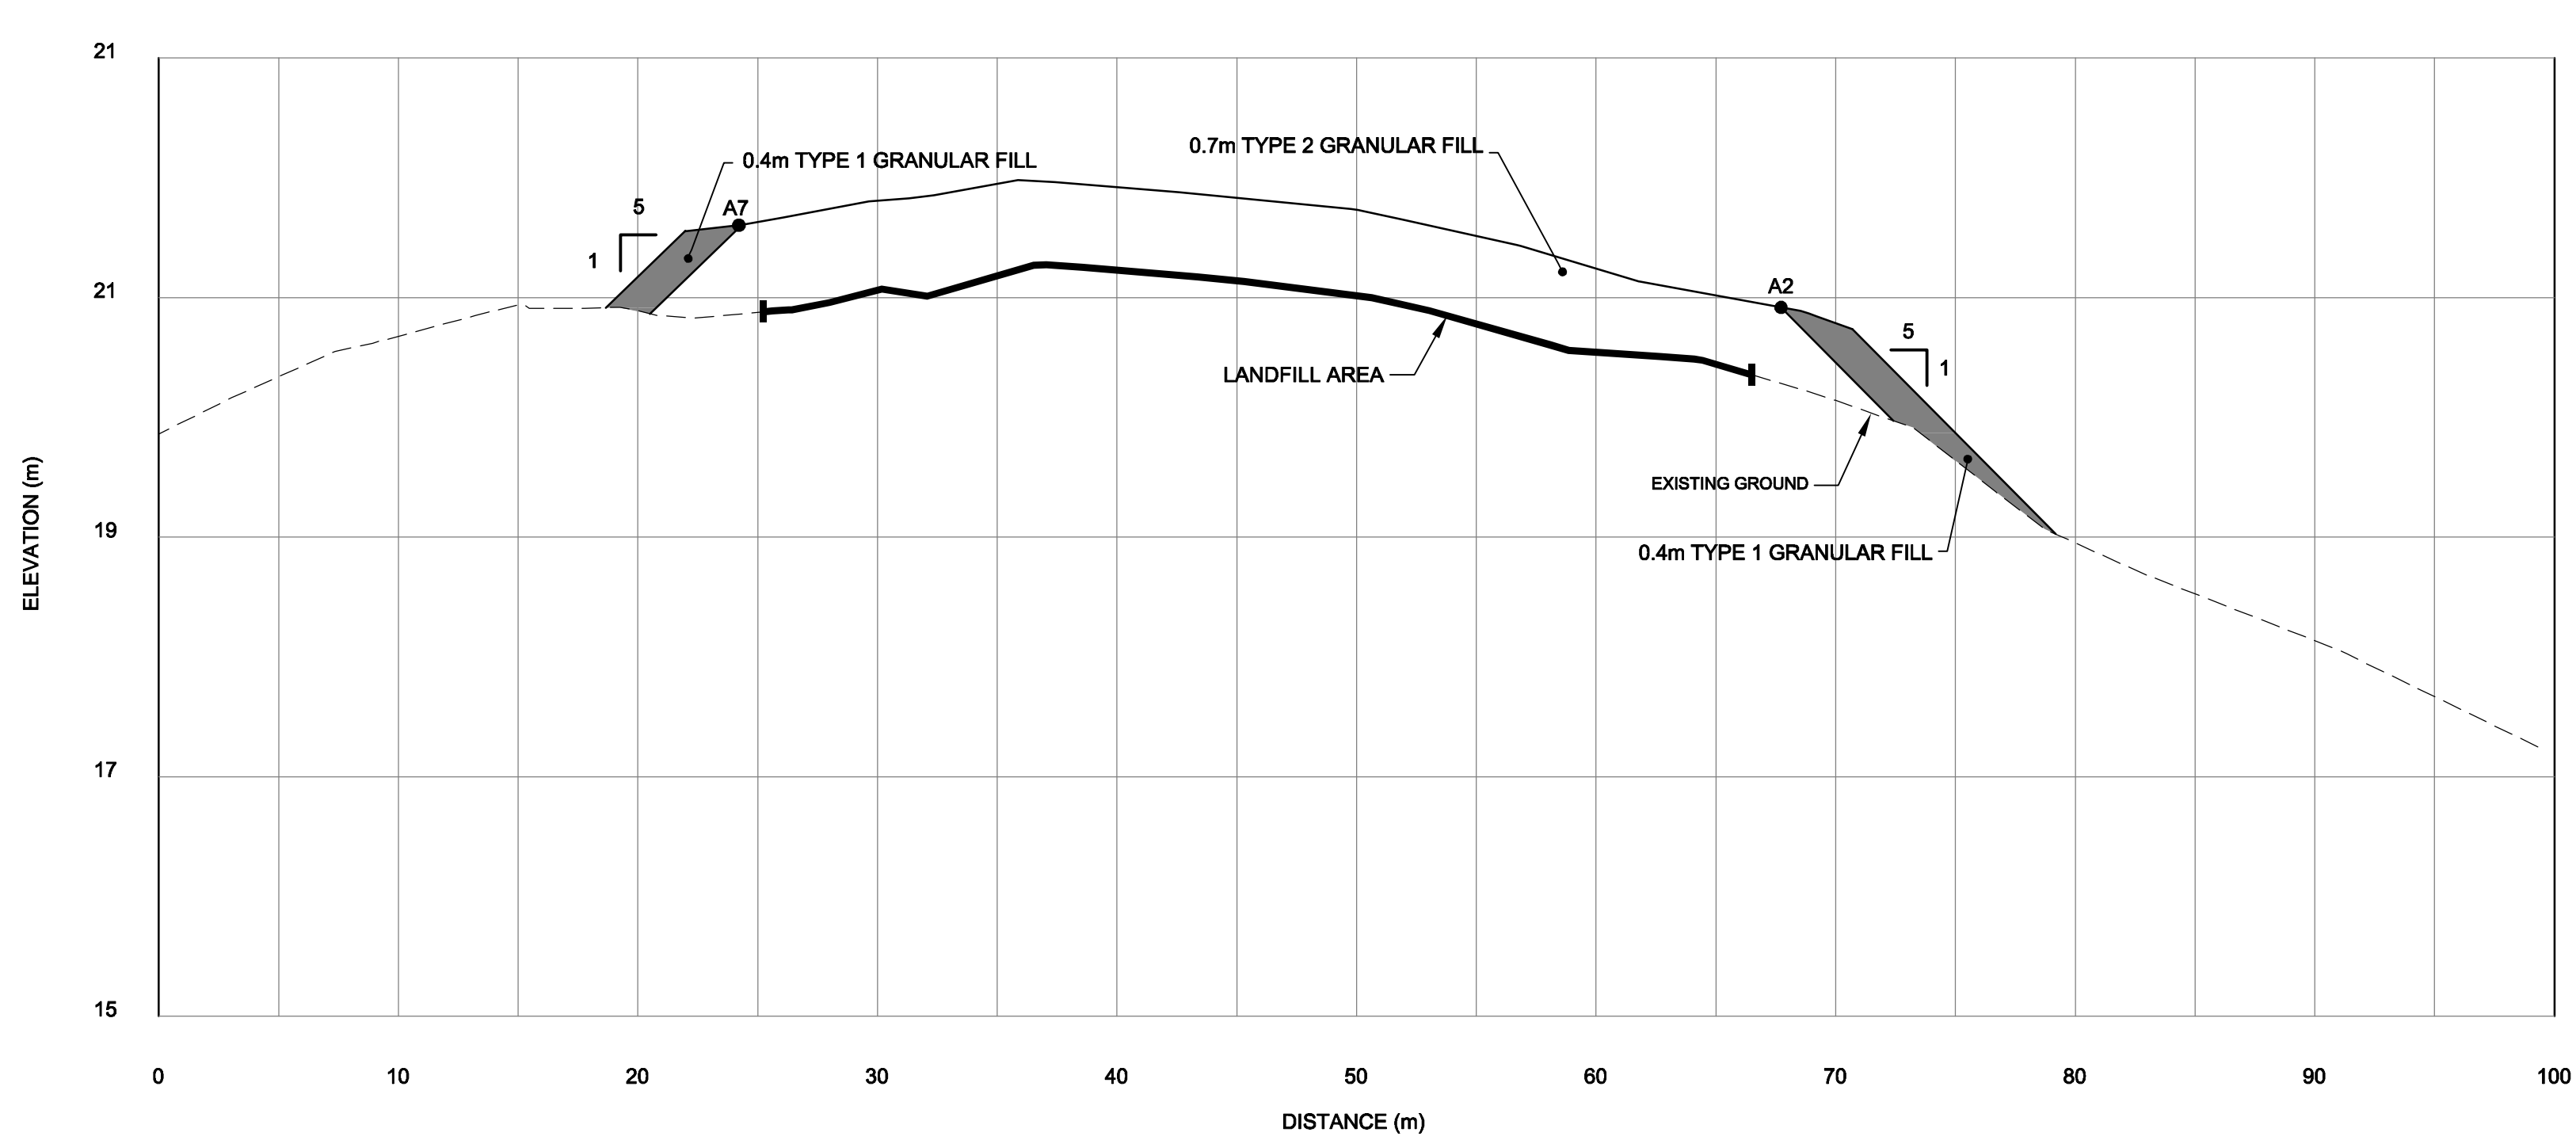
EXISTING LANDFILL D REGRADE (TYPICAL SECTION)

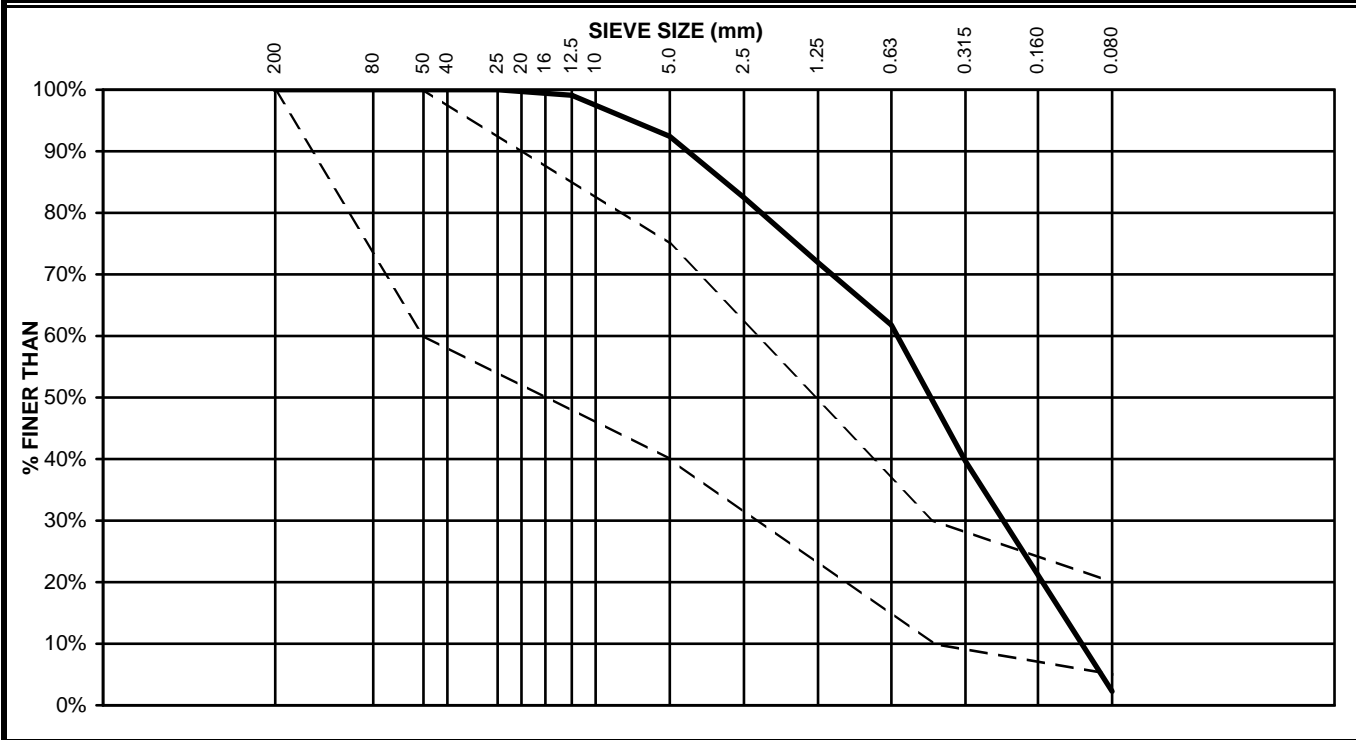
CLIENT : PWGSC
 PROJECT : JOHNSON POINT CLEAN UP
 JOB No. : 2977-371-00
 LOCATION : Geotechnical Testpit 2, Borrow Area 4
 SAMPLE: 1 DEPTH : 0-0.3m
 DATE : September 4, 2008 TECHNICIAN : BHN

Classification: **SP**
 Description and Remarks: Light brownish grey fine-grs SAND, loose. Pit walls show cross bedding and lag deposits indicating a glacio-fluvial origin.
 d_{10} 0.22
 C_c 0.89
 C_u 5.79

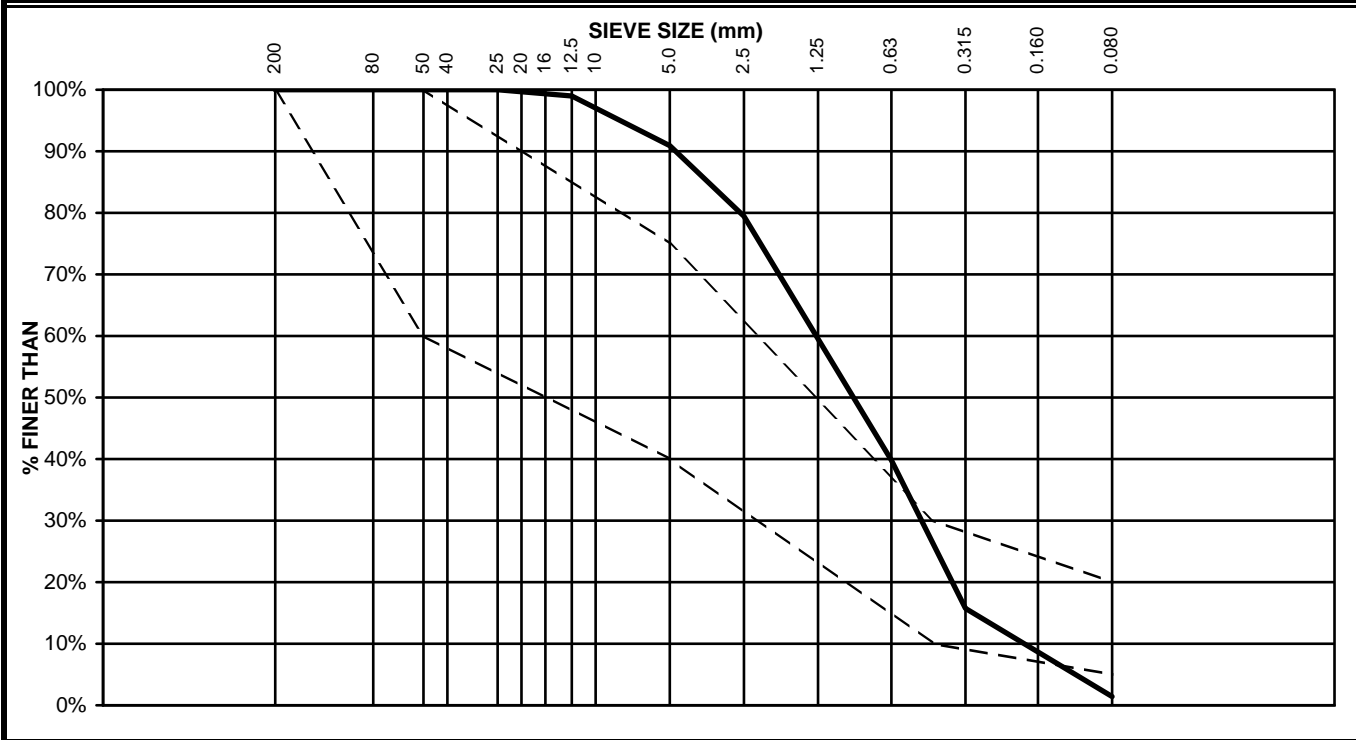
CLIENT : PWGSC
 PROJECT : JOHNSON POINT CLEAN UP
 JOB No. : 2977-371-00
 LOCATION : Geotechnical Testpit 3, Borrow Area 6
 SAMPLE: 1 DEPTH : 0-0.3m
 DATE : September 4, 2008 TECHNICIAN : BHN

Classification: **SP**
 Description and Remarks: Light grey to light brnsh grey interbedded/ intermixed fine SAND and fine-crs SAND, loose.
 d_{10} 0.22
 C_c 1.24
 C_u 2.71

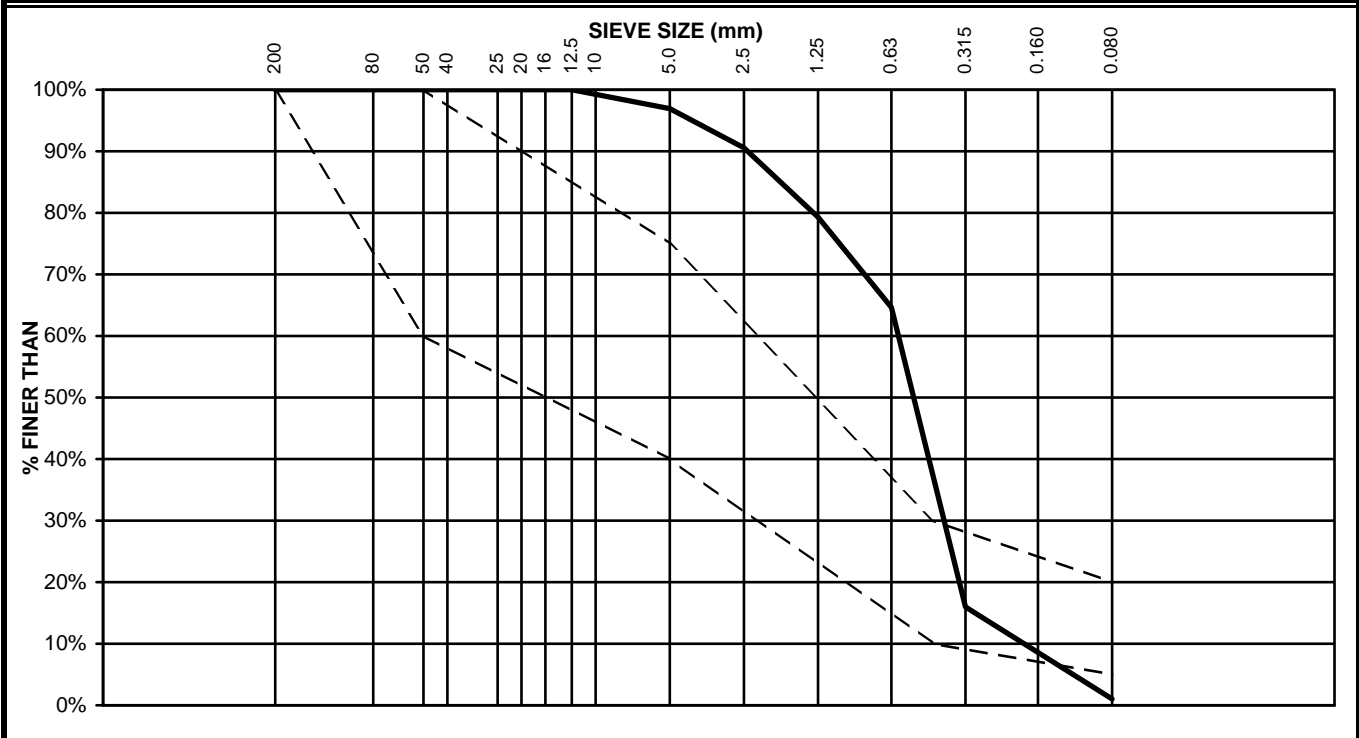
CLIENT : PWGSC
 PROJECT : JOHNSON POINT CLEAN UP
 JOB No. : 2977-371-00
 LOCATION : Geotechnical Testpit 4, Borrow Area 3
 SAMPLE: 1 DEPTH : 0-0.5m
 DATE : September 4, 2008 TECHNICIAN : BHN

Classification: **SP**
 Description and Remarks: Silty fine- crs SAND, trace fine gravel, silty organic seams
 d_{10} 0.15
 C_c 0.92
 C_u 7.57

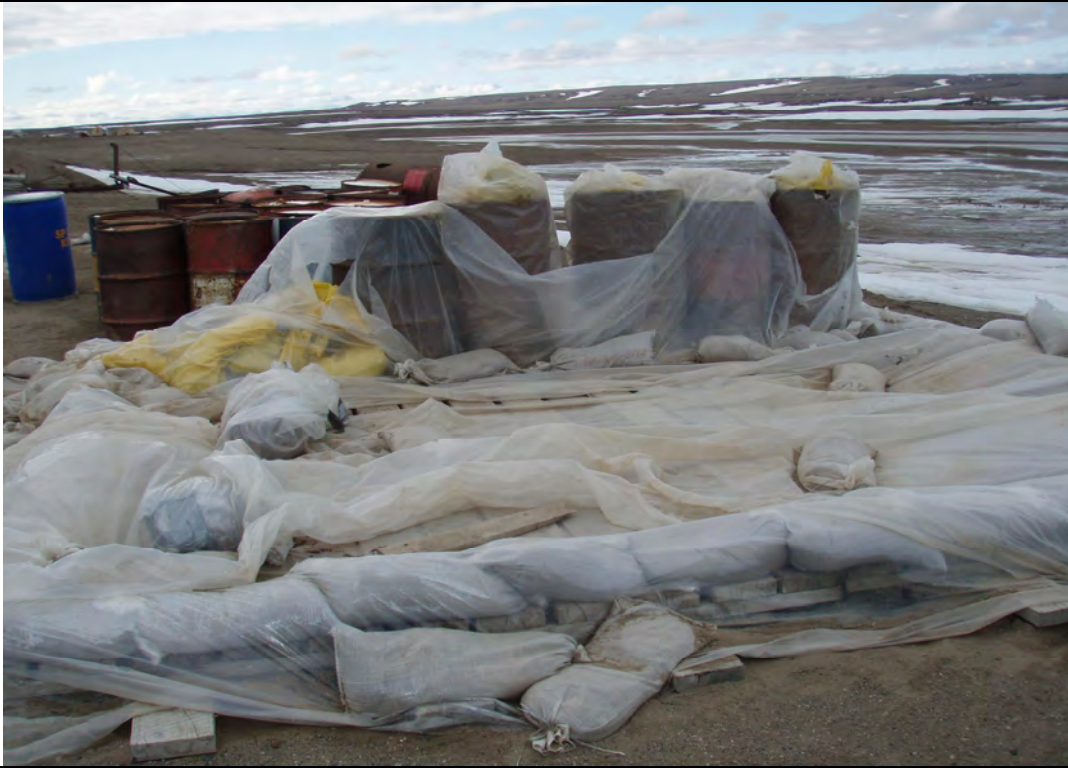
Photo 10: Hazardous Waste Storage Area

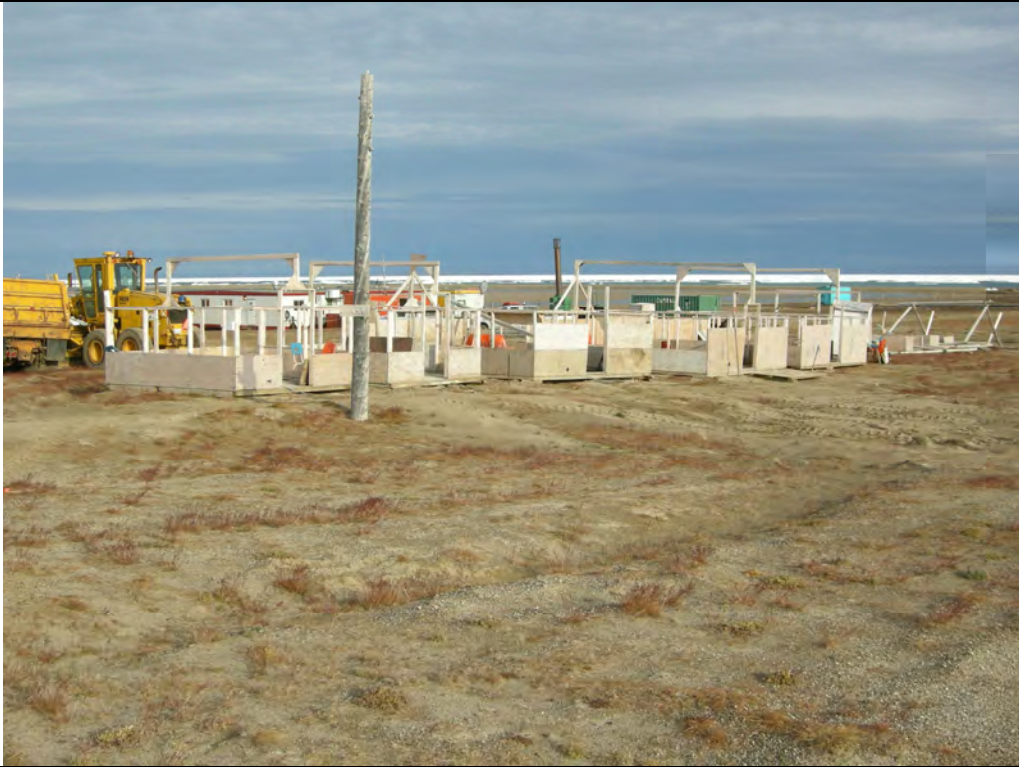
Photo 11: Wooden tent frames prior to demolition

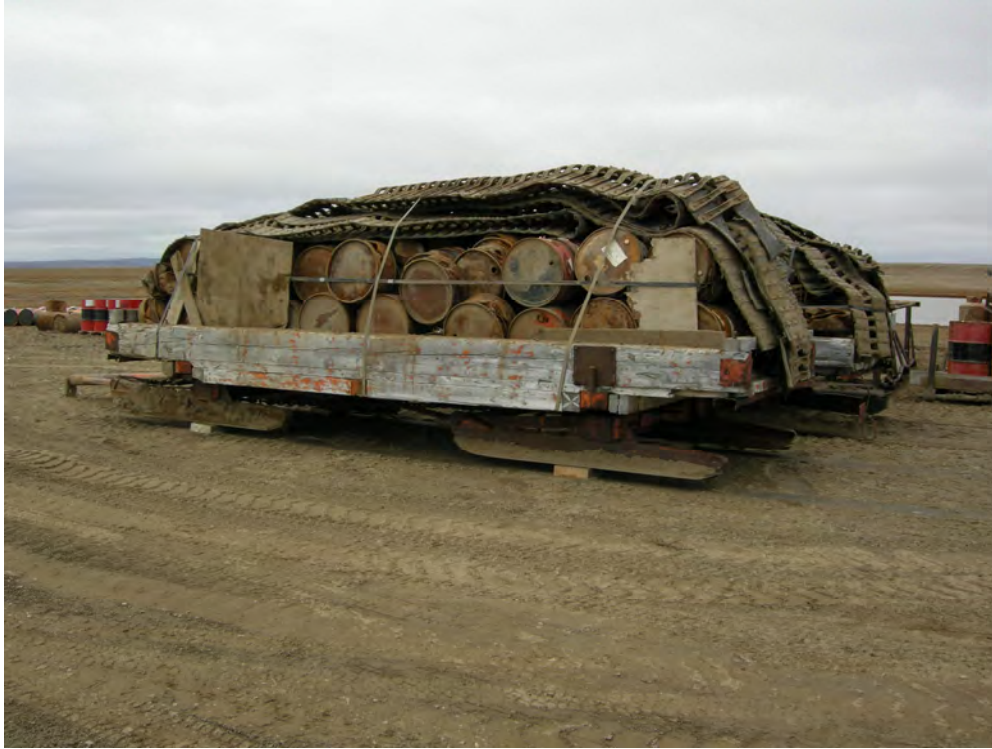
Photo 13: Non-hazardous Waste packaged for off site transport

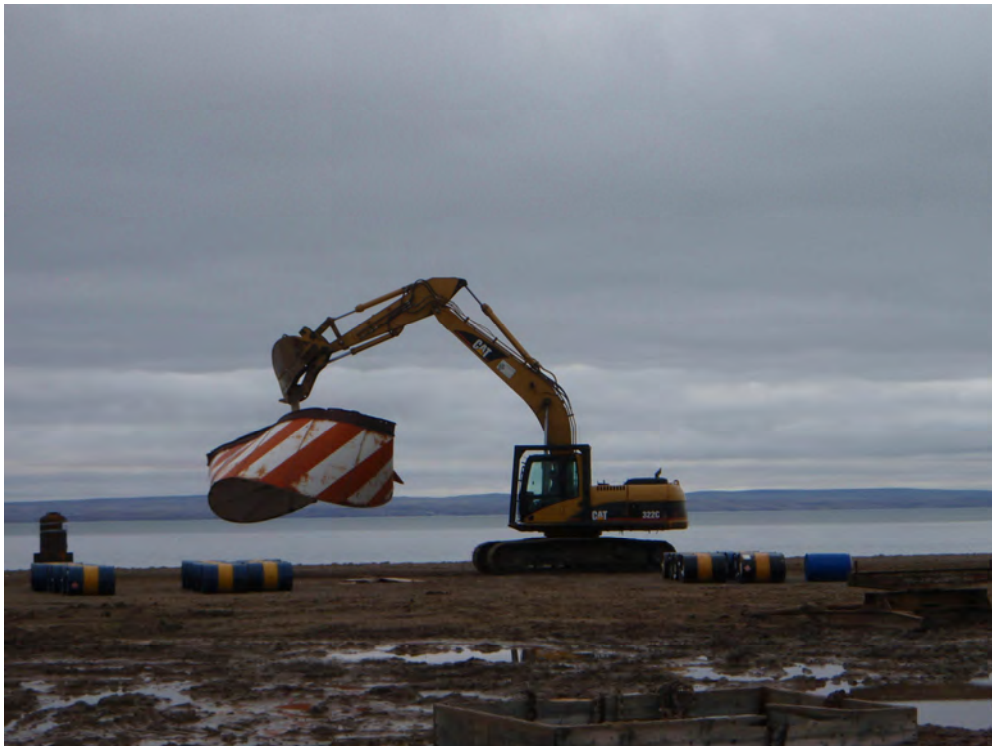
Photo 14: NAVAID structure during demolition

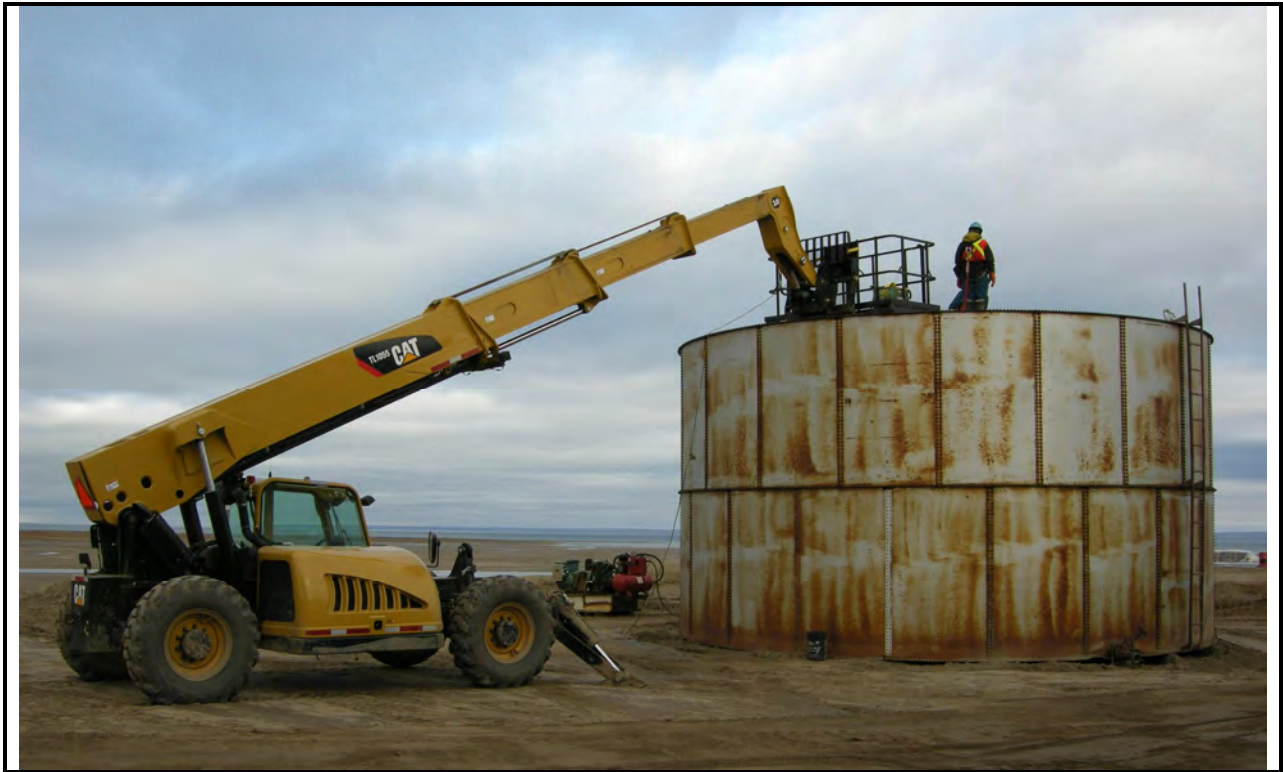
Photo 19: POL Tank demolition operations

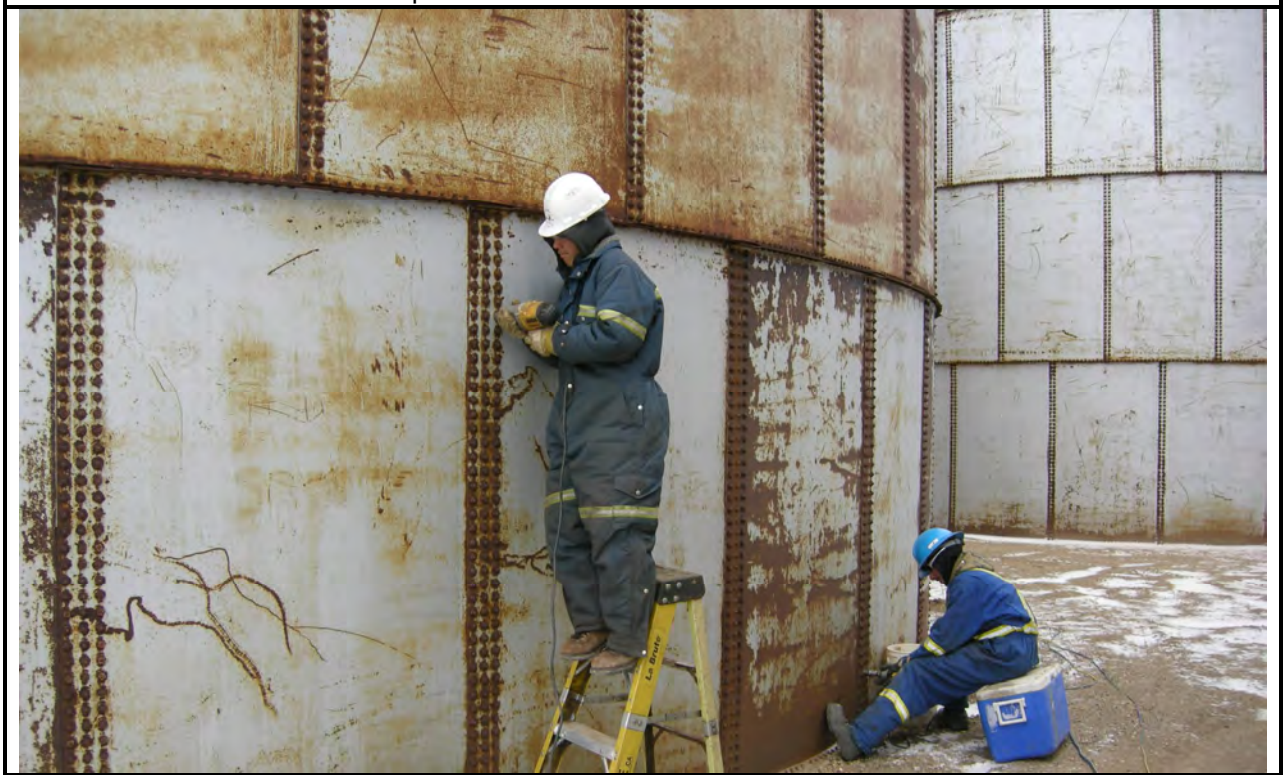
Photo 20: POL Tank demolition operations

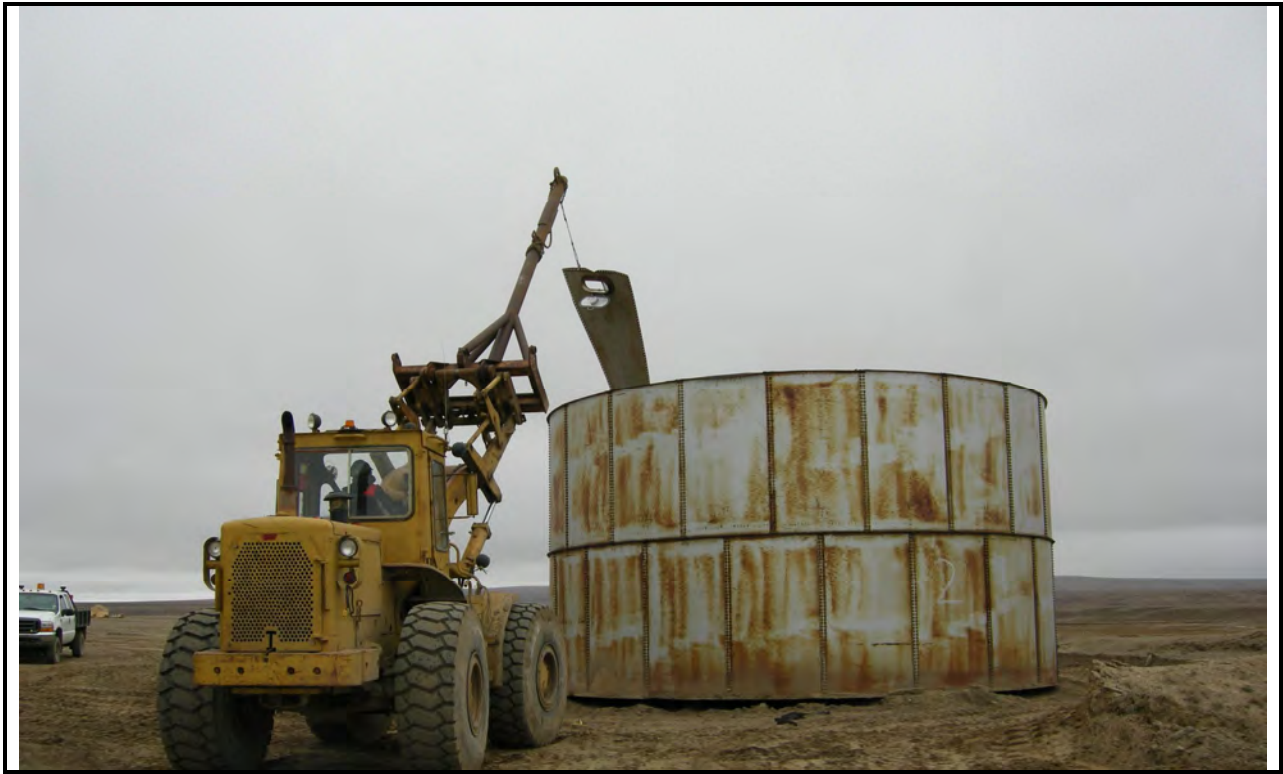
Photo 21: POL Tank demolition operations

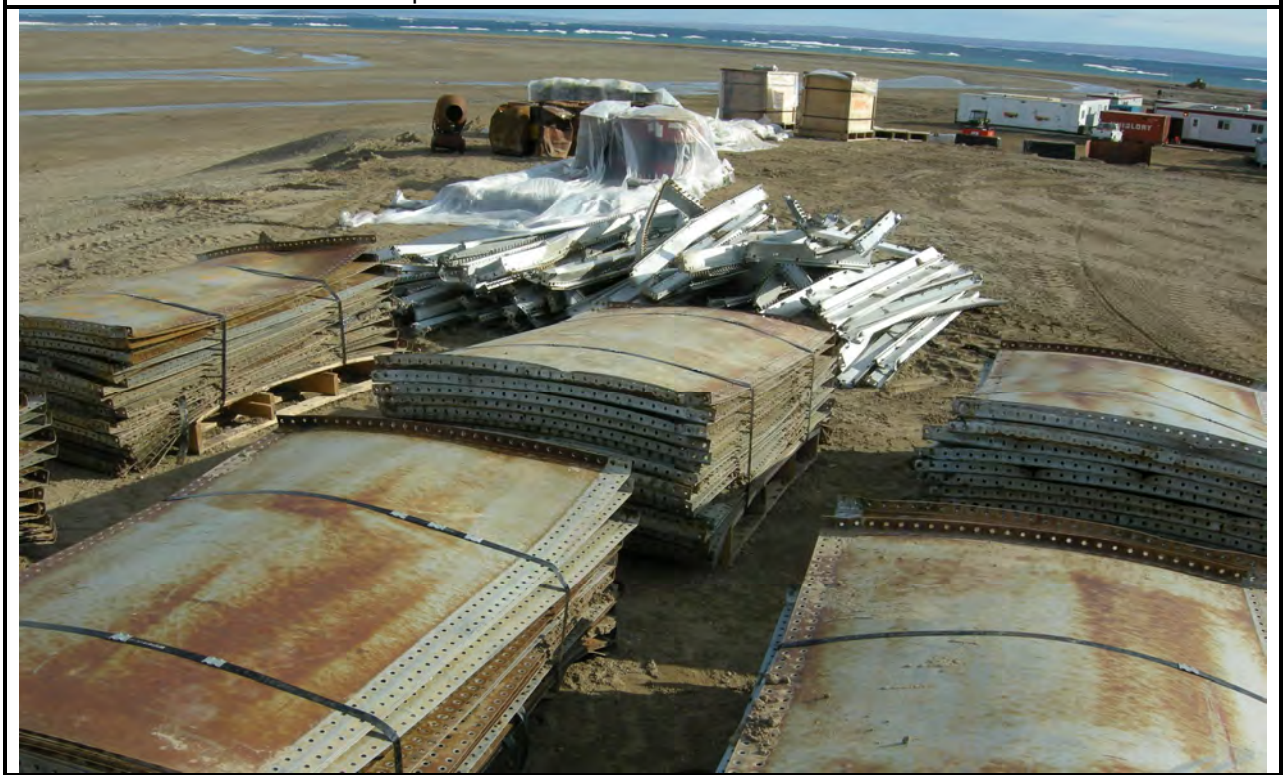
Photo 22: Palletised POL tank sections
