Public Works and Government Services Canada

Remediation Completion Report Johnson Point, Northwest Territories

AECOM

December 21, 2009

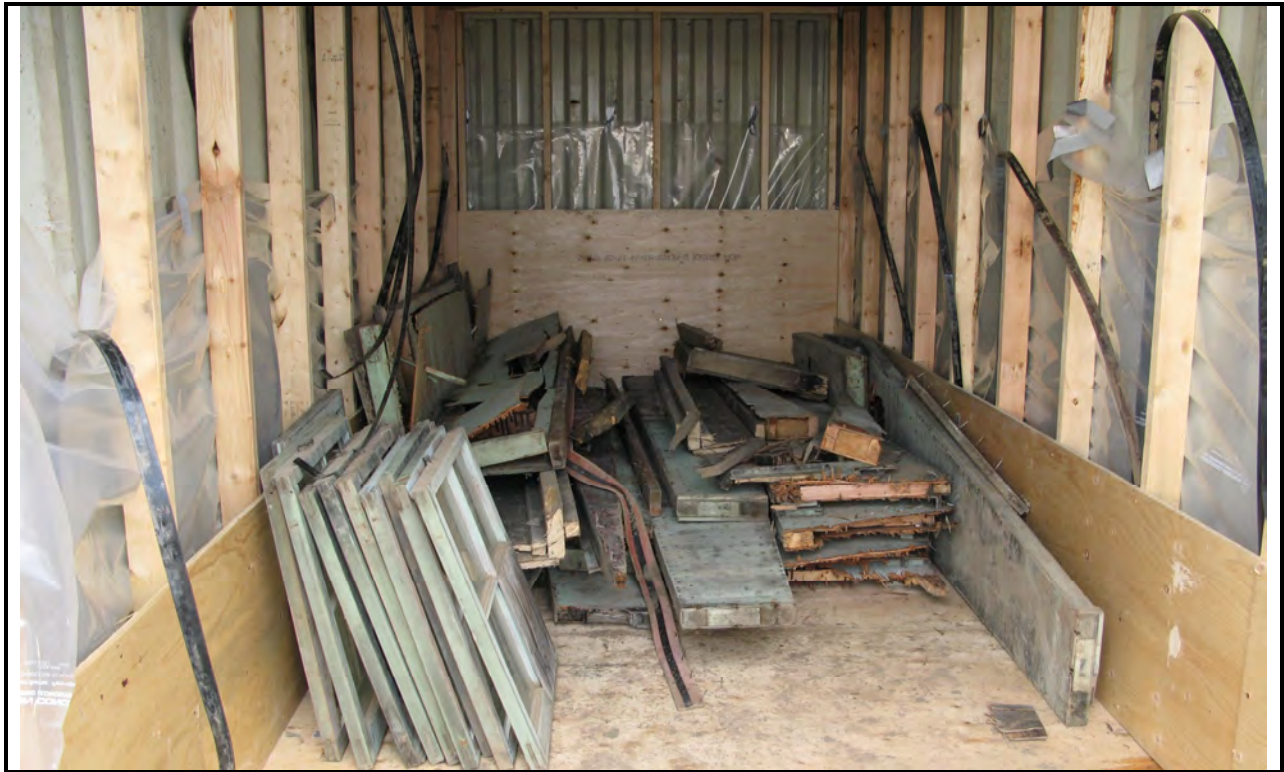
Photo 23: Leachable lead painted waste in lined Marine Shipping Container

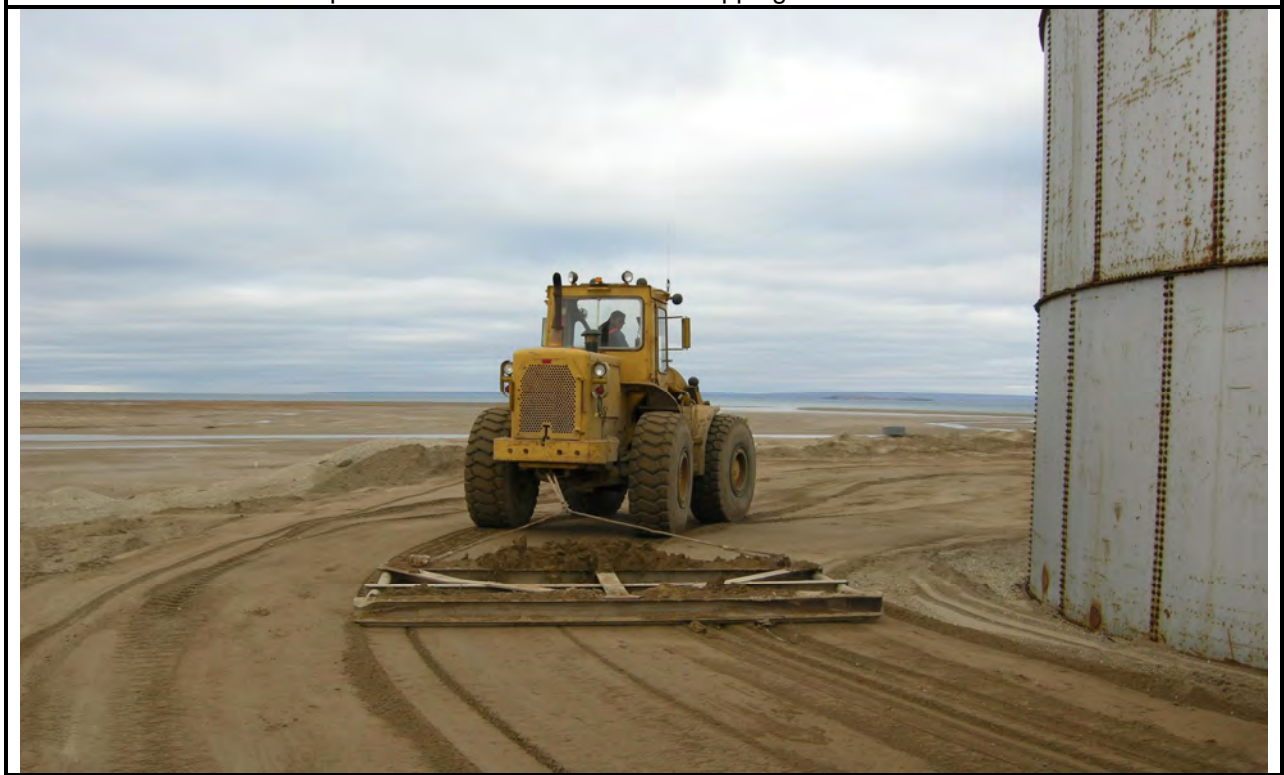
Photo 24: reshaping of tankfarm berms using drag

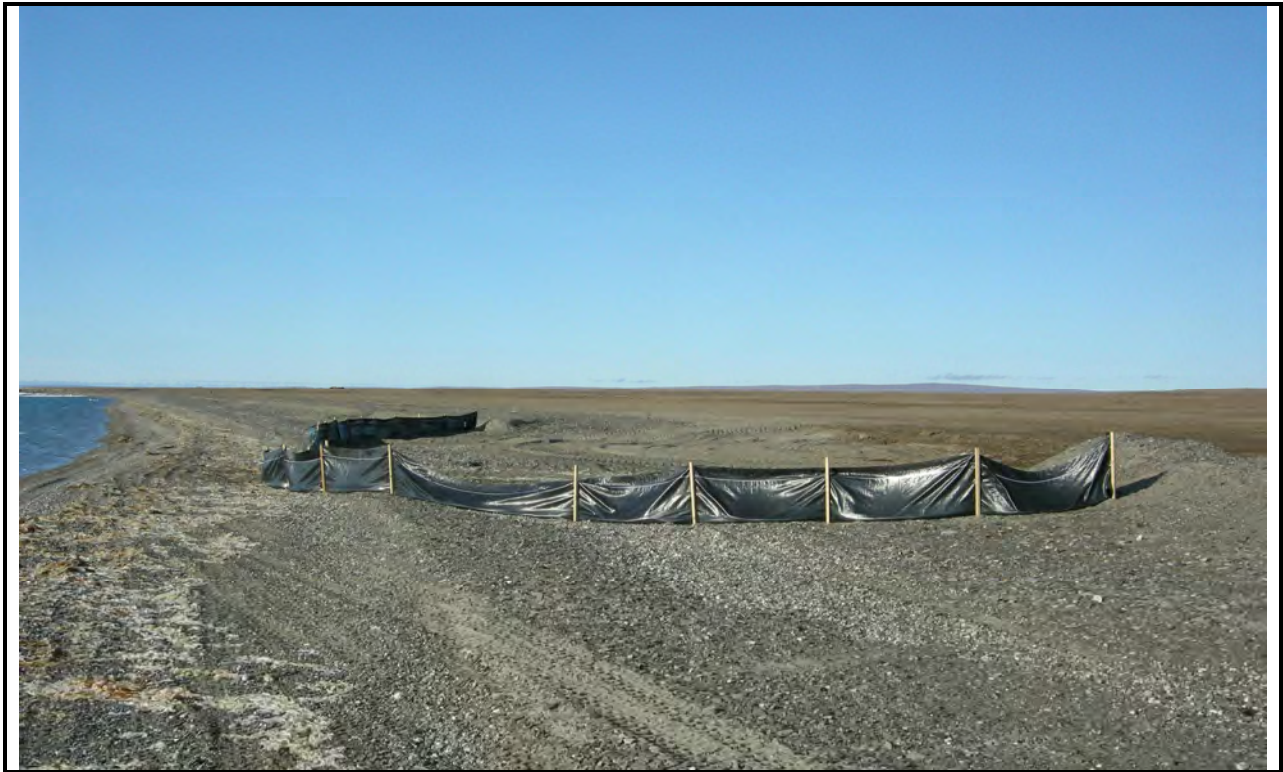
Photo 27: Silt screen erected around airstrip wash out during fill placement

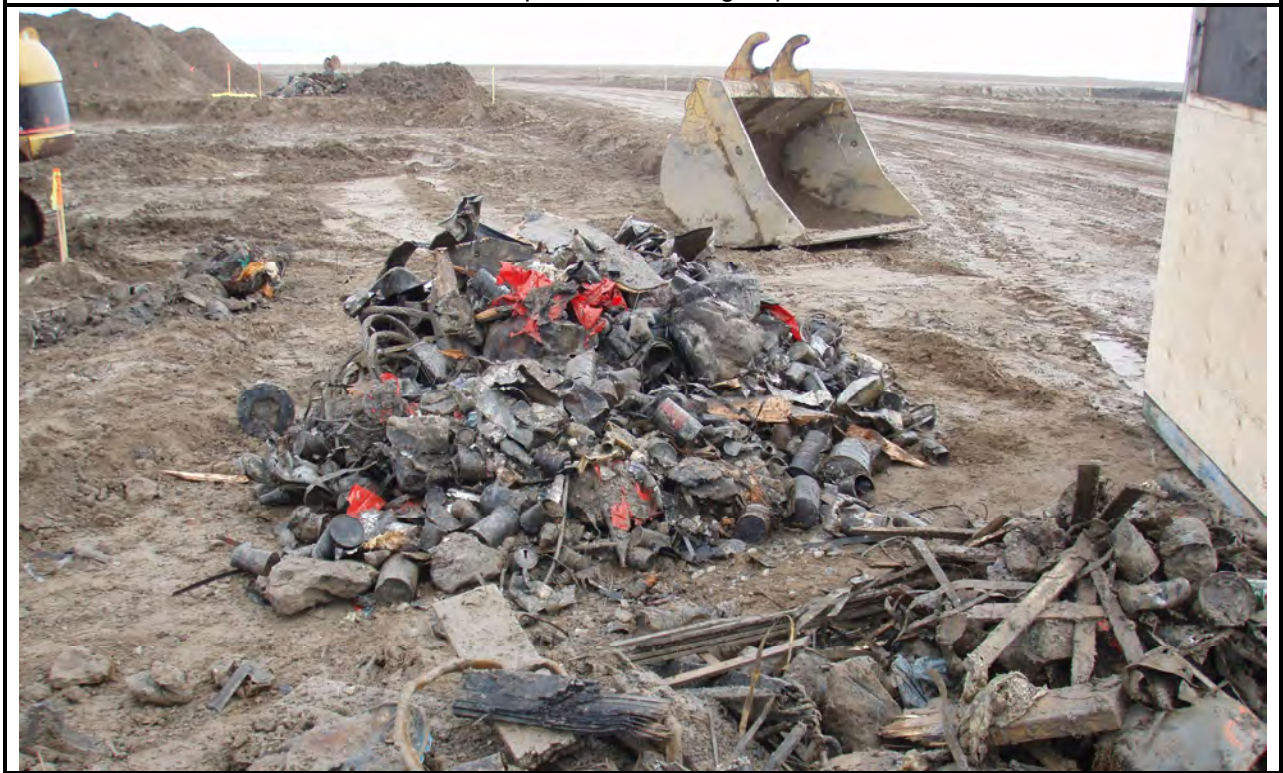
Photo 28: Debris removed from Buried Debris Lobe P

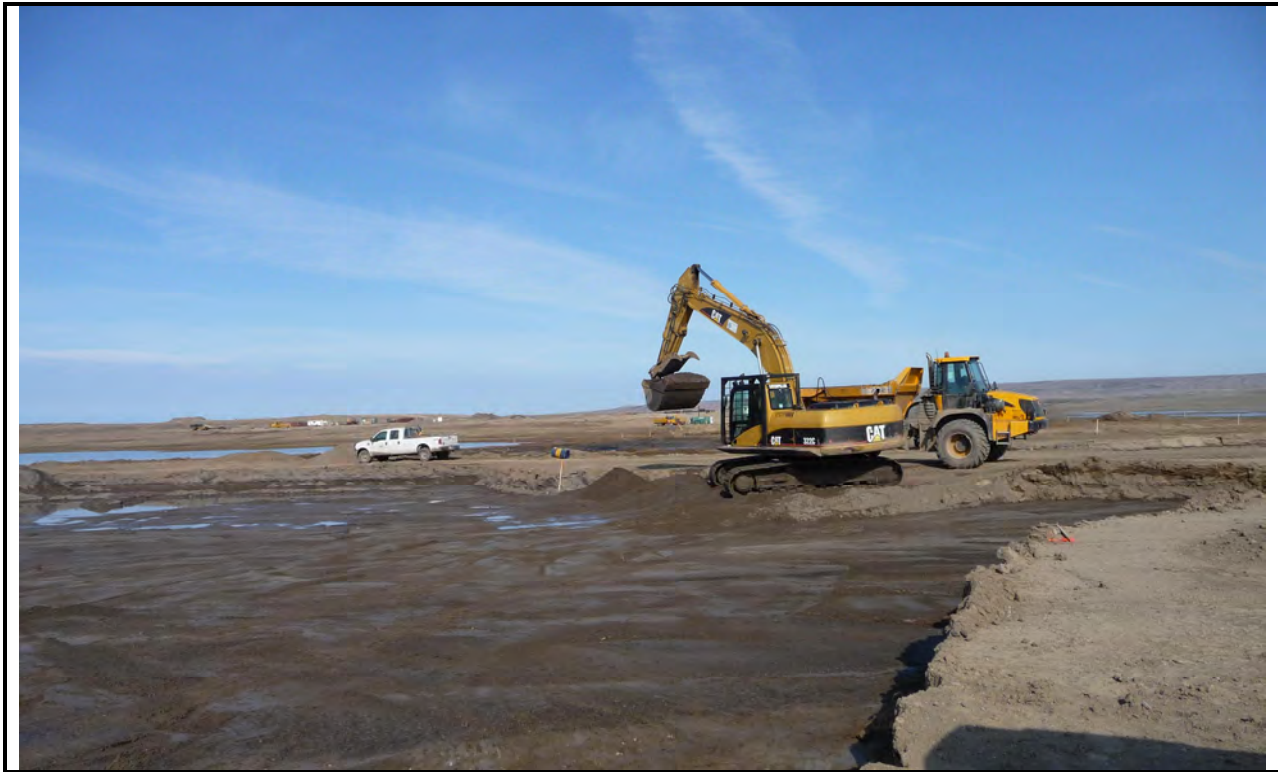
Photo 29: Excavation of Apron Area SW plume (Part 3)

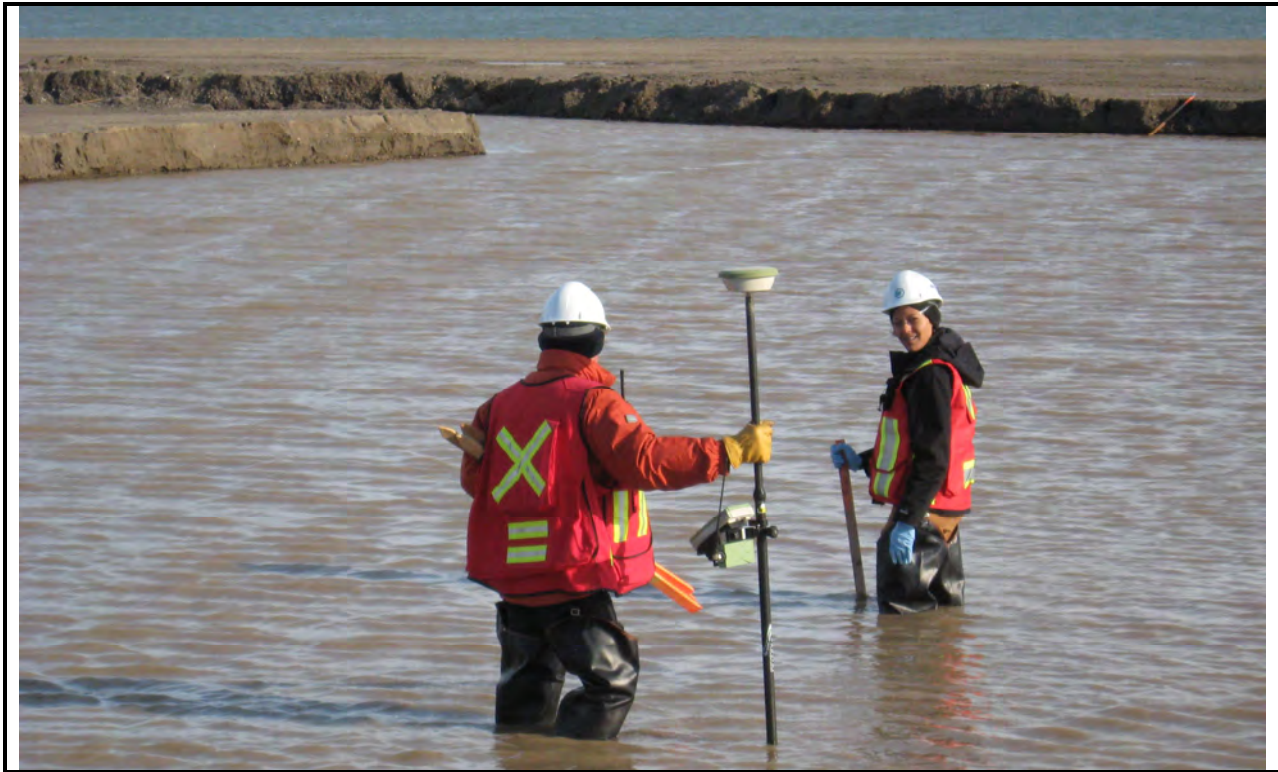
Photo 31: Soil sampling in SW plume excavation following rain

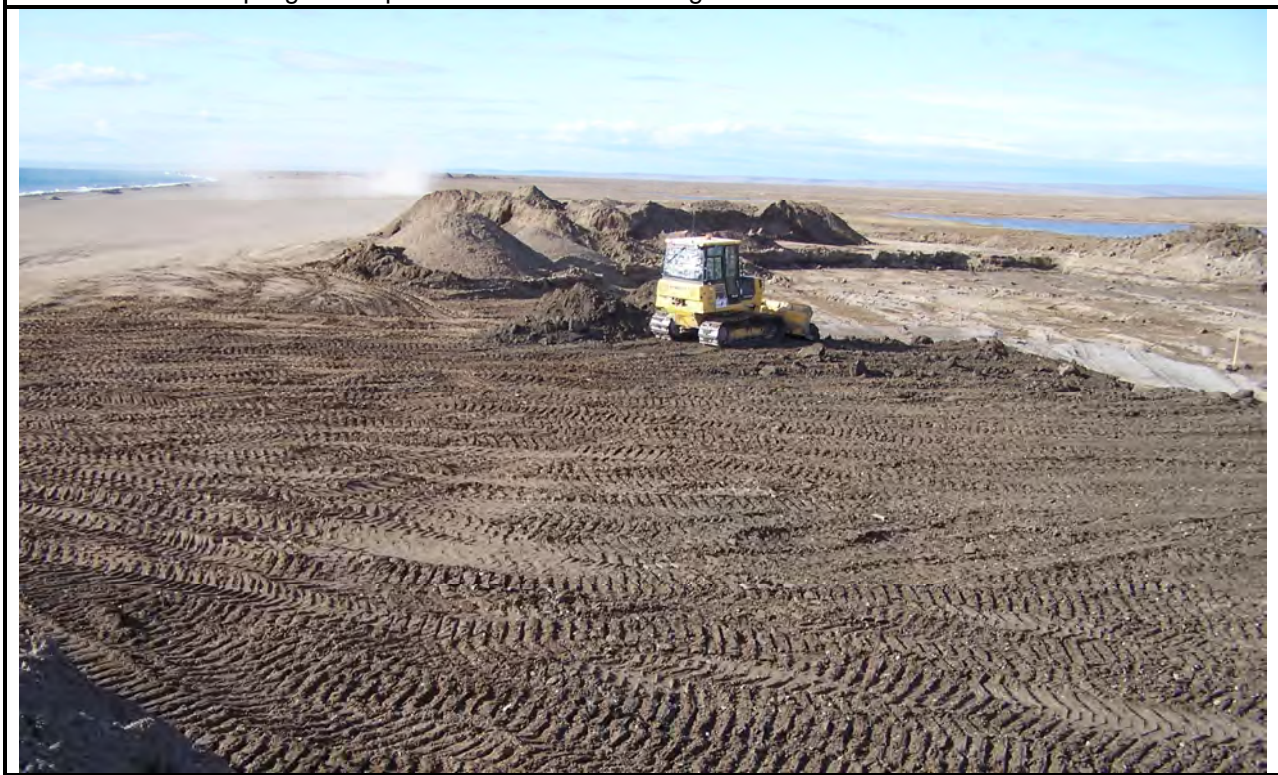
Photo 32: Trackpacking of SW Plume backfill material.

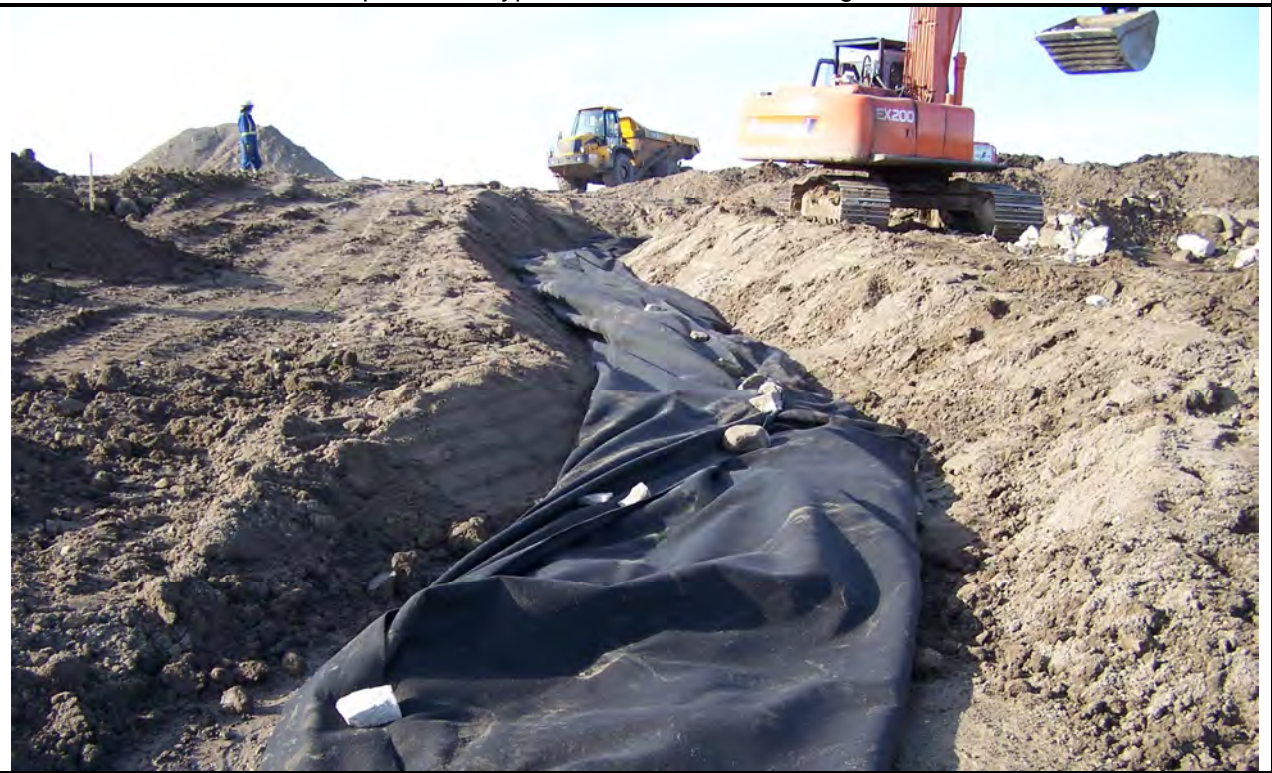
Photo 34: Type 1 Material and geotextile French Drains along base of Landfill Regrade A

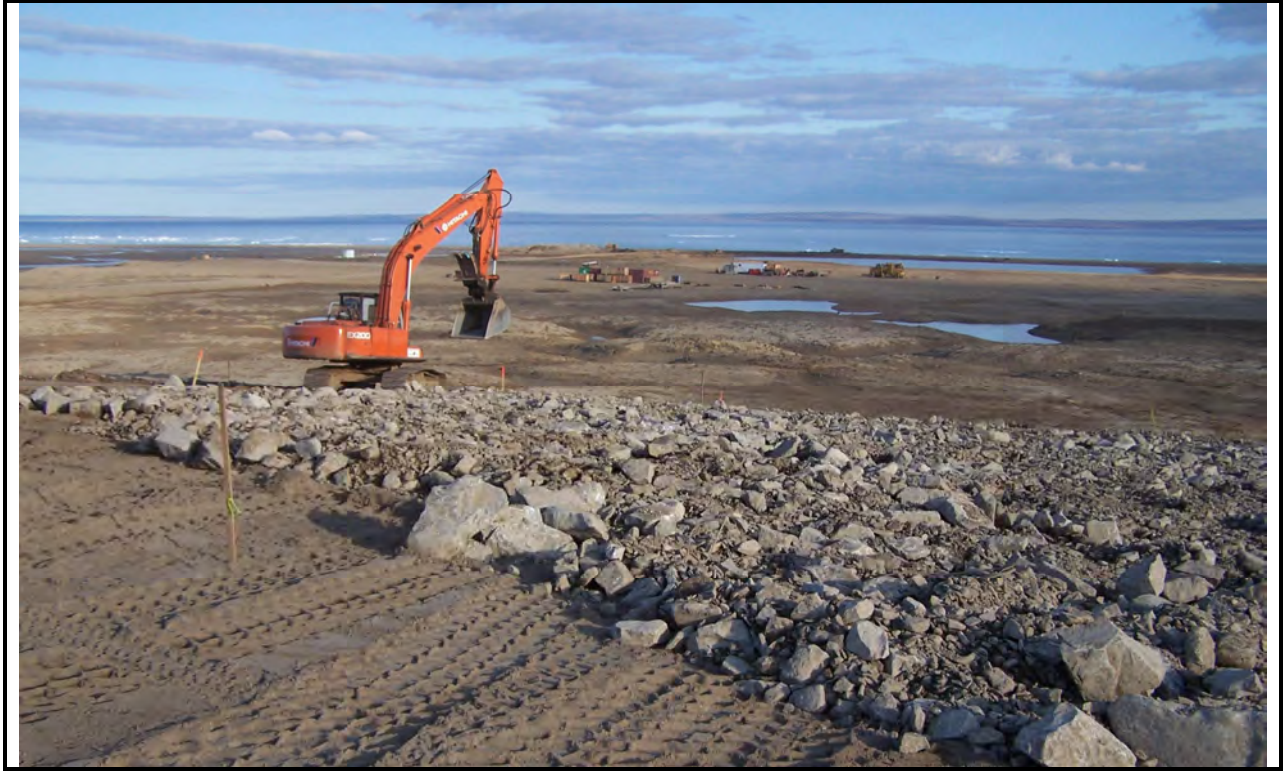
Photo 35: Type 1 material cover on Landfill Regrade C

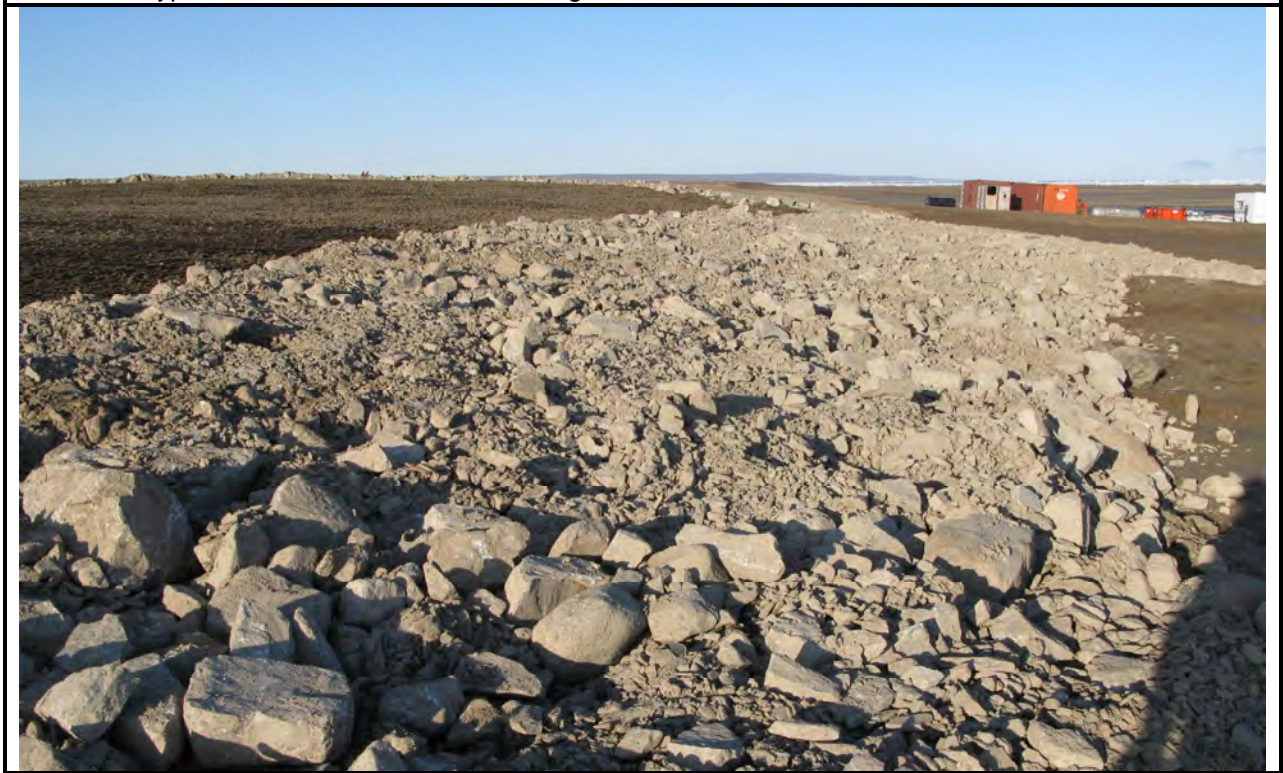
Photo 36: Type 1 material cover on SE slope of Landfill Regrade A

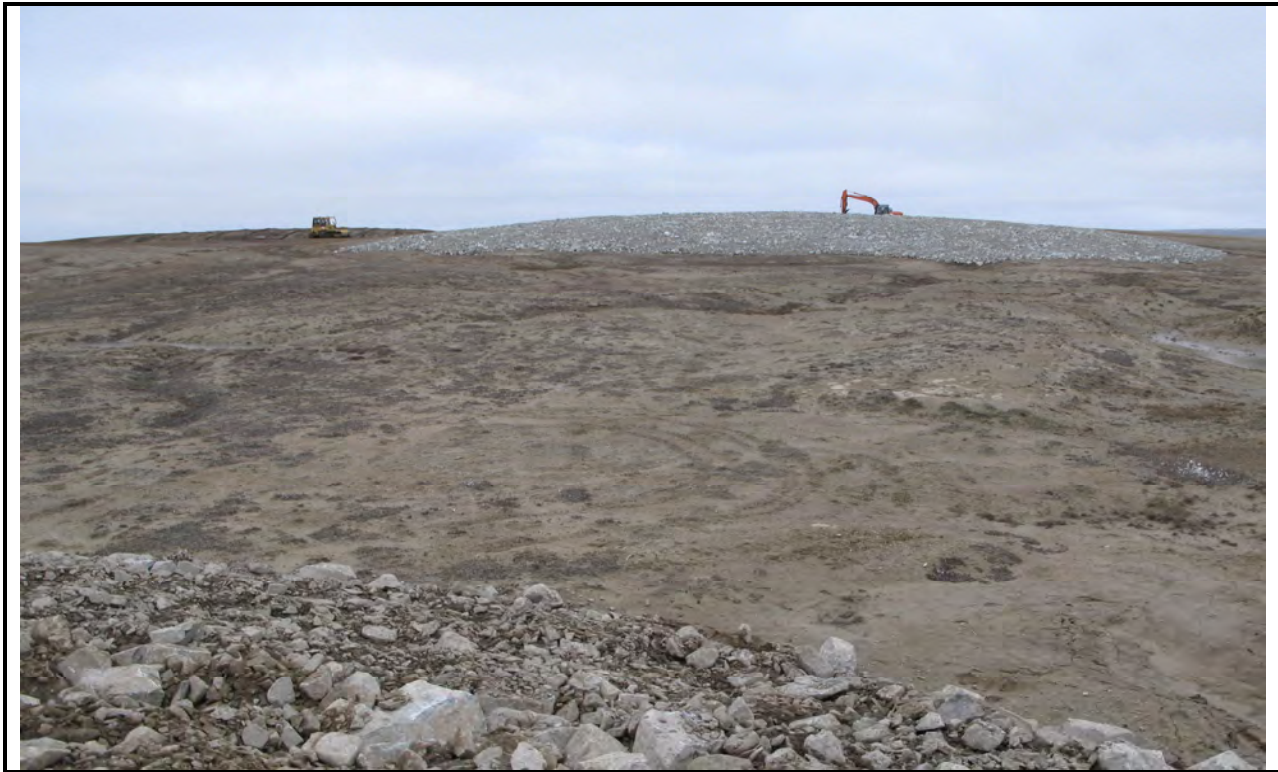
Photo 37: View from finished Landfill Regrade B towards finished Landfill Regrade C

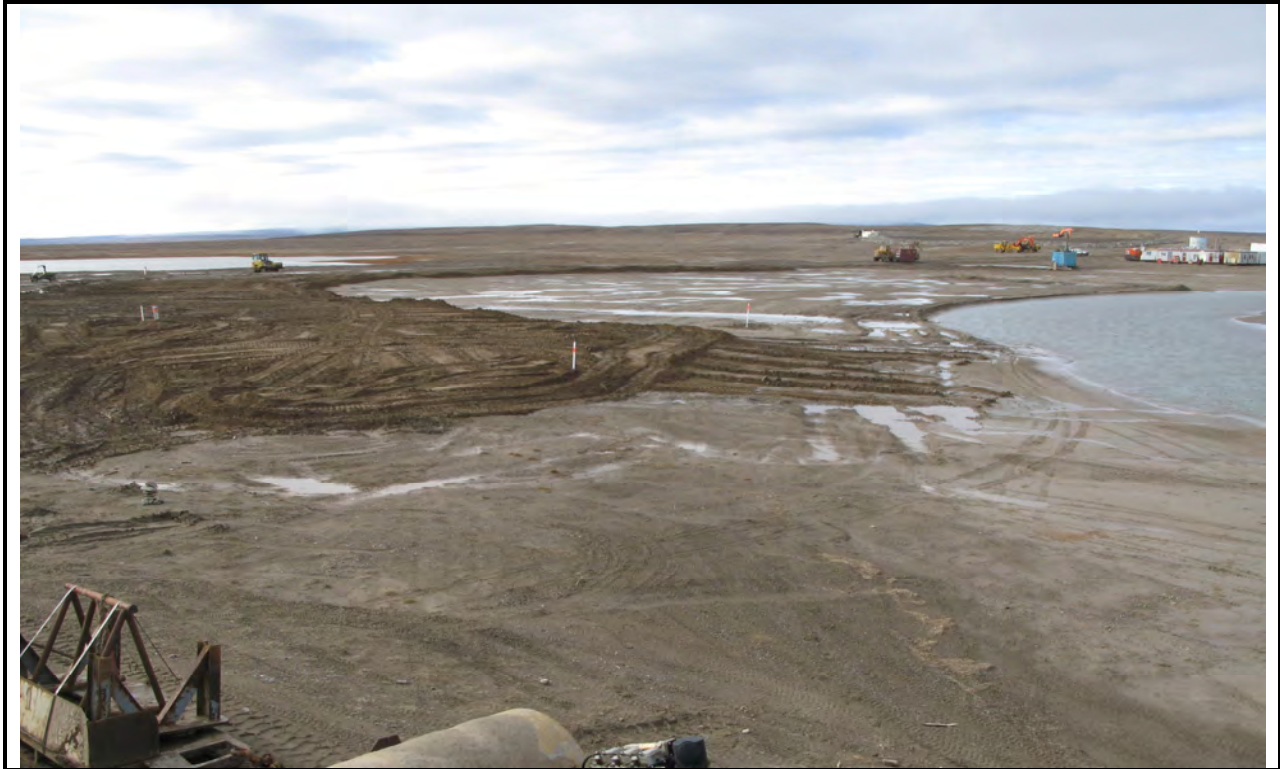
Photo 43: View west across backfilled Apron Area NE Plume

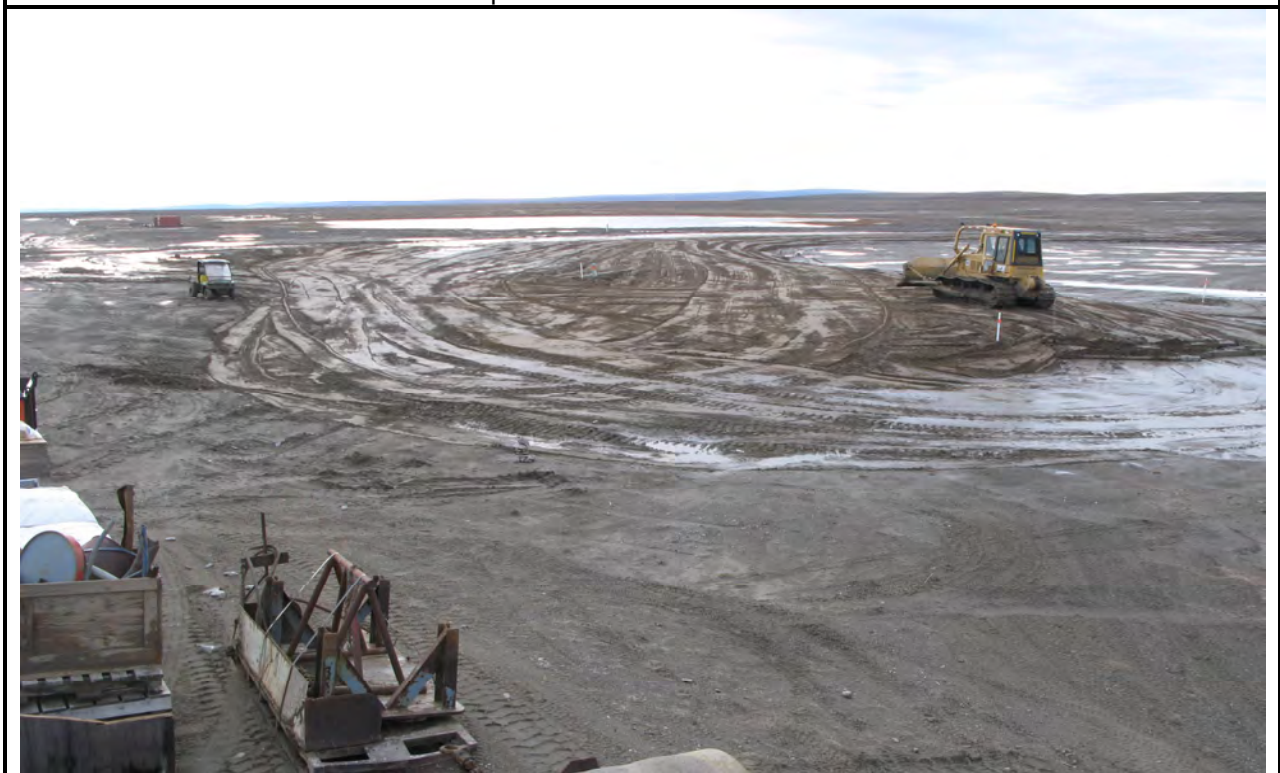
Photo 44: View SW across backfilled Apron Area excavations.
