**SUPPLEMENTAL ENVIRONMENTAL SITE
ASSESSMENT**

**JOHNSON POINT
NORTHWEST TERRITORIES**

IMG-Golder Corporation in association with Golder Associates Ltd.

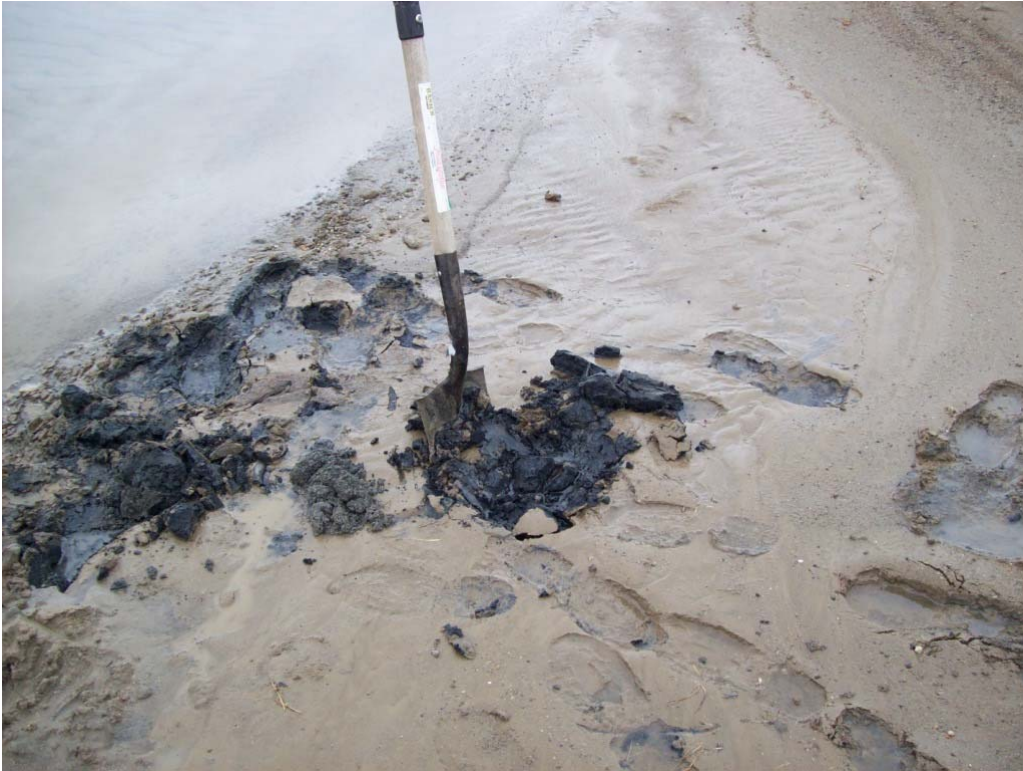
Photograph 11: View of sediment from SED-STR-5 – Johnson Point 2007

Hydrocarbon contamination was also measured in sediments within the flood plain of the Unnamed River, located to the east of the apron area. One area, at STR-05, is likely associated with an isolated spill as it is predominantly F3/F4 contamination. The impacted area is anticipated to be less than 10 m² with a volume of approximately 2 to 3 m³. The hydrocarbon impacts associated with JP07-03 and JP07-02 may encompass an area of 400 to 600 m² (40 m by 10 to 15 m) and the volume may be in excess of 150 m³. Although, elevated hydrocarbon concentrations were measured in the sediment, surface water dissolved hydrocarbon concentrations (BTEX, F1, and F2) were below the method detection limit.

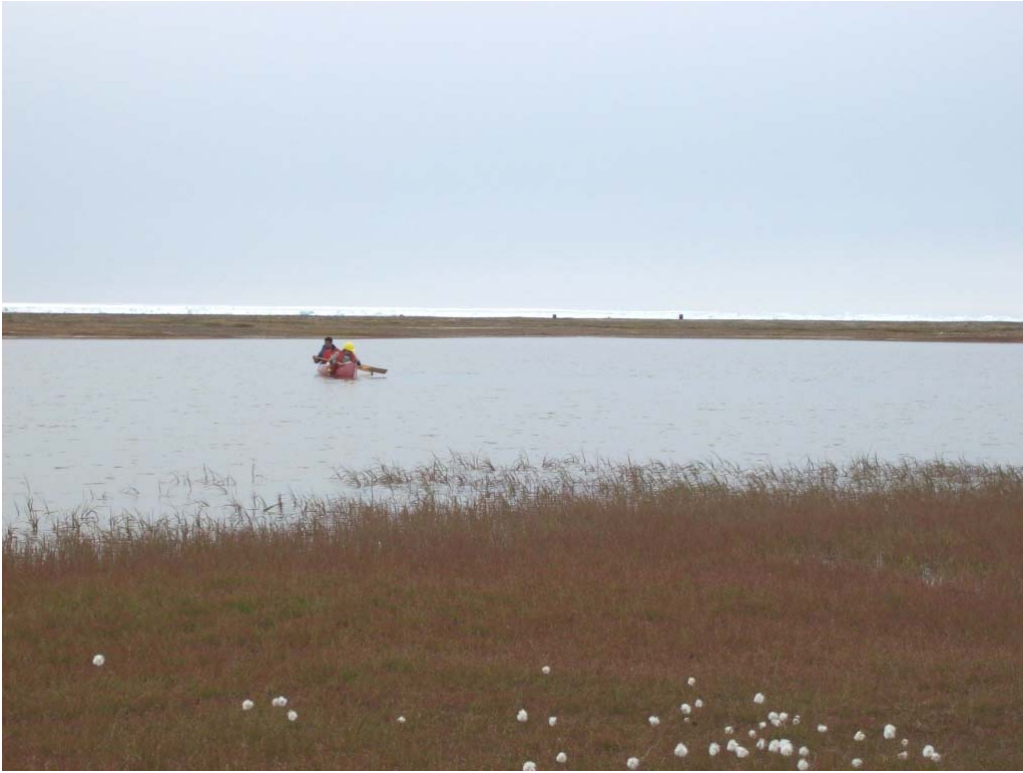
Photograph 13: View of Sediment Collection Apron Pond - Johnson Point 2007

Sediment samples were collected from the Apron pond, adjacent to the west side of the Apron, and analytical results indicated hydrocarbon concentrations in excess of background levels for the F2 to F4 fractions, and in excess of ecological direct contact soil guidelines in the area directly adjacent to the Apron. It was noted that the pond is only 0.5 m deep, and therefore will freeze to the full depth. As a result, it is not expected to support significant aquatic life. It is noted that although elevated hydrocarbon concentrations were measured in the sediment, surface water dissolved hydrocarbon concentrations (BTEX, F1, F2) in two samples were less than the method detection limit, with the

exception of F2 hydrocarbons in one location, adjacent to the apron. Removal of hydrocarbon impacted soils from the Apron area should mitigate against future inputs to the pond, and the existing F2 contamination would naturally attenuate over time. Excavation of the sediments in this area if required, would be difficult to carry out and would likely result in excessive siltation of the pond in the short term. Excavation of sediments in this area is likely not warranted.

Sediment samples from across the width and length of the pond contain hydrocarbon concentrations in excess of background levels for the F2 to F4 fractions, and in excess of ecological direct contact soil guidelines in the area directly adjacent to the Apron. It was noted that the pond is only 0.5 m deep, and therefore will freeze to the full depth. As a result, it is not expected to support significant aquatic life. It is noted that although elevated hydrocarbon concentrations were measured in the sediment, surface water dissolved hydrocarbon concentrations (BTEX, F1, F2) in two samples were less than the method detection limit, with the exception of F2 hydrocarbons in one location, adjacent to the apron. Removal of hydrocarbon impacted soils from the Apron area should mitigate against future inputs to the pond, and the existing F2 contamination would naturally attenuate over time. Excavation of the sediments in this area if required, would be difficult to carry out, and would likely result in excessive silting of the pond in the short term. Excavation of impacted sediments in this area is likely not warranted.

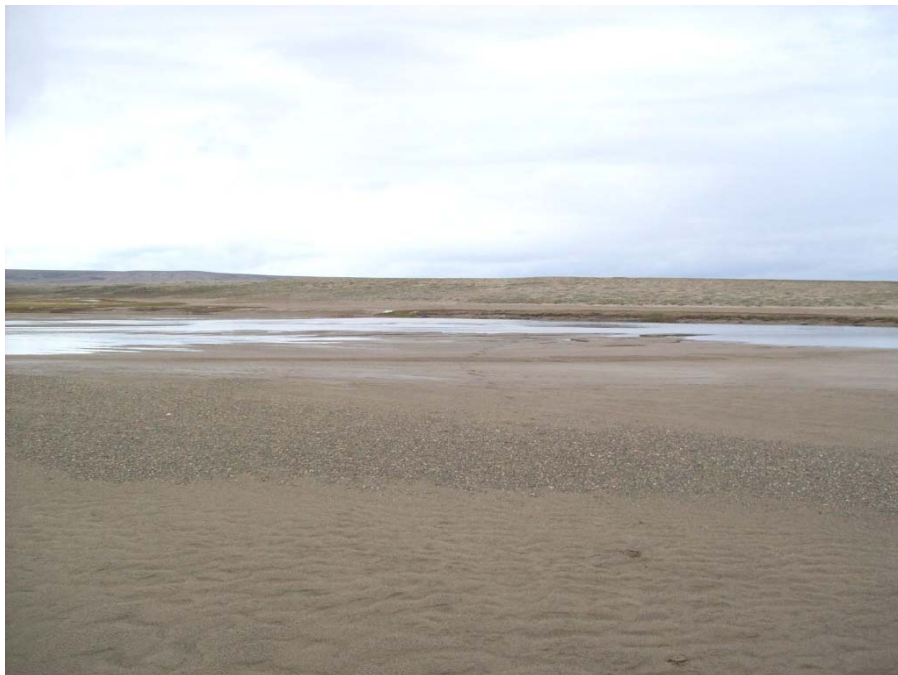
Photograph 14: View upstream in Unnamed River towards potable water sampling location, POT2 – Johnson Point 2007

The analytical results of two samples of water collected from the Unnamed River confirmed that from a water quality perspective that the river could be used as a potable water source. Water withdrawal rates should not exceed 10% of the daily flow rate, when Arctic char or other fish are present in the river during spawning. Spawning occurs in the fall time period as fish migrate upstream to freshwater bodies. Low flows may be expected near the end of the thaw season (August-September). Water lines will require screened intakes in accordance with Department of Fisheries and Oceans requirements. (DFO 2007).

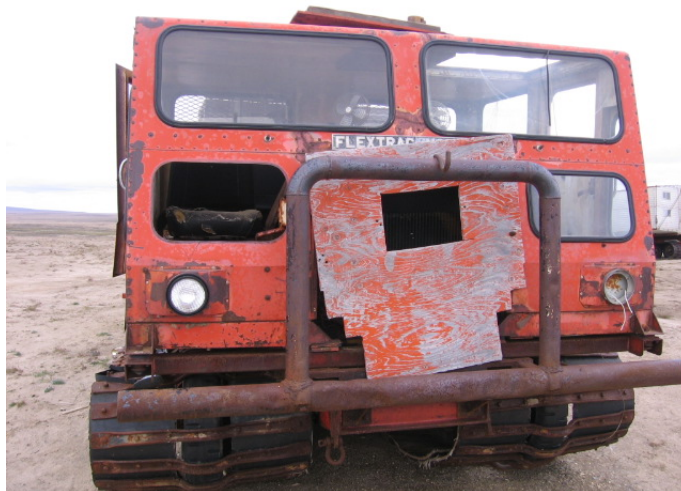
Photograph 16: Orange Nodwell Paint Sample No. 2– Johnson Point 2007

The results of leachability testing indicate that the orange Nodwells, and the light green building in the tank farm area (shop like building, footprint dimensions 7 m x 15 m) exceed criteria for leachable lead and are considered hazardous waste materials under Transport Canada TDG Regulations and require disposal off-site. The remaining structures are considered non-hazardous. Based on EBA results for total lead, the majority of painted facilities and equipment exceed the NWT guidelines for total lead of 600 mg/kg. It is noted that these guidelines only apply to disposal of waste materials on Commissioner's Land in the NWT.

The results of leachability testing indicate that the orange Nodwells, and the light green building in the tank farm area (shop-like building, footprint of approximately 7 m by 15 m) exceed criteria for leachable lead and are considered hazardous waste materials. The remaining materials are considered non-hazardous. Based on EBA results for total lead, the majority of painted facilities and equipment exceed the NWT guidelines for total lead of 600 mg/kg. It is noted that these guidelines only apply to the disposal on Commissioner's Land in the NWT.

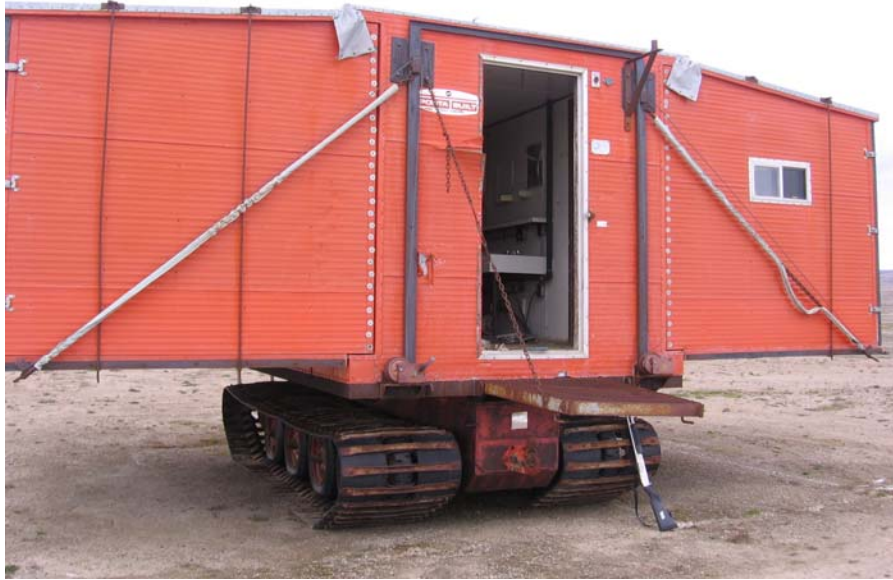
#5	White wood stripping on nodwell ceiling	<0.5	-	641	From ceiling, good condition, 5 mm thick wood
#6	Orange paint on nodwell	4.2	-	42100	Exterior nodwell, 1 mm thick metal

Photograph 19: Paint/Substrate Sample 6 – Orange on Nodwell – Johnson Point 2007

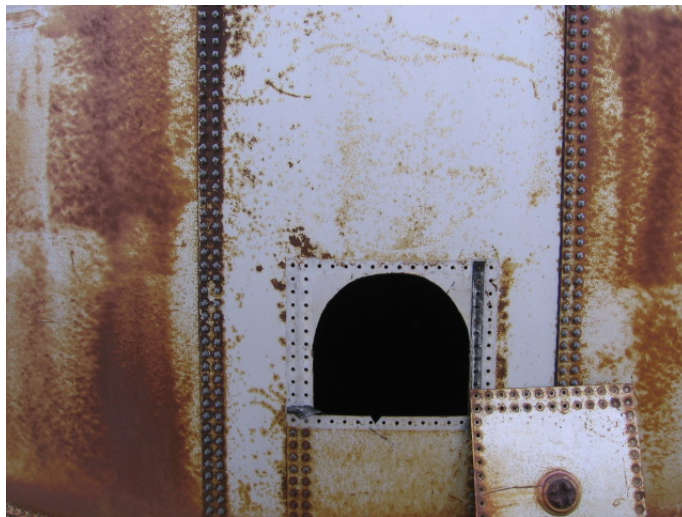
Photograph 24: Paint Sample – silver tanks – Johnson Point 2007

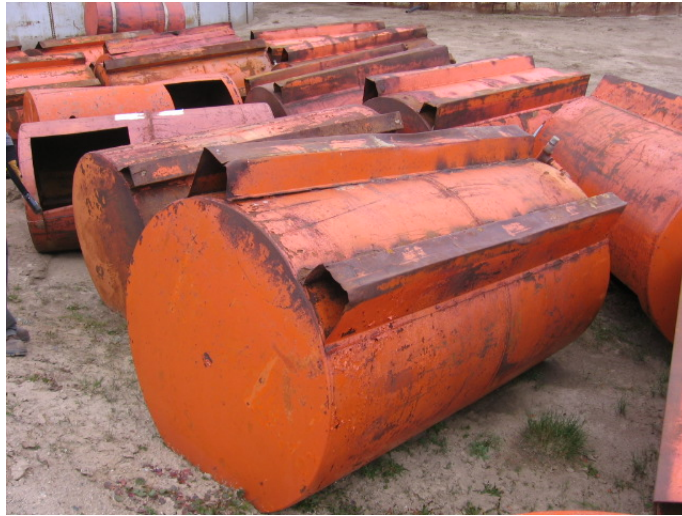
Photograph 25: Paint/Substrate Sample 15 – Orange Tanks – Johnson Point 2007

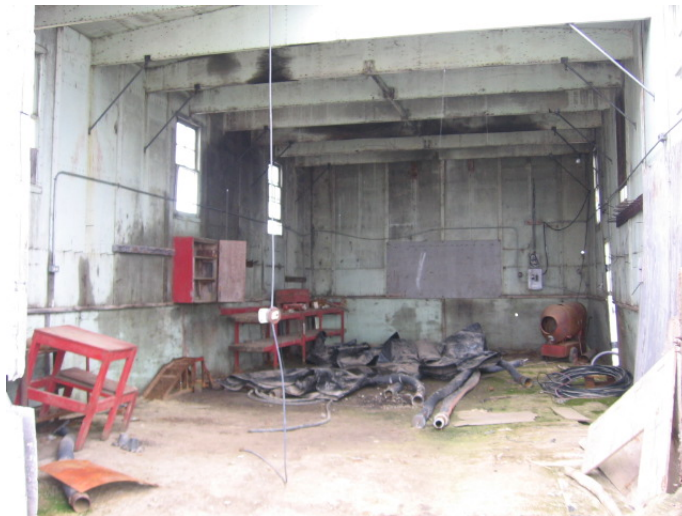
Photograph 26: Paint/Substrate Sample 17 – Shop Type Building - Johnson Point 2007

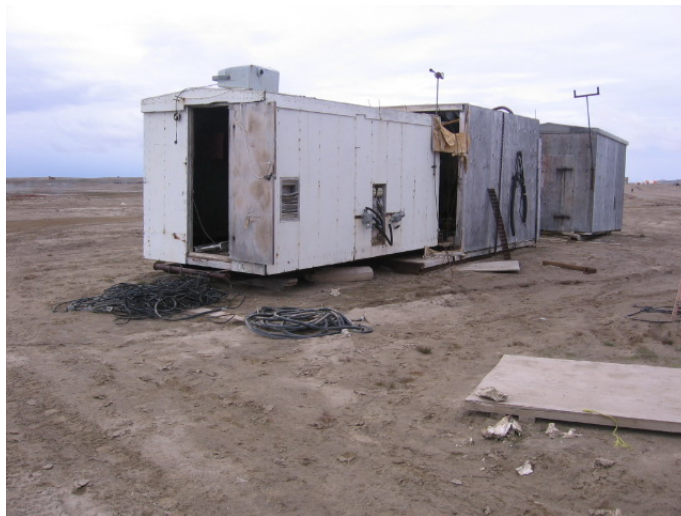
#19	White paint on wood shed at airstrip	0.9	-	7670	Paint in good condition
#21	Red paint on wood at airstrip	0.8	-	-	Not easily flaking
#22	Yellow paint on siding on airstrip nodwell	0.9	-	-	Metal cladding 1 mm thick, 3 nodwells

Photograph 28: Paint/Substrate Sample 19 – White on Shed near Airstrip - Johnson Point 2007

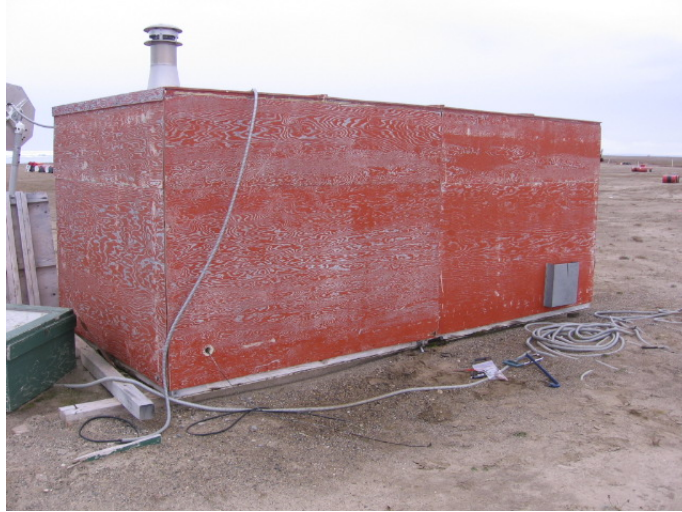
Photograph 29: Paint/Substrate Sample 21 Red on wood shed near airstrip - Johnson Point 2007

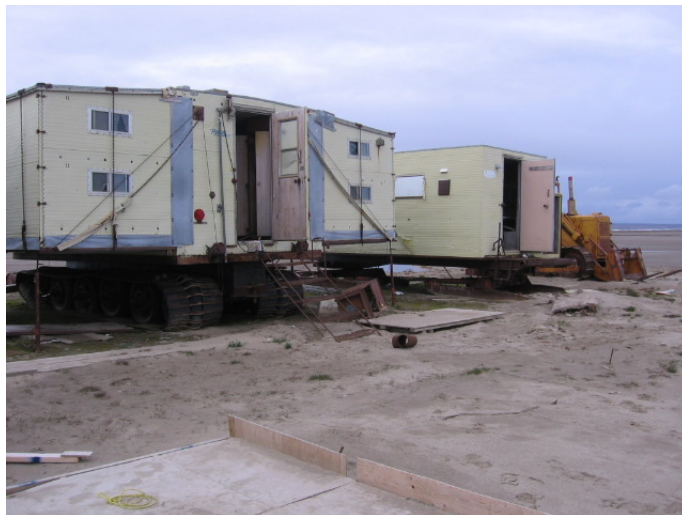
Photograph 30: Paint/Substrate Sample 22 – metal siding from nodwells at airstrip - Johnson Point 2007
