**RE: INDUSTRIAL Water Use N7L1-1834
CLASS B – INDUSTRIAL
Camp Farewell
Mackenzie River**

INDUSTRIAL WATER USE INSPECTION REPORT

LICENCE #:	N7L1-1834, Camp Farewell	EXPIRY DATE:	July 17, 2017
LICENCEE:	Shell Canada Energy	PREVIOUS INSPECTION:	New
COMPANY REP:	Randall Warren	INSPECTION DATE:	July 31, 2013

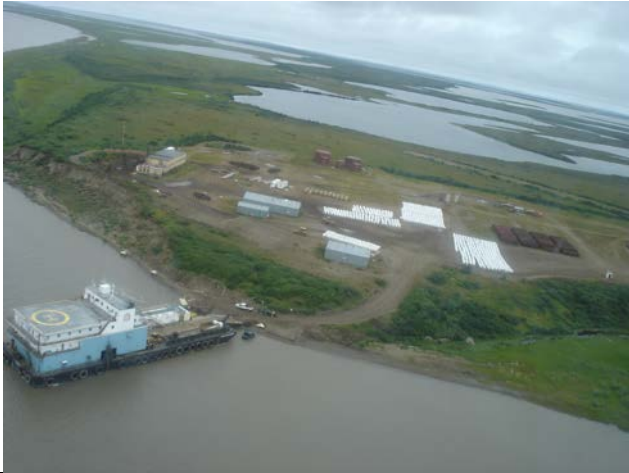
Figure 1

Aerial view of Camp Farwell and the remediation program for the sewage lagoon excavation including the John Wurmlinger barge used for camp accommodations.

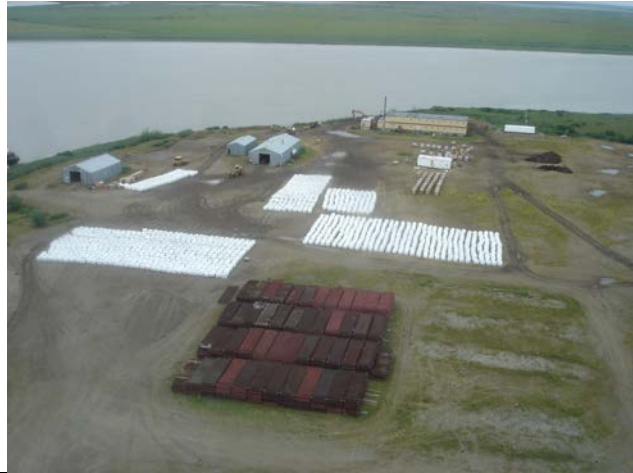
Figure 2

- Tervita was on site managing the contaminated soil removal. There were 1600 super sacks plus additional sea crates for a total of 2000 tonnes of soil and waste material being stored for removal from the site. Super sacks are being shipped out on barges.

1600 super sacks and sea crates for contaminated soil from the sewage lagoon excavation.

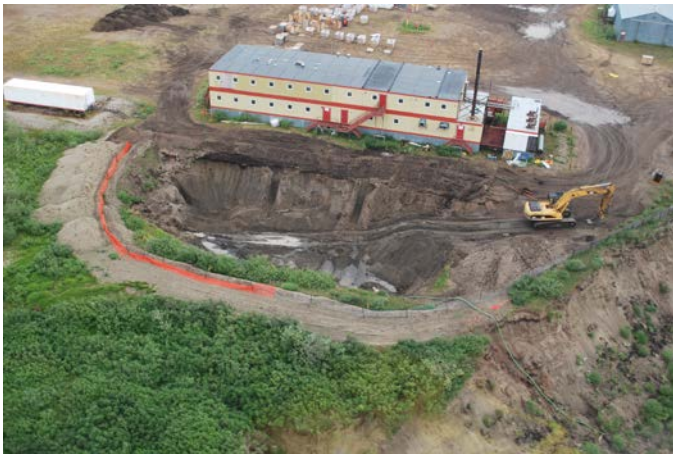
Figure 3

- John Wurmlinger barge was being used for the camp and the associated sewage facilities were not inspected.
- At the time of inspection the former sewage lagoon was being excavated as part of the process for the decommissioning of the lagoon site. The water contained in the former sewage lagoon was sampled and found acceptable prior to discharge.

Aerial view of excavation for the sewage lagoon and immediate area.

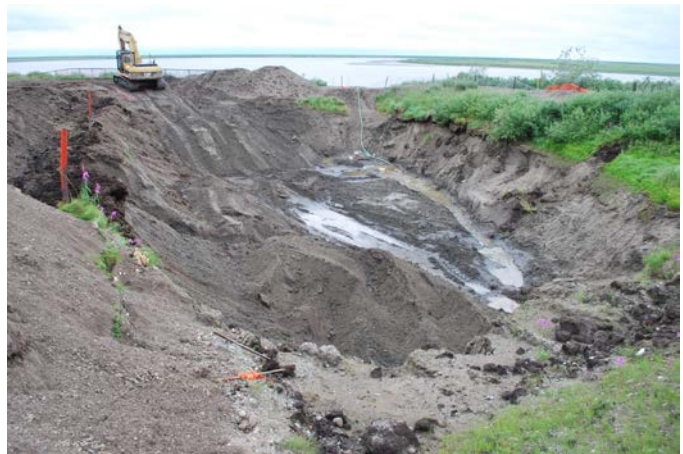
Figure 4

- Excavation of soil from the former sewage lagoon has gone well. There was additional soil contamination found but it was being followed and excavated until the extent of the contamination was found. Debris has been found while excavating contaminated soil.

Extent of the pit for the sewage lagoon excavation.

- Backfill of the excavation will occur with excess material from the site such as the airplane runway (airstrip).

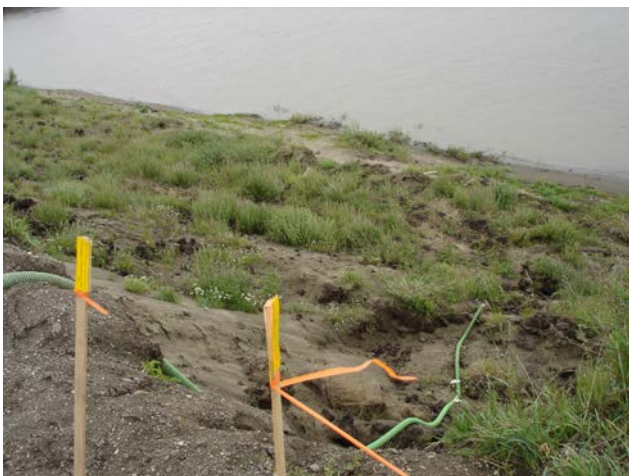
Figure 5

Discharge line and area for the standing water in the excavation pit.

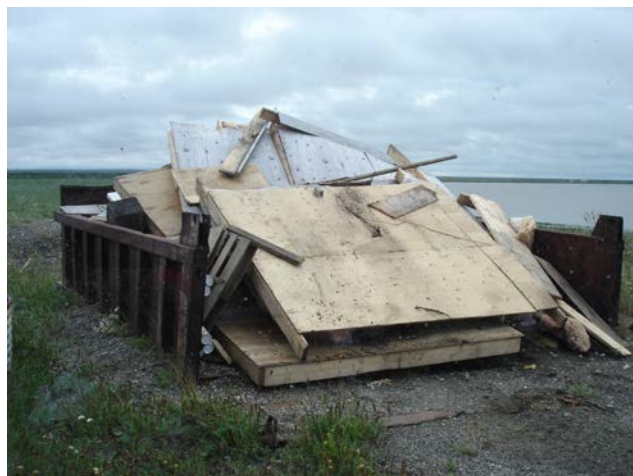
Figure 6

- Solide waste being disposed of by landfill.
- Waste wood on site being put in burn bin. Fiberglass insulation present in the waste wood burn bin. This material is unacceptable for burning. Please ensure only approved materials are burned.

Burn bin full of waste wood. Insulation seen present and is not acceptable for burning. Please ensure only approved materials are burned.
