**RE: BAR-C TUNUNUK POINT  
DOCK REMOVAL PROJECT DETAILED REPORT (PDR)**

## **Appendix A    AECOM Dock Removal Execution Plan**

**Regarding: 2015 Execution Plan - Area H (Dock Removal)**

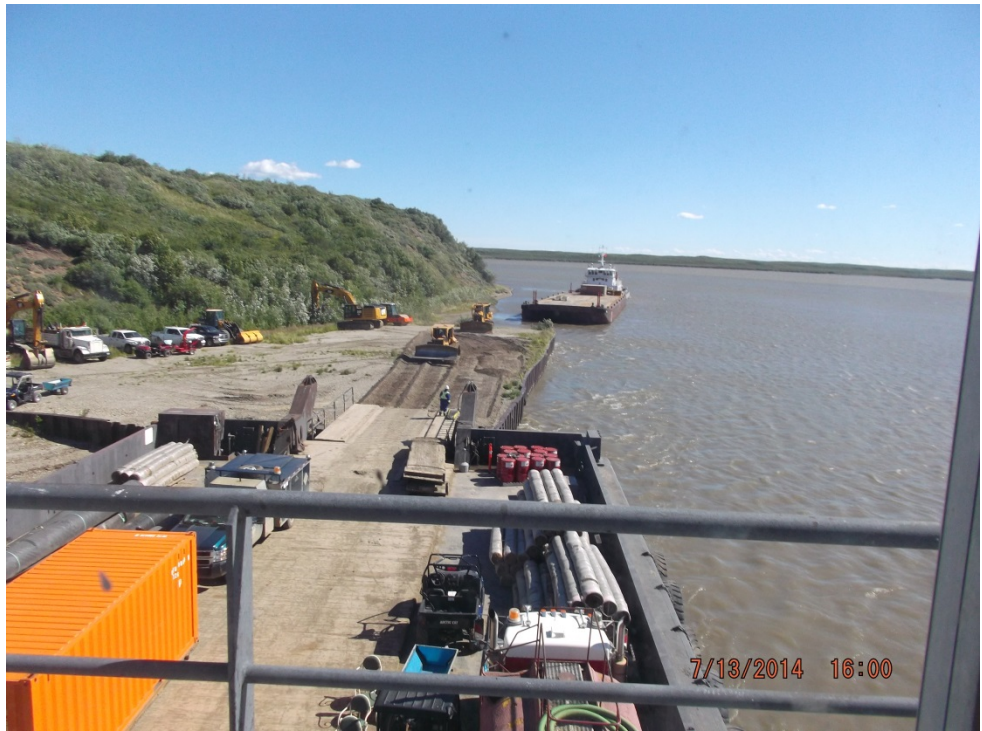
Photo No.      Date:  
1                    13/07/2014

View of the Area H dock  
from the barge

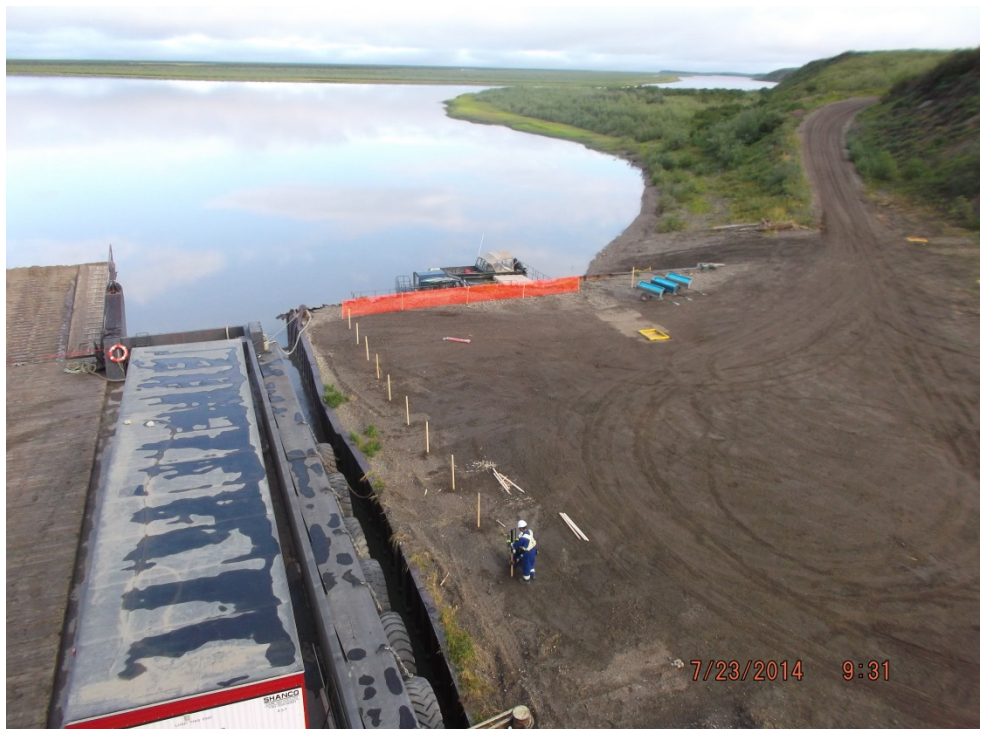
Photo No.  
4

Aerial view of the Area H  
dock

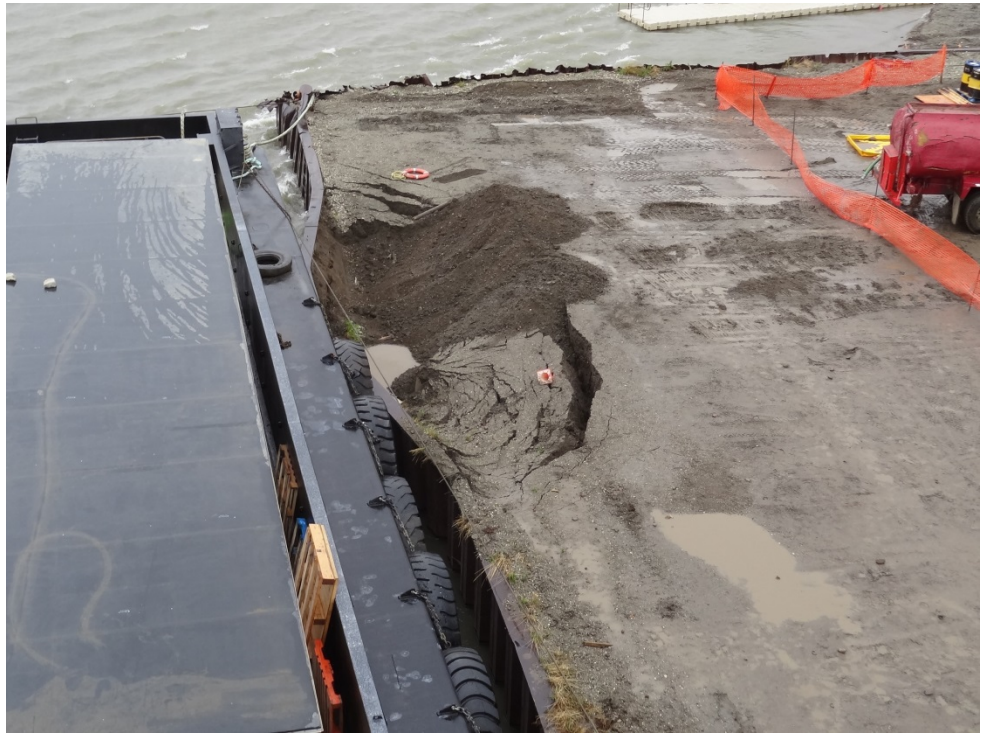
**Photo No.**  
5

Sheet pile failure and associated erosion of soil

Reinforcements to the sheet piles walls on the southwest corner of the dock were completed in September 2014 and April 2015. A series of cables attached to deadmen were used as temporary repair measures after a partial wall collapse in late August 2014.

**Issue:** Continued failure at the sinkhole and zippering breaking of tie-rods at adjacent sections.

**Issue:** Full failure of wall at sinkhole (toe kickout).

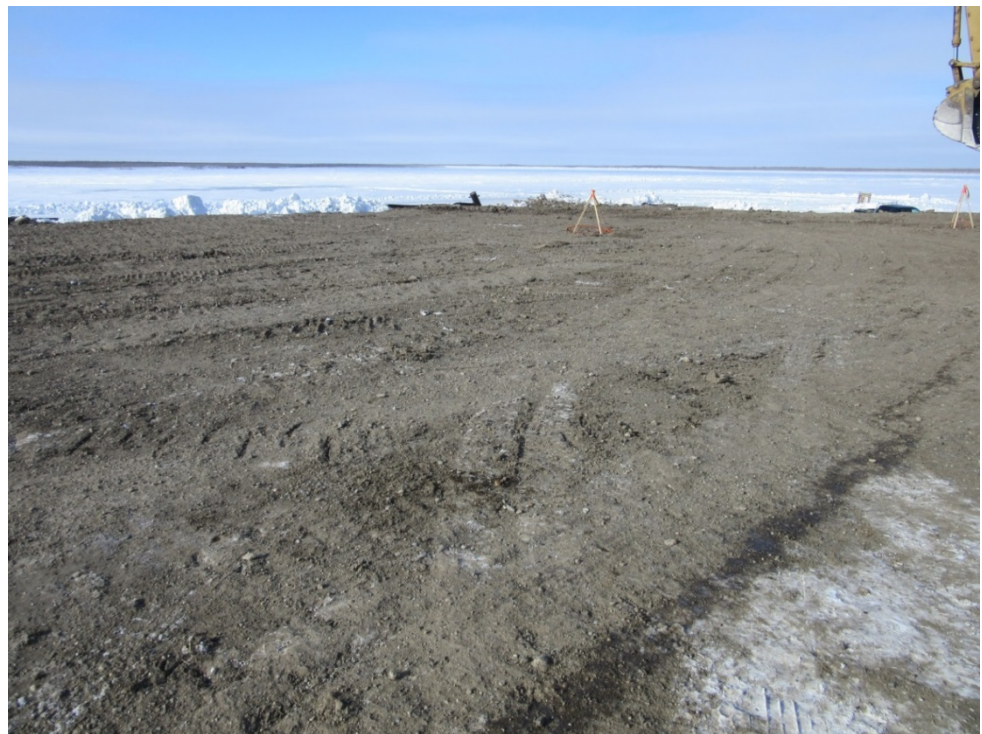
**Photo No.**  
6

Repair of sheet pile failure

**Mitigation:** Inspect winter repair measures before commencing operations. Keep water level behind bulkhead even with outside. Prioritize excavation in failed areas. Employ measures similar to above to ensure supplemental cables are disturbed as little as possible during excavation.

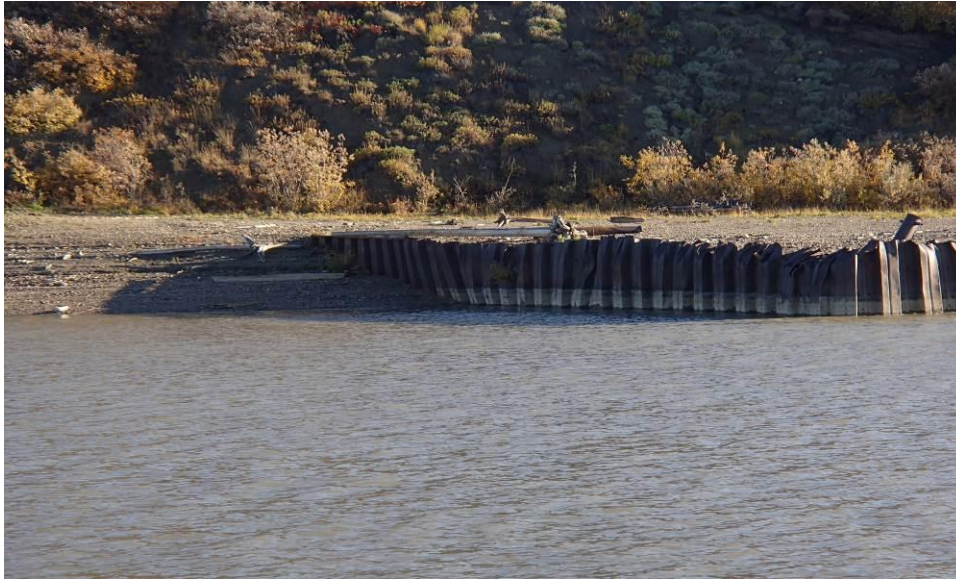
**Photo 1:** General view of the west wall.

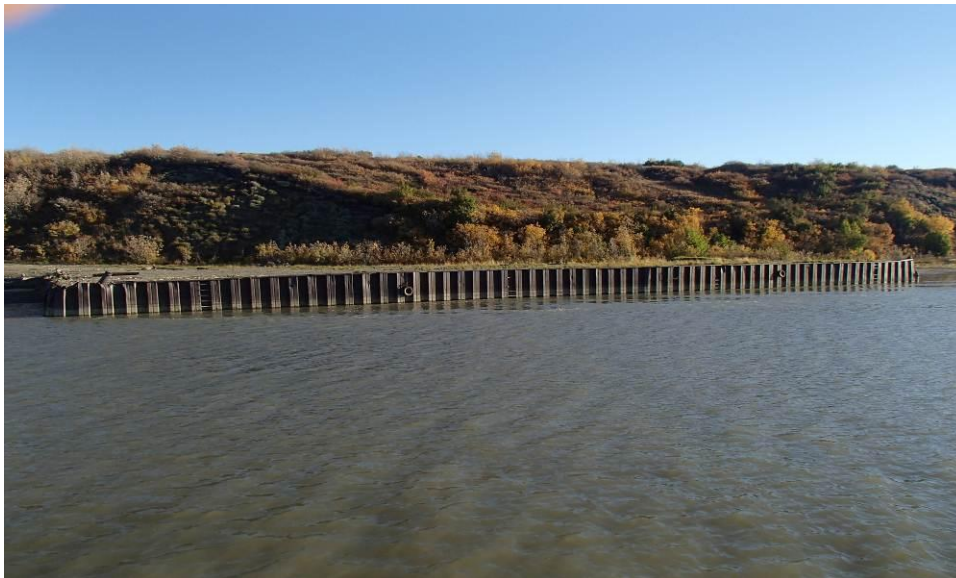
**Photo 2:** General view of the south wall.

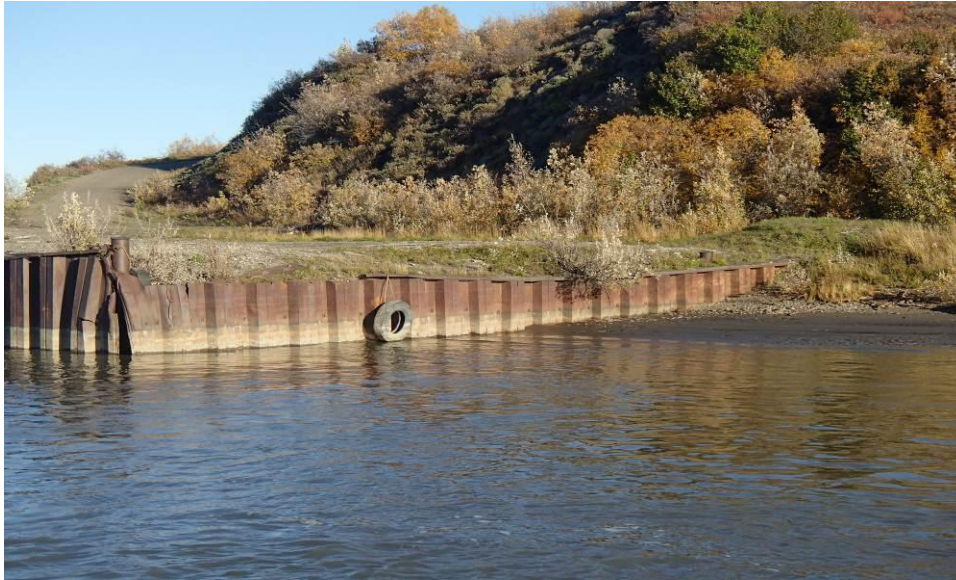
**Photo 3:** General view of the east wall.
