I completed an inspection of the Hamlet of Aklavik's landfill, sewage lagoon, water treatment Plant, Garage and office buildings during the Inuvialuit Water Board's tour of Aklavik on August 21, 2019

«INSP_TYPE» WATER USE INSPECTION REPORT

LICENCE #:	N3L3 - 0570	EXPIRY DATE:	Nov. 30, 2019
LICENCEE:	Hamlet of Aklavik	PREVIOUS INSPECTION:	Aug 24, 2017
COMPANY REP:	Fred Behrens	INSPECTION DATE:	Aug. 21, 2019

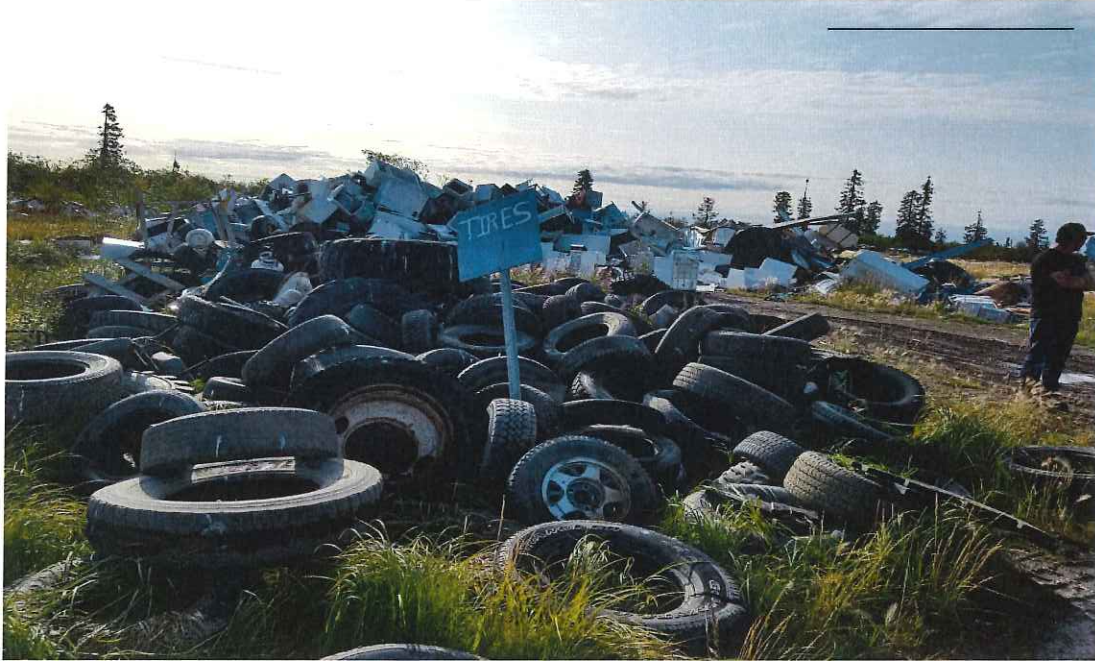
Some segregation One area for regular household garbage
 There is some good signage for tires, used oil, appliances, old vehicles
 Old fuel tanks from Housing, not cleaned
 One area has lot of empty 45 gal. drums
 Lot of empty propane tanks all over. Stated to the staff, for safety reasons, area needed for empty propane bottles
 Area for old appliances
 All used oil, batteries and paint containers brought to shop. Used oil dumped into tote container, Batteries and paint containers placed in drums and wooden boxes on pallets for batteries
 Section set aside for old vehicles, atv's and snowmobiles
 Section for old steel

Figure 1 Sign for Tires at Landfill

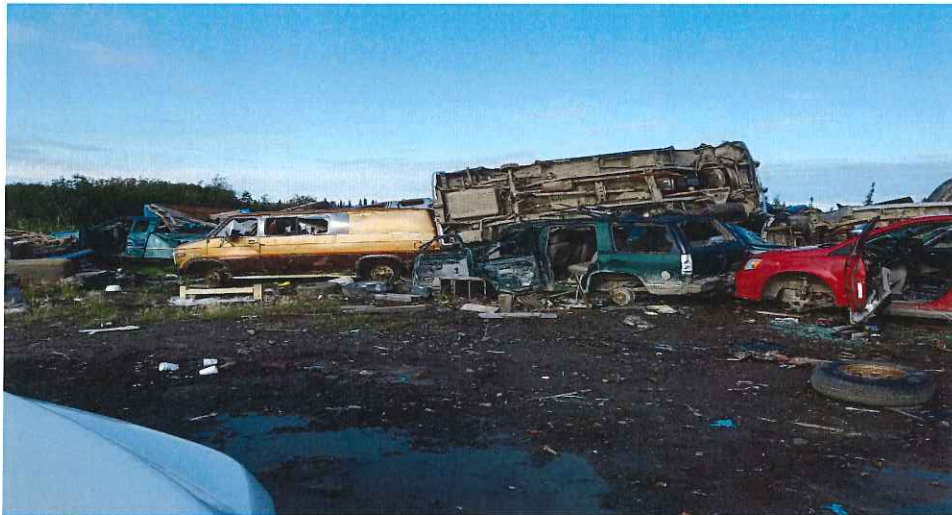
Figure 2 Area for Old Vehicles

- Set aside area in solid waste site for empty propane bottles
- Debris not disposed by sewage lagoon
- Windblown material be picked up outside landfill area
- SNP samples be collected and sent out for analysis
- Annual report submitted each year by April 30 submission date
- Inventory landfill to determine whether or not vehicles are drained and drain if needed

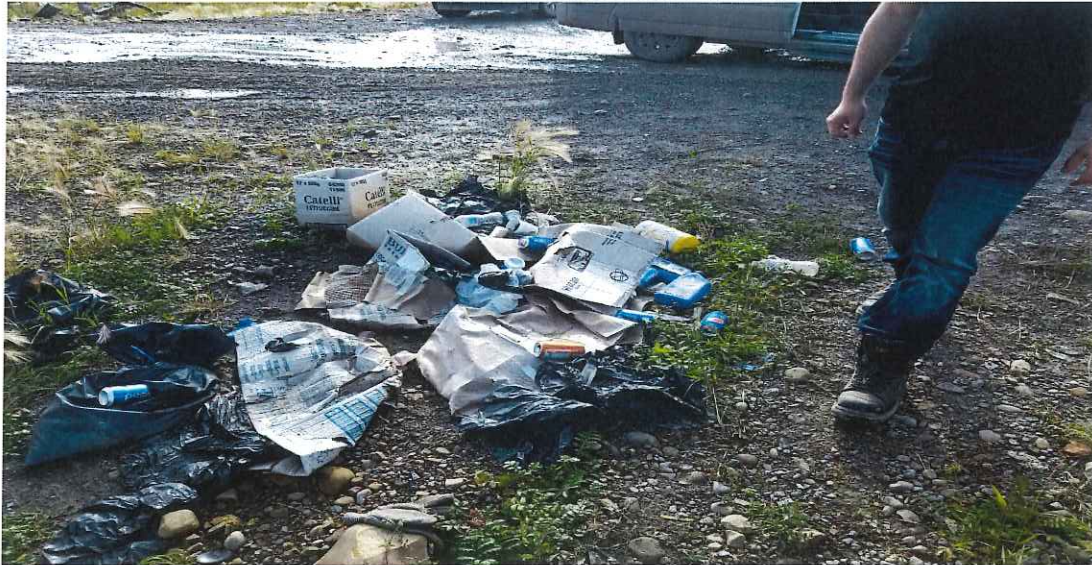
1. Part B, Section 1 (a – n)
2. Debris and empty plastic oil containers on ground by lagoon
3. Windblown material blown into creek west of landfill and within the trees

Improvements done to dumping chute
 Good base of ground below chute
 Berm used to prevent sewage truck from hitting chute
 Lot of debris, cardboard boxes, plastic bags, empty cans left by lagoon

Annual Report submitted late
Debris dumped by sewage lagoon
No signs stating sewage lagoon
No control of what brought to landfill as no operator
Landfill access 24 hrs/day
Section 5(2)(c) (d) of the Used Oil and Waste Fuel Management Regulations states: A person storing used oil, waste fuel in a container shall ensure that the container (c) is stored on a site where access is controlled and monitored; and (d) is clearly, legibly and indelibly labelled to indicate that its contents are waste used oil, waste derived fuel or waste fuel, as the case may be

Figure 3 Garbage left by Sewage Lagoon

In the future, have all required information for the Annual Water Report ready for the April 30 submission deadline. Have all windblown material picked up from area outside landfill, creek and sewage lagoon.

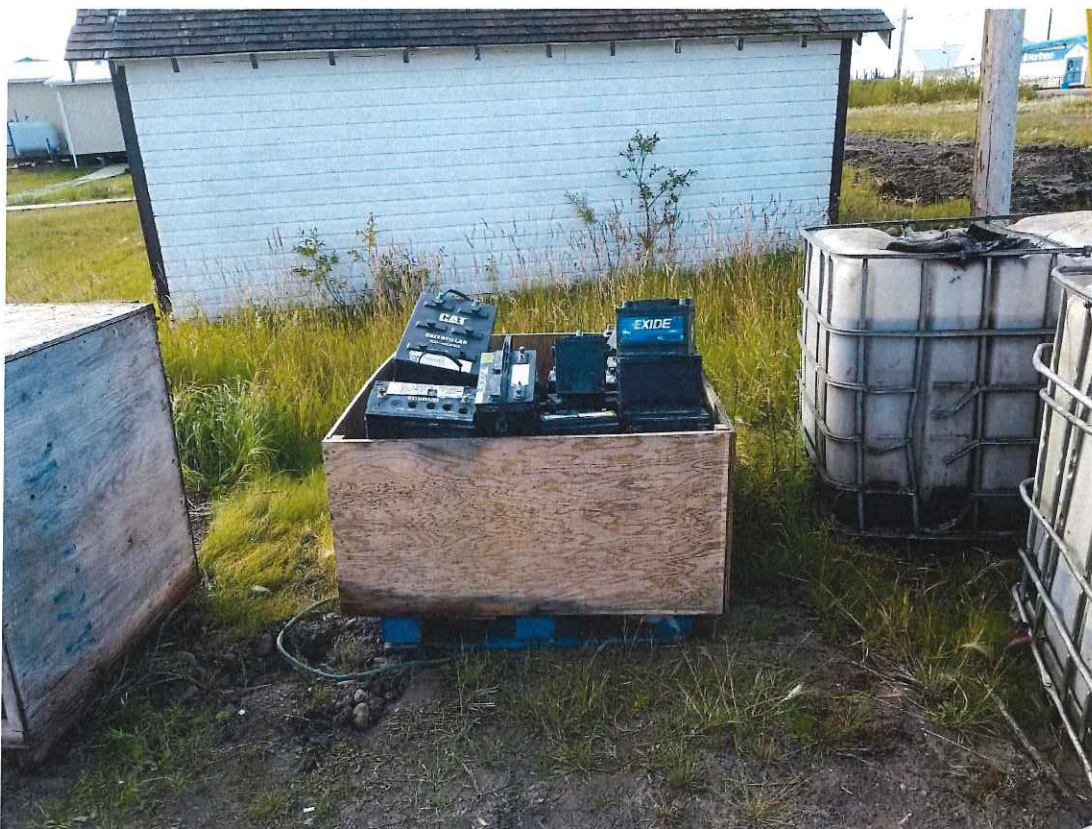
Figure 4 Wooden Box on pallets filled with old batteries

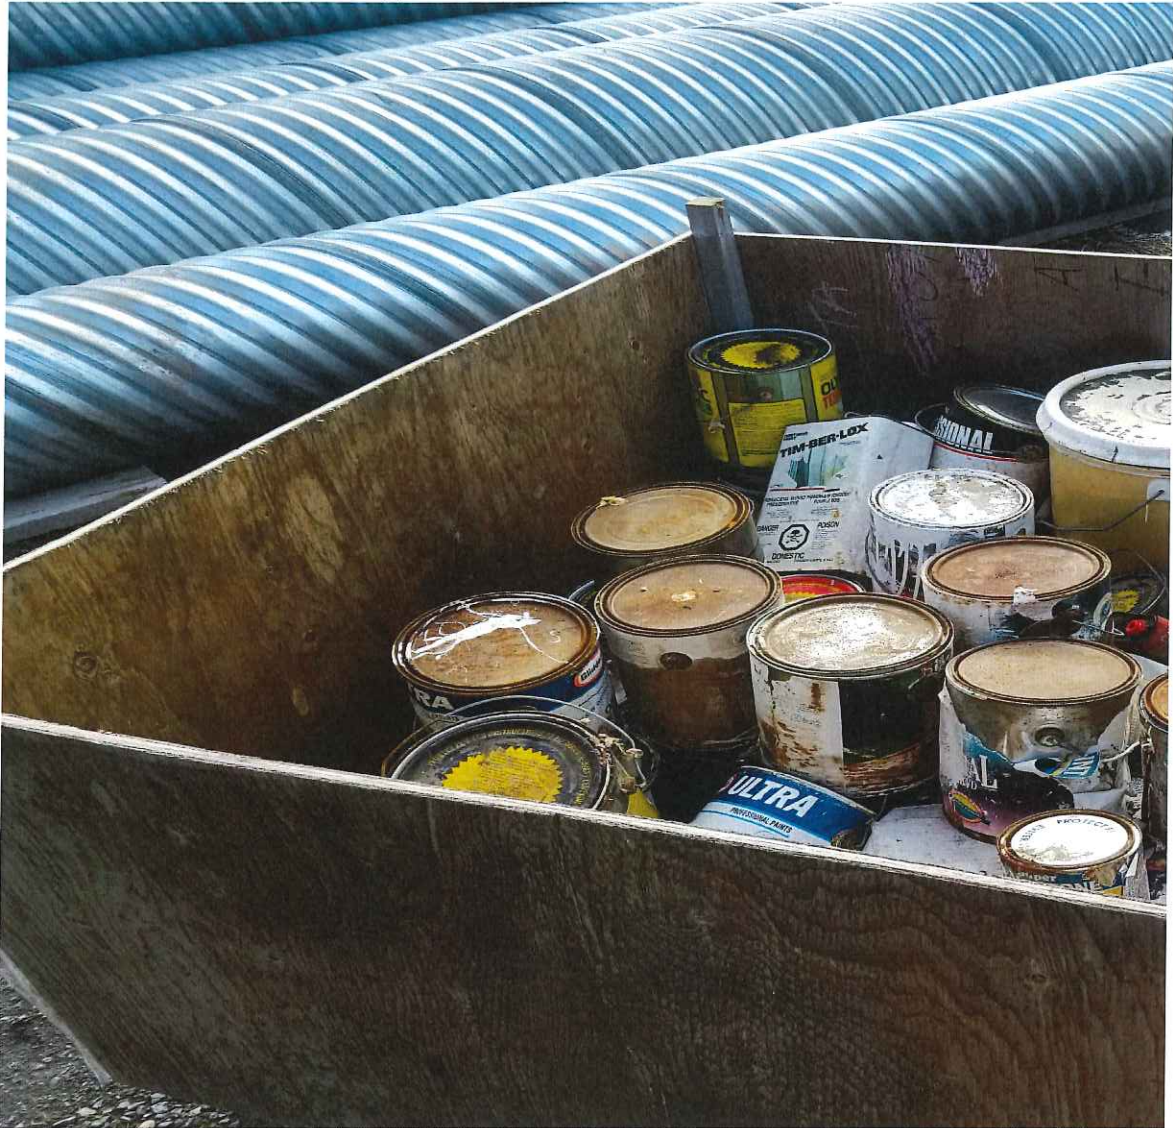
Figure 5 Box of Paint containers
