ISSUED FOR USE
FILE: E11103085-01
Via Email: NWills@klohn.com

Subject: Camp Farewell Buried Debris Locate

**Camp Farewell
Buried Debris Locate**

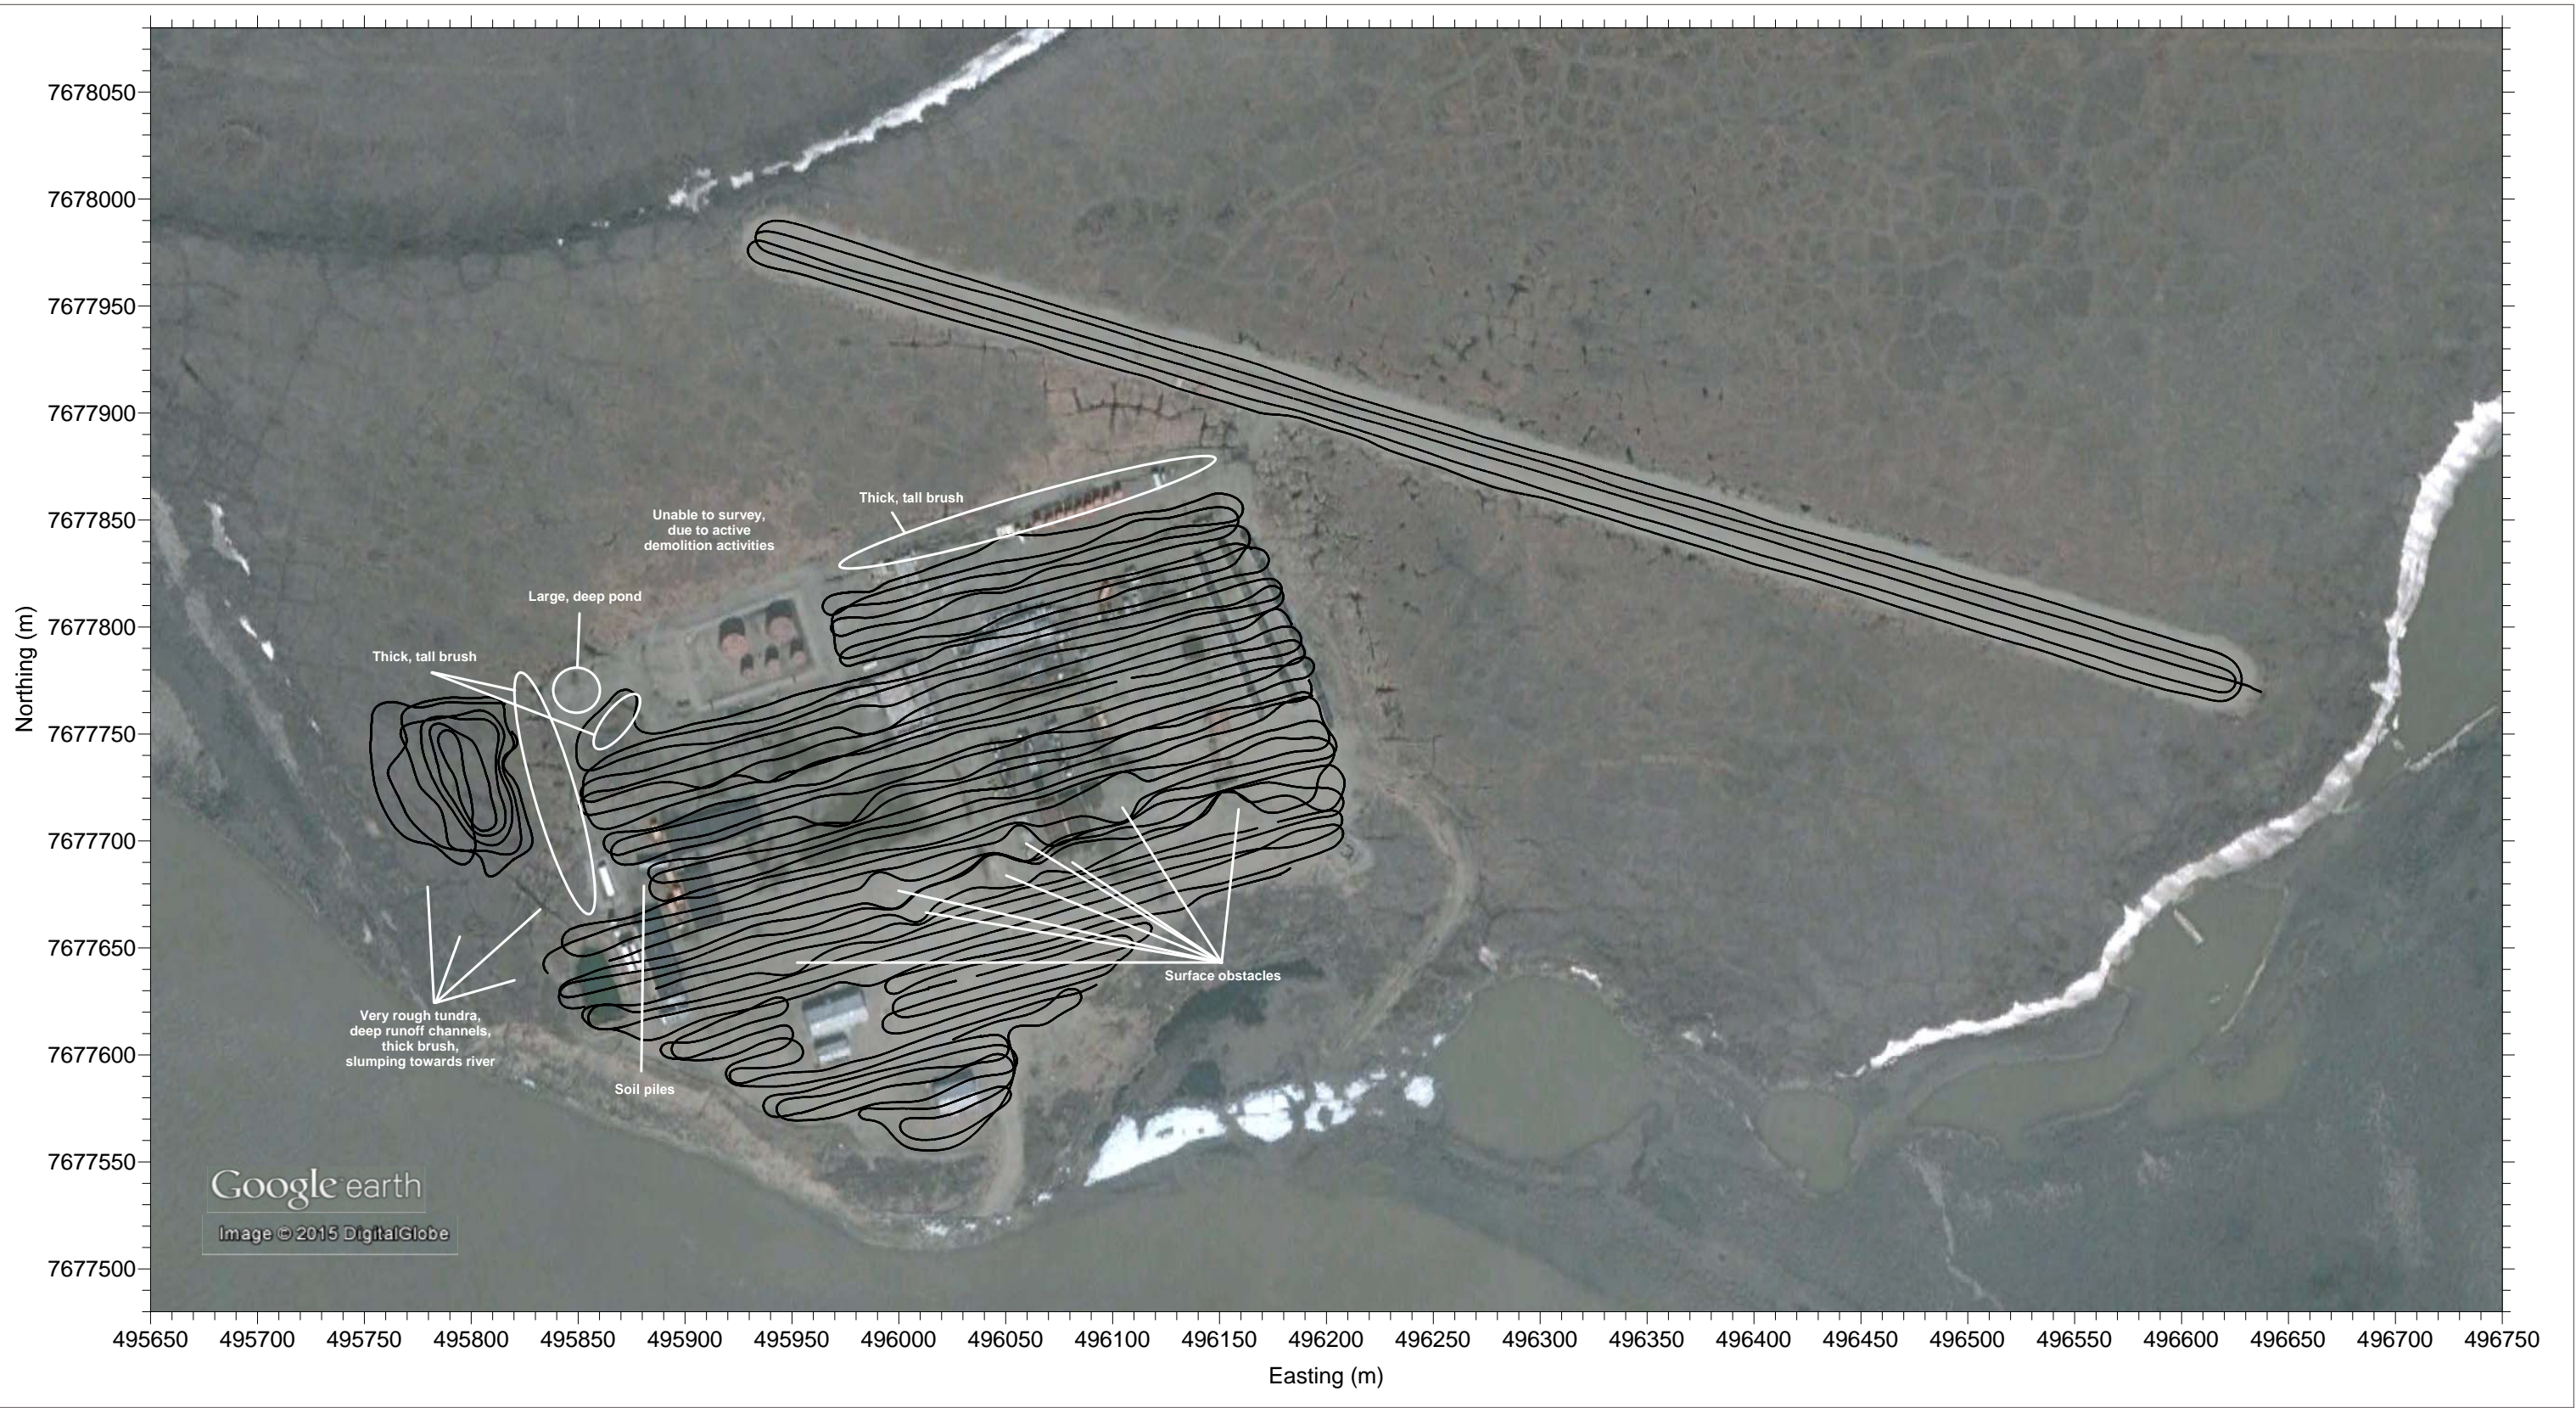
Figure 03

were present in numerous locations on-site during the surveys. In addition to creating obstacles for the survey, these were detected by the various geophysical instruments at various levels of proximity, and thus represent false “targets.” The presence or absence of buried materials in these locations is impossible to distinguish from the signature of the above-ground materials. Most of these obstacles were located in a line, northeast of the remaining shed, and appear as gaps in the survey coverage in Figures 01, 03 and 05. Examples of these obstacles are shown in Photos 2 and 3.

EM31 Data Collection Tracks

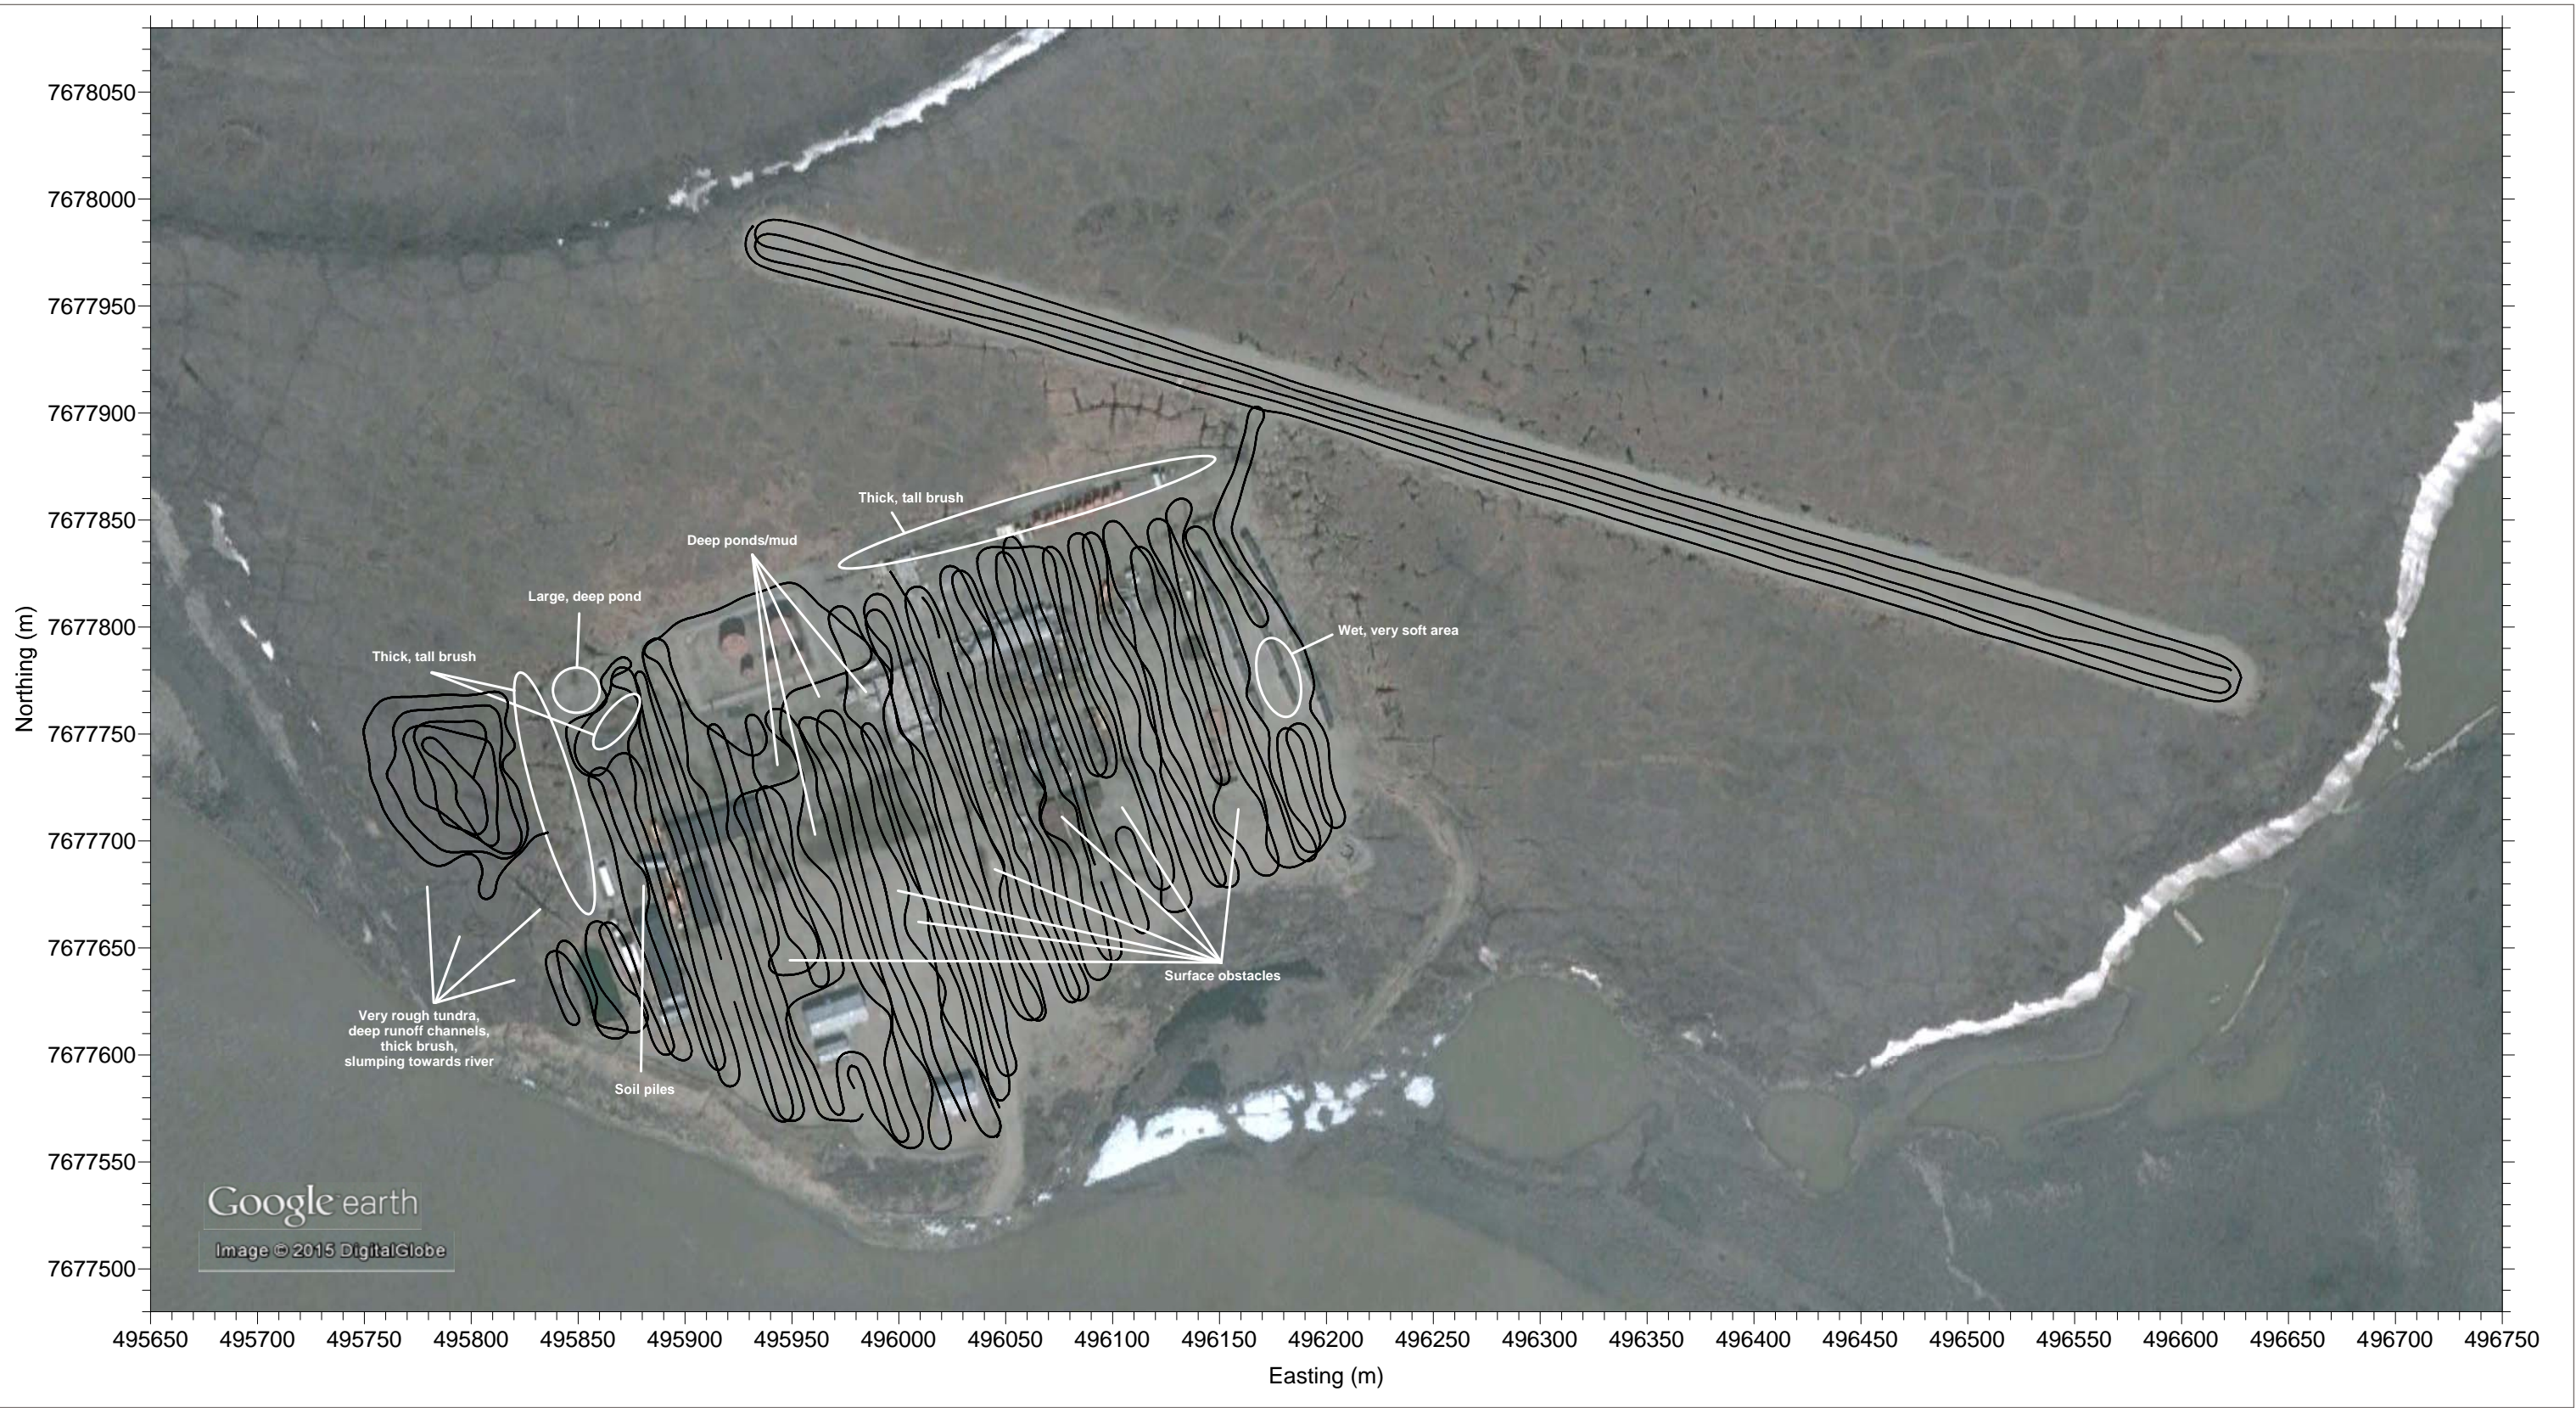
Figure 05

EM38 Data Collection Tracks

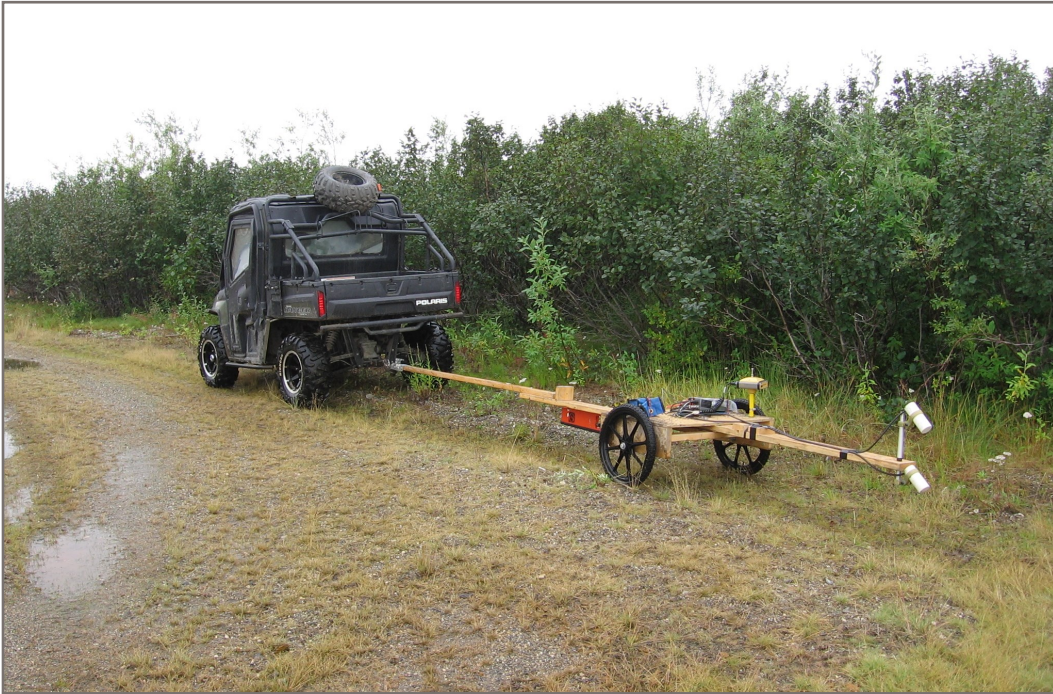
For each survey, the respective instrument was mounted on a custom-made non-conductive, non-magnetic cart towed behind a side-by-side. Each instrument was set to collect data at a rate of 10 readings per second. GPS positions were recorded once per second using a Topcon GPS/GLONASS unit mounted on the cart, operating in RTK mode. Positioning information was interpolated and integrated into all the data sets. A photo of the survey setup can be seen in Photo 1.

Photo 1: View of Geophysical Survey setup. All equipment was towed behind the side-by-side, mounted to a non-magnetic and non-conductive wooden cart.

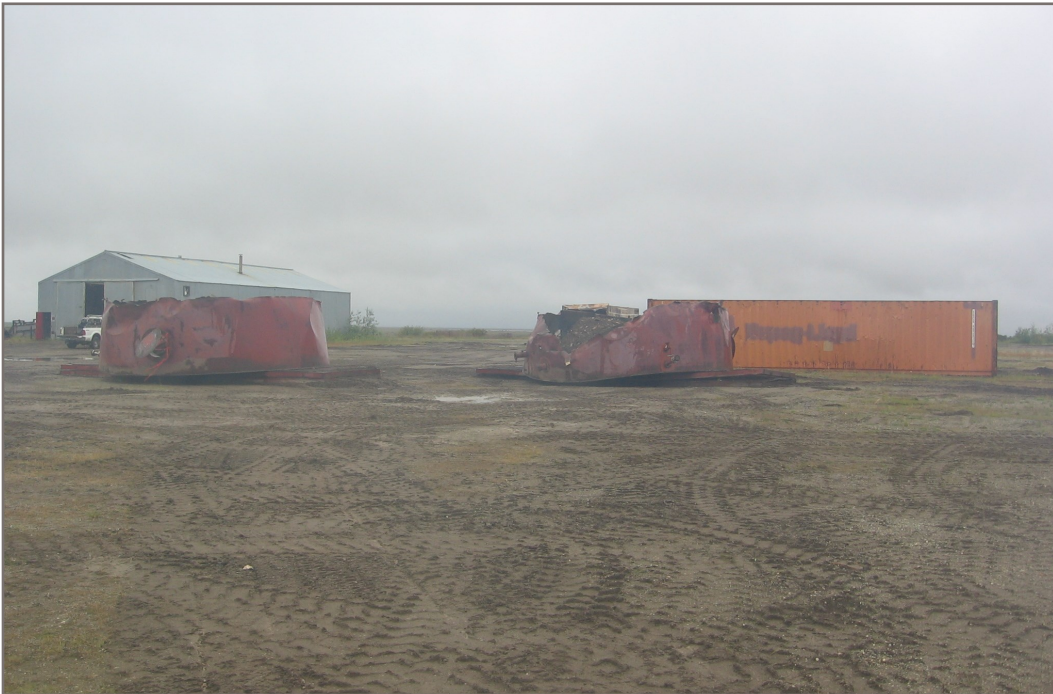
Photo 2: Example of large, highly magnetic objects that were located within the survey area at the time of the survey.

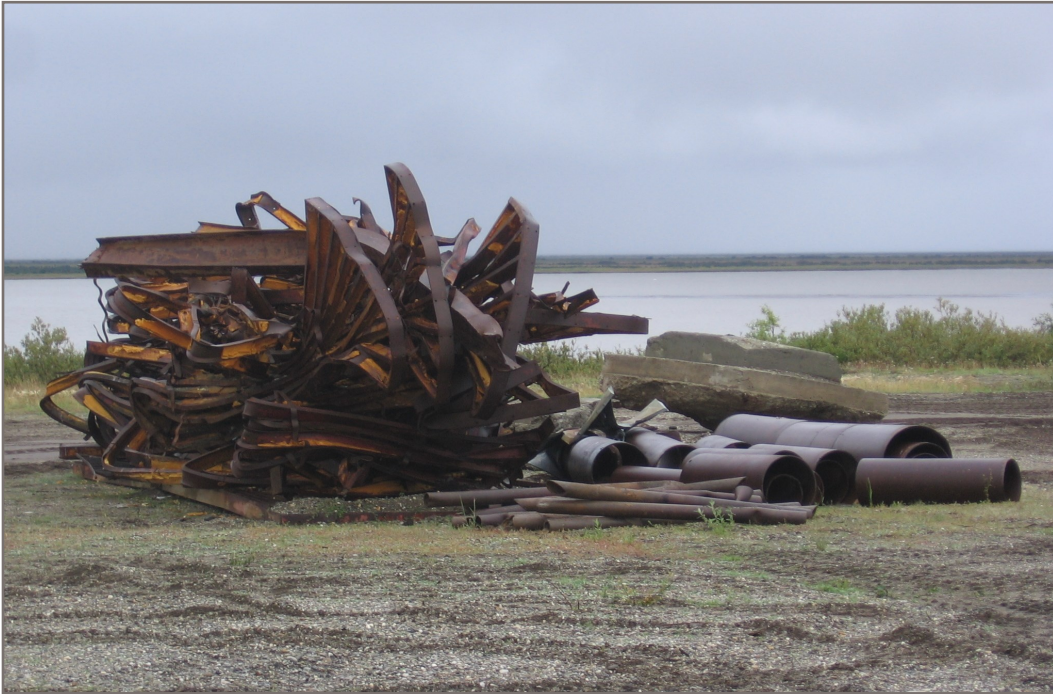
Photo 3: Example of large, highly magnetic objects that were located within the survey area at the time of survey.

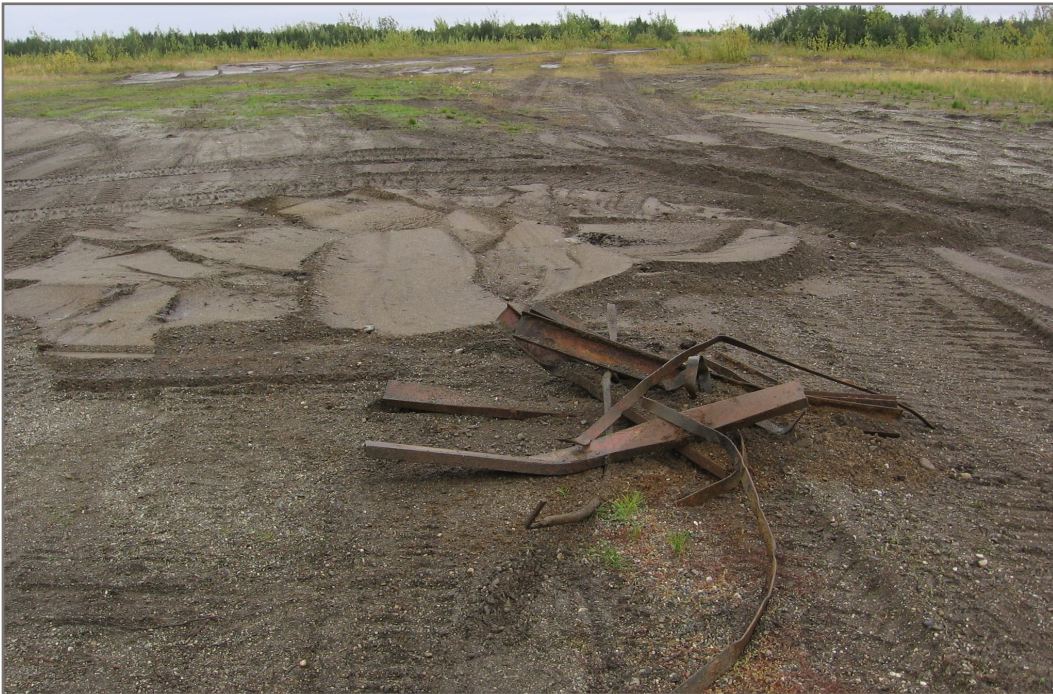
| Anomaly ID | Source | Photo ID | Excavated |
|---|--|---|---|
| EE | Rig mat pieces | 4 | Y |

Photo 4: Geophysical anomaly EE, post-excitation.

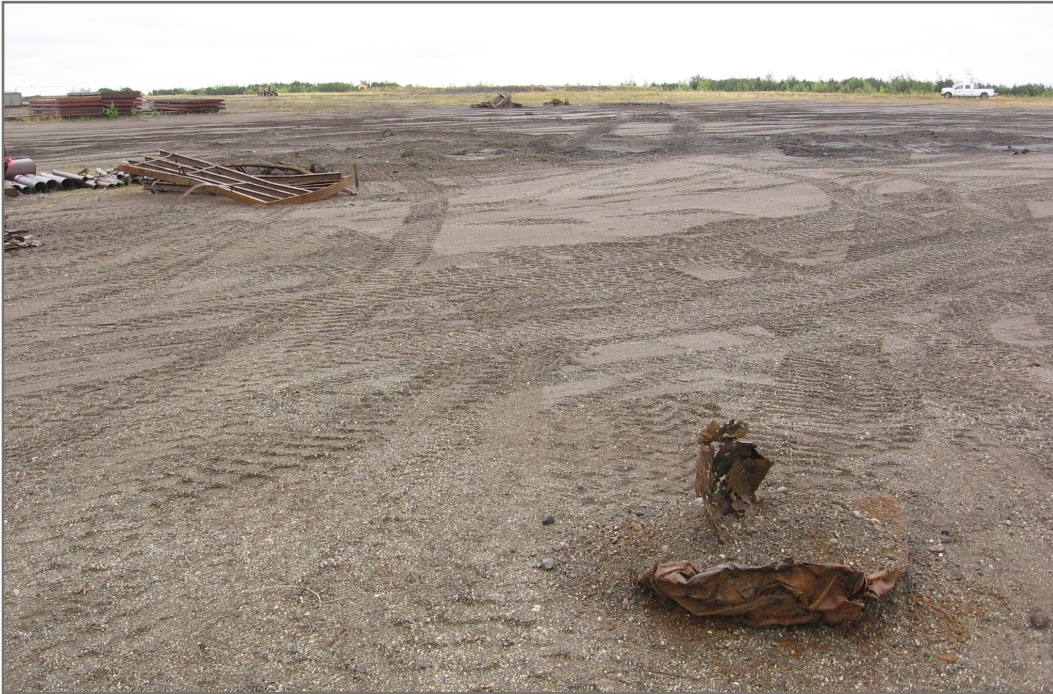
| Anomaly ID | Source | Photo ID | Excavated |
|---|--|---|---|
| FF | Drum | 5 | Y |

Photo 5: Geophysical anomaly FF, post-excavation.

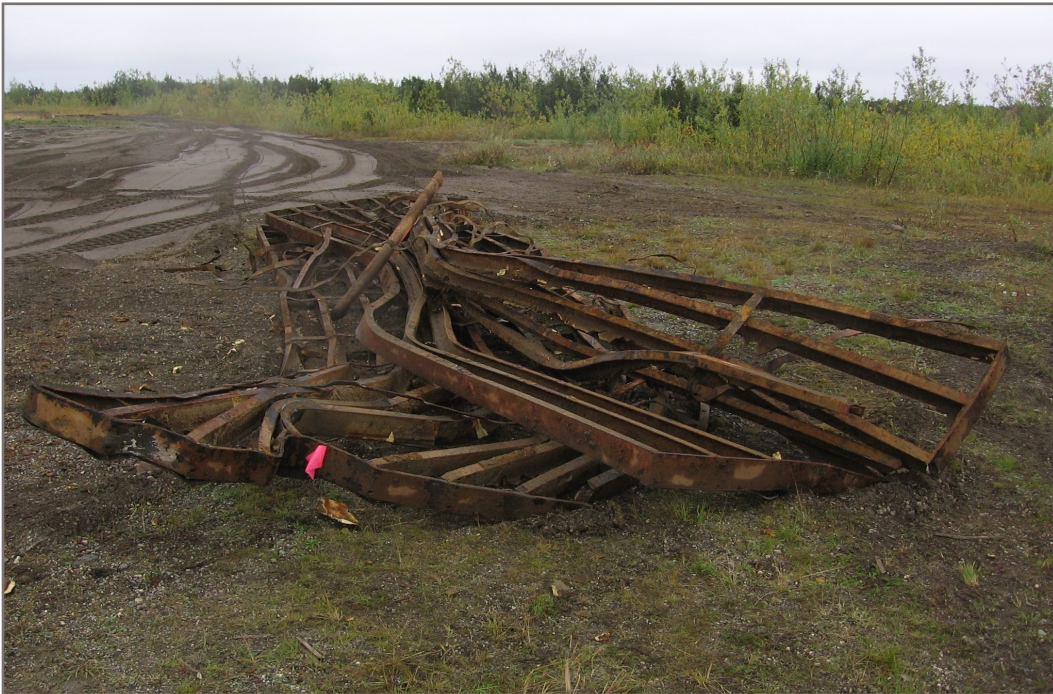
| Anomaly ID | Source | Photo ID | Excavated |
|---|--|---|---|
| R | Rig mats | 6 | Y |

Photo 6: Geophysical anomaly R, post-excavation.

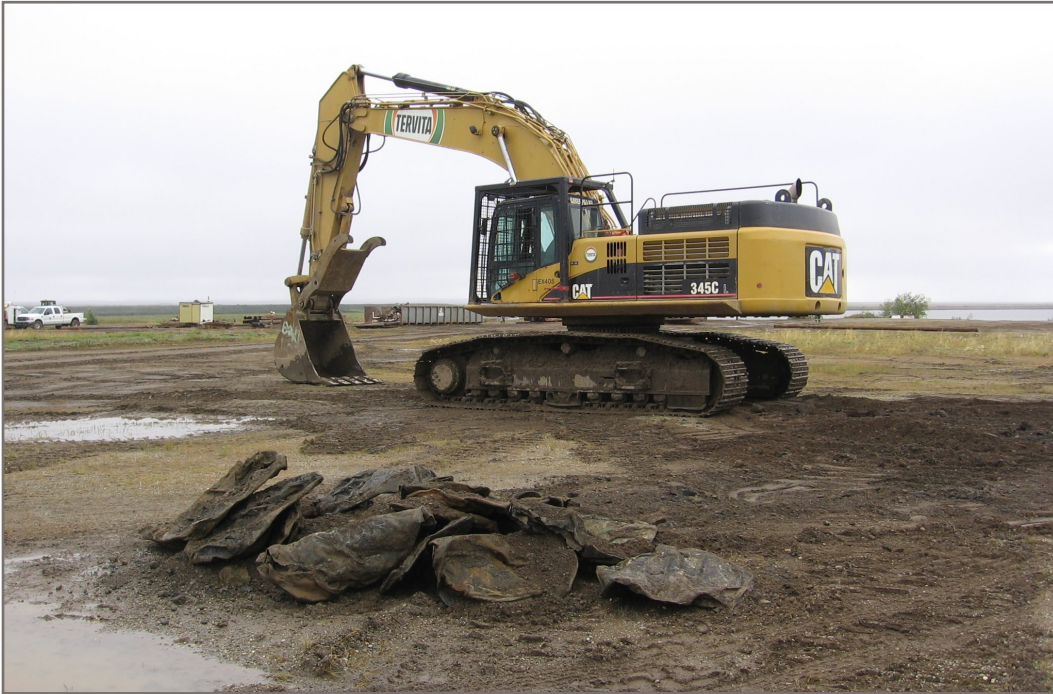
| Anomaly ID | Source | Photo ID | Excavated |
|---|--|---|---|
| W | Crushed fuel drums | 7 | Y |

Photo 7: Geophysical anomaly W, post-excavation.

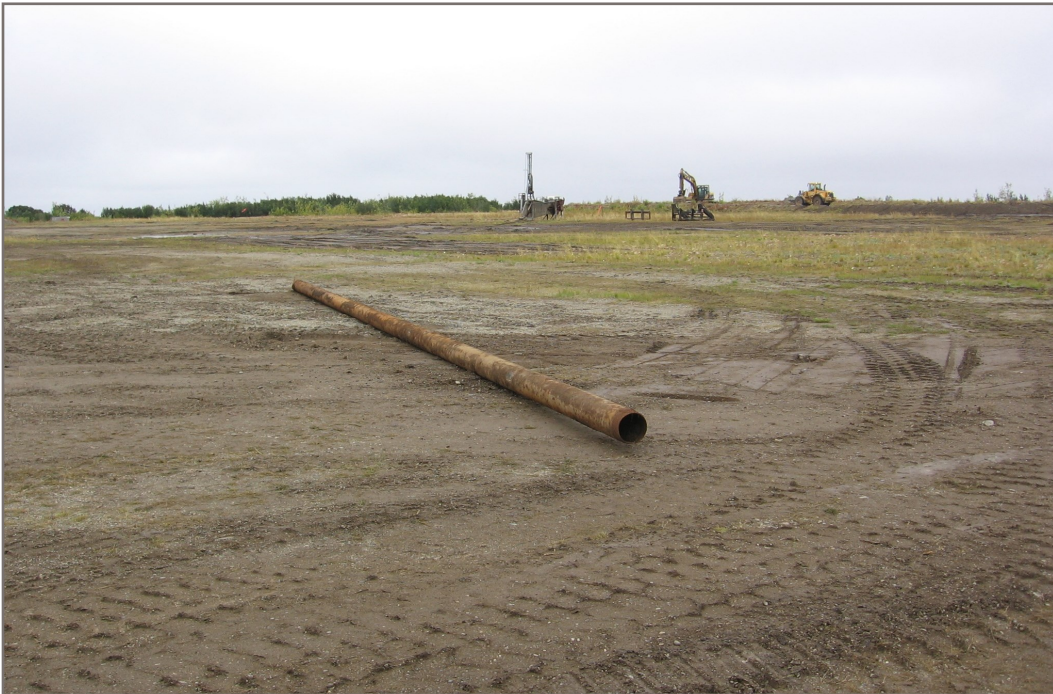
| Anomaly ID | Source | Photo ID | Excavated |
|---|--|---|---|
| X | Pipe | 8, 9 | Y |

Photo 8: Geophysical anomaly X, post-excavation.

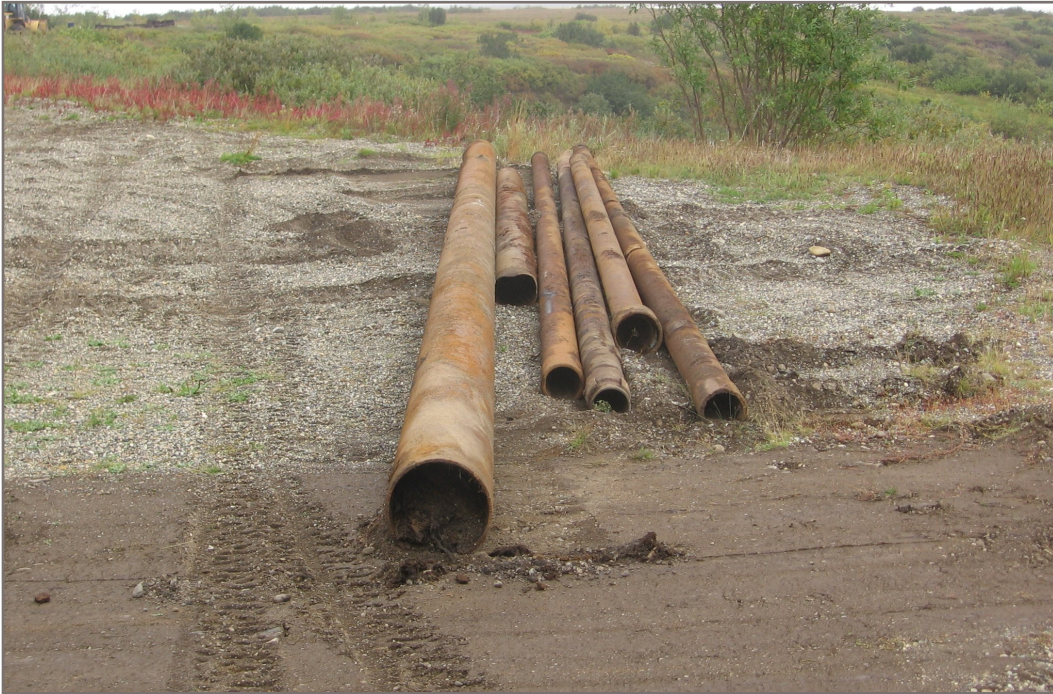
| Anomaly ID | Source | Photo ID | Excavated |
|---|--|---|---|
| S | Pipe | 9 | Y |
| T | Pipe | 9 | Y |

Photo 9: Geophysical anomaly X, S and T, post-excitation.

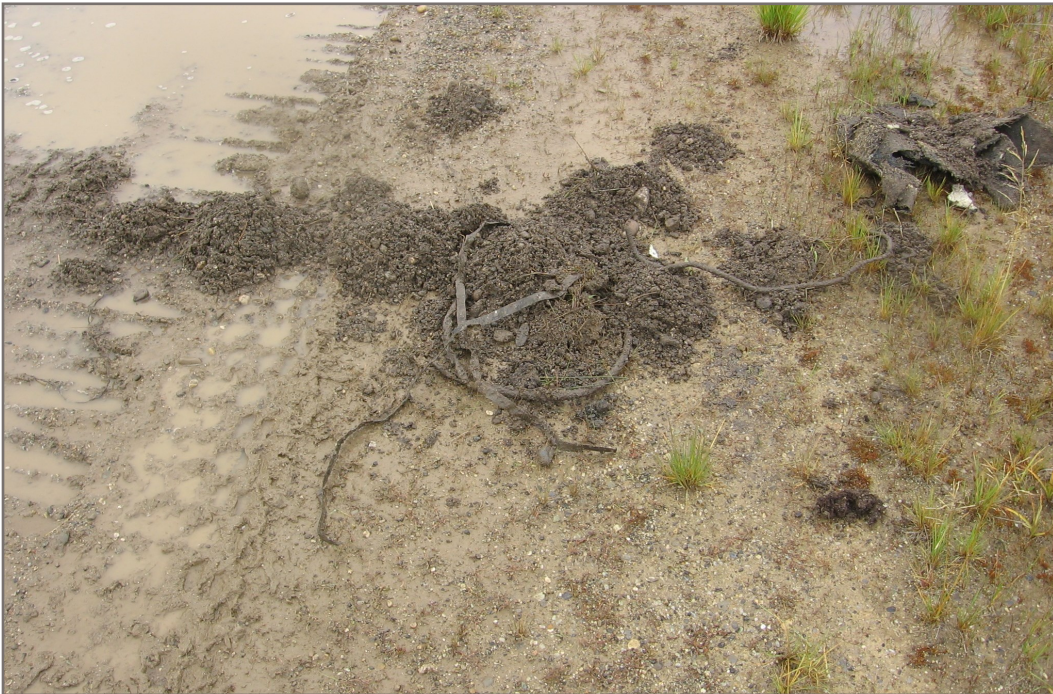
| Anomaly ID | Source | Photo ID | Excavated |
|---|--|---|---|
| Z | Small straps, cables | 10 | Partially |

Photo 10: Geophysical anomaly Z, post-excitation.

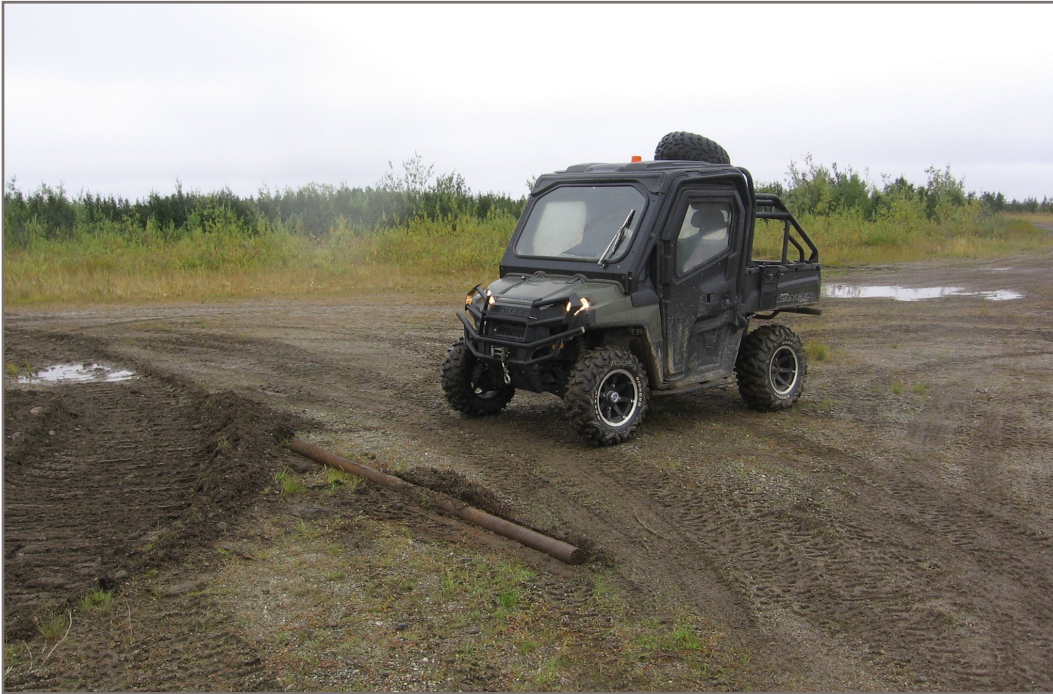
| Anomaly ID | Source | Photo ID | Excavated |
|---|--|---|---|
| AA | Pipe | 11 | Y |

Photo 11: Geophysical anomaly AA, post-excavation.

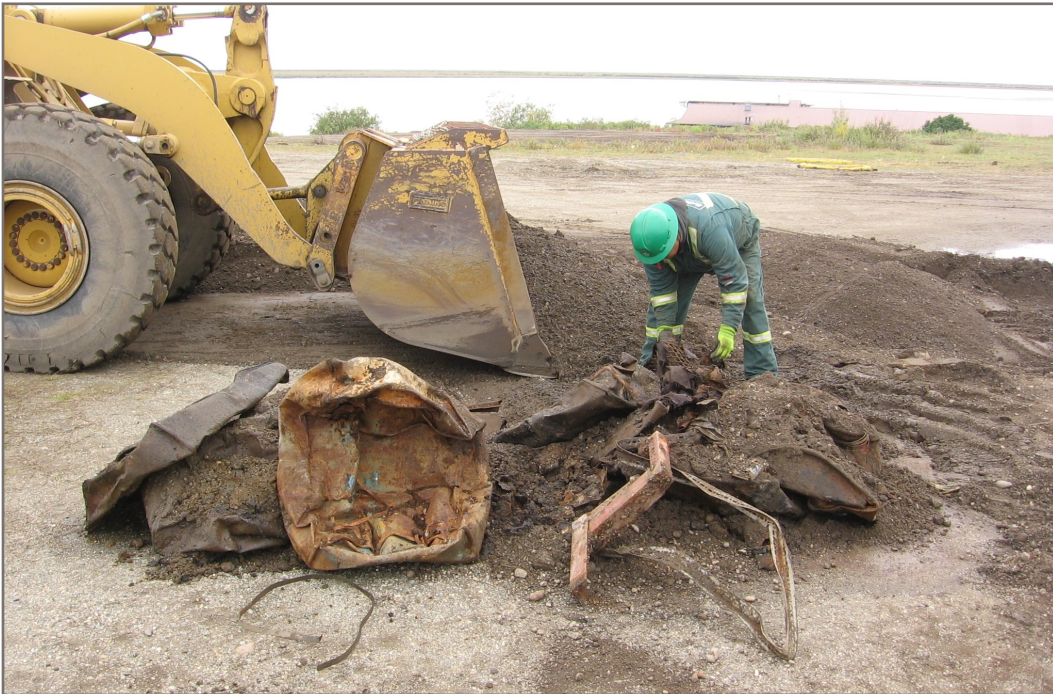
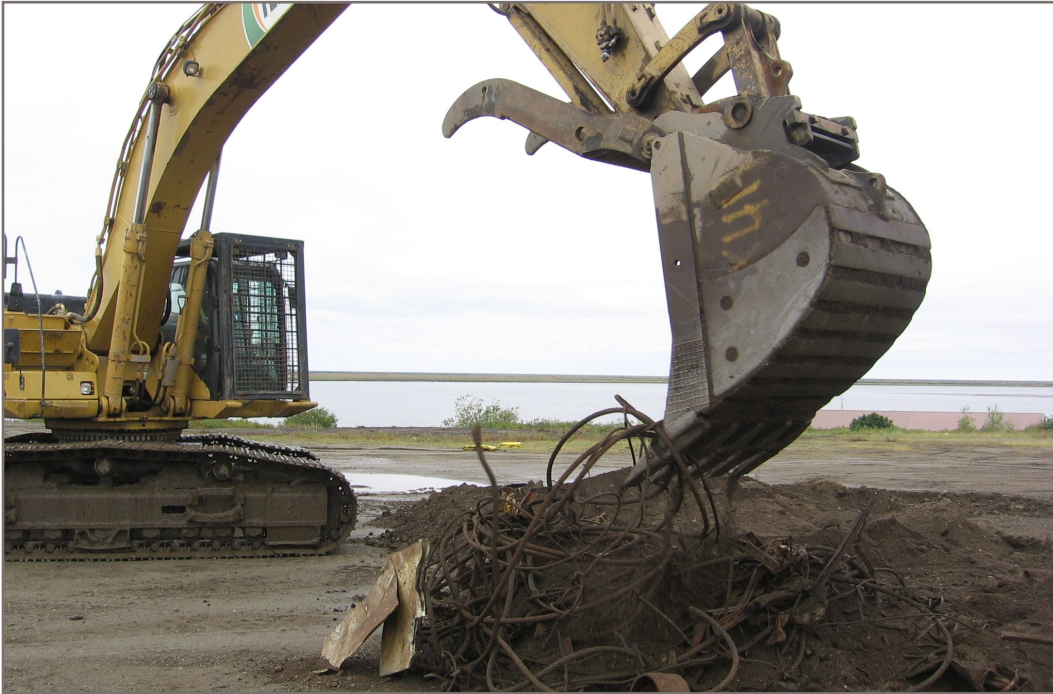
| Anomaly ID | Source | Photo ID | Excavated |
|---|--|---|---|
| CC | Misc waste, cables, tin cans, drums, possible burn pit | 12, 13 | Partially |

Photo 12: Geophysical anomaly CC, post-excavation.

Photo 13: Geophysical anomaly CC, post-excavation.

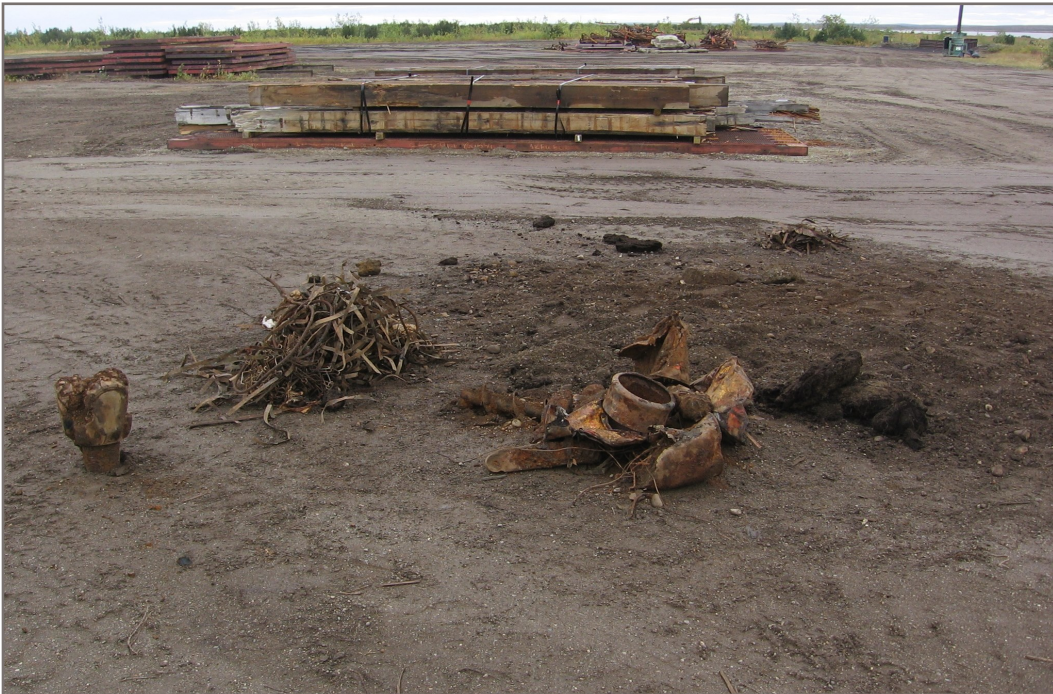
| Anomaly ID | Source | Photo ID | Excavated |
|---|--|---|---|
| DD | Drill head, auger flight, collars, straps | 14 | Y |

Photo 14: Geophysical anomaly DD, post-excavation.

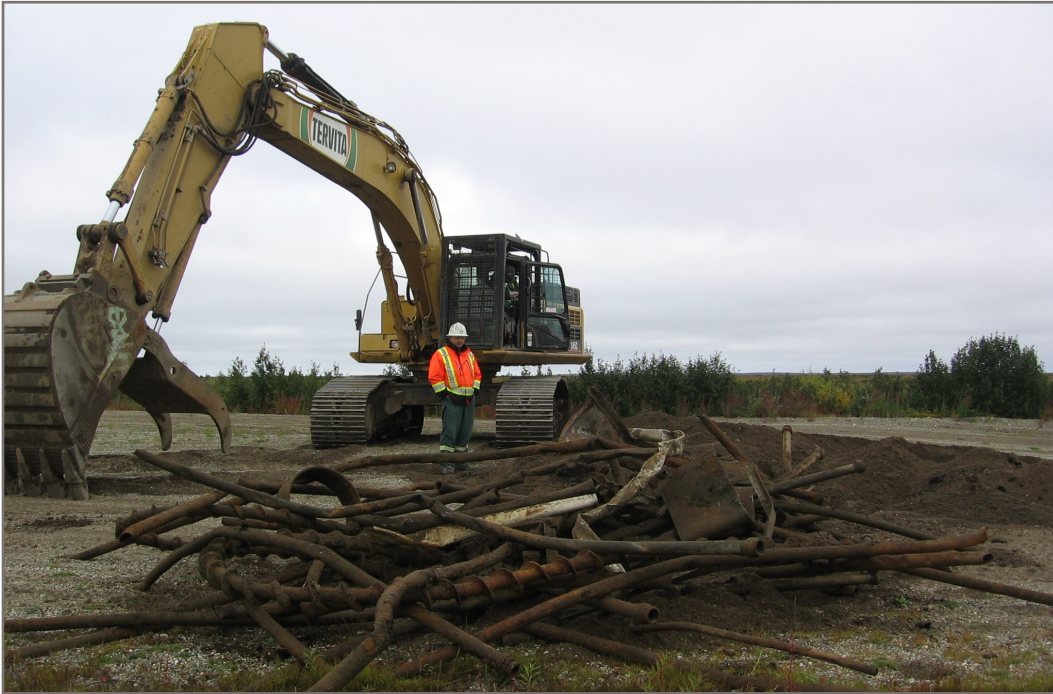
| Anomaly ID | Source | Photo ID | Excavated |
|---|--|---|---|
| Rwy1 | Auger flights, pipes, misc steel objects | 15 | Y |

Photo 15: Geophysical anomaly Rwy1, post-excavation.

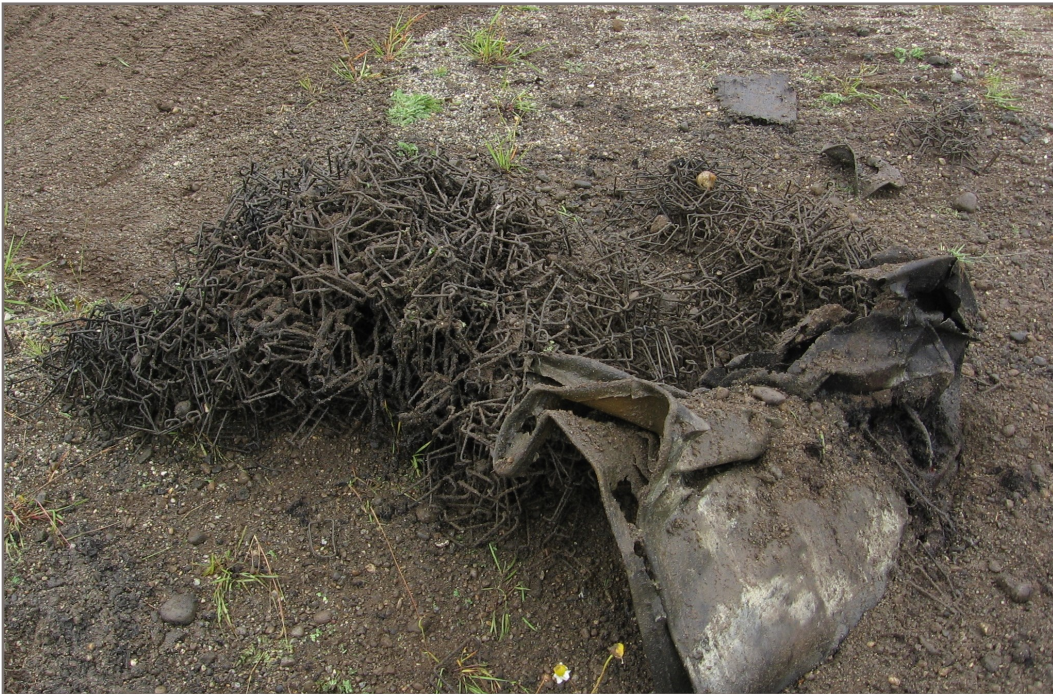
| Anomaly ID | Source | Photo ID | Excavated |
|---|--|---|---|
| Rwy5 | Clips, drum | 16 | Y |

Photo 16: Geophysical anomaly Rwy5, post-excavation.

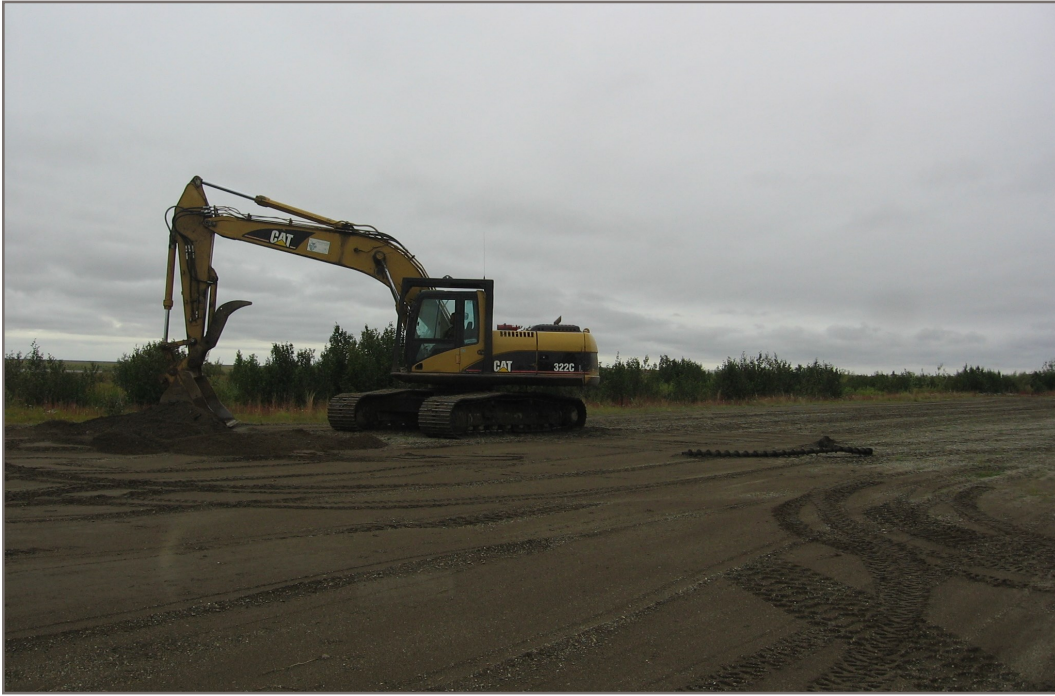
| Anomaly ID | Source | Photo ID | Excavated |
|---|--|---|---|
| Rwy7 | Auger flight | 17 | Y |

Photo 17: Geophysical anomaly Rwy7, post-excavation.
