**MGM Energy Corporation – 2015 Environmental
Site Monitoring Report**

Site Umiak N-16 Sump

March 2016

Prepared by:
KAVIK-STANTEC Inc.
Inuvik, NWT

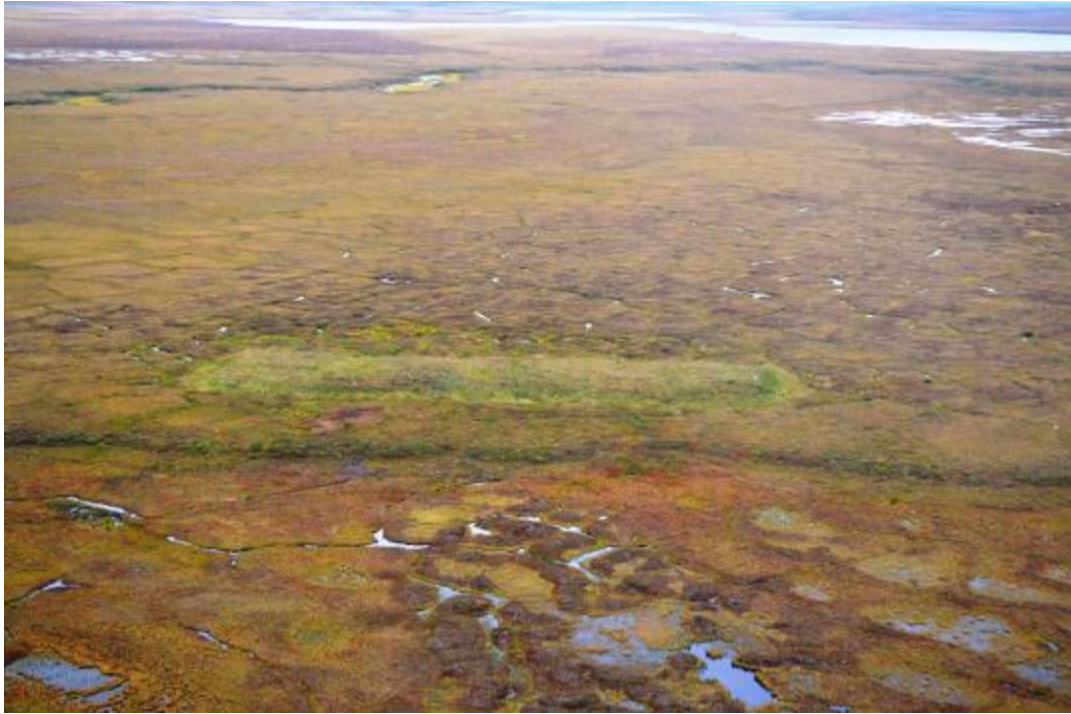
Photo 1 Aerial overview of Umiak N-16 sump looking south. August 2015.

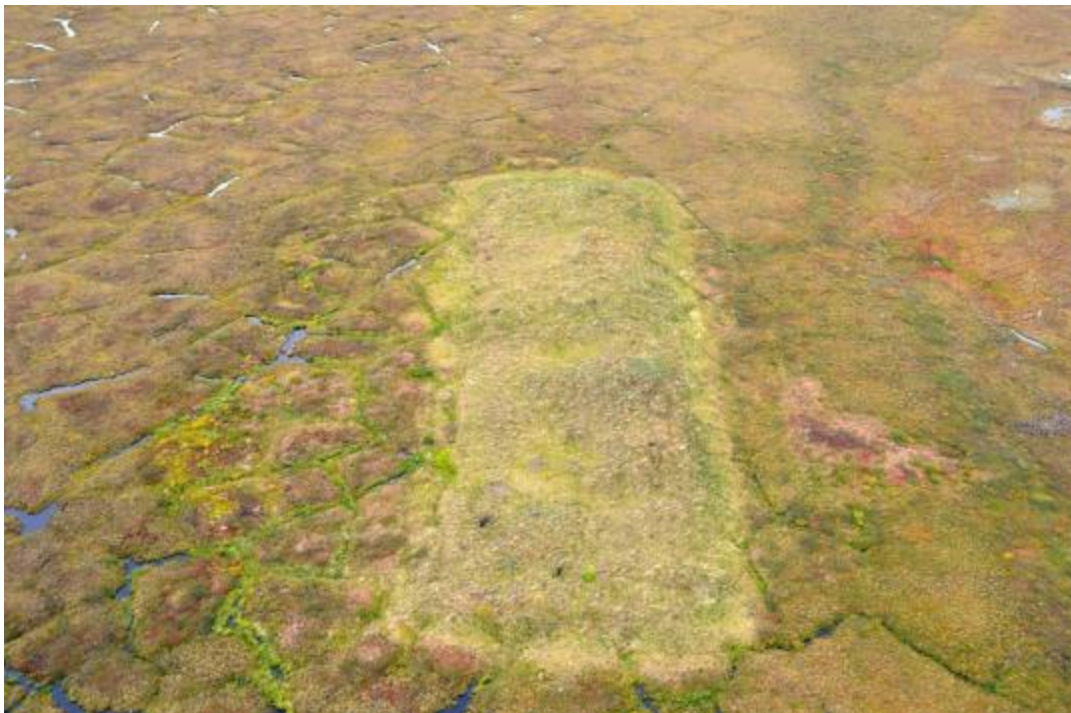
Photo 2 Aerial overview of Umiak N-16 sump looking east. August 2015.

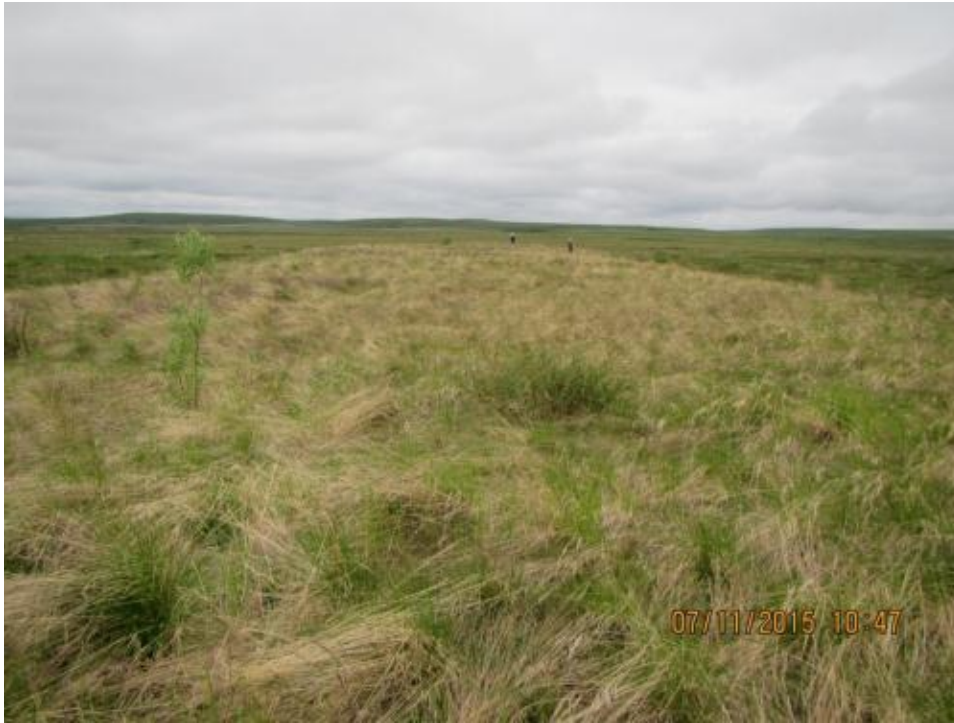
Overall, vegetation health and condition was considered good at the surface of the N-16 sump cap as well as along the perimeter of the sump. There was no visual evidence of affected vegetation and plant foliage was green and robust. On the N-16 sump that underwent reclamation treatments, the site did have a large accumulation of leaf/stem litter from previous years' grass plant growth (Appendix B, Photos 1 to 5).

Photo 3 Native grass growth on top of the N-16 sump (photo facing west).
July 2015.

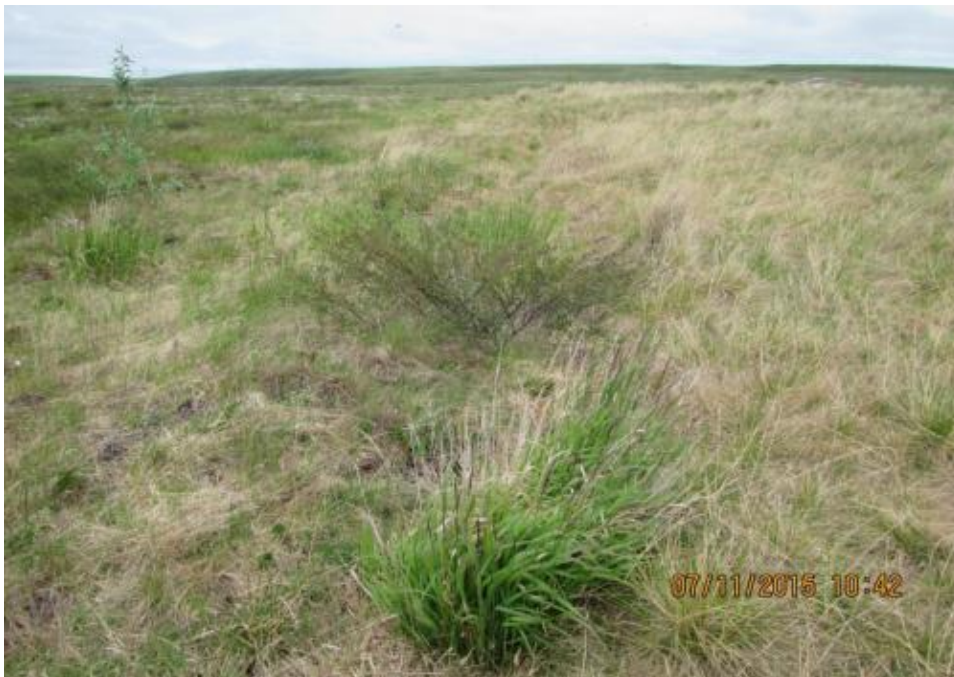
Photo 4 Native grass and shrub growth along the north slope of the sump (photo facing east). July 2015.

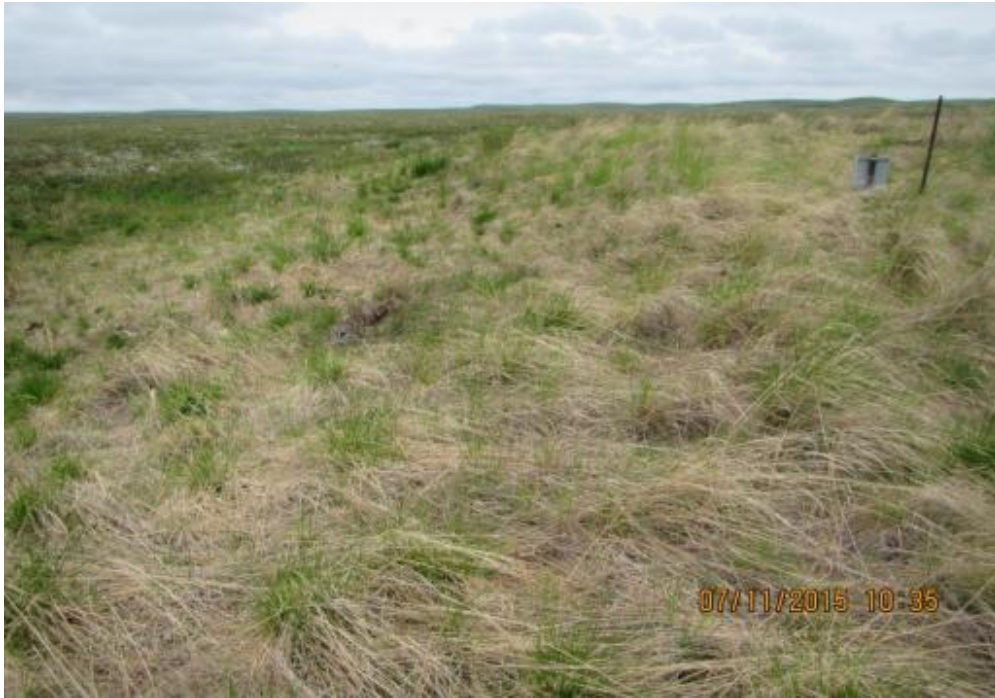
Photo 5 Native grass growth on south slope of sump (photo facing west). July 2015.

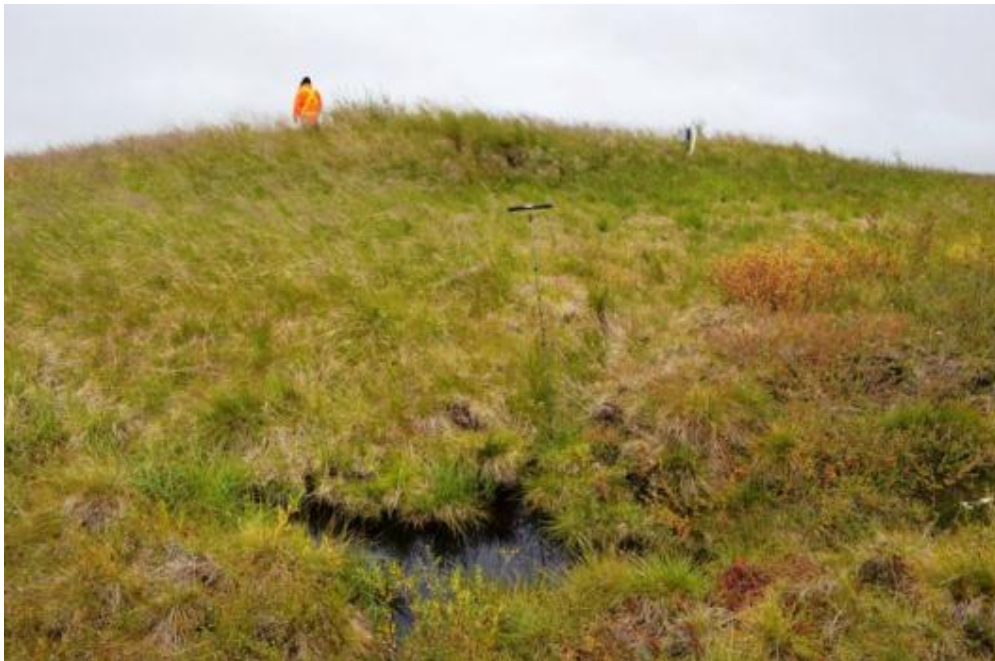
Water ponding above ice-wedges (i.e., within narrow linear depressions commonly referred as ice-wedge troughs or polygon cracks) was observed at several locations in contact with the perimeter of the sump (Appendix B, Photos 6 and 7). Some of the depressions correspond to a single ice-wedge, while others correspond to the contact between two or three ice-wedges. The width, length and depth of the ice-wedge troughs are variable and the amount of ponding water appear directly related to the topographic position of each gully (note that some of the ice-wedges have no water). The presence of ponding water above some ice-wedges was reported in previous monitoring reports. Although no major visual signs of melting, ground subsidence and/or active tension cracks were observed along the ice-wedges during the 2015 site visits; some progressive deepening of some of the ice wedges troughs in contact with the perimeter of the sump could be occurring (i.e. there are no monitoring systems or topographic benchmarks in place).

Photo 6 Water ponding at the intersection between two ice-wedges; northwest corner of the sump. August 2015.

Water ponding above ice-wedges was observed at several locations in contact with the perimeter of the sump. Continued site monitoring in 2016 is recommended to observe the stability of the various ice-wedges located in contact with the perimeter of the sump cap, and to further assess the potential migration of sump-impacted water primarily north of the sump.

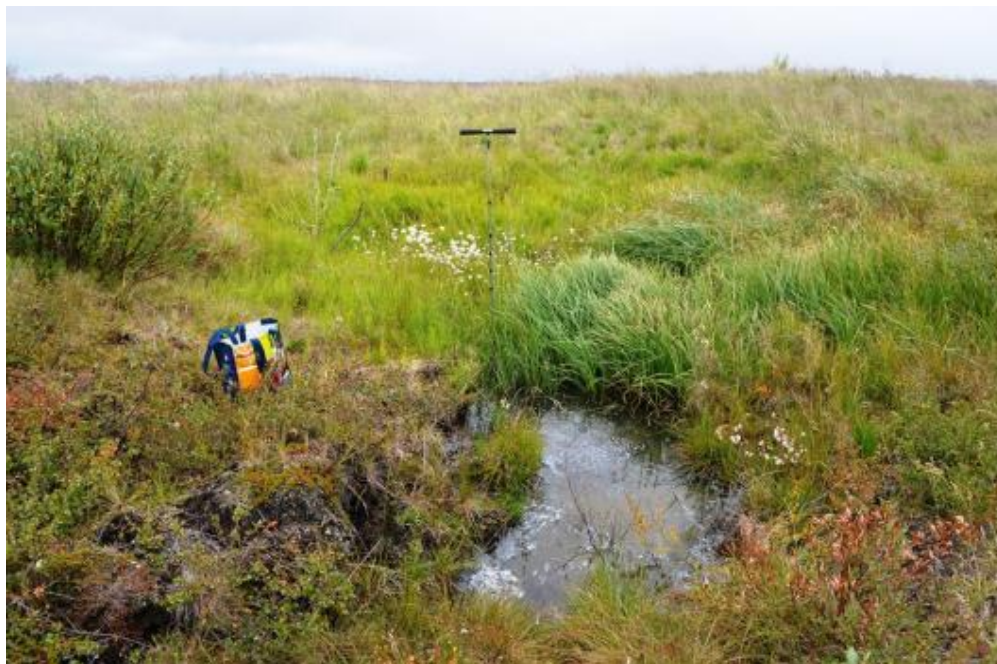
During the time of the site visit, the ponded water in contact with the perimeter of the sump had a distinctive sheen as well as some minor foam (Appendix B, Photo 7). A stick test was conducted to assess the potential presence of petroleum hydrocarbon. The test was negative indicating that the sheen was not of petrogenic origin. However, it is unclear as to what is causing the sheen. Sheen from natural biodegradation or plant and organic water is common in the area but the distinctive grayish-brown color of the sheen observed at the site appear different when compared to other sheens at nearby sites. Sample N16-15-04 was collected from ponded water displaying this distinctive sheen. Laboratory results indicate the most elevated level of total dissolved solids (TDS) of all samples taken at the site. TDS includes inorganic salts (principally calcium, magnesium, potassium, sodium, bicarbonates, chlorides, and sulfates) and some small amounts of organic matter that are dissolved in water. The TDS concentration of sample N16-15-04 was 3,300 mg/L, nearly 100 times higher than the control sample N16-15-08 at 35 mg/L.

Photo 7 Apparent sump-impacted water above an ice-wedge along the north perimeter of the sump (water sample N16-05-04) August 2015.

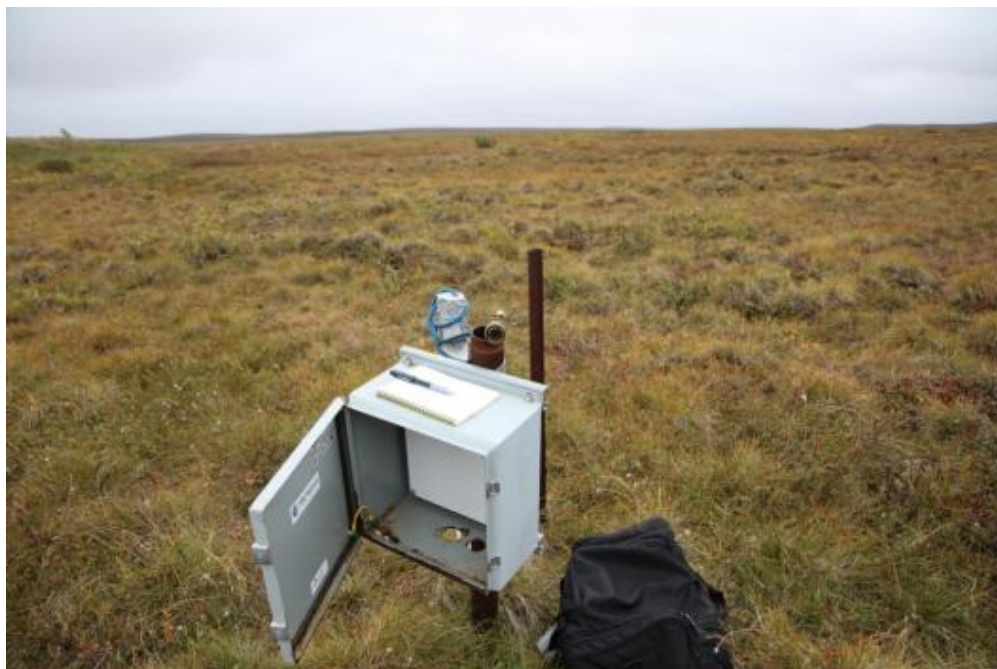
PVC tubing, thermistor cables and metal protective casings that use to host the data loggers were observed at the sump site (Appendix B, Photo 8). Four thermistors were originally installed at the site in 2004 to monitor thermal characteristics within the sump and at an undisturbed area (control location) surrounding the sump. During the August 18, 2015 site visit, it was discovered that the thermistors had been forcefully removed from the data loggers, with some of the connectors torn from the thermistor strings. Local wildlife is assumed to be responsible for the damaged equipment. As a result, no data could be retrieved from these data loggers either at the time of the assessment or once the data loggers were removed from the site. Data on Thermistor 1728 has not been able to be retrieved since 2008 due to an unknown data logger malfunction.

The thermistor cables currently present at the N-16 sump are in poor condition and assumed to be unrepairable.

Photo 8 Empty protective casing previously used to store the thermistor cable's data logger.

The PVC tubing and the steel pipes supporting the protective casings are frozen in the permafrost. Removing them would require digging down to the base of the active-layer (approximately 70 cm) and cutting up the uppermost section of the pipes (three in total). The lower portions of the PVC tubing and steel pipes would remain on site. Very minor to no ground disturbance will be generated by removing the equipment.

Remains from four thermistor cables are present at the site and are assumed to be unrepairable. The presence of the equipment on site is not anticipated to pose concern to the stability of the sump or to the local wildlife. If not replaced, it is recommended to remove the remaining ground temperature equipment that is presently on site (i.e. the top portion of the thermistor cables and PVC tubing, steel pipe supporting the data logger and the metal protective casings).

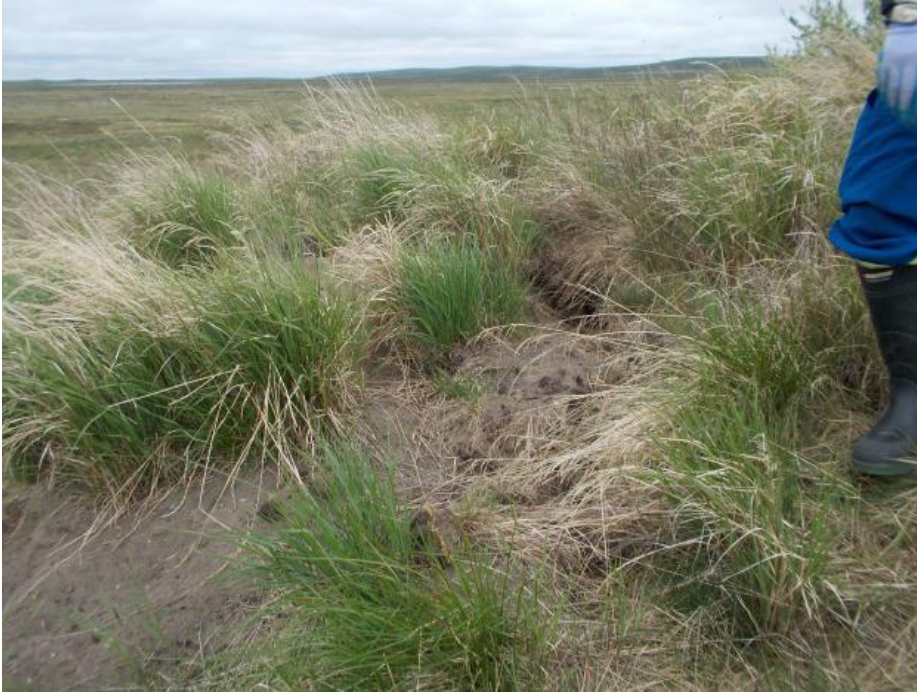
Photo 9 Umiak N-16 Sump – south side of the sump. Typical silt with gravel material on the sump. July 2015.

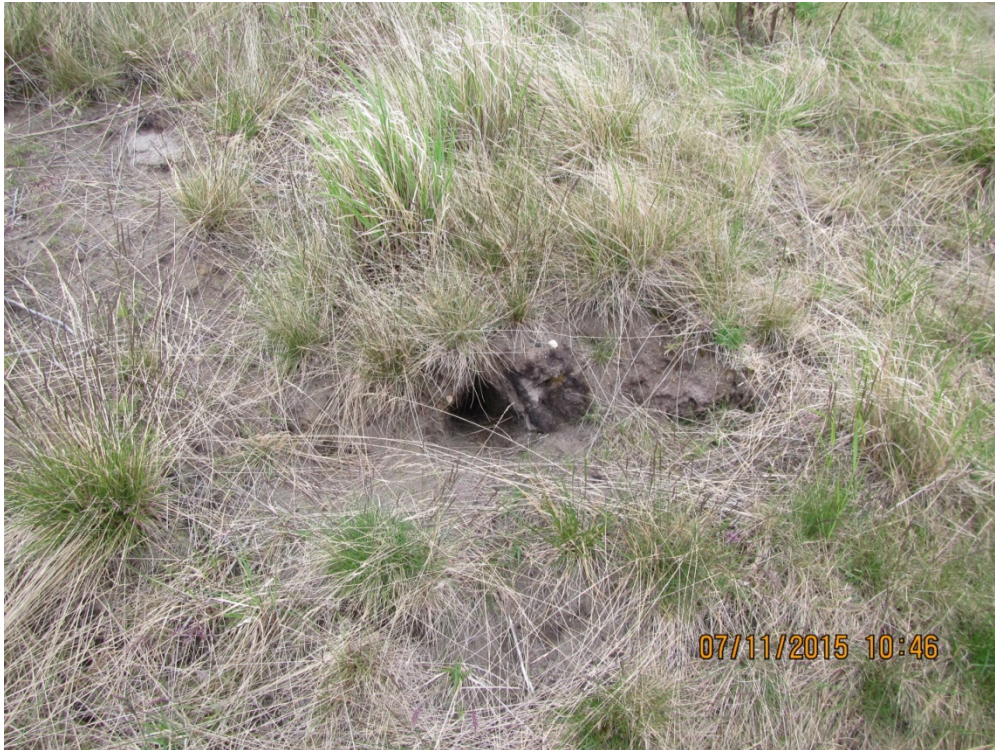
Birds were observed on and adjacent to the N-16 sump. Species observed included ptarmigan (*Lagopus sp.*) and gulls (*Laridae sp.*). No signs of nesting were observed on the sump and surrounding area. A fox (*Vulpes sp.*) den was observed on the top of the sump at the northeast end; it did not appear to be an actively used den (Appendix B, Photo 11).

Photo 11 **Umiak N-16 Sump – Fox den located on top of sump at northeast end. July 2015.**
