## **SITE REMEDIATION**

**Anglican Cemetery  
Aklavik, Northwest Territories**

**Final Report  
(Y/Ref.: 107306) (O/Ref.: NT4025)**

**NORTHWEST TERRITORIES POWER  
CORPORATION**

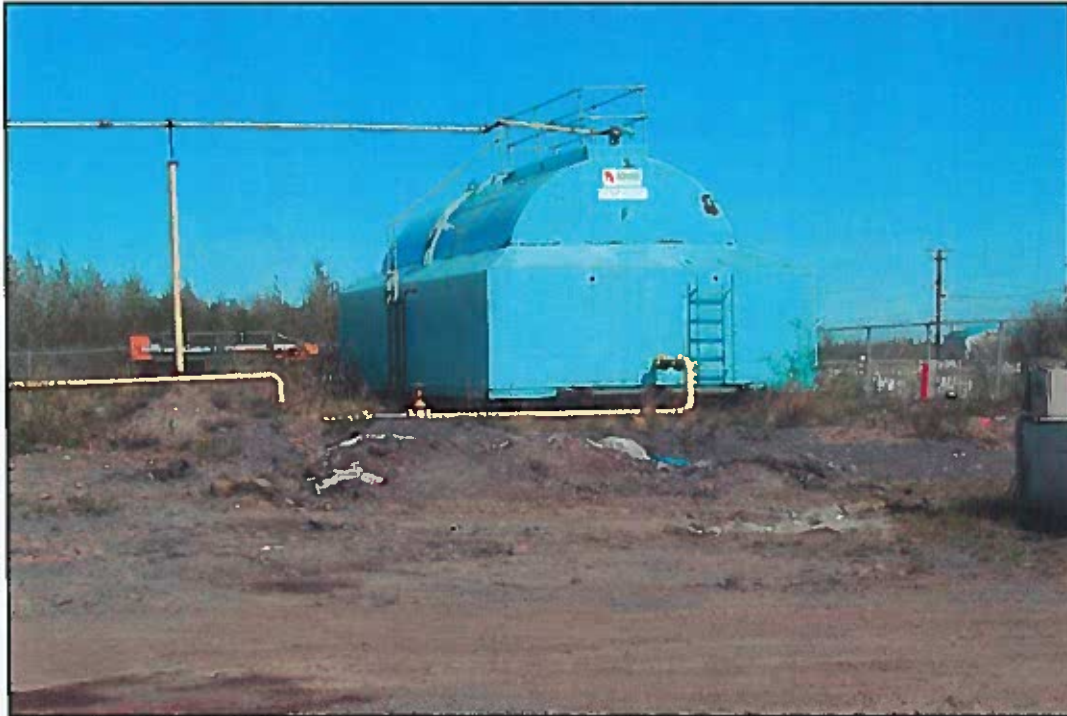
**Photo 1 : View of the soil remains from the July 2003 site visit.**

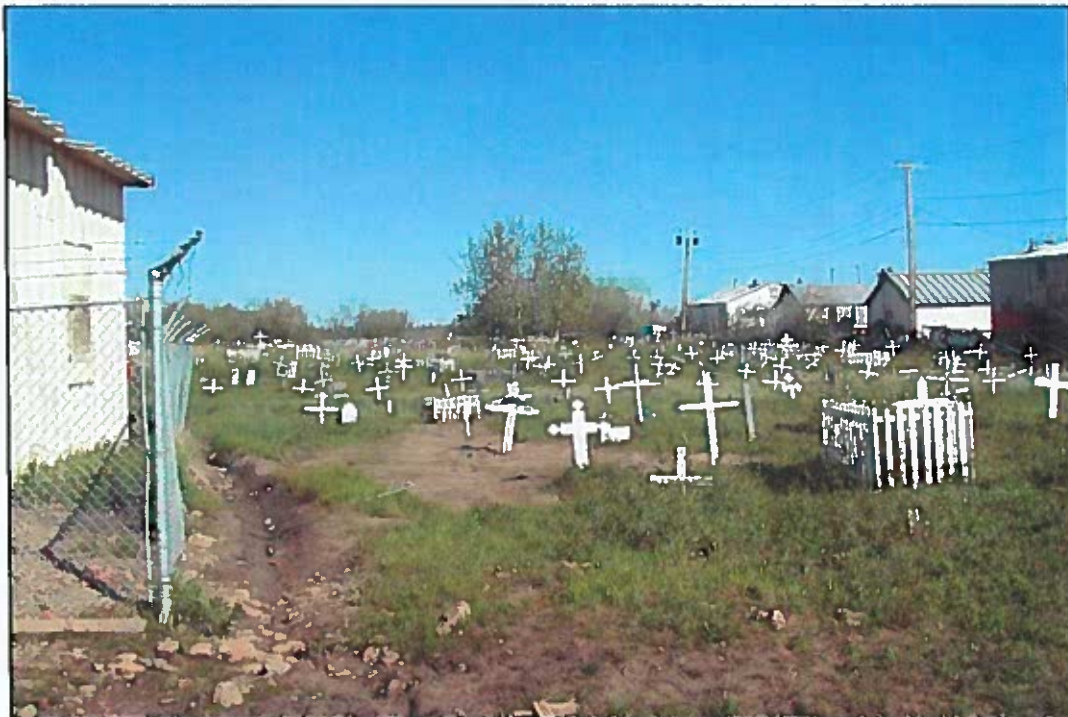
**Photo 2 : View of the site before the start of the excavation work.**

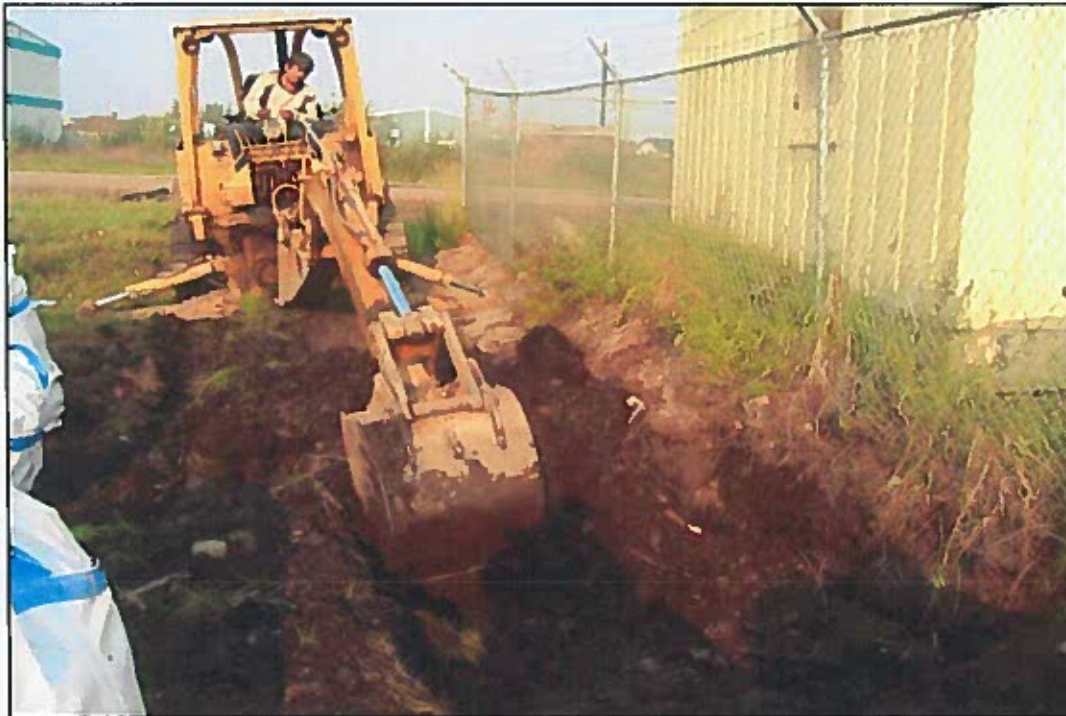
**Photo 3 : Remediation work in progress in the Anglican cemetery.**

Remediation activities took place using a backhoe provided by a local contractor. Hydrocarbon-impacted soil was excavated to a maximum depth of 1.3 m below grade in the cemetery just south of NTPC's office. Excavated soil was immediately placed into 0.6 m<sup>3</sup> bags which were then transferred and stored on NTPC's property. A plastic membrane was installed on the northern wall of the excavation (EX2) in order to prevent the migration of contaminants from the power plant site to the cemetery and to differentiate between the remediated area and the undisturbed one. The open excavation was backfilled using clean soil and the area was seeded to insure the growth of the indigenous vegetation. The soil stockpile present from the 1999 spill was also sampled to measure its PHC concentration.

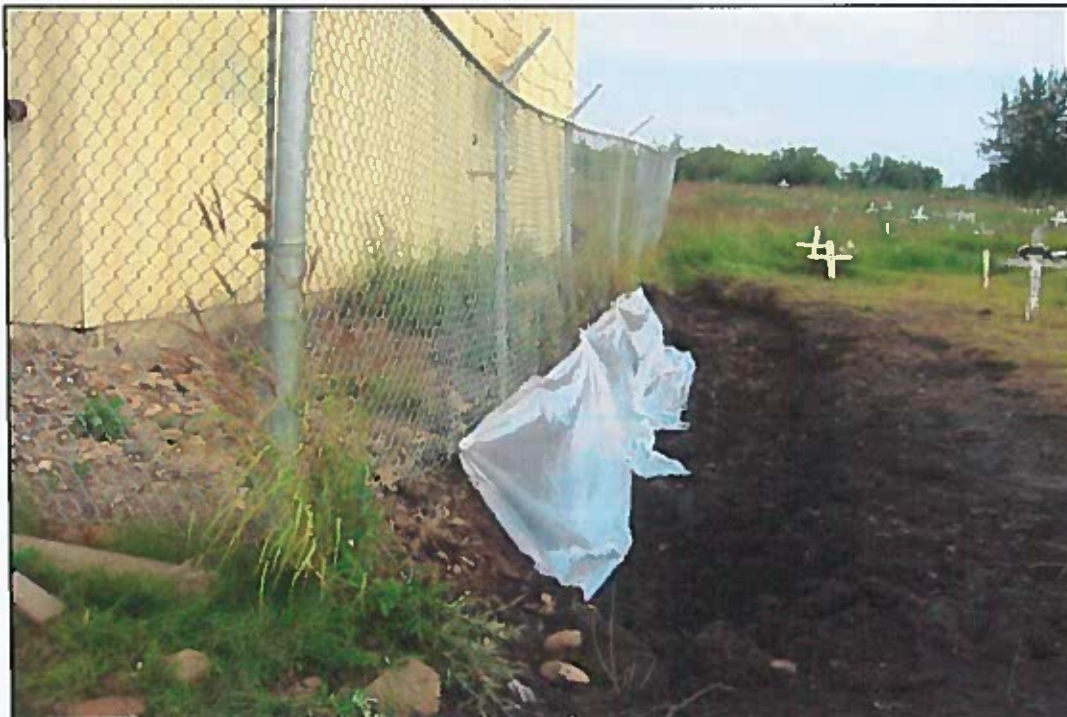
**Photo 4 : Installation of the membrane on NTPC's property limit.**

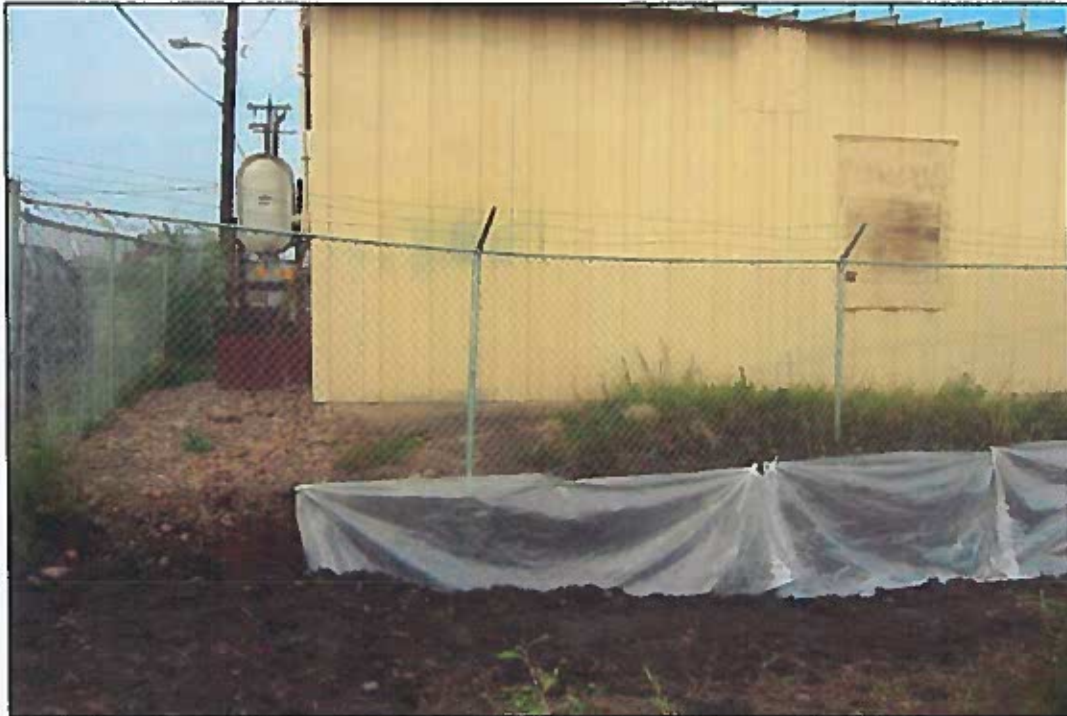
**Photo 5 : View of the membrane (west side) on the northern wall of EX2.**

Some PHC contamination was left beneath the fence, just south of the office building (north wall of excavation No. 2). It is recommended that the remainder of this soil be excavated and remediated when the power plant site is decommissioned.

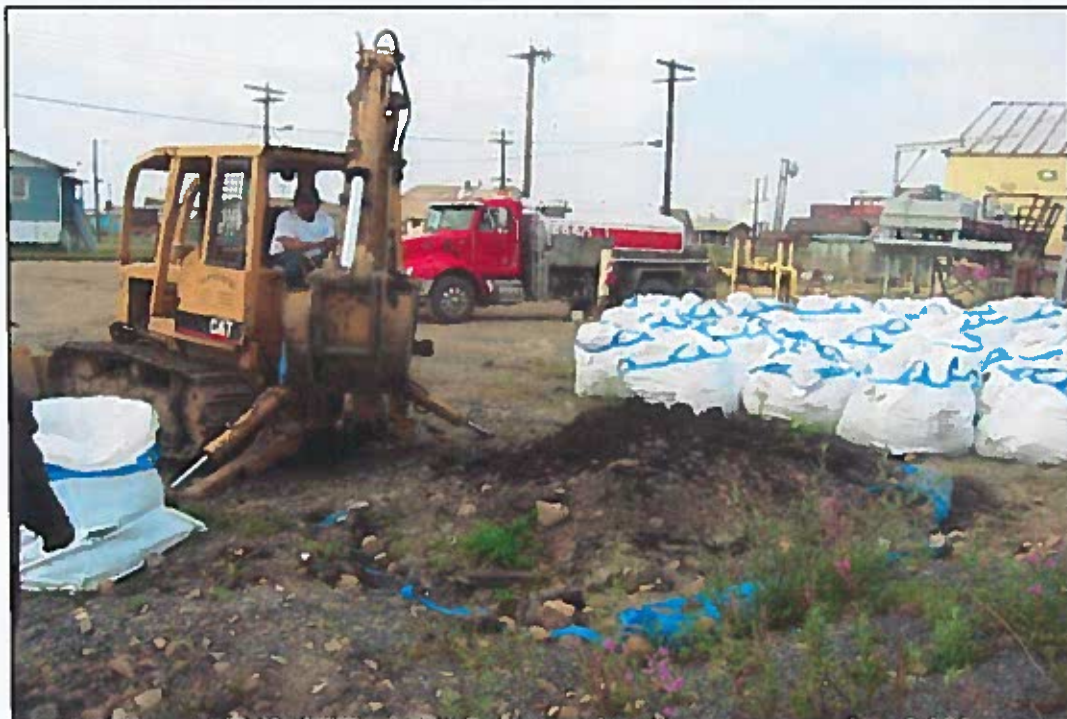
**Photo 6 : Placing of the July 2003 hydrocarbon-impacted soil into bags.**

Following the remediation work, a total of 24 bags, or approximately 14.4 m<sup>3</sup> of soil, were filled with the soil excavated from the Anglican cemetery. An additional 14 bags, or approximately 8.4 m<sup>3</sup> of soil, were filled with the remainder of hydrocarbon-impacted soil excavated from the cemetery in July 2003 and stored on NTPC's property.

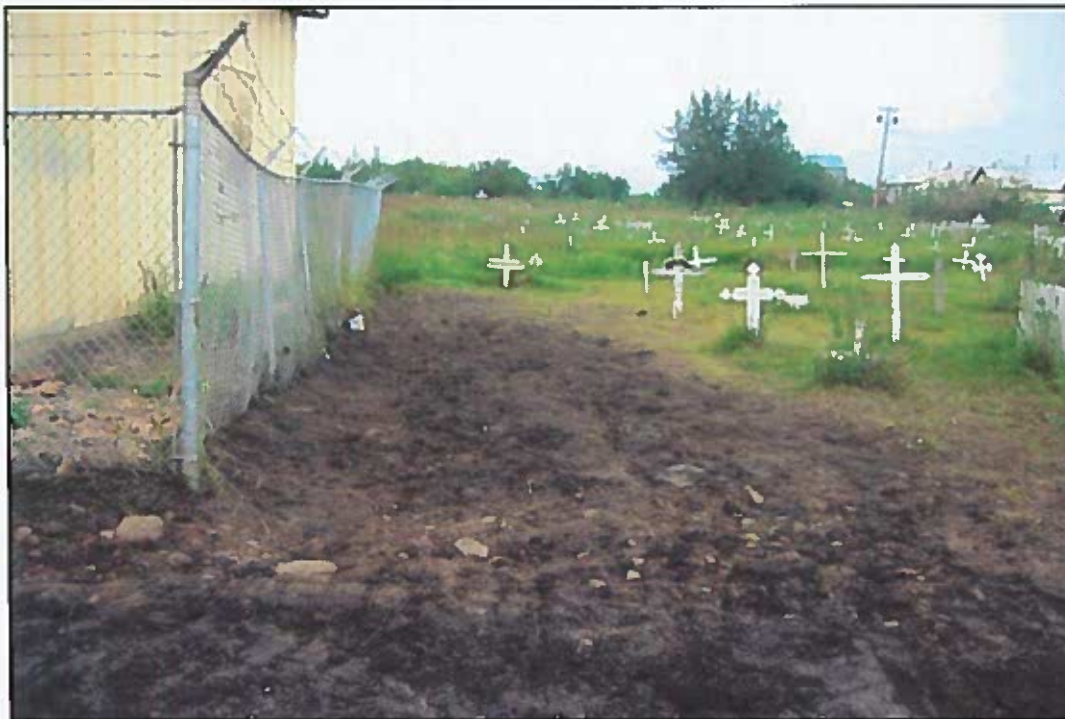
**Photo 7 : Final view of the site at the completion of the remediation work.**

Site remediation activities carried out at the Aklavik Anglican cemetery successfully removed all hydrocarbon-contaminated soil present in the graveyard. An estimated volume of 14.4 m<sup>3</sup> of hydrocarbon-impacted soil was removed from the cemetery during the site remediation activities. The soil was placed in 0.6 m<sup>3</sup> bags and stored on NTPC's property for later disposal. An additional 14 bags, or approximately 8.4 m<sup>3</sup> of soil, were filled with the remainder of hydrocarbon-impacted soil excavated from the July 2003 visit.

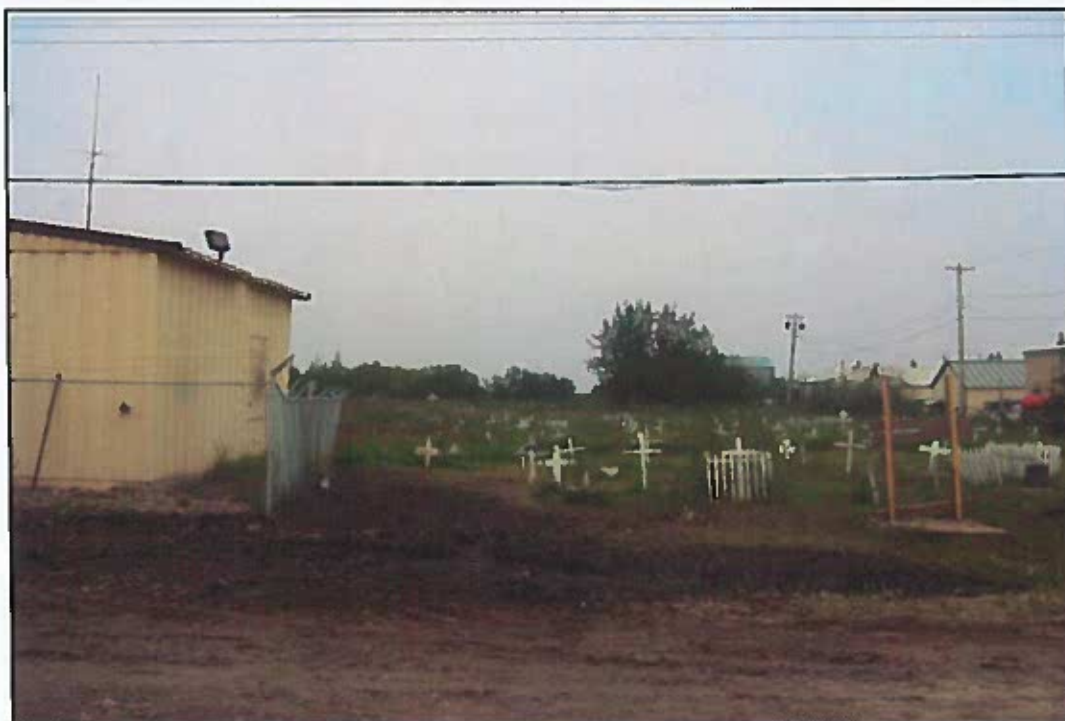
**Photo 8 : Final view of the site at the completion of the work (cont'd).**

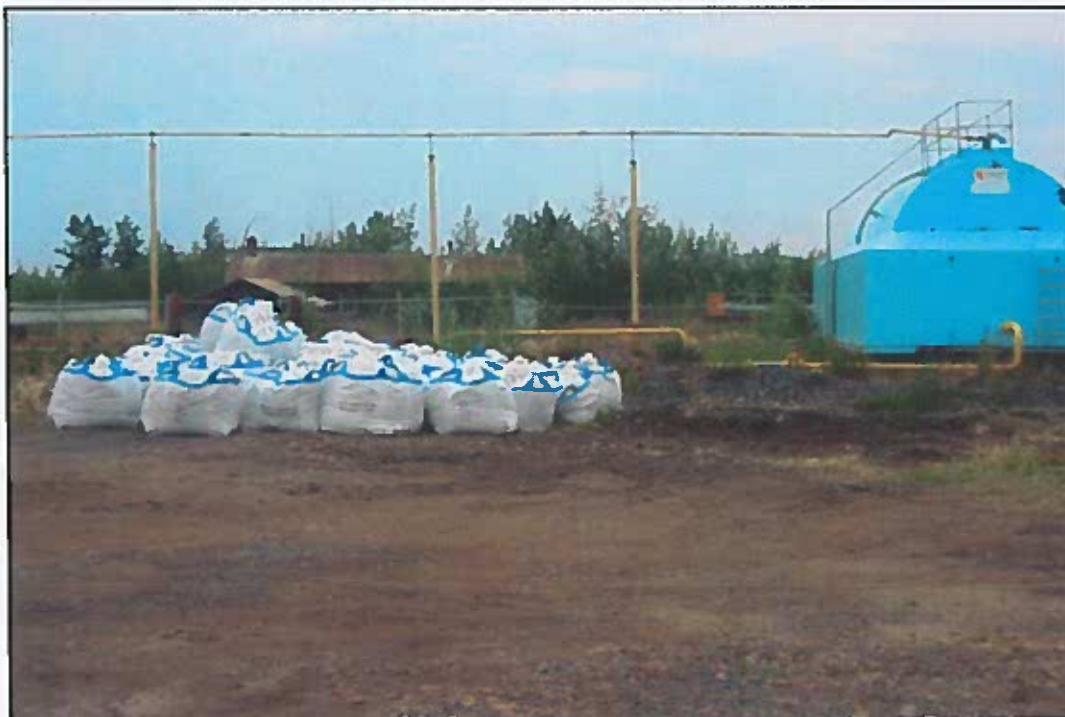
**Photo 9 : View of 38 bags of soil and the location of the former July 2003 soil stockpile.**
