**MGM Energy – 2016 Environmental Site
Monitoring Report**

Site: Umiak N-16 Wellsite and Sump

December 2016

Water License N7L1-1797 and Land Use Permit N2003A0035

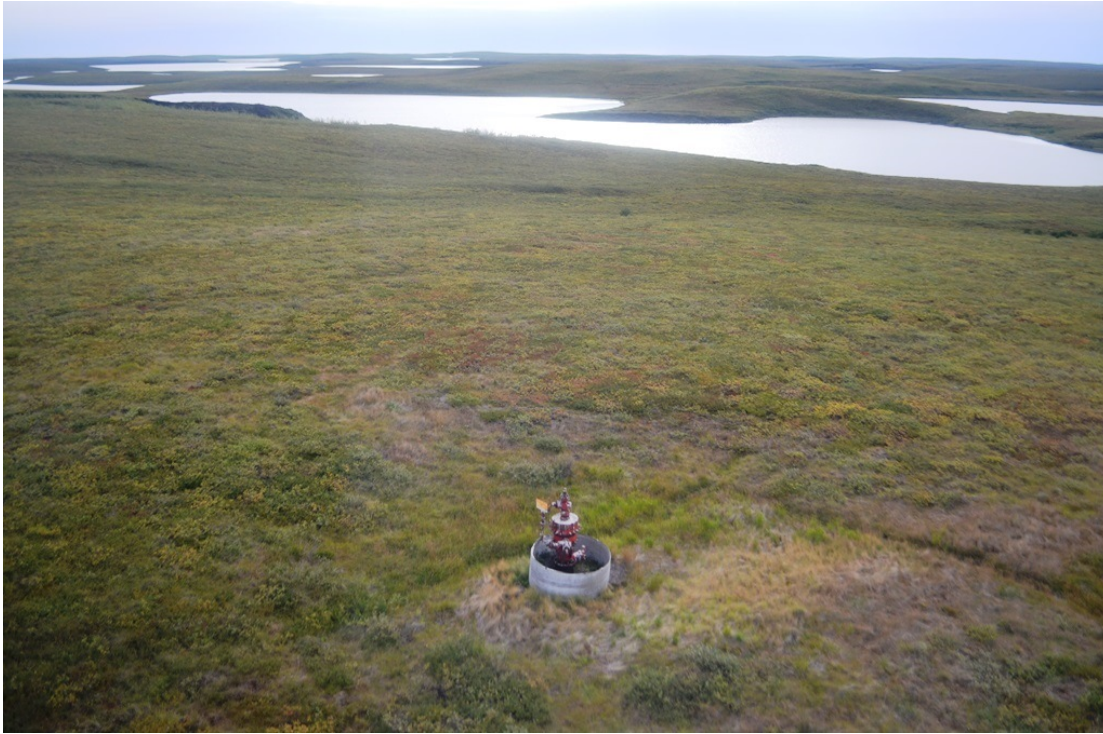
Photo B-1 N-16 Wellsite: Aerial overview of wellhead and surrounding Wellsite Area (looking east). August 22, 2016.

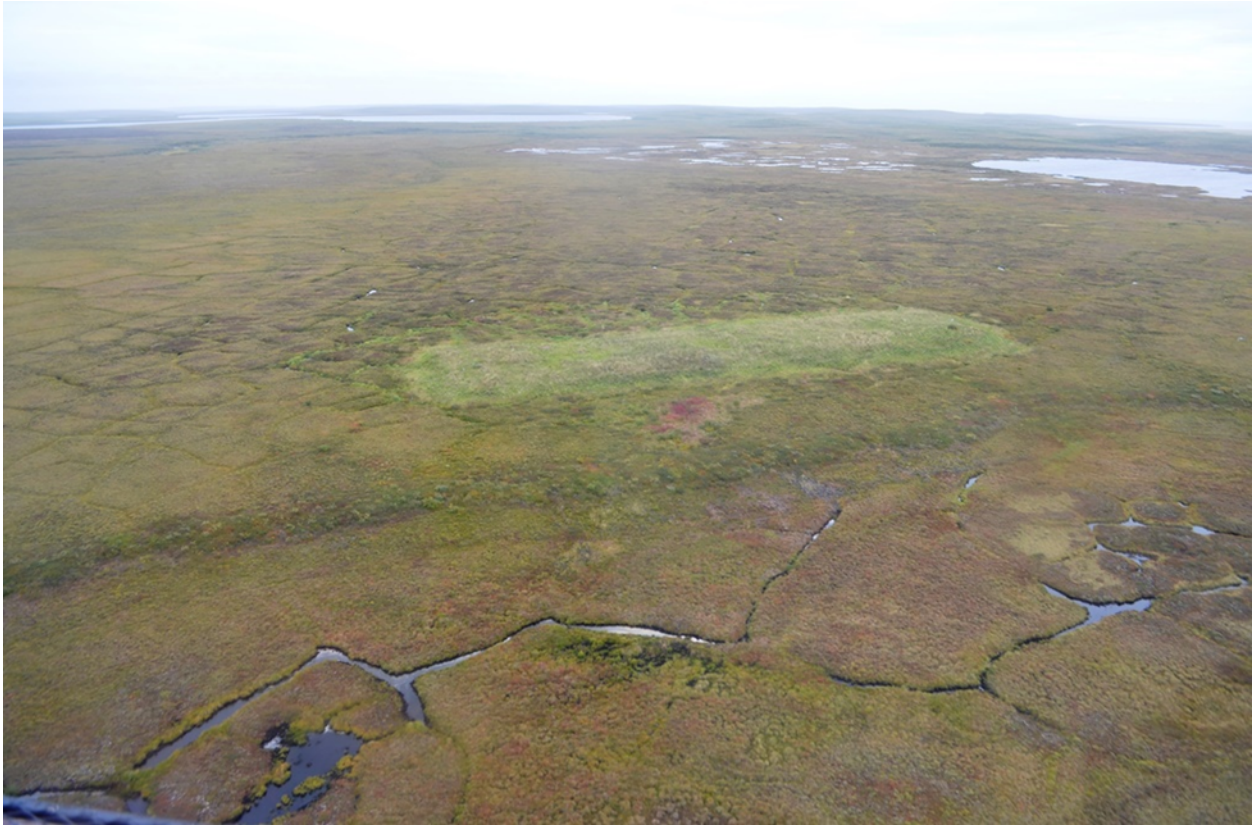
The surface of the sump (referred to as the sump top) was observed to be flat to gently undulating (less than 2% slope gradient), while the slopes marking the perimeter of the sump ranged from 20% to 60%. The sump cap itself appeared to be stable with no visual signs of erosion and/or evidence of subsidence or settling. No tension cracks were observed at the surface of the sump, although the vegetation might have hid some tension cracks.

The slopes marking the perimeter of the sump appeared to be stable, with no physical evidence of recent surface erosion, stress or new tension cracks. Depressions matching the location of ice-wedges overlapped by the sump cap were visible along the lower slope; however, there were no indications that size of the depressions has increased from those observed during the 2015 site visit.

Photo B-2 **N-16 Sump: Aerial overview of the sump (looking northeast). August 22, 2016**

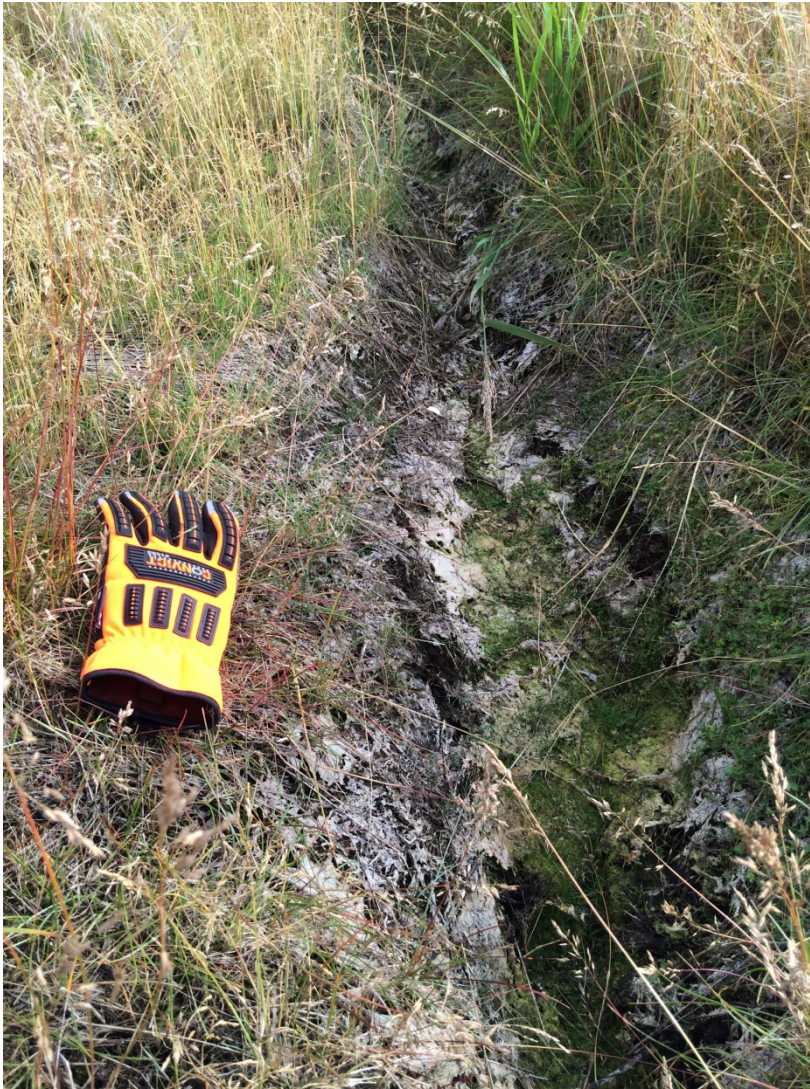
- Two ice-wedges were observed within 5 m of the wellhead. The troughs - approximately 0.30 m wide, 0.30 m deep and 10 to 20 m long - had no standing water present and showed no signs of erosion.

Photo B-3 N-16 Wellsite: View of shallow linear depression (trough) located above a suspected ice wedge near wellhead (looking east). August 22, 2016.

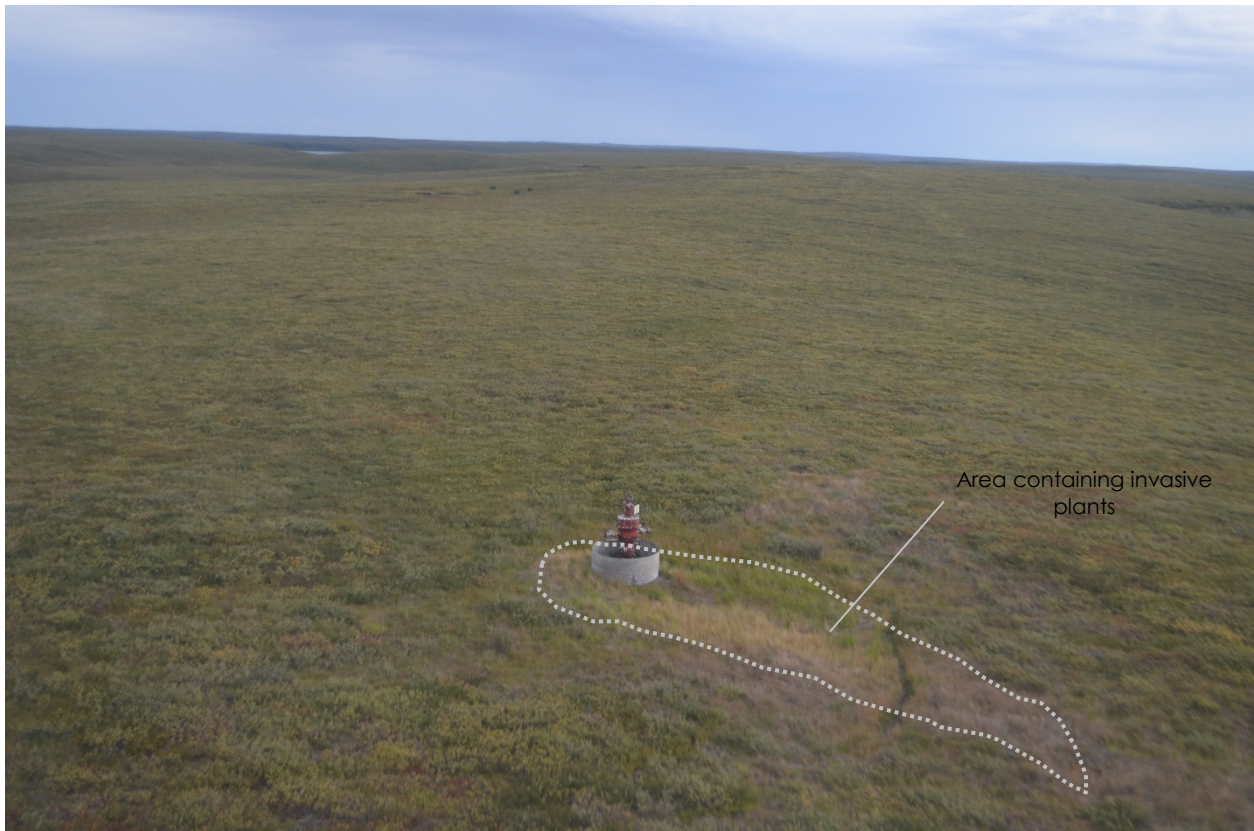
- An invasive species, scentless chamomile (*Tripleurospermum inodorum*) was observed to be growing immediately south of the wellhead. At the time of the site visit, the infestation area was approximately 200 m² area with a 10% cover of scentless chamomile plants, which is considered a moderate infestation.

Photo B-6 N-16 Wellsite. Aerial overview of the Wellsite Area vegetation cover. Note dashed line delineates native grass seeded area south of the wellhead containing invasive plants. Photo looking east. August 22, 2016.

Parameter	Recommendations
Sump Area Reclamation	<ul style="list-style-type: none"> • Conduct vegetation monitoring of the impacted vegetation areas south of the sump to delineate the currently identified areas, monitor for changes, and locate new areas. Monitoring should include vegetation species composition and cover, plant establishment and growth and overall vegetation health. Also conduct vegetation monitoring at non-impacted reference sites in surrounding areas for comparison of vegetation cover and species composition. • Findings of the vegetation monitoring could be used to determine if impacted vegetation areas can be left on their own to naturally develop a self-sustaining vegetation cover, or if phytoremediation/reclamation treatments would be required in 2018.
Invasive plants	<ul style="list-style-type: none"> • Monitor invasive plant infestation (scentless chamomile) in native grass seeded area immediately south of the wellhead. • Carry out control treatments including pulling plants, storing in garbage bags, and disposing offsite in the Inuvik landfill. Monitoring and control treatment should be carried out in the summer of 2017 prior to seed ripening. • Study potential alternative treatments, such as herbicide application or biocontrol (i.e., control of invasive plants using insects, parasites, and pathogens), that would provide more effective and longer term control.

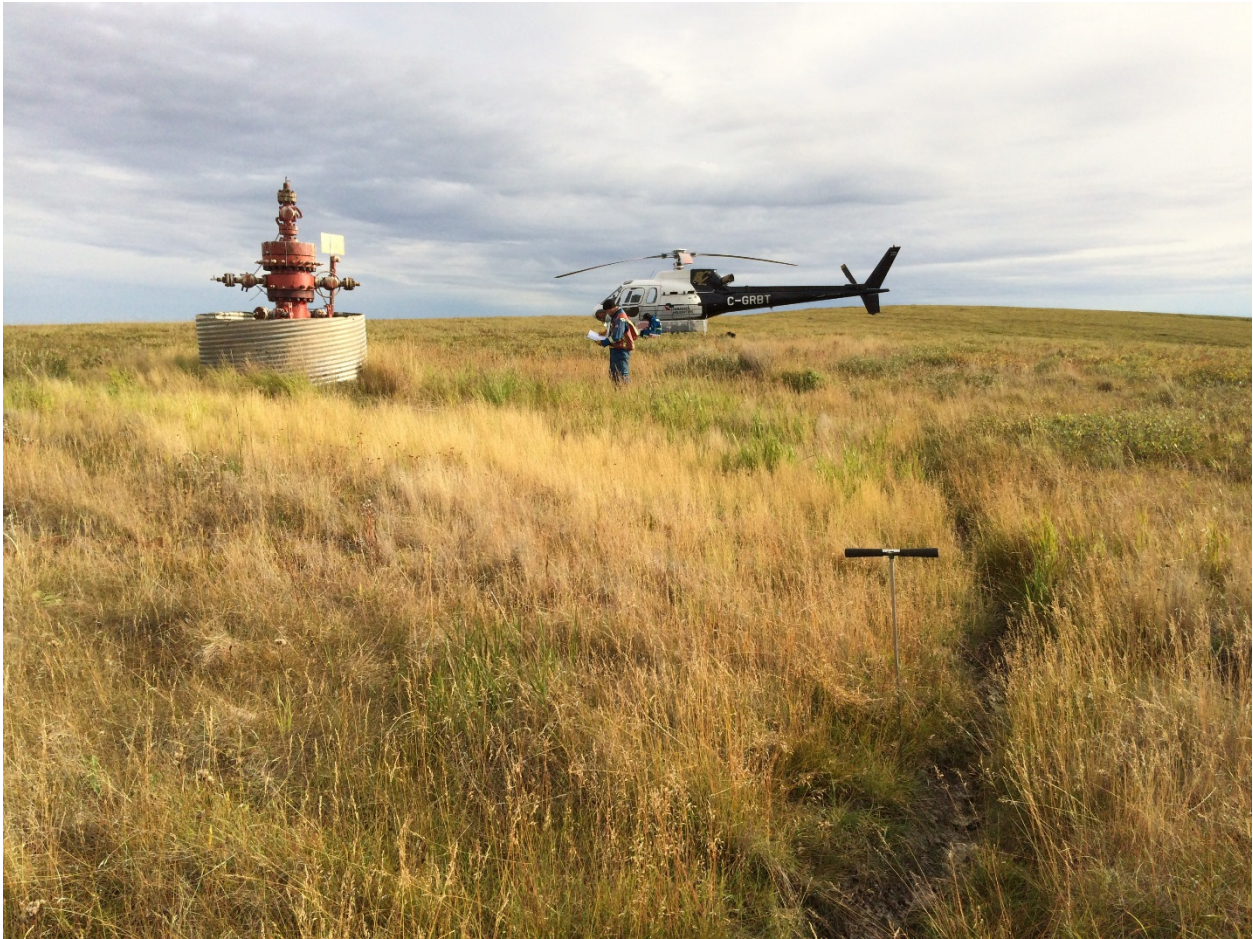
At the time of the 2016 site visit, the area to the south of the wellhead was well vegetated with the seeded native grasses, predominantly tufted hairgrass (*Deschampsia caespitosa*) with minor amounts of polargrass (*Arctagrostis latifolia*) and violet wheatgrass (*Agropyron violaceum/Elymus alaskanus*); trace amounts of the native forbs arnica (*Arnica sp.*) and coltsfoot (*Petasites sp.*) were present (Photo B-6 and B-7, Appendix B). Vegetation cover conditions in the area to the south of the wellhead were observed to be similar to conditions observed in 2015 in both species composition and percent cover.

Photo B-7 N-16 Wellsite. View of native grass seeded area south of wellhead containing invasive plants. Photo looking northeast. August 22, 2016.

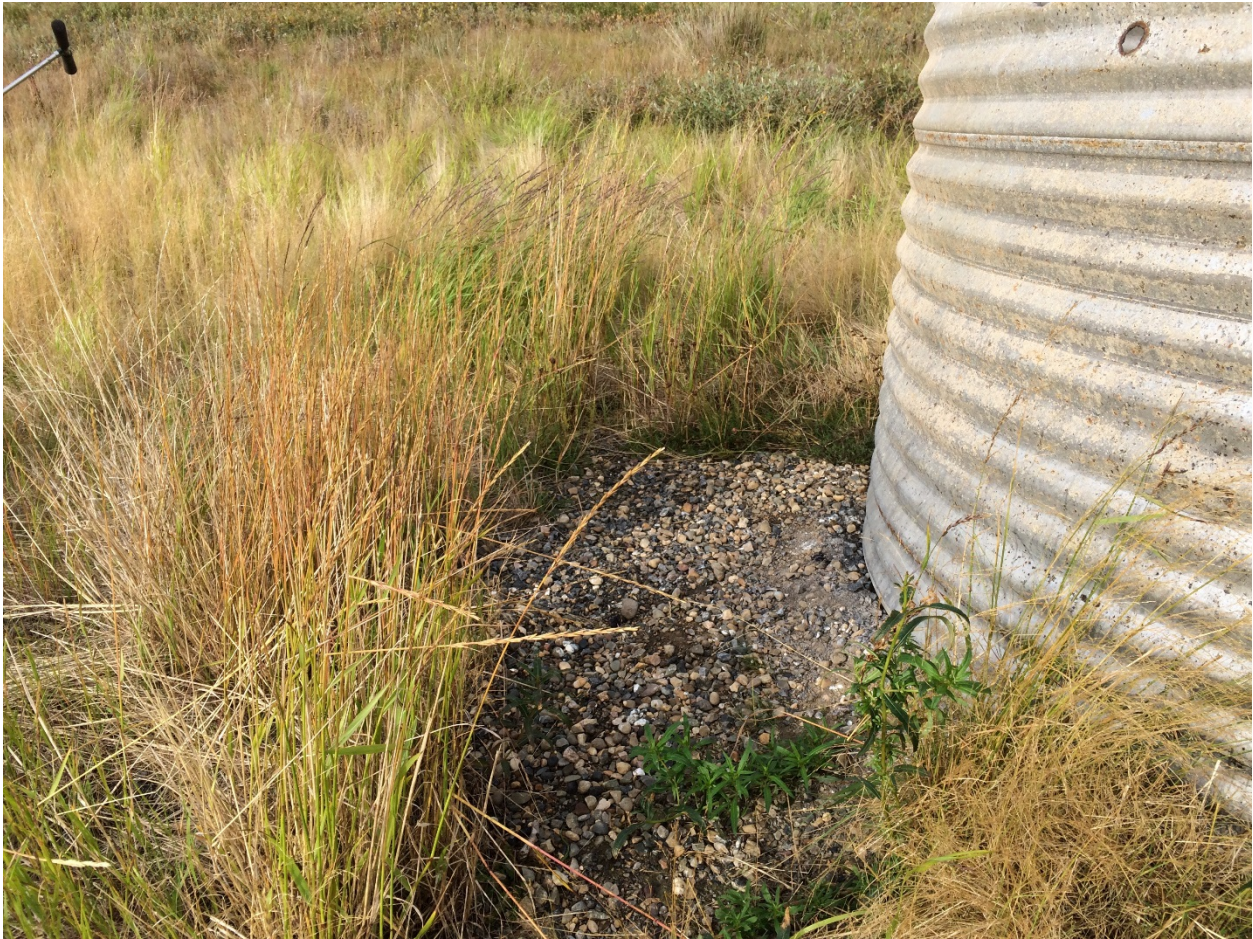
A small area containing sandy gravelly material with lower density plant cover was observed immediately surrounding the wellhead culvert. This lightly vegetated area consisted of previously seeded native grasses (Priddis 2014) and naturally established forbs and was approximately 3 m² in area (Photo B-8, Appendix B). At the time of the 2016 site visit, the native grass and forb cover was approximately 57% and consisted of tufted hairgrass (*Deschampsia caespitosa*) and violet wheatgrass (*Agropyron violaceum/Elymus alaskanus*) and low amounts of the native forb fireweed (*Epilobium angustifolium*); plant heights were up to approximately 0.40 m.

Photo B-8 N-16 Wellsite. View of lightly vegetated area around wellhead culvert.
Photo looking west. August 22, 2016.

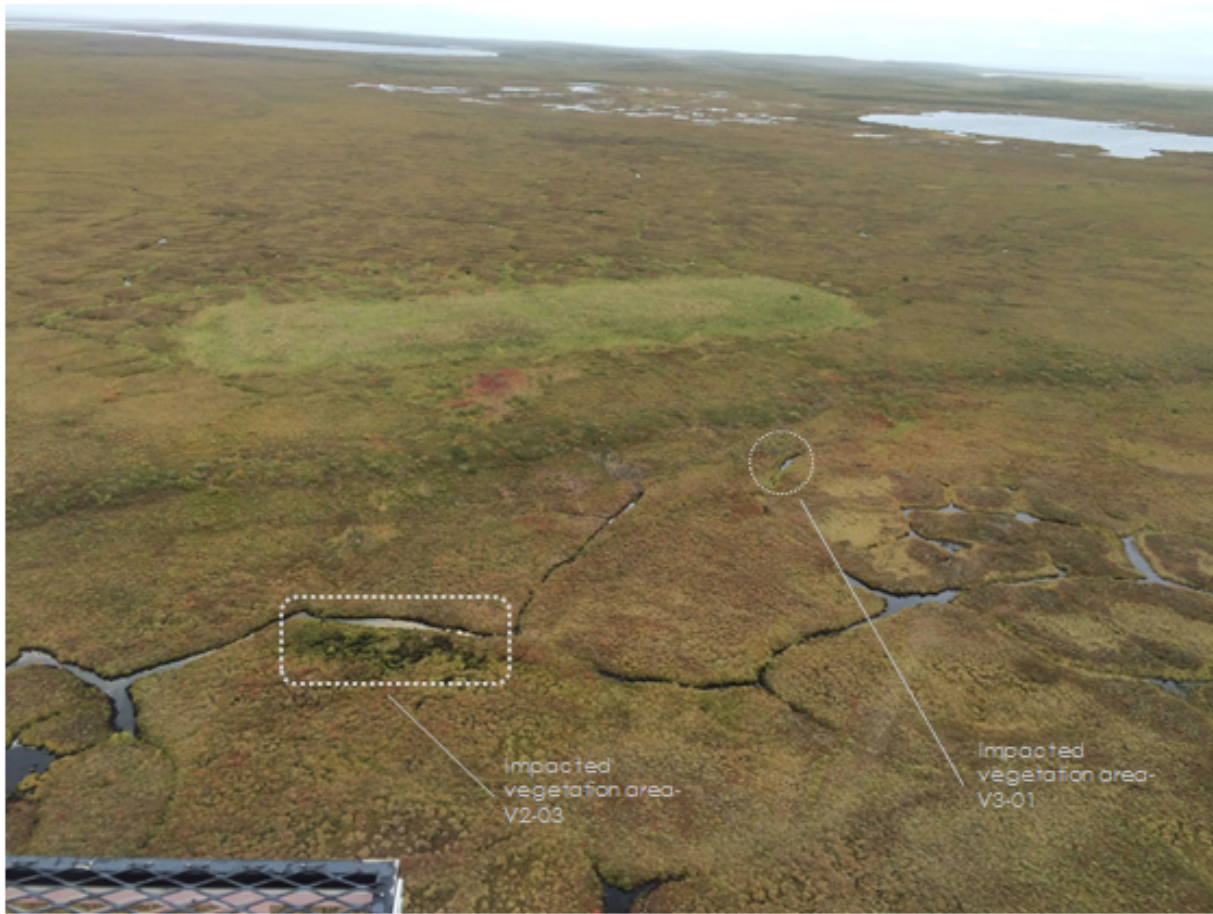
Photo B-9 N-16 Sump. Aerial overview of the sump vegetation cover and surrounding area vegetation cover. Note impacted vegetation areas to the south of the sump, delineated with dashed lines. Photo looking northwest. August 22, 2016.

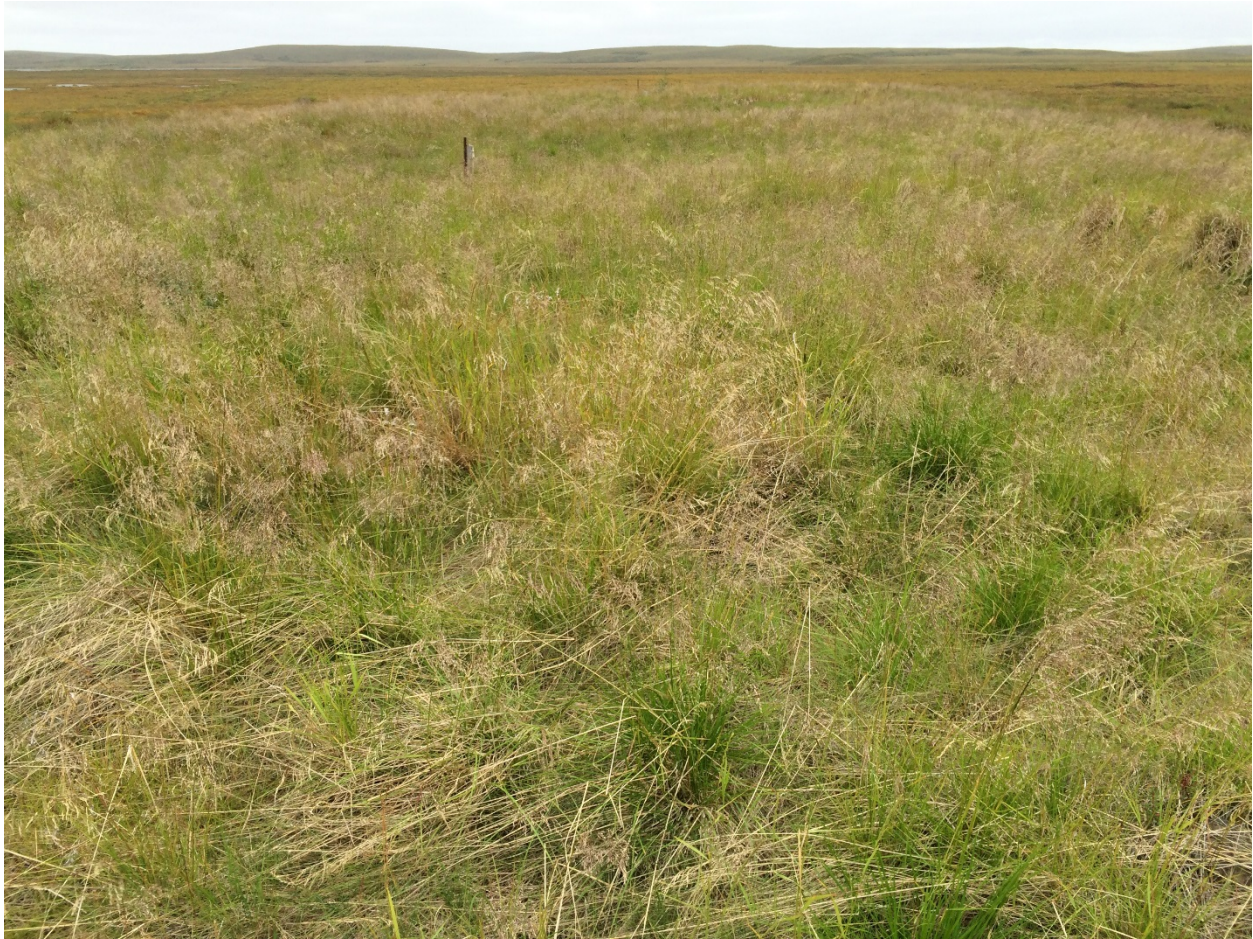
Vegetation observed on the Sump Area in the 2016 site visit consisted primarily of native grasses including tufted hairgrass (*Deschampsia caespitosa*), sheep fescue (*Festuca ovina*), creeping red fescue (*Festuca rubra*), rocky mountain fescue (*Festuca saximontana*), alpine bluegrass (*Poa alpina*) and bluegrass (*Poa sp.*). Naturally established native shrub and forb species also observed included alpine bearberry (*Arctostaphylos alpina*), broad leaved willowherb (*Epilobium latifolium*), small bog cranberry (*Oxycoccus microcarpus*), cloudberry (*Rubus chamaemorus*), net veined willow (*Salix reticulata*), and willows (*Salix sp.*). Vegetation cover conditions on the sump during the 2016 site visit were observed to be similar to conditions observed in 2015 in both species composition and percent cover (Photos B-2, B-9, and B-10, Appendix B). Vegetation conditions observed during 2016 in the undisturbed area

Photo B-10 N-16 Sump. Native grass growth on the sump top. Photo looking southeast. August 22, 2016.

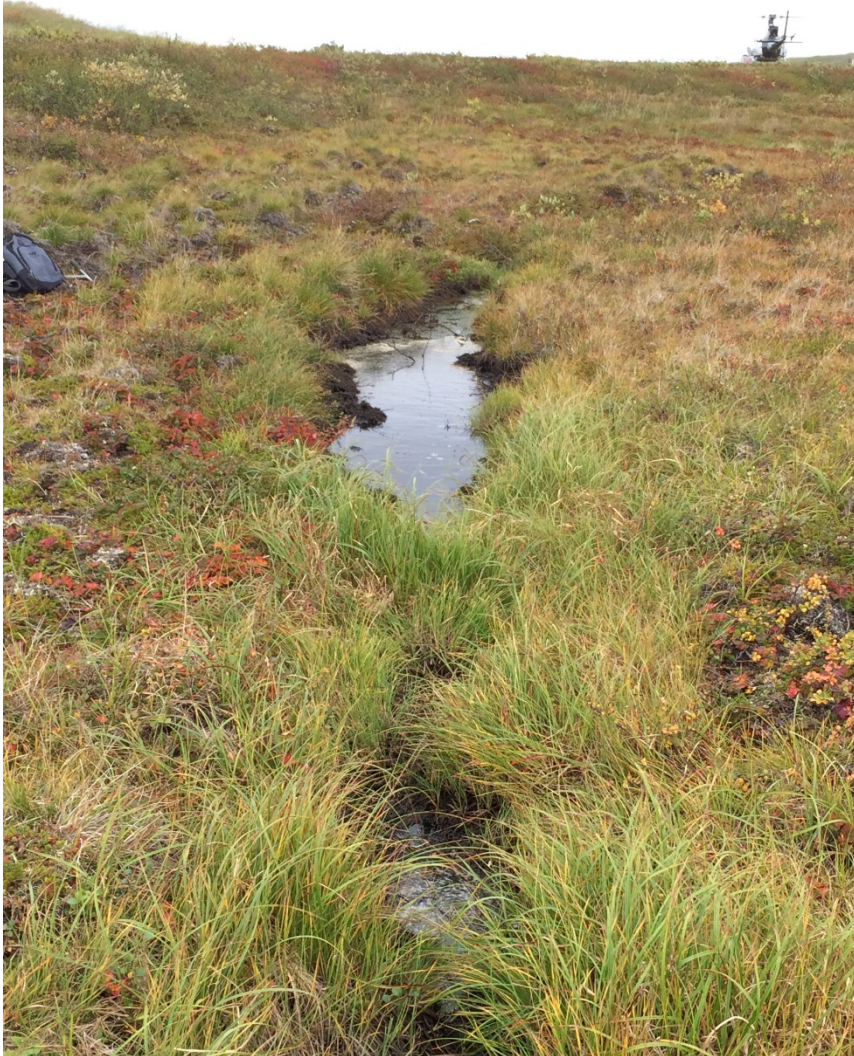
Vegetation displaying either dead, withered or yellowing foliage with lower density plant cover were observed approximately 50 m south of the sump (Impacted vegetation location V3-01) and 70 m southwest of the sump (Impacted vegetation location V2-03) (Photo B-9, Appendix B) (Figure A-4, Appendix A). These impacted vegetation areas consisted predominantly of naturally established native plant species adapted to lower soil pH conditions; the V3-01 impacted vegetation area was approximately 10 m² in area and the V2-03 impacted vegetation area was approximately 60 m² in area (Photos B-11 to B-14, Appendix B). At the time of the 2016 site visit, the native vegetation cover was approximately 70% for the V3-01 impacted vegetation area and 40% for the V2-03 impacted vegetation area. Vegetation litter, consisting primarily of dead cottongrass, was approximately 25% and 5% cover for the V3-01 and V2-03 impacted vegetation areas, respectively. Vegetation species observed in both areas consisted of alpine bearberry (*Arctostaphylos alpina*), dwarf birch (*Betula glandulosa*), sedges (*Carex sp.*), crowberry (*Empetrum nigrum*), cottongrass (*Eriophorum sp.*), cloudberry (*Rubus chamaemorus*), willow (*Salix sp.*), bog cranberry (*Vaccinium vitis idaea*), lichens and mosses; plant heights ranged from approximately 0.10 to 0.40 m.

Photo B-11 N-16 Sump. View of impacted vegetation area located approximately 50 m south of the sump (Impacted vegetation location: V3-01). Photo looking northeast. August 22, 2016.

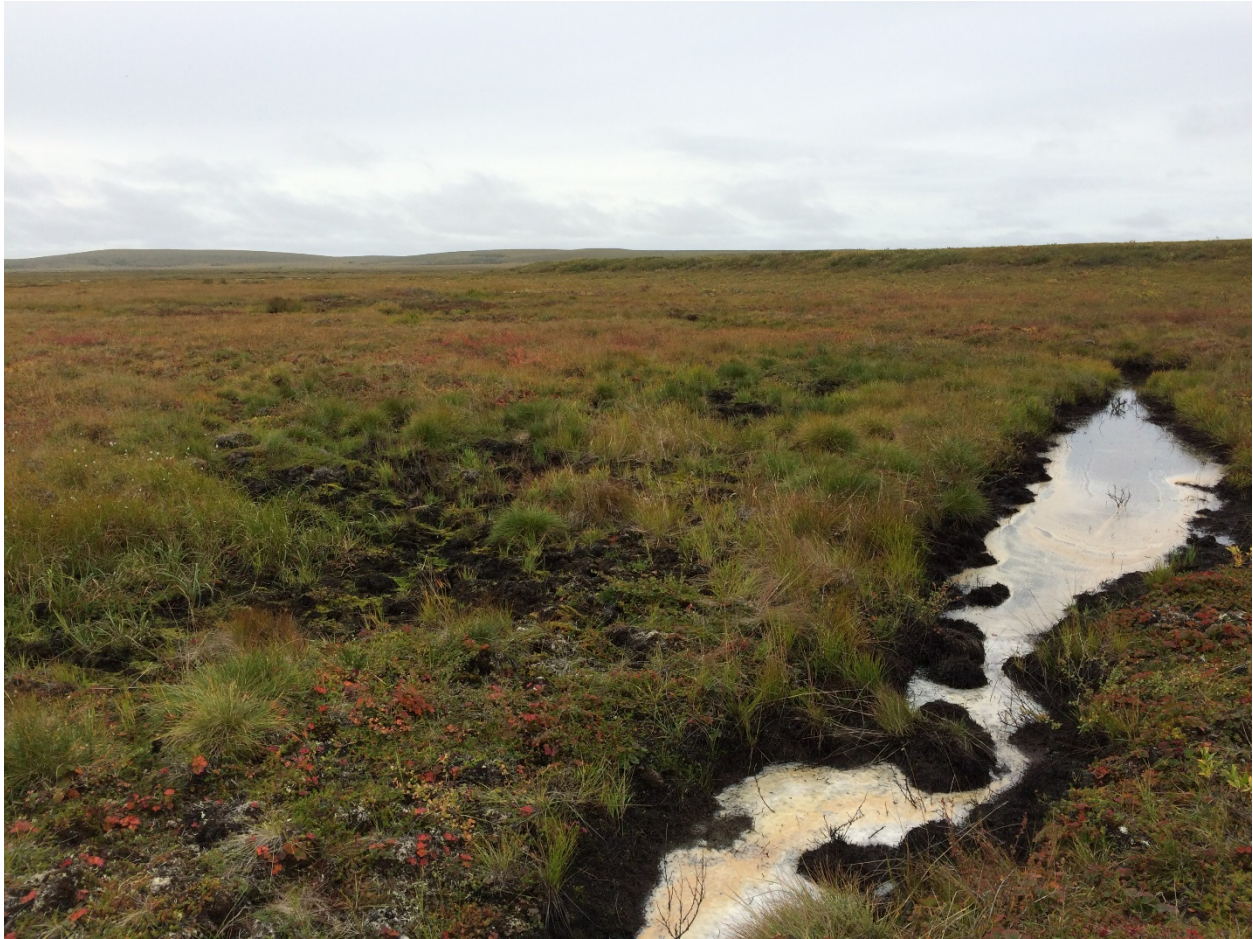
Impacted vegetation areas were observed south of the Sump Area (impacted vegetation location V3-01; impacted vegetation location V2-03) adjacent to waterbodies in topographical low areas (Figure A-4, Appendix A). The vegetation in those areas appears to be in similar condition to that observed in previous monitoring programs (KAVIK-STANTEC 2013, KAVIK-STANTEC 2016b). In addition, these areas were detected to have low pH values, and elevated concentrations of dissolved parameters (calcium, chloride, magnesium, sodium, sulphate, potassium) (Sections 4.3.2.2 and 4.4.2.3). Tussock cottongrass and sedges were the most impacted species that were observed, displaying either dead or withered and yellowing foliage. Species that are more tolerant of low pH conditions such as alpine bearberry, dwarf birch, crowberry, cloudberry, willow, bog cranberry, lichens and mosses appeared in good health and condition. The vegetation in impacted vegetation location V2-03 was the most affected out of the two areas (Photos B-11 to B-14, Appendix B).

Photo B-13 N-16 Sump. View of impacted vegetation area located approximately 70 m southwest of the sump (Impacted vegetation location: V2-03). Photo looking west. August 22, 2016.

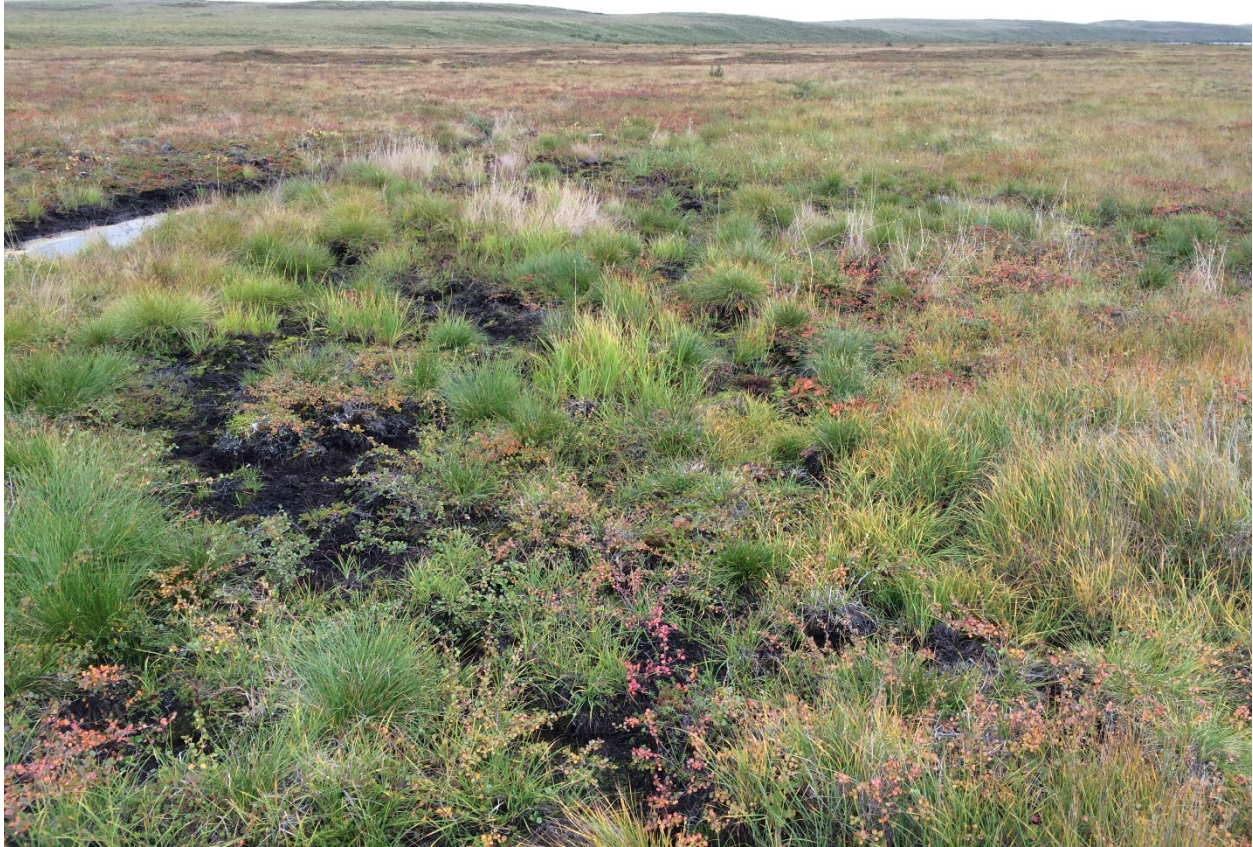
Photo B-14 N-16 Sump. View of impacted vegetation area located approximately 70 m southwest of sump (Impacted vegetation location: V2-03). Photo looking east. August 22, 2016.
