Hamlet of Aklavik
P.O. Box 88
Aklavik, NT X0E 0A0

File Number: N3L3 - 0570
Type of Operation: Type B - MUNICIPAL

WATER USE INSPECTION REPORT

LICENCE #:	N3L3 - 0570	EXPIRY DATE:	November 30, 2024
LICENCEE:	Incorporated Hamlet of Aklavik	PREVIOUS INSPECTION:	August 21, 2019
COMPANY REP:	Lloyd Petrie	INSPECTION DATE:	August 4, 2021

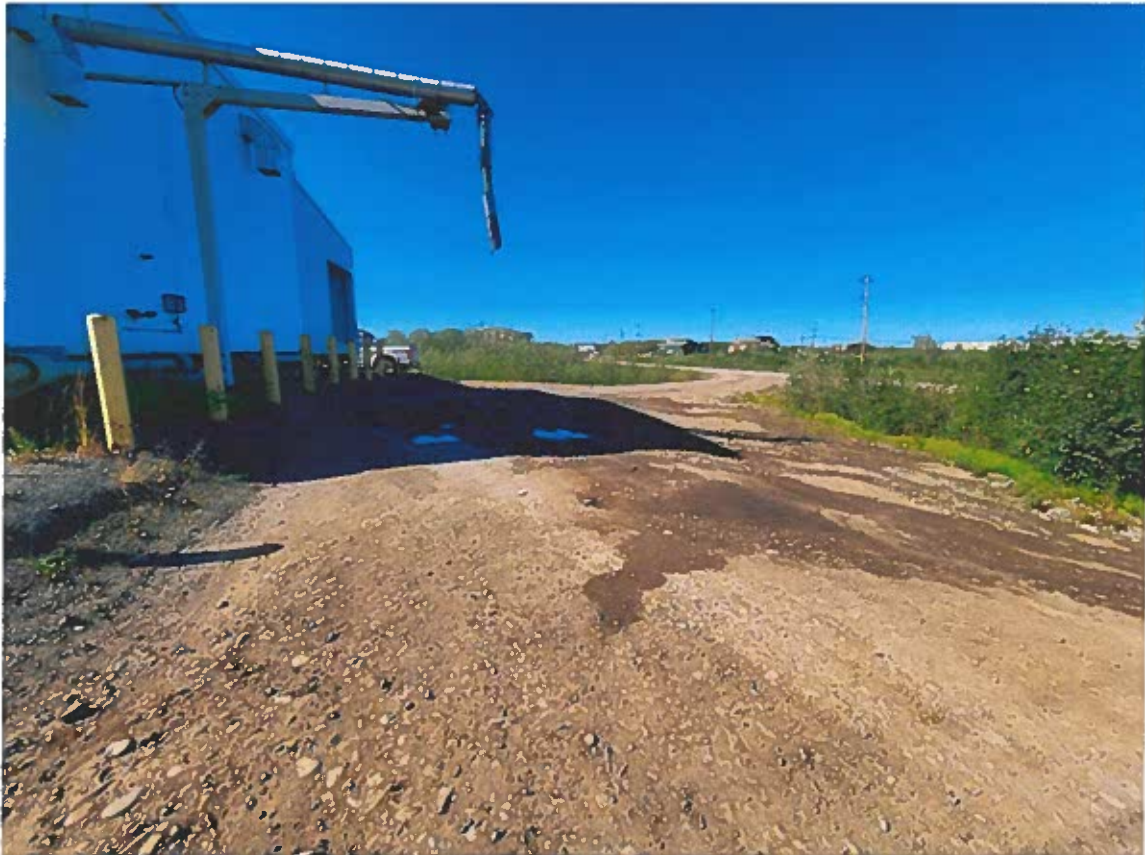
Figure 1 - Access Road to Water Treatment Plant

- The interior of the WTP is clean and well organized.
- The access road to the WTP will require maintenance as there are pot holes and water pooling underneath the potable water fill station (see Figure 1).

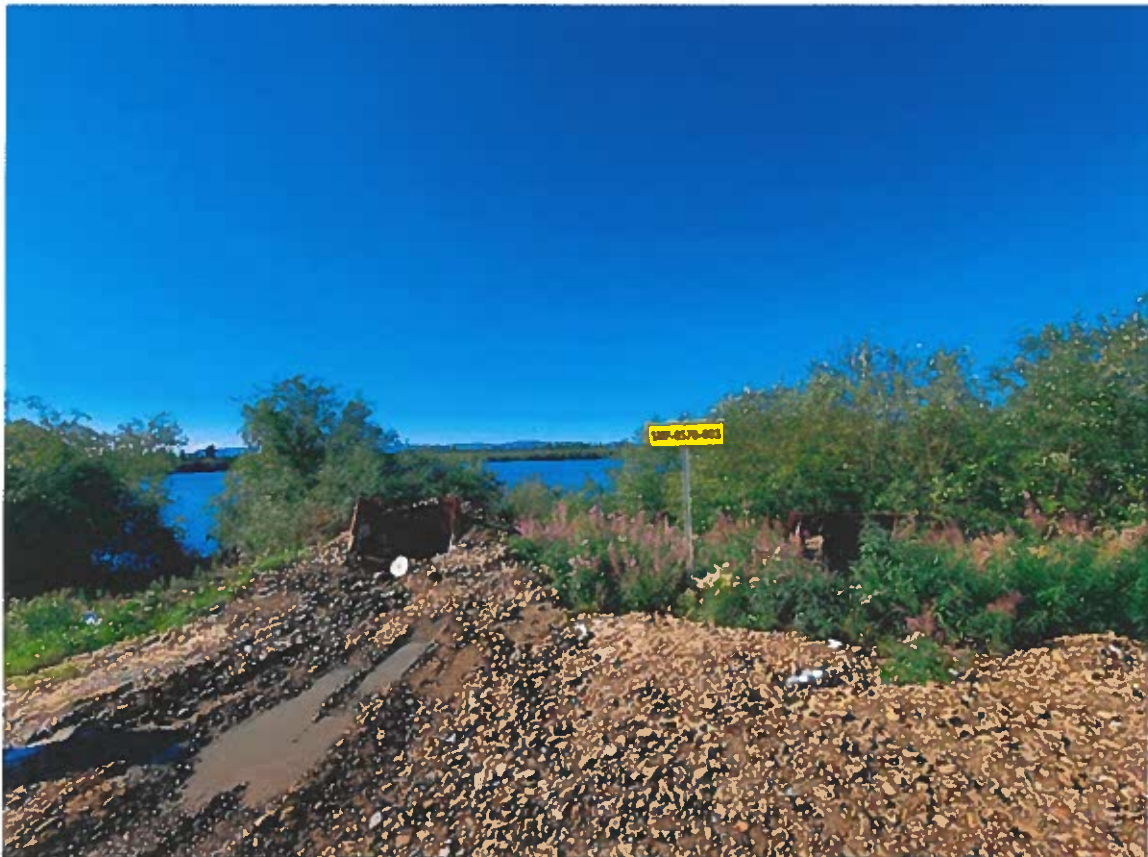
Figure 2 - Sewage Spill at the Sewage Waste Disposal Facility

- During the inspection, the Inspector observed the sewage truck spilling sewage onto the ground in front of the sewage disposal chute during disposal. The sewage was pooling in front of the Sewage Disposal Chute (See Figure 2). The spill (Spill 2021331) was reported to the NWT Spill Line, by the Inspector, on August 6, 2021.

- The sign for SNP 0570-3 is located near the Sewage Waste Disposal Facility Chute (see Figure 2). ENR recommends that the sign be moved to the point of outflow where SNP samples are collected.

- ENR worked with the Hamlet of Aklavik to ensure clean-up. The contaminated soil has since been removed and contained and is currently being stored until it can be shipped to a registered Receiver. ENR will continue to work with the Hamlet to ensure proper storage and disposal.

- ENR strongly recommends that the Hamlet conduct regular inspections at the sewage waste disposal facility and report all spills as per *Section 4 of Part G of Water Licence N3L3-0570*.

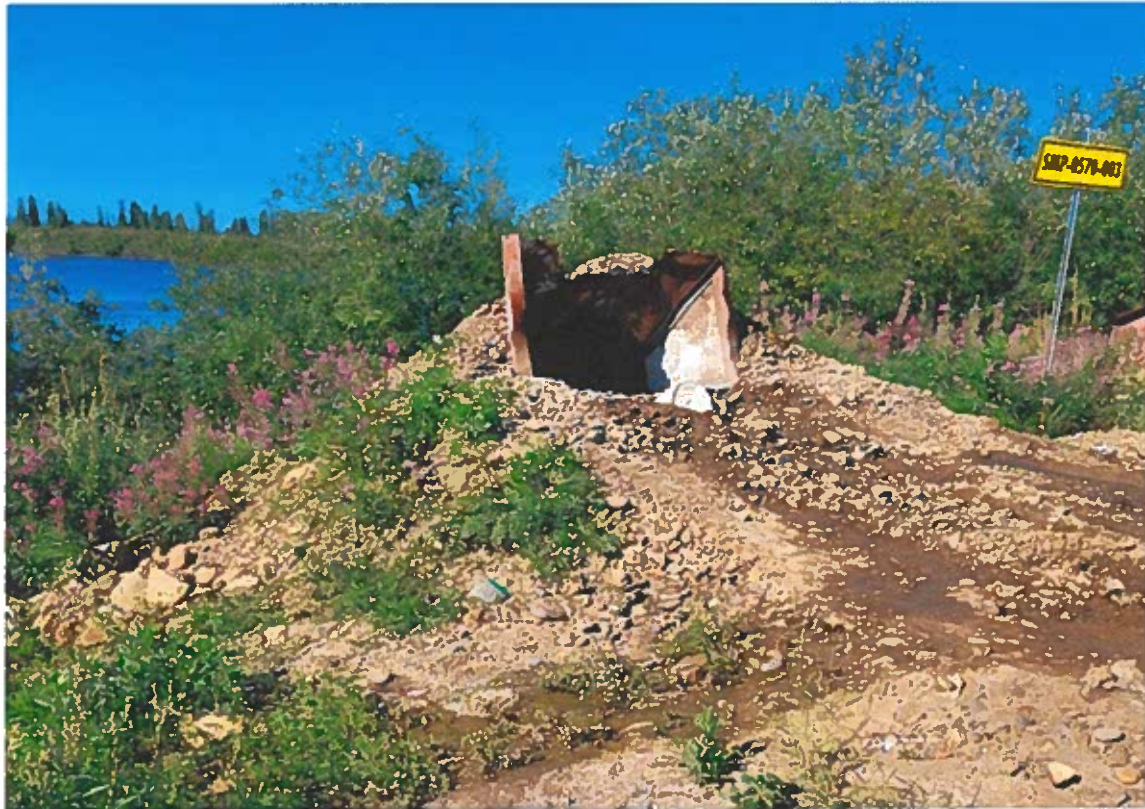
Figure 3 - Sewage Waste Disposal Chute

- The sewage waste disposal chute is in poor condition and is currently propped up with a five gallon pail (see Figure 3). ENR recommends that the Hamlet adequately address maintenance requirements for the chute as soon as possible to prevent further spills, and budget for a new sewage waste disposal chute.

- ENR strongly recommends better waste segregation and more frequent monitoring and maintenance within the SWDF.
- ENR strongly recommends replacement of the sewage disposal chute at the Sewage Waste Disposal Facility. Until this is implemented, the Hamlet must address maintenance requirements for the chute as soon as possible to prevent further spills.

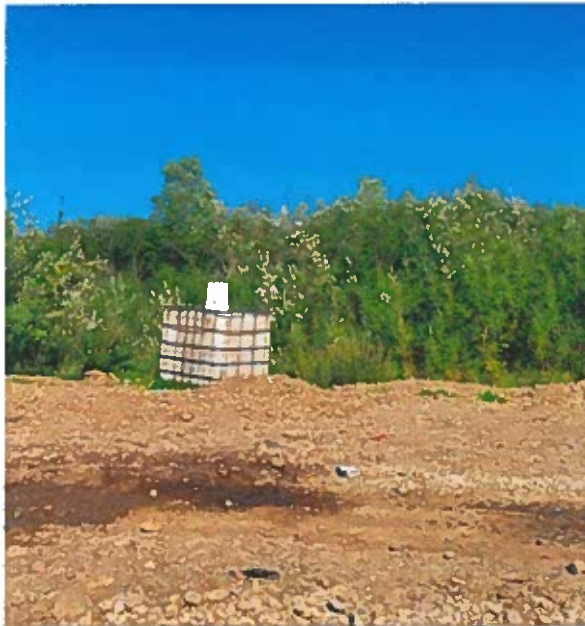
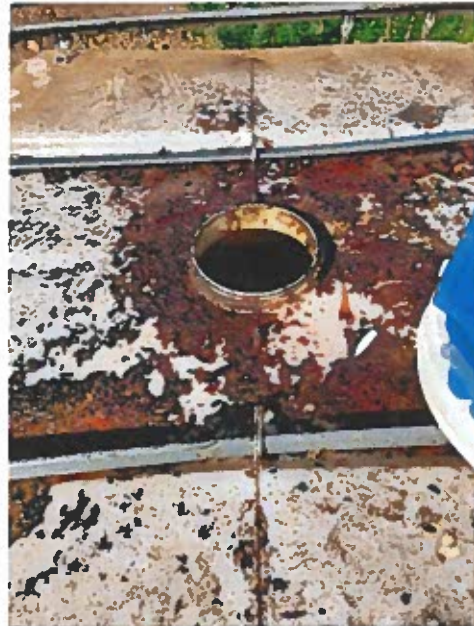
Figure 4 - Plastic Tote stored in near the Sewage Waste Disposal Facility

- There is a plastic tote half filled with what appears to be waste oil at the sewage waste disposal facility (see Figure 4). ENR recommended that all waste oil be transferred into sealable containers and stored in accordance with *Section 5 of the Used Oil and Waste Fuel Management Regulations*.

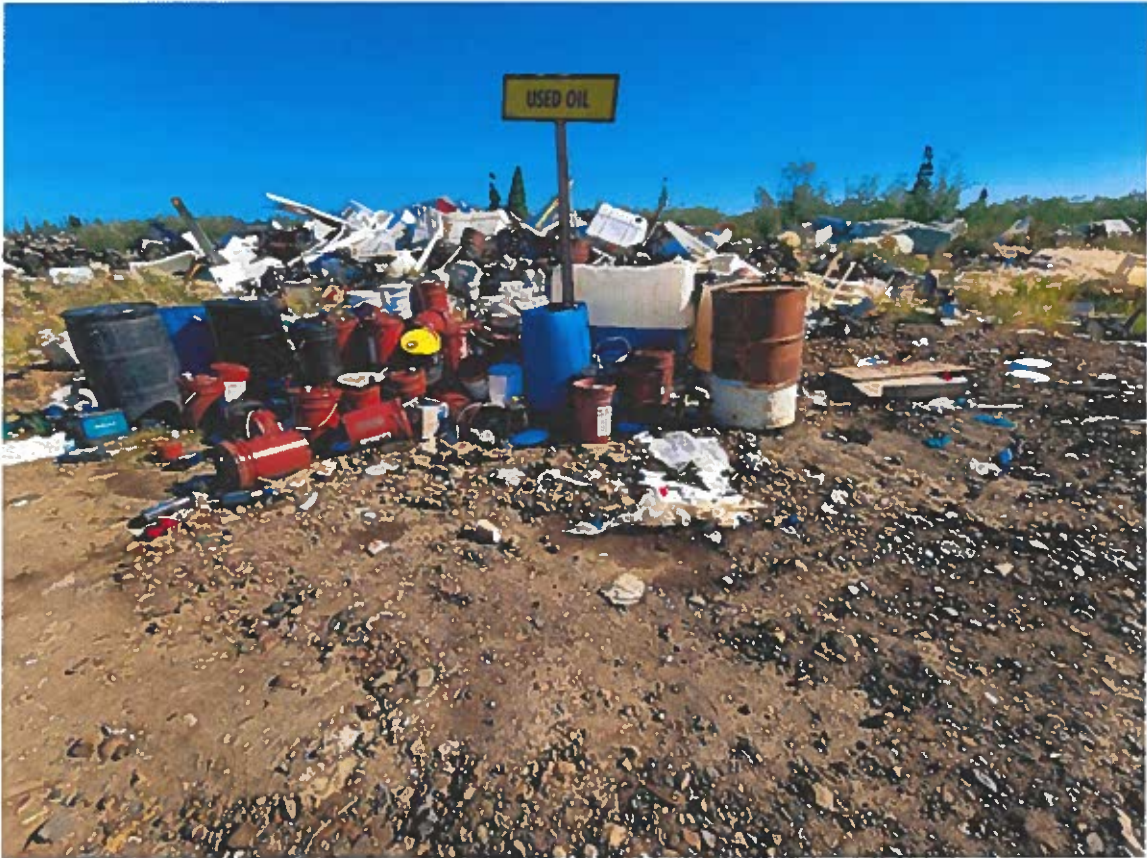
Figure 5 - Used Oil Section of the Solid Waste Disposal Facility

- The Hamlet designated an area for used oil (see Figure 5) for users to dispose of their used oil. The Hamlet placed a plastic tote in the Solid Waste Disposal Facility (SWDF) so users can empty their used oil into the plastic tote.

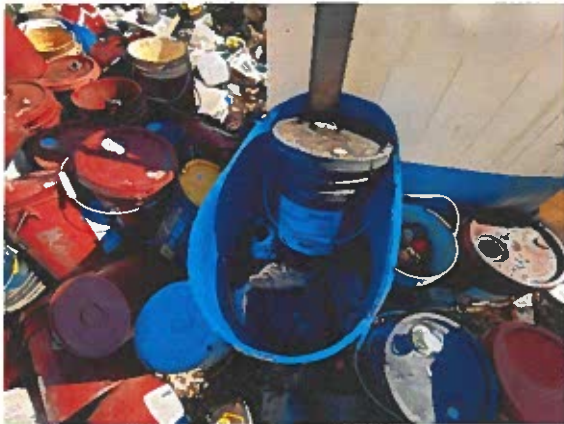
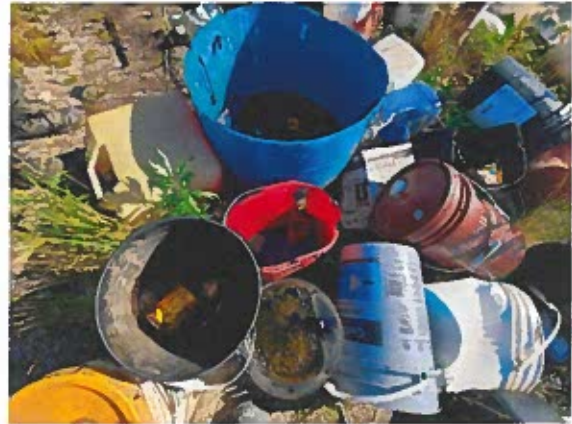
Figure 6 - Improper Storage of Used Oil

- The Inspector observed and noted numerous plastic drums, pails, and plastic totes filled with used oil throughout the eastside of the SWDF (See Figure 6-9). The Hamlet was instructed to contain and store all used oil in accordance with *Section 5.(1) and 5.(2) of the Used Oil and Waste Fuel Management Regulations*.

- The Hamlet shall designate an area for the temporary storage of used oil and other hazardous waste in accordance with *Section 9 of Part D of Water Licence N3L3-0570* and the *Used Oil and Waste Fuel Management Regulations*.

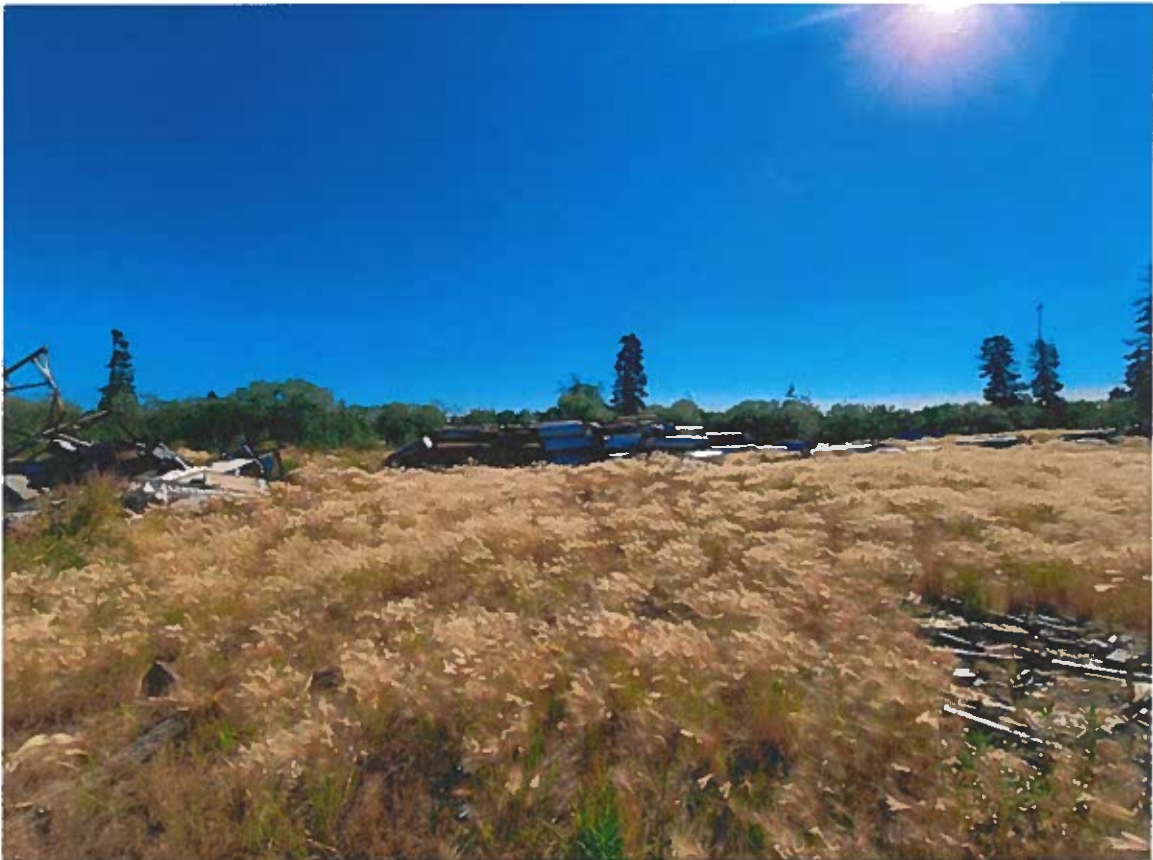
Figure 10 - Fuel Tanks located on the East side of the SWDF.

- There was a hydrocarbon (diesel fuel) odor near a stack of fuel tanks on the eastside of the Solid Waste Site Disposal Facility (See Figure 10). The Hamlet will need to address this by inspecting all fuel tanks and cleaning up any spills that are found in the area. ENR strongly recommends that the Hamlet provide ENR with regular updates during clean-up. [See Guideline for Contaminated Site Remediation.](#)

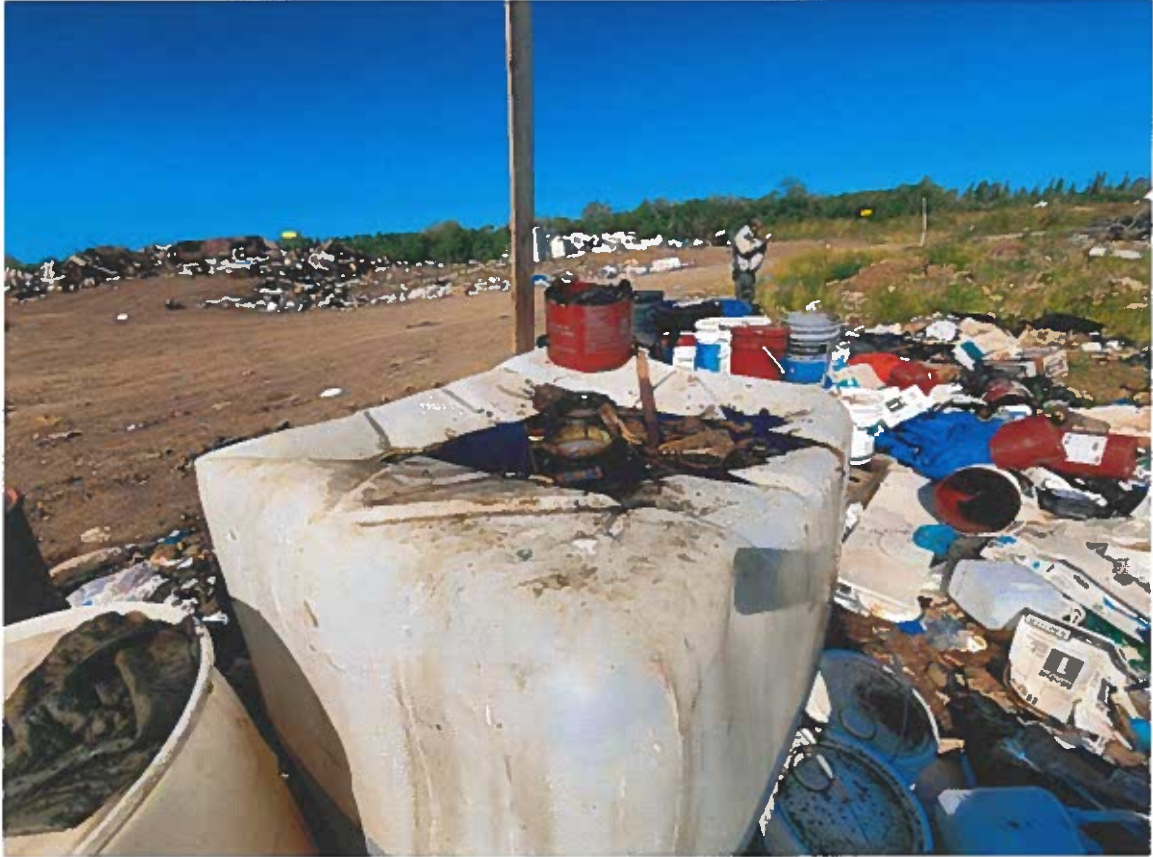
Figure 11 - Plastic Tote with oil spilling from the top

- There is also evidence of used oil spilling onto the ground in the Waste Oil area of the SWDF (see Figure 11-13). The Hamlet will need to clean-up these spills and ensure any resulting contaminated soils are properly stored prior to being shipped to a registered Receiver. Please contact the Inspector with any questions regarding spill clean-up and remediation.

- Clean-up is required and more frequent monitoring and maintenance is required at the Used Oil Section of the Solid Waste Site Facility.
- Used Oil/Waste Fuel are to be transferred into approved containment and individually labeled.

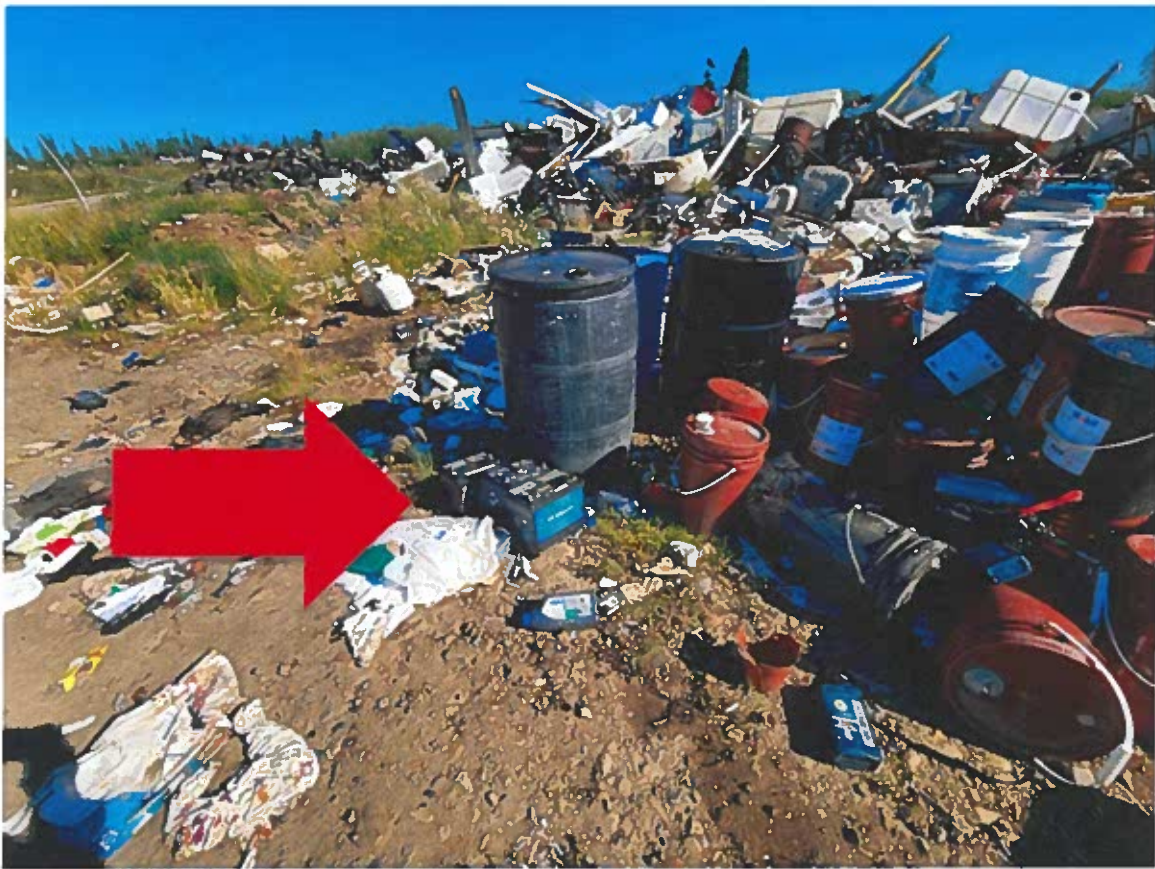
Figure 14 - Improper Disposal of Used Batteries

- There is evidence of unauthorized disposal/improper storage of batteries within the SWDF. ENR recommends that that Hamlet designate an area within the temporary hazardous waste containment facility for this waste (see Figure 14). All received hazardous wastes must be stored in accordance with the licence requirements and as per the *Guideline for Hazardous Waste Management*.

- All stockpiled Hazardous Waste needs to be shipped to a registered Receiver as soon as possible to avoid spills and increased risk/liability.
- Used batteries destined for disposal are to be placed on pallets for storage until shipped to a registered Receiver.

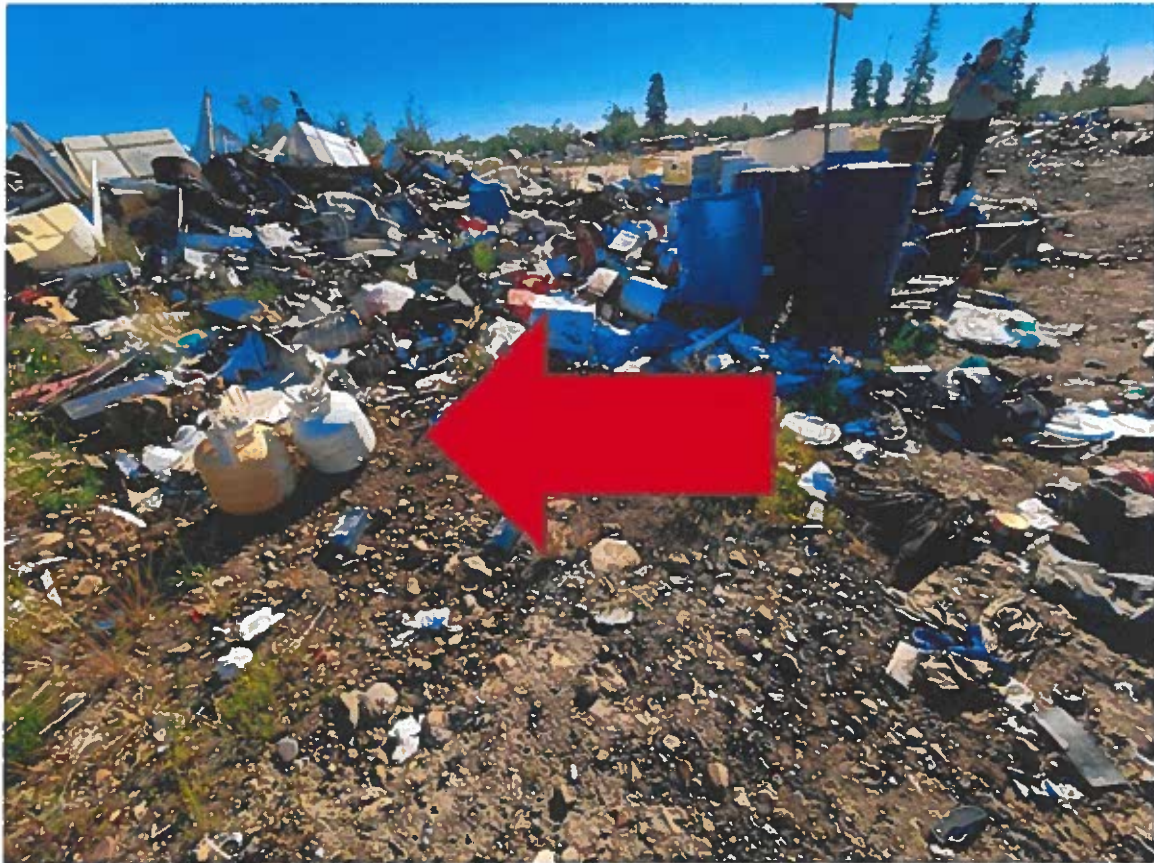
Figure 15 - Propane Tanks in Used Oil Section of SWDF

- There is currently no designated area for propane tanks – propane tanks are being deposited in the used oil section of the SWDF (see Figure 15). ENR recommends that these items be stored in a designated area at the Hazardous Waste Containment Facility.

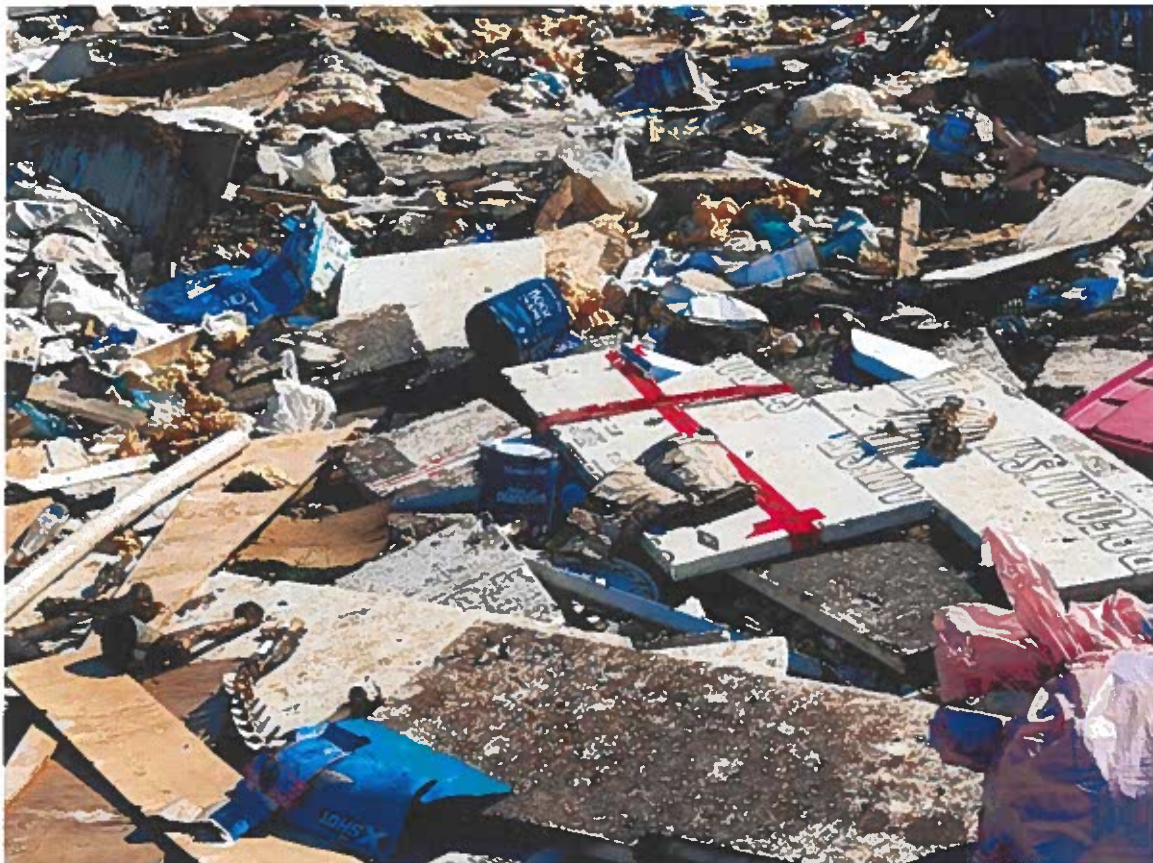
Figure 16 - Paint cans and insulation in household waste stream area of the SWDF.

- There was new waste stream signs placed throughout the SWDF, but users are not depositing wastes at the appropriate locations. There were paint cans observed in the household waste area (see Figure 16). All paint wastes are to be removed from the household waste area and stored in the Hazardous Waste Containment Facility and disposed of as per the *Guideline for Hazardous Waste Management*.

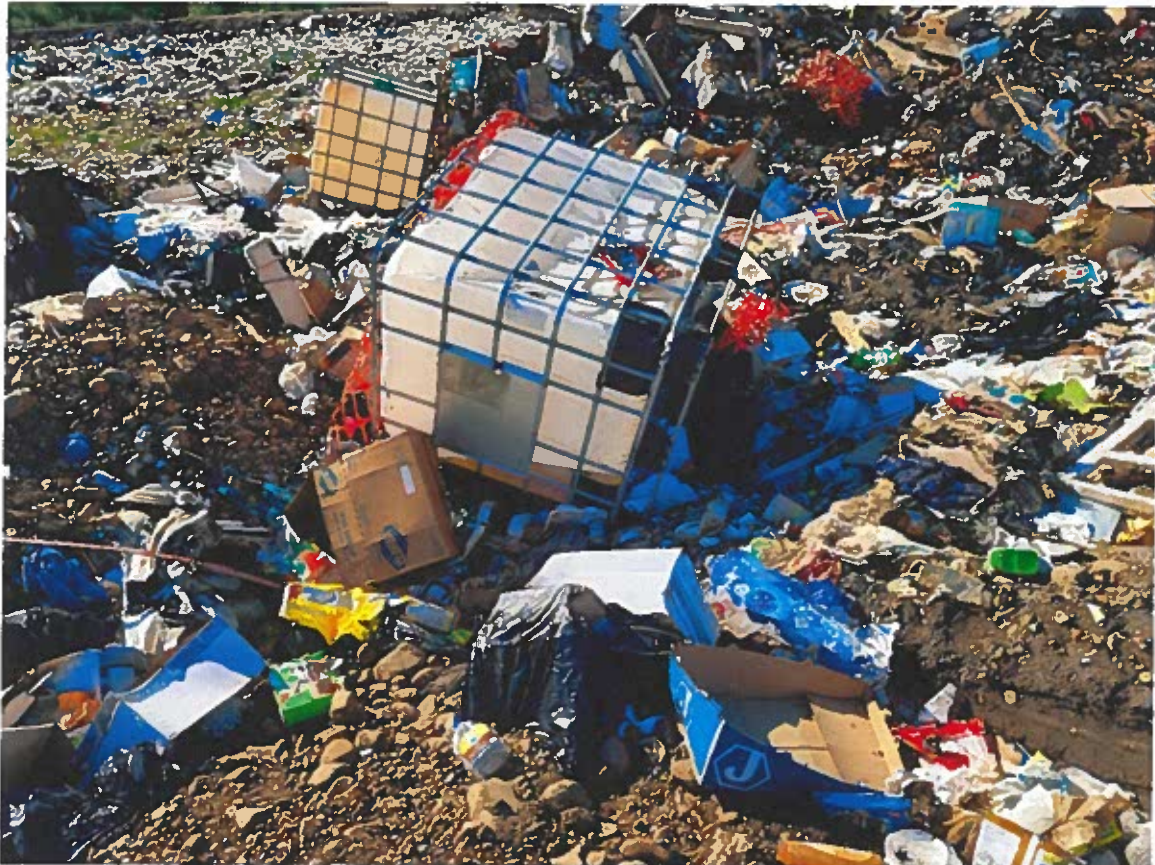
Figure 17 - Plastic tote with some hazardous waste located in the household hazardous waste stream area of the SWDF.

- There were seven plastic totes, one of which had hazardous waste, disposed of in the household waste stream area (See Figure 17). ENR recommended that the totes be removed and stored with the hazardous waste.

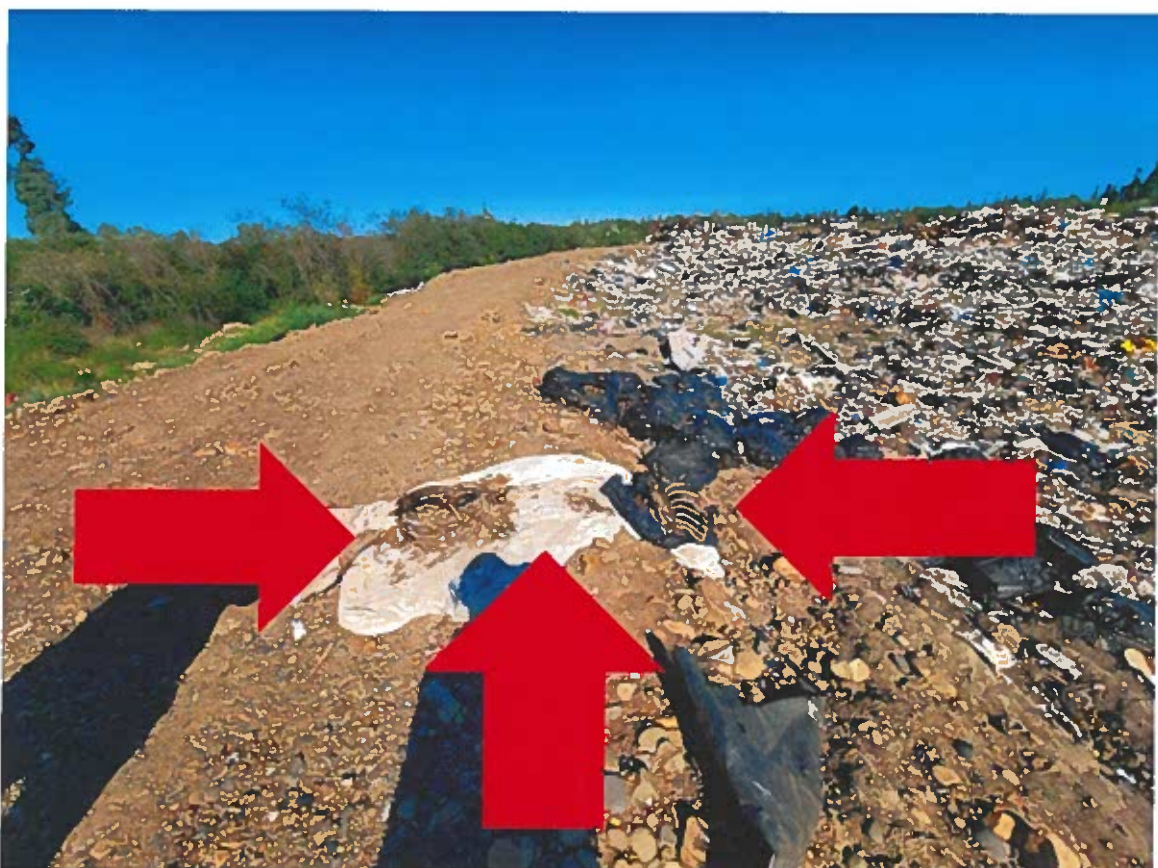
Figure 18 - Evidence of Wastage of Meat of Big Game at the SWDF.

- There was evidence of wastage of meat of big game in the household/domestic waste area (see Figure 18). The Hamlet reported that there were whole caribou carcasses in the SWDF during the winter/spring 2021. To reiterate, ENR suggests that the Hamlet control access to the SWDF to prevent the unlawful disposal of meat of big game and report all wastage to a Renewable Resource Officer.

- ENR recommends that the Hamlet designate an area to openly burn animal carcasses as per *Section 15 of Part D of Water Licence N3L3-0570*.
