Northwest Territories Power Corporation

Inuvialuit Water Board License Number: N3L8-1838
Aklavik, Northwest Territories

2021 Annual Report

2021 Remediation Progress Report

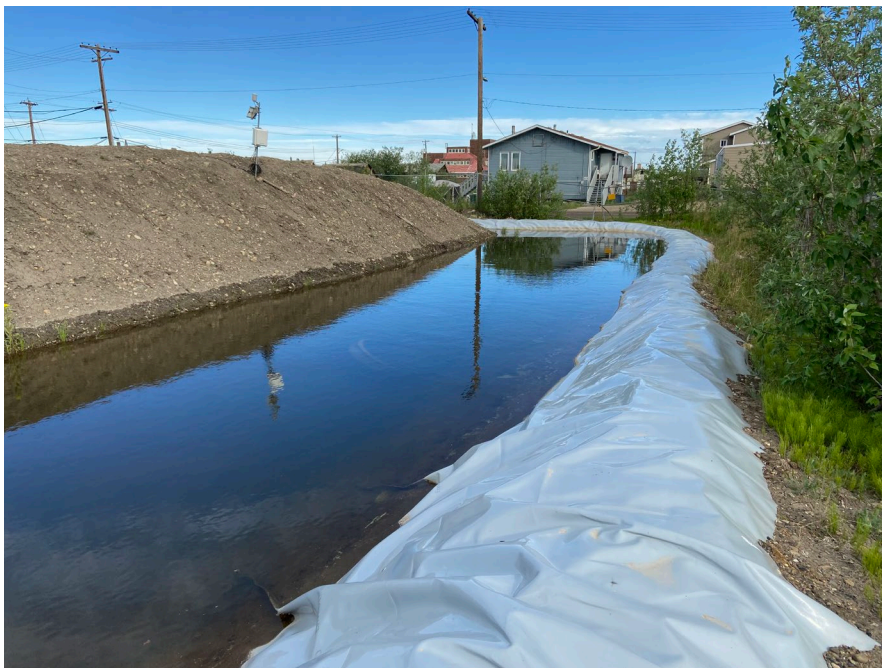
Photo 1: Untreated water in biotreatment cell prior to pumping into totes. June 29, 2021

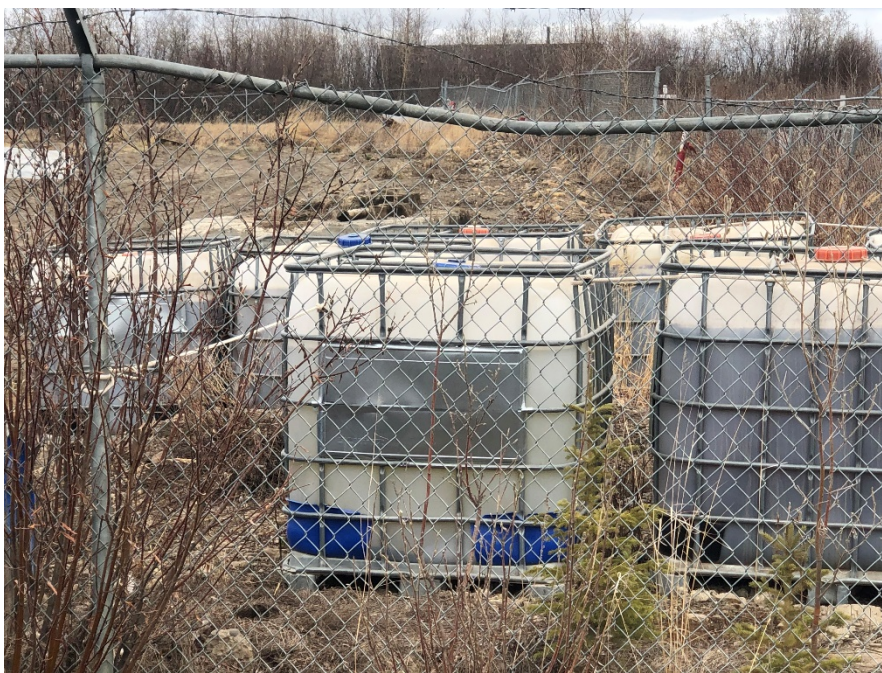
Photo 2: Untreated water stored in totes on site. May 27, 2021

- KBL recommends mitigation measures proposed in the Environmental Impact Screening be implemented during remediation activities planned for 2022.
- Untreated water remains on site in 100 – one cubic meter totes.

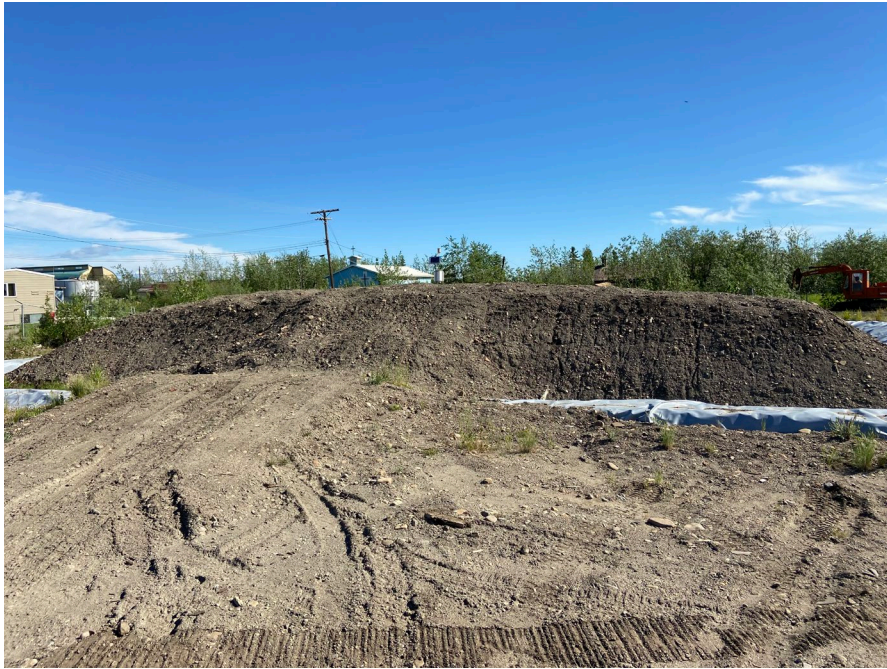
Photo 3: Hydrocarbon impacted soils on biotreatment cell. June 29, 2021

Approximately 920 m³ of hydrocarbon impacted soil has been undergoing bioaugmentation treatment in the biotreatment cell. Approximately 1,980 m³ of impacted soil remains onsite, outside the biotreatment cell.

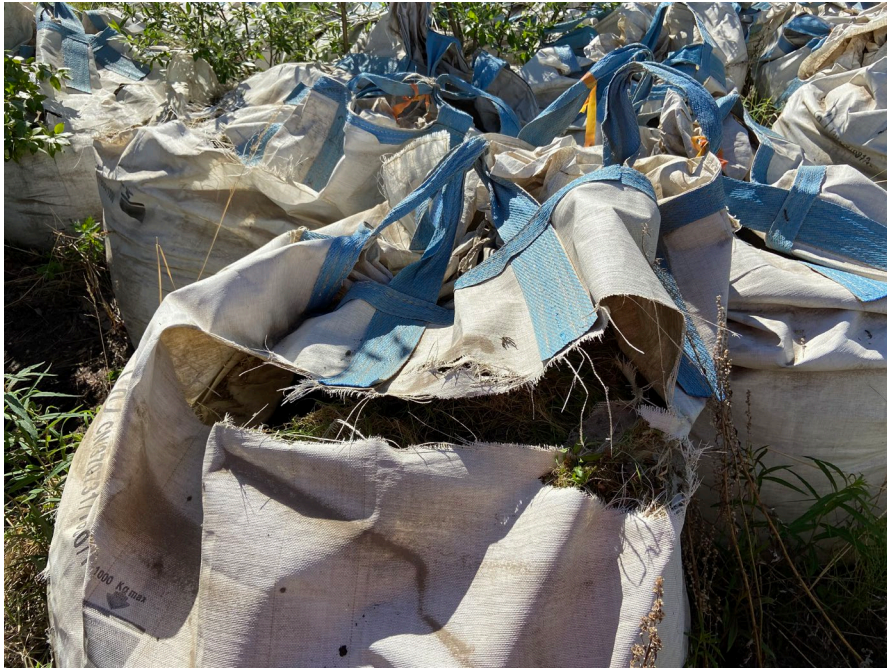
Photo 5: Torn soil bag after attempting to relocate for test pitting activities on western portion of the Site. June 29, 2021

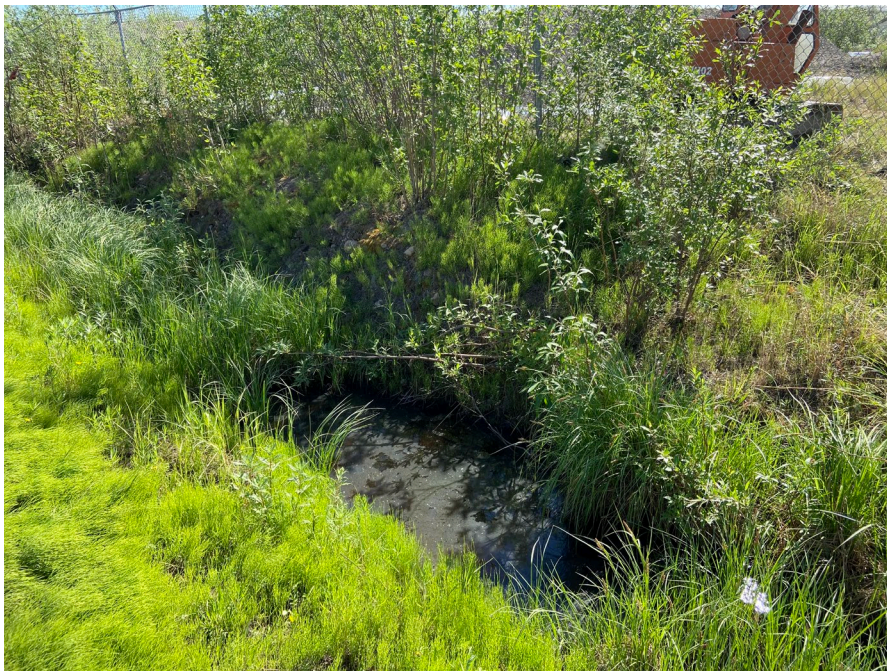
Photo 6: Location of proposed test pitting on northern portion of Site. June 29, 2021.

- Test pitting was also attempted in the northern portion of the Site near TP3 and TP15. The area surrounding TP3 could not be sampled as it is located on the northern property boundary, outside the property boundary fence in a ditch that was filled with water at the time of the site visit. The area surrounding TP15 could not be sampled as soil bags were stored on top of the desired sampling location. KBL attempted to move the bags, however they began to rip open and created a potential for contaminated soil spill onto the surface of the site. KBL recommends this work be completed in conjunction with scheduled remediation activities in 2022.

- KBL recommends this work be completed in conjunction with scheduled remediation activities in 2022.

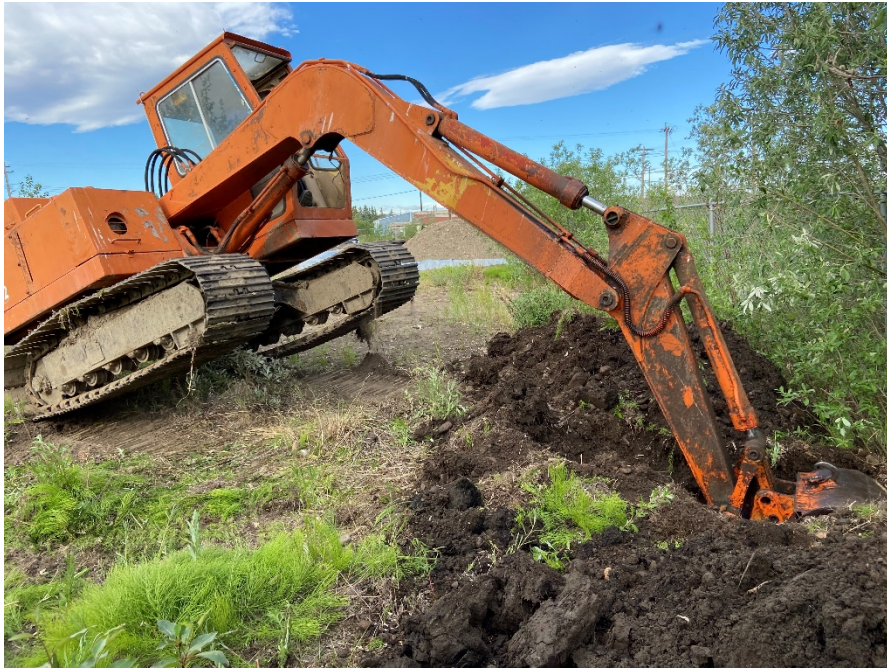
Based upon the information provided in the RRGAs, test pitting was completed in the southeastern portion of the Site near TP13 on June 29, 2021. The test pit program consisted of four test pits using an excavator with samples obtained from 0.3m, 0.8m, and 1.2m bgs. A total of 12 soil samples were obtained and sent to a third party laboratory for analysis of contaminants of concern (BTEX and F1-F4). Excavator refusal was encountered at 1.3m bgs, likely due to the permafrost. (Appendix A, Figure 5).

Photo 7: Excavator encountering refusal at 1.3m bgs. June 29, 2021

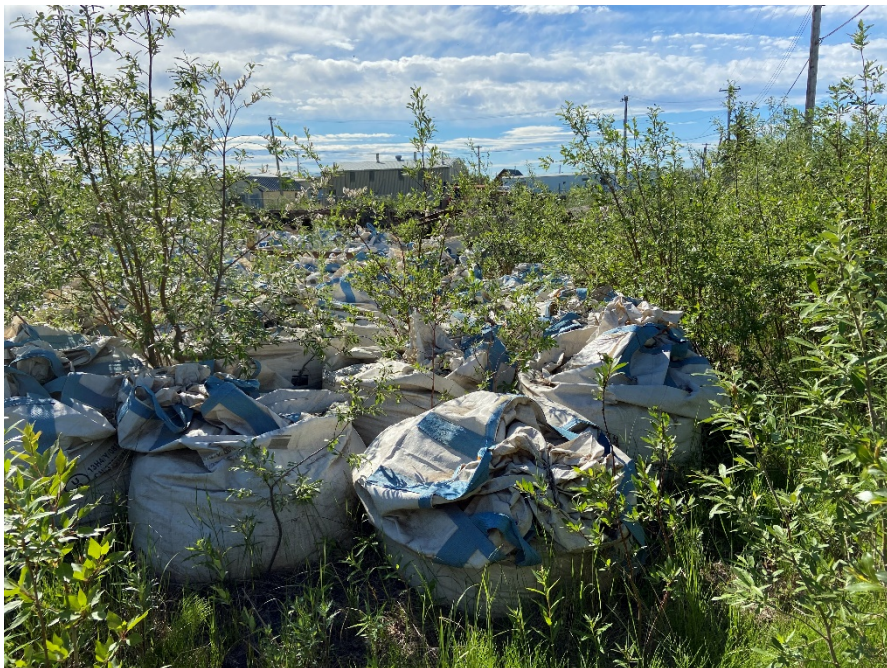
Photo 8: Soil bags stored on northwestern portion of the Site. June 29, 2021.

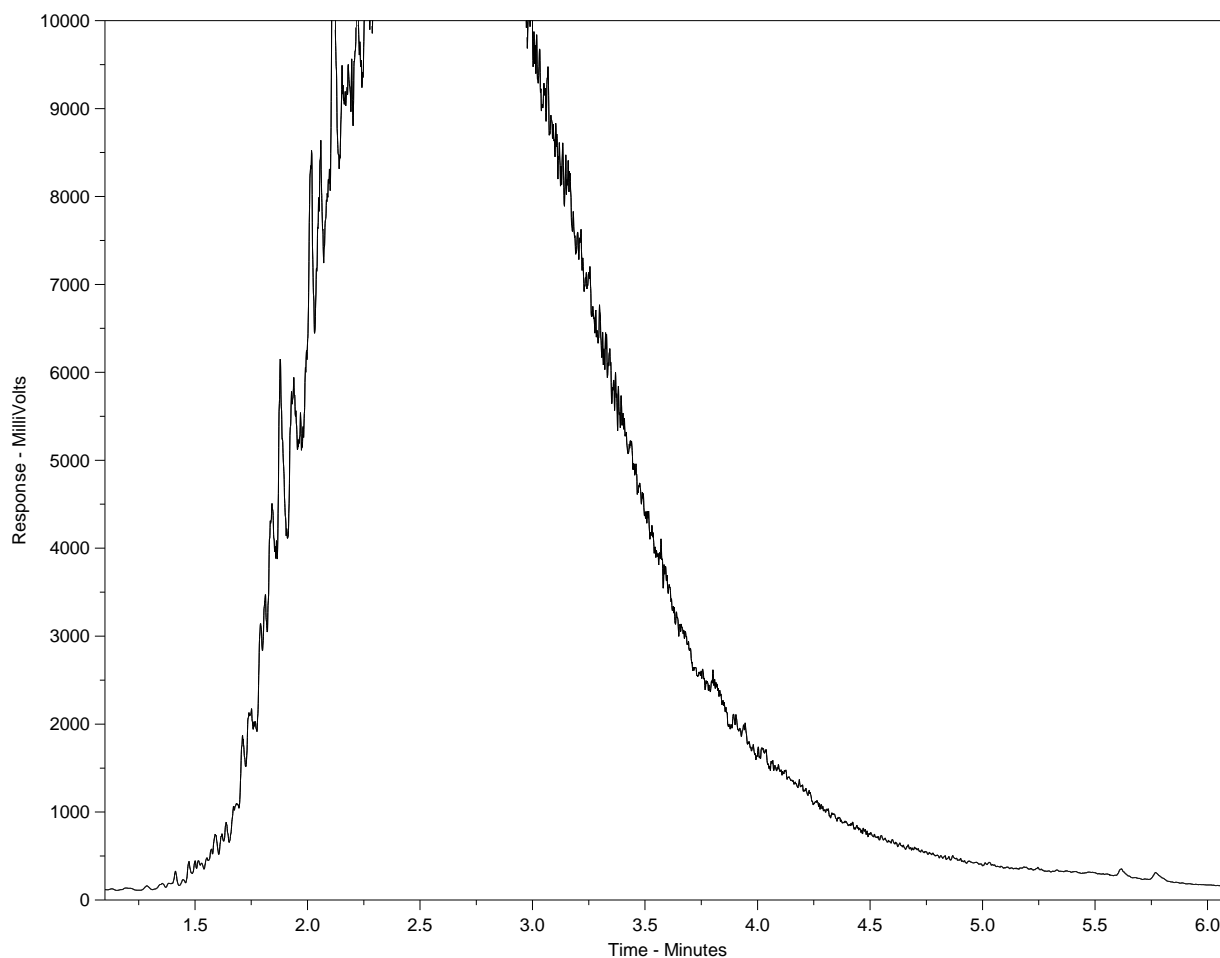
ALS Sample ID: L2656073-1
Client ID: 21BH01

F2		F3		F4		>F4
nC10	nC16		nC34		nC50	
174°C	287°C		481°C		575°C	
346°F	549°F		898°F		1067°F	
Gasoline		Motor Oils/ Lube Oils/ Grease				
Diesel/ Jet Fuels

The Canada Wide Standard Hydrocarbon Distribution Report is intended to assist you in characterizing hydrocarbon products that may be present in your sample. The scale at the bottom of the chromatogram indicates the approximate retention times of common petroleum products as well as a number of specified n-alkane hydrocarbon marker compounds. Comparison of this report with those of reference standards may also assist in characterizing hydrocarbons present in the sample.

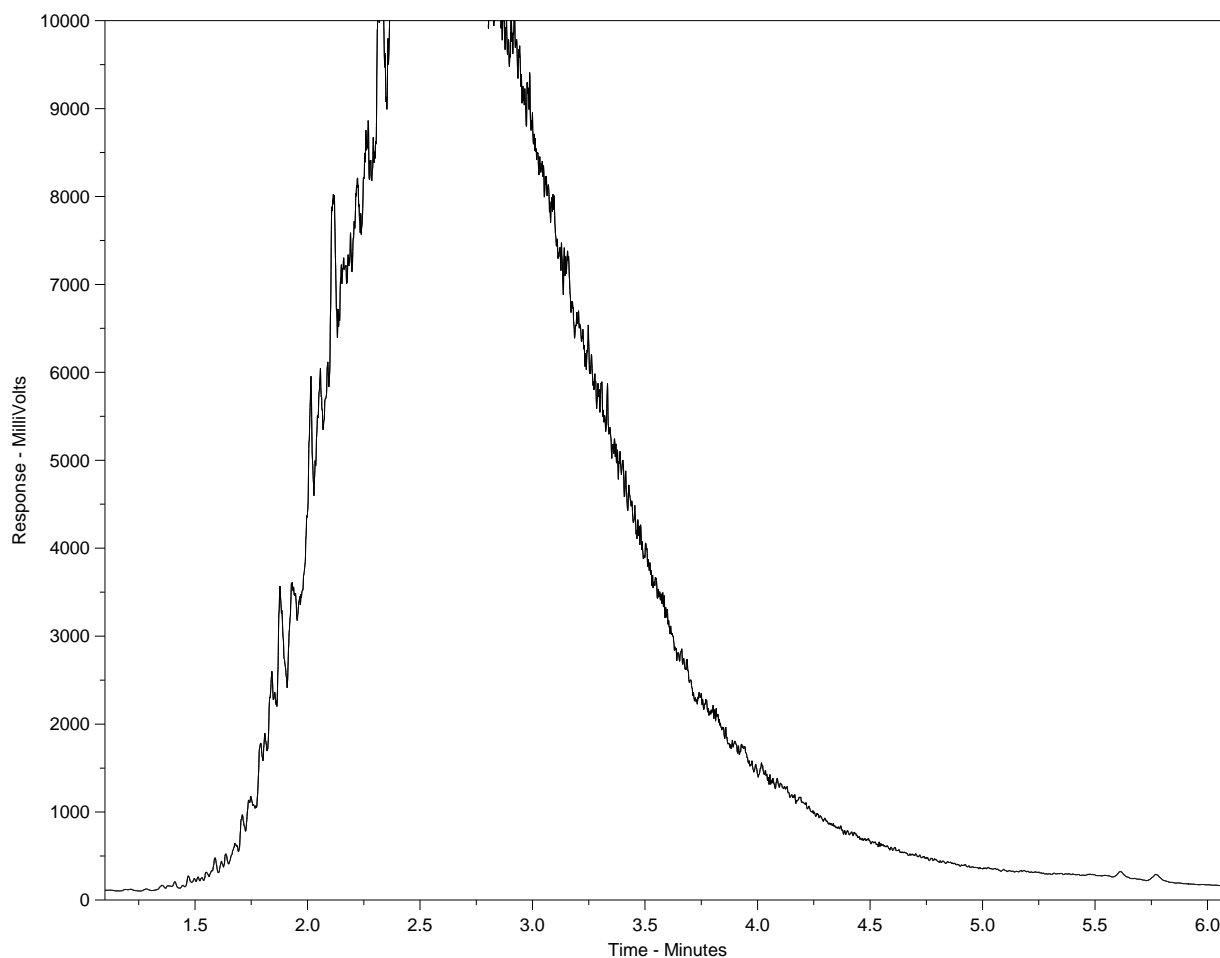
ALS Sample ID: L2656073-2
Client ID: 21BH02

F2		F3		F4		>F4
nC10	nC16		nC34		nC50	
174°C	287°C		481°C		575°C	
346°F	549°F		898°F		1067°F	
Gasoline		Motor Oils/ Lube Oils/ Grease				
Diesel/ Jet Fuels

The Canada Wide Standard Hydrocarbon Distribution Report is intended to assist you in characterizing hydrocarbon products that may be present in your sample. The scale at the bottom of the chromatogram indicates the approximate retention times of common petroleum products as well as a number of specified n-alkane hydrocarbon marker compounds. Comparison of this report with those of reference standards may also assist in characterizing hydrocarbons present in the sample.

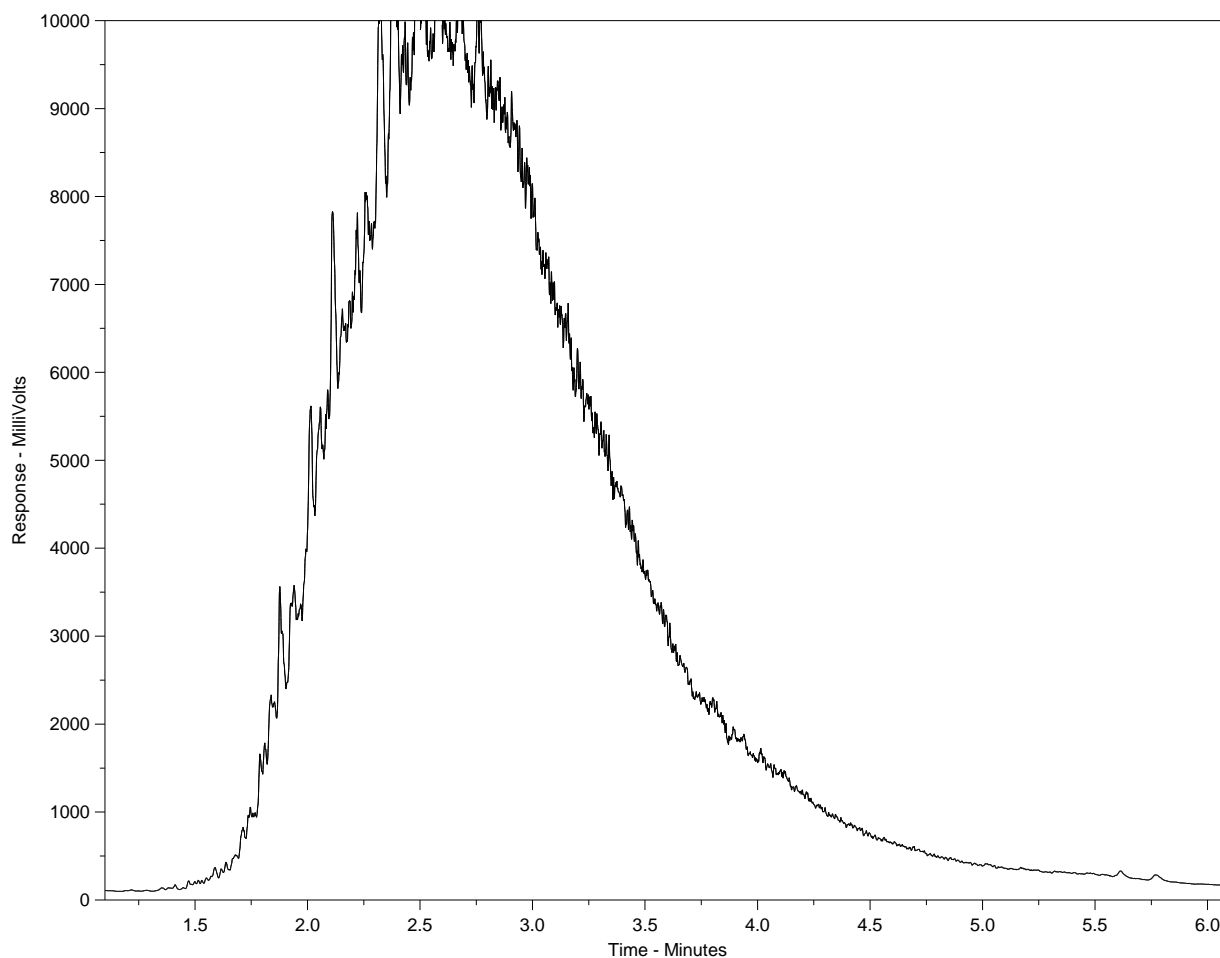
ALS Sample ID: L2656073-3
Client ID: 21BH03

F2		F3		F4		>F4
nC10	nC16		nC34		nC50	
174°C	287°C		481°C		575°C	
346°F	549°F		898°F		1067°F	
Gasoline		Motor Oils/ Lube Oils/ Grease				
Diesel/ Jet Fuels

The Canada Wide Standard Hydrocarbon Distribution Report is intended to assist you in characterizing hydrocarbon products that may be present in your sample. The scale at the bottom of the chromatogram indicates the approximate retention times of common petroleum products as well as a number of specified n-alkane hydrocarbon marker compounds. Comparison of this report with those of reference standards may also assist in characterizing hydrocarbons present in the sample.

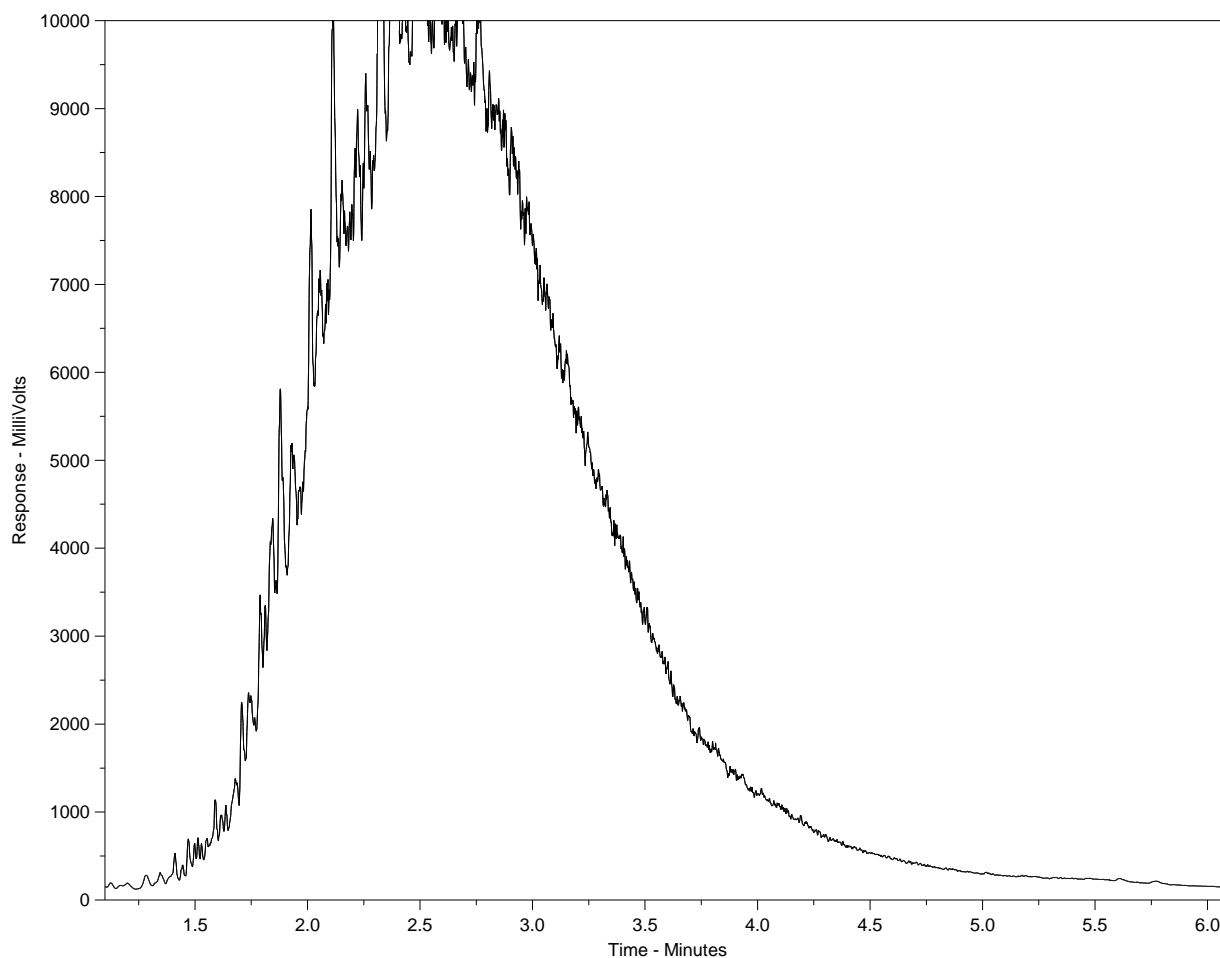
ALS Sample ID: L2656073-4
Client ID: 21BH04

F2		F3		F4	>F4
nC10	nC16		nC34	nC50	
174°C	287°C		481°C	575°C	
346°F	549°F		898°F	1067°F	
Gasoline		Motor Oils/ Lube Oils/ Grease			
Diesel/ Jet Fuels

The Canada Wide Standard Hydrocarbon Distribution Report is intended to assist you in characterizing hydrocarbon products that may be present in your sample. The scale at the bottom of the chromatogram indicates the approximate retention times of common petroleum products as well as a number of specified n-alkane hydrocarbon marker compounds. Comparison of this report with those of reference standards may also assist in characterizing hydrocarbons present in the sample.

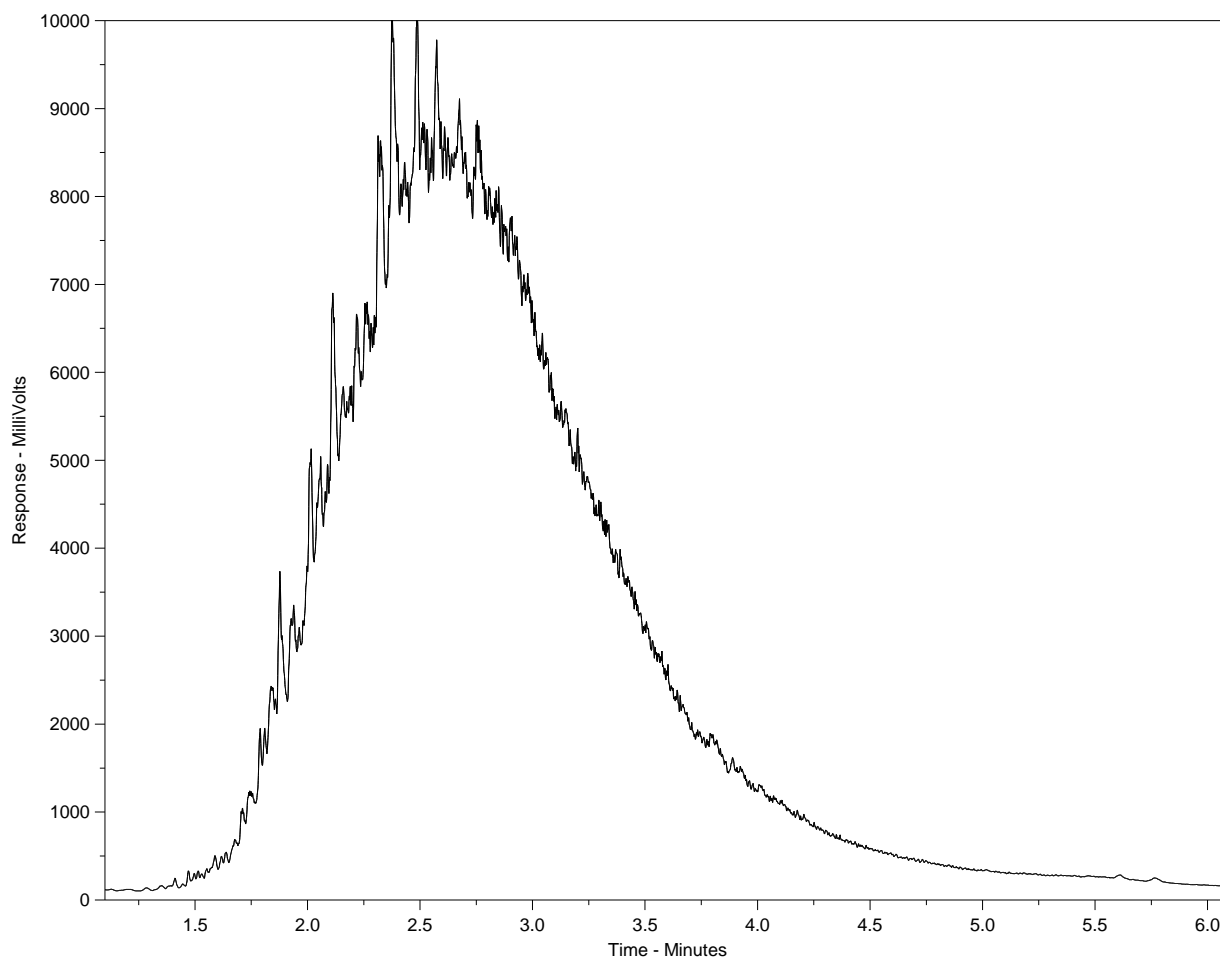
ALS Sample ID: L2656073-5
Client ID: 21BH05

F2		F3		F4		>F4
nC10	nC16		nC34		nC50	
174°C	287°C		481°C		575°C	
346°F	549°F		898°F		1067°F	
Gasoline		Motor Oils/ Lube Oils/ Grease				
Diesel/ Jet Fuels

The Canada Wide Standard Hydrocarbon Distribution Report is intended to assist you in characterizing hydrocarbon products that may be present in your sample. The scale at the bottom of the chromatogram indicates the approximate retention times of common petroleum products as well as a number of specified n-alkane hydrocarbon marker compounds. Comparison of this report with those of reference standards may also assist in characterizing hydrocarbons present in the sample.

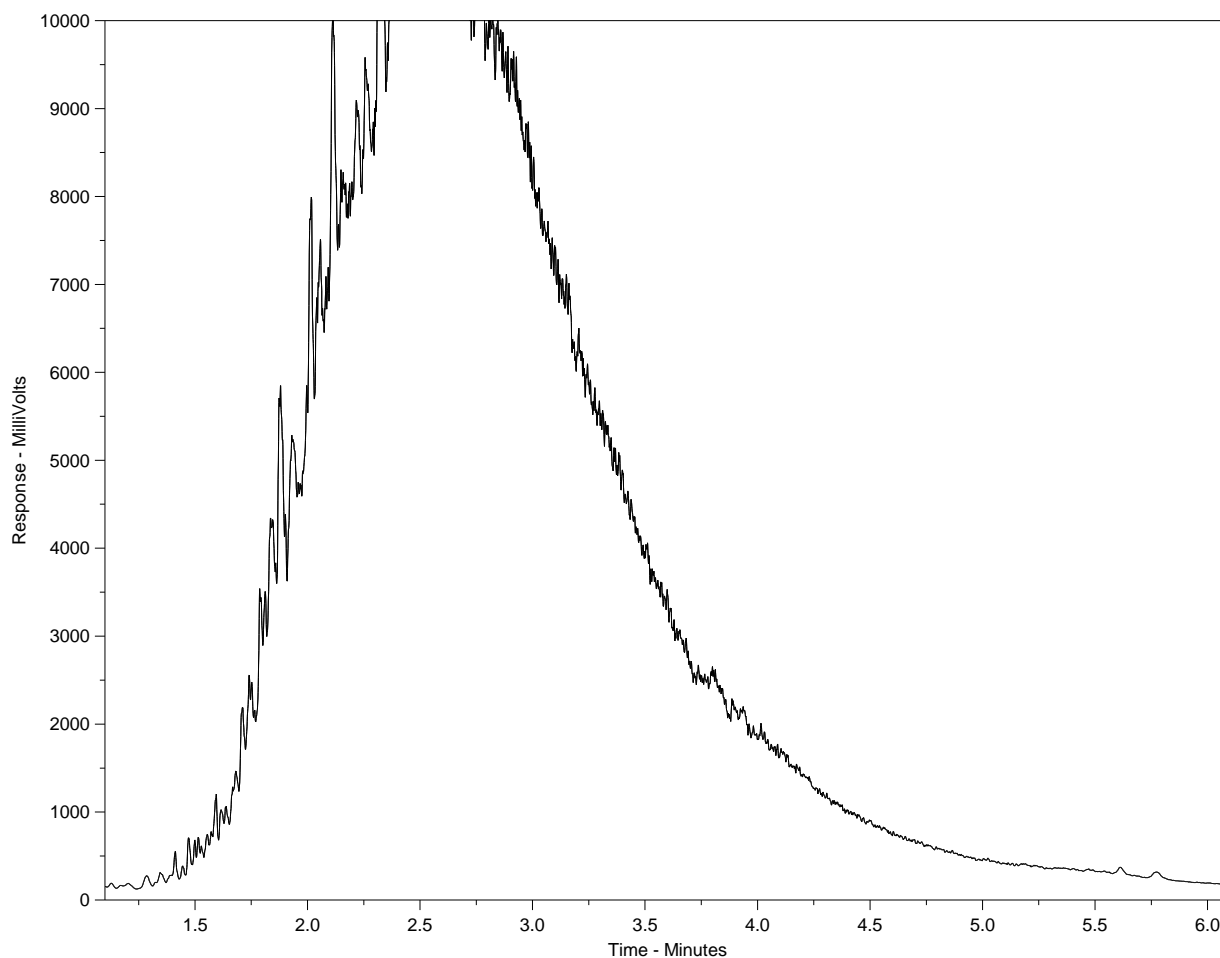
ALS Sample ID: L2656073-6
Client ID: 21BH06

F2		F3		F4		>F4
nC10	nC16		nC34		nC50	
174°C	287°C		481°C		575°C	
346°F	549°F		898°F		1067°F	
Gasoline		Motor Oils/ Lube Oils/ Grease				
Diesel/ Jet Fuels

The Canada Wide Standard Hydrocarbon Distribution Report is intended to assist you in characterizing hydrocarbon products that may be present in your sample. The scale at the bottom of the chromatogram indicates the approximate retention times of common petroleum products as well as a number of specified n-alkane hydrocarbon marker compounds. Comparison of this report with those of reference standards may also assist in characterizing hydrocarbons present in the sample.
