Project: Tuk Base Remediation Project
RE: N5L8-1841 Imperial Oil Environmental and Property Solutions (E&Ps) – Tuk Base Remediation Project
– Tuktoyaktuk Base Remediation 2025 Annual IWB Report

**RE: N5L8-1841 IMPERIAL OIL ENVIRONMENTAL AND PROPERTY SOLUTIONS (E&PS) – TUK BASE
REMEDATION PROJECT – 2025 ANNUAL REPORT – ADDITIONAL INFORMATION REQUEST**

TITLE
Photographs of 2025 Summer Field Season

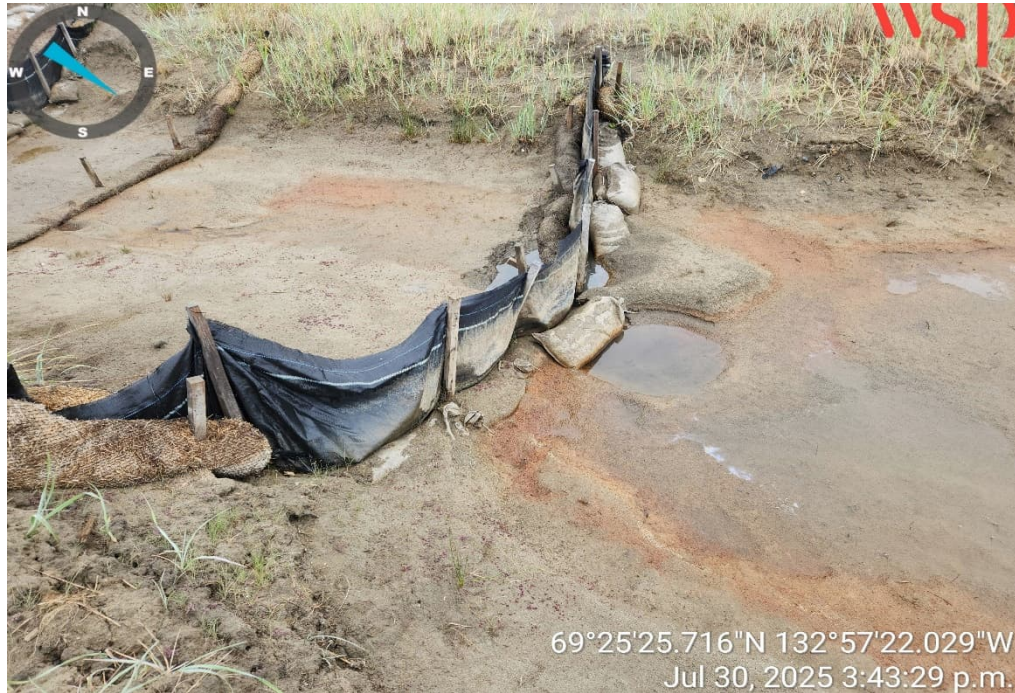
Photo 1 – Sedimentation before repairs were completed at the Lower Terrace main water management swale (30 July 2025).

From 31 July to 4 August 2025, care and maintenance activities were completed at the main drainage area in the lower terrace. On 31 July to 2 August 2025, the silt fence at the main drainage area in the lower terrace was refurbished, re-keyed (tied into surface soil) and eroded areas were backfilled. In addition, damaged straw wattles were replaced, and stakes and sandbags were added to provide additional structural support where necessary. On 3 and 4 August, the CAT 966K loader reconstructed the southwest settling pond berms for the swales extending from the Metal & Debris Stockpile, using a total of 33 m³ from the on-site clean backfill pile. The existing 2" PVC overflow pipe was replaced with a 6" steel pipe, liner and rip rap installed on the inlet side, with a splash pad on the outlet site. The maintenance work at the lower terrace was completed on 4 August 2025 (see Photos 1, 8, 11, 17, 18, 19 and 20 in Appendix A).

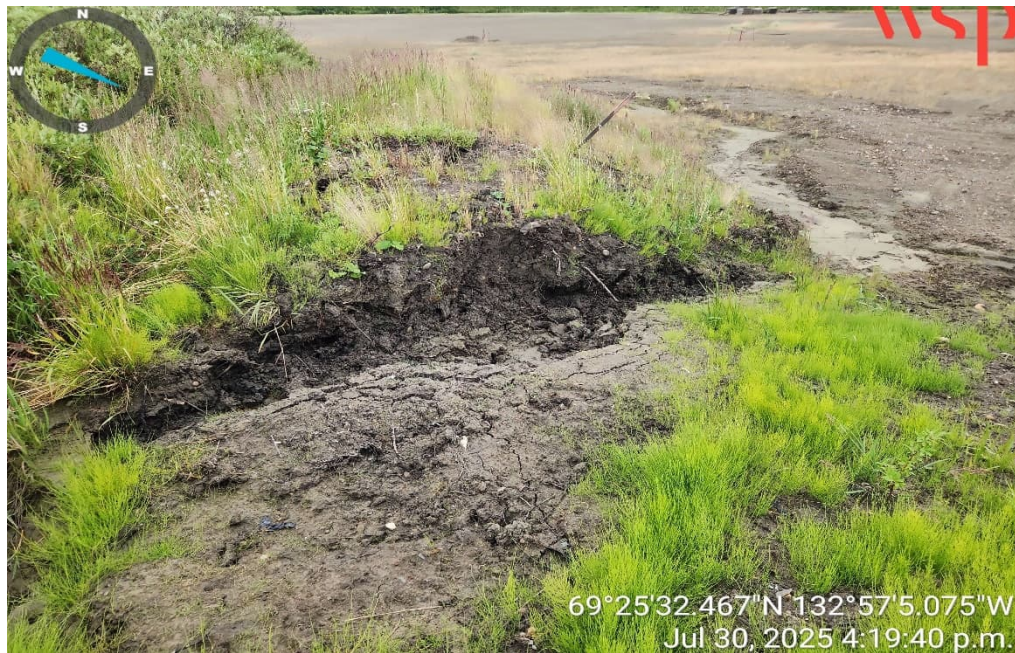
Photo 2 – Erosion from a swale requiring redirection along the east side of the South Landfill (30 July 2025).

On 31 July to 4 August 2025, maintenance activities were completed around the perimeter of the South Landfill, including reconstructing berms, redirecting swales and cleanout of erosion control features. On 31 July 2025, the CAT 349 excavator was used to rebuild and compact the berm along the east side of the South Landfill to limit water infiltration into the landfill. Drainage restoration and surface grading in the southeast corner of the South Landfill was completed to allow for positive drainage.

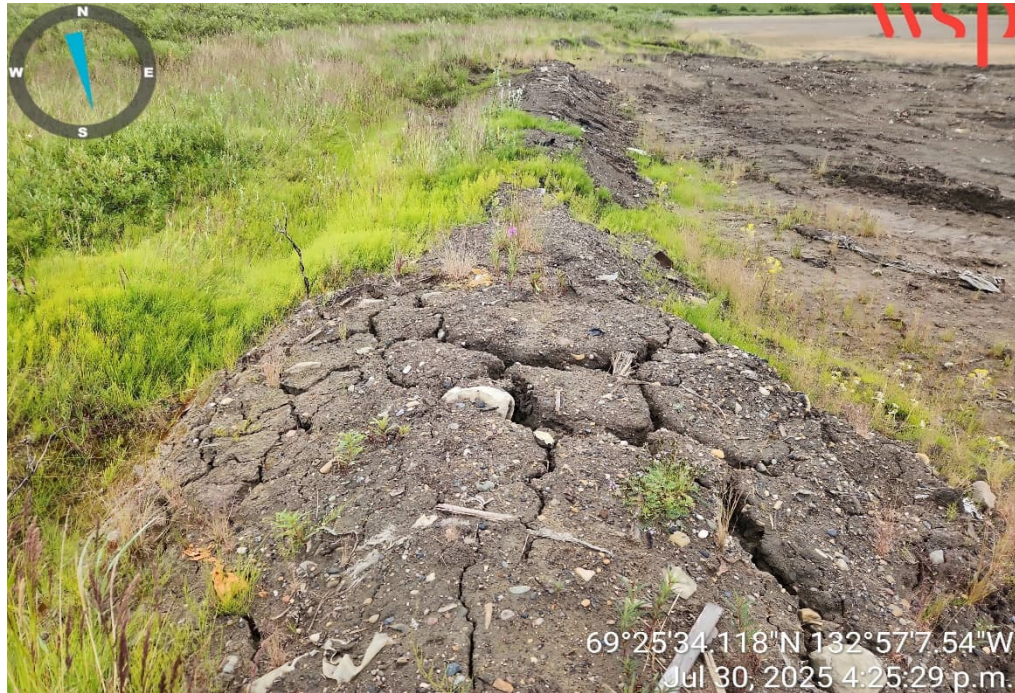
Photo 3 – Berm deterioration around the South Landfill (30 July 2025).

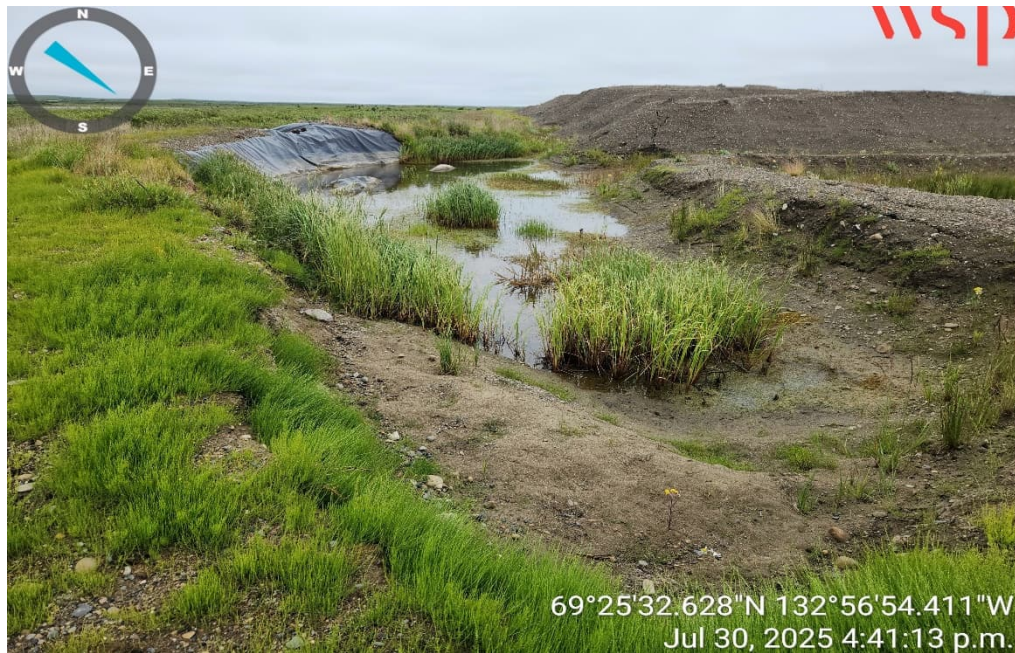
Photo 4 – Sump at ESSA 1 (30 July 2025).

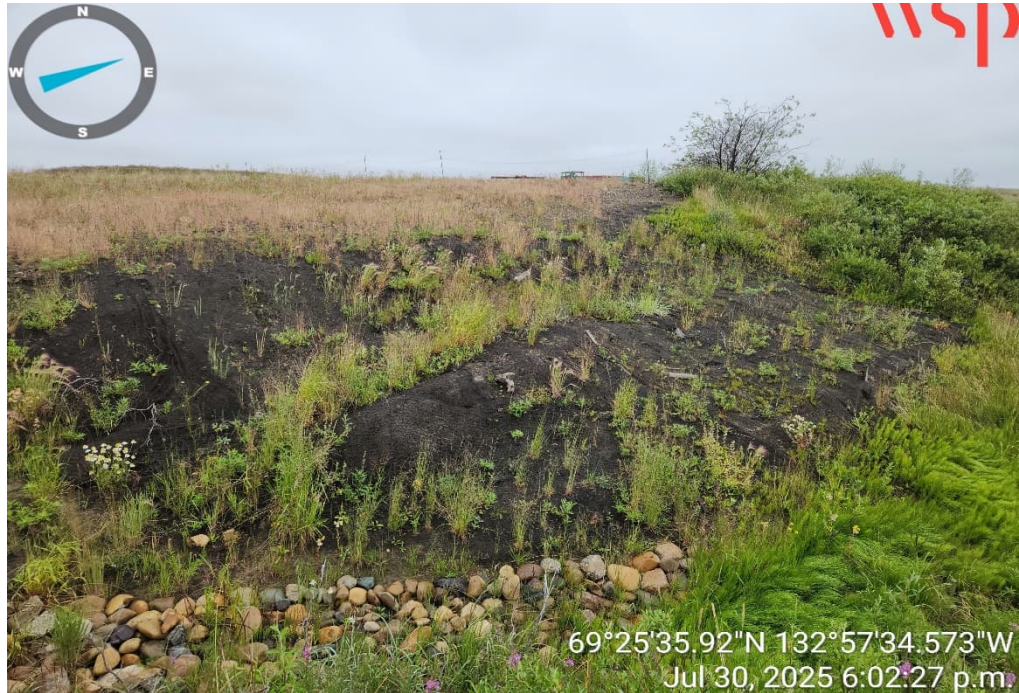
Photo 5 – Slope slumping in area of previously remediated D2 on Upper Terrace (30 July 2025).

On 2 and 3 August 2025, areas of observed erosion and subsidence around previous remediated areas were levelled and new erosion control materials were installed. A CAT 966K loader backfilled, compacted and levelled subsided areas with gravel from the on-site gravel stockpile. On 2 August 2025, installed silt fence and straw wattles at the D2 remediated area to reduce soil erosion. The deteriorated silt fence and wattles downslope of the D2 remediated area were removed. The maintenance work at the Upper Terrace was completed on 3 August 2025 (see photos 5, 14 and 15 in Appendix A).

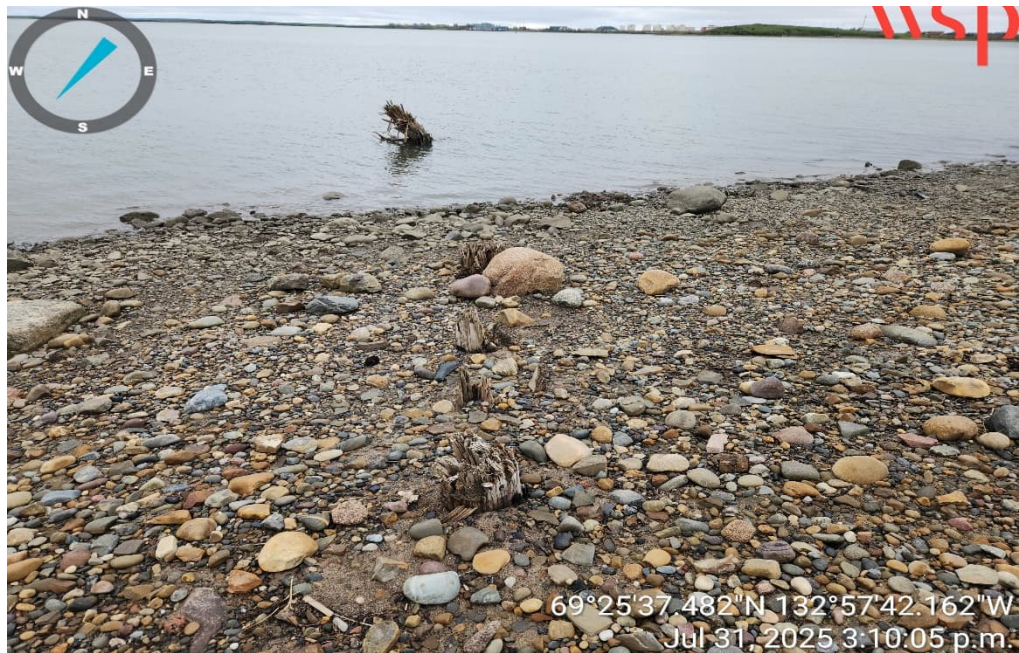
Photo 6 – Exposed wood pilings at the former wood wharf (31 July 2025).

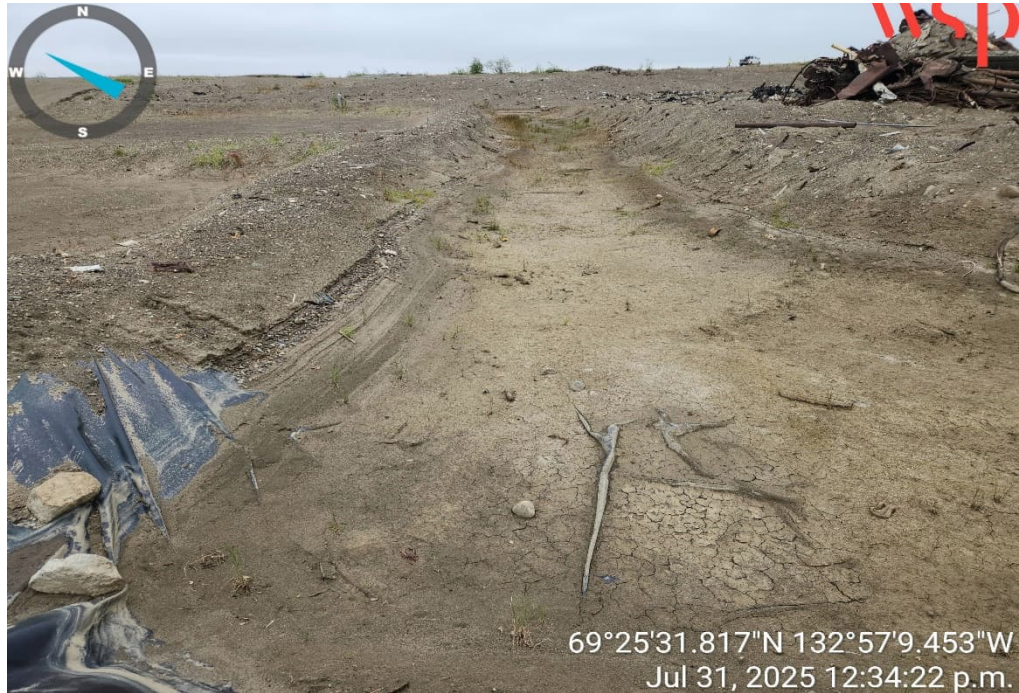
Photo 7 – Sedimentation within swales at Metal & Debris Stockpile (31 July 2025).

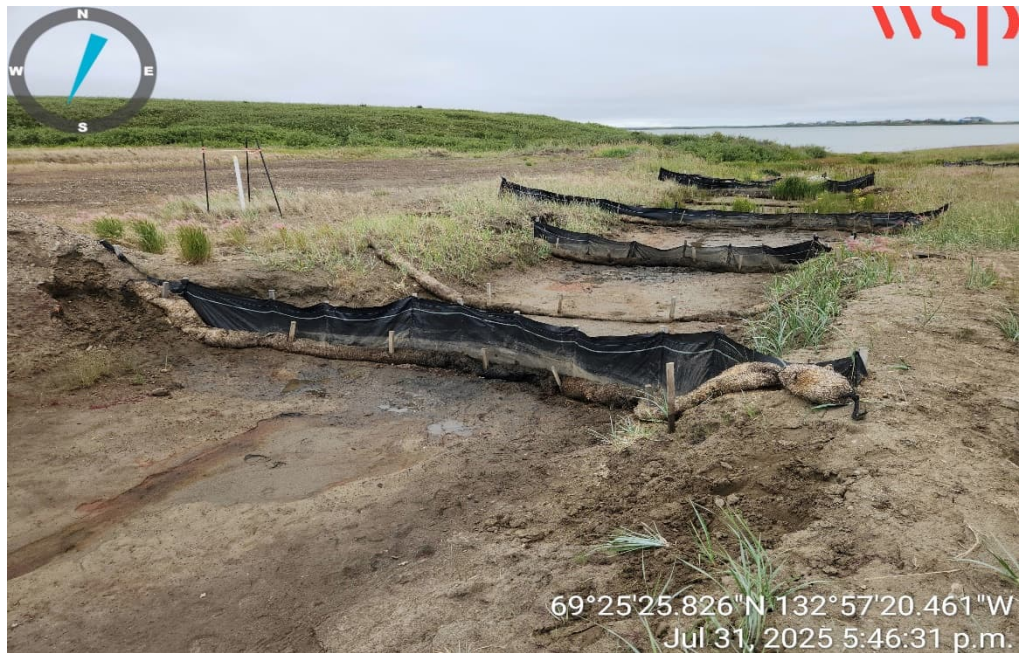
Photo 8 – Repaired silt fence in the Lower Terrace main water management swale (31 July 2025).

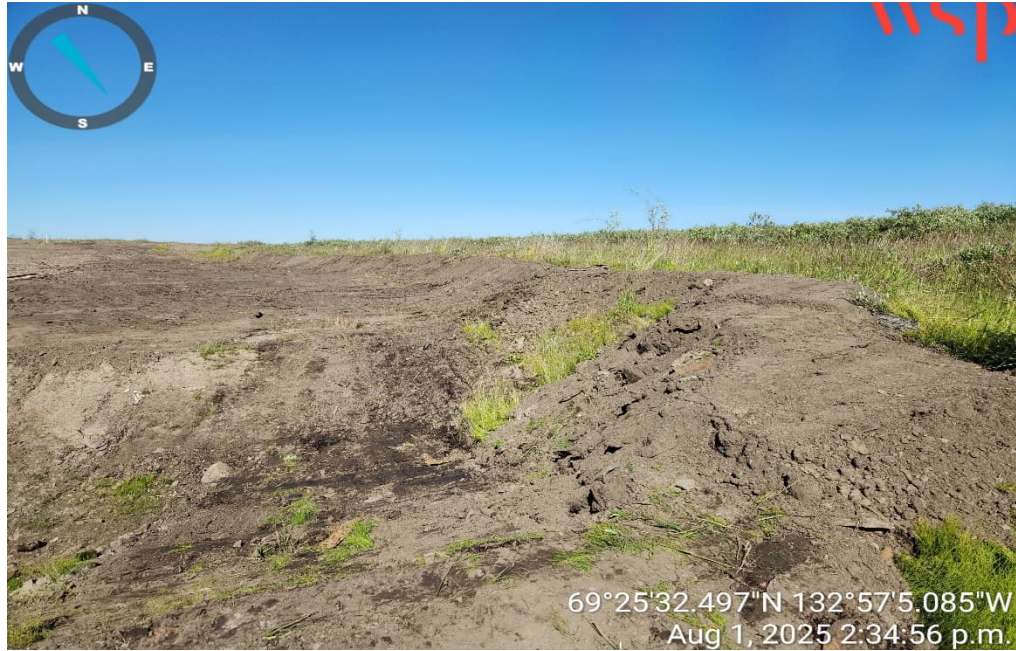
Photo 9 – Repaired berm along the east side of the South Landfill (1 August 2025).

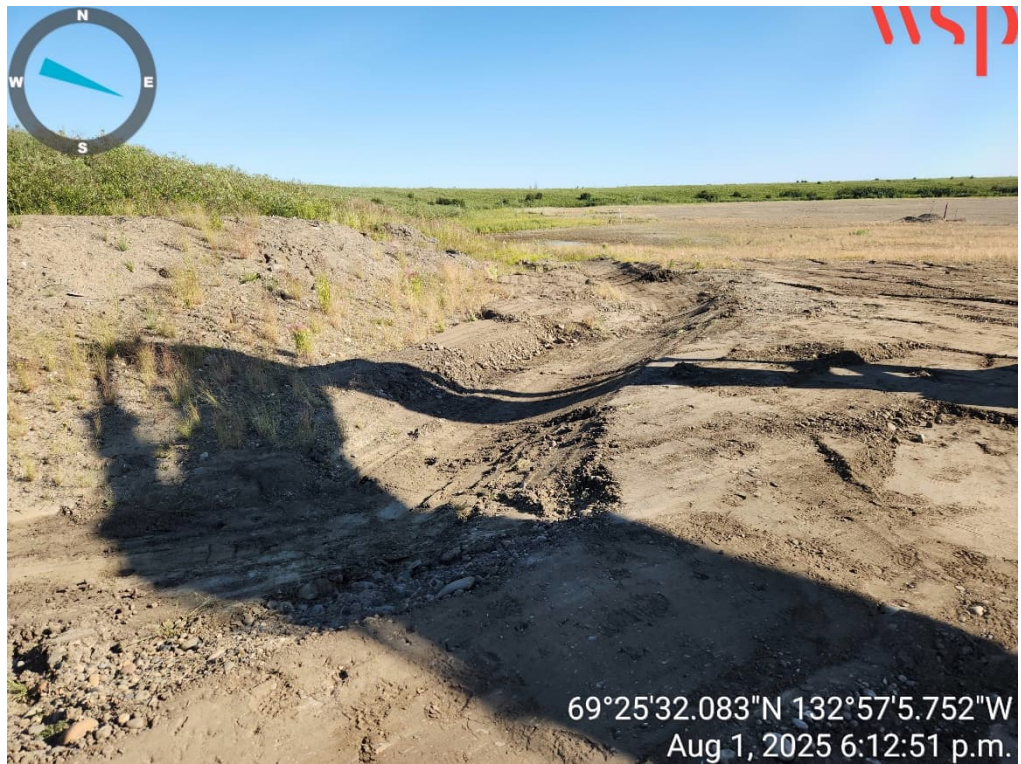
Photo 10 – Restored water management swale at the southeast corner of the South Landfill (1 August 2025).

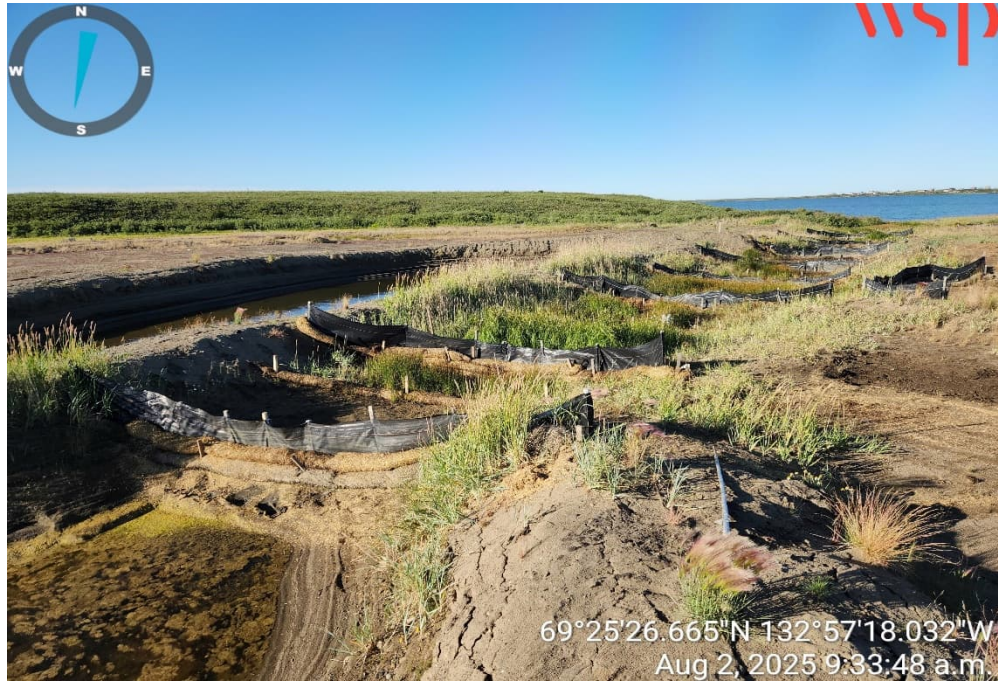
Photo 11 – Completed straw-wattle replacement and minor repairs on the Lower Terrace main water management swale (2 August 2025).

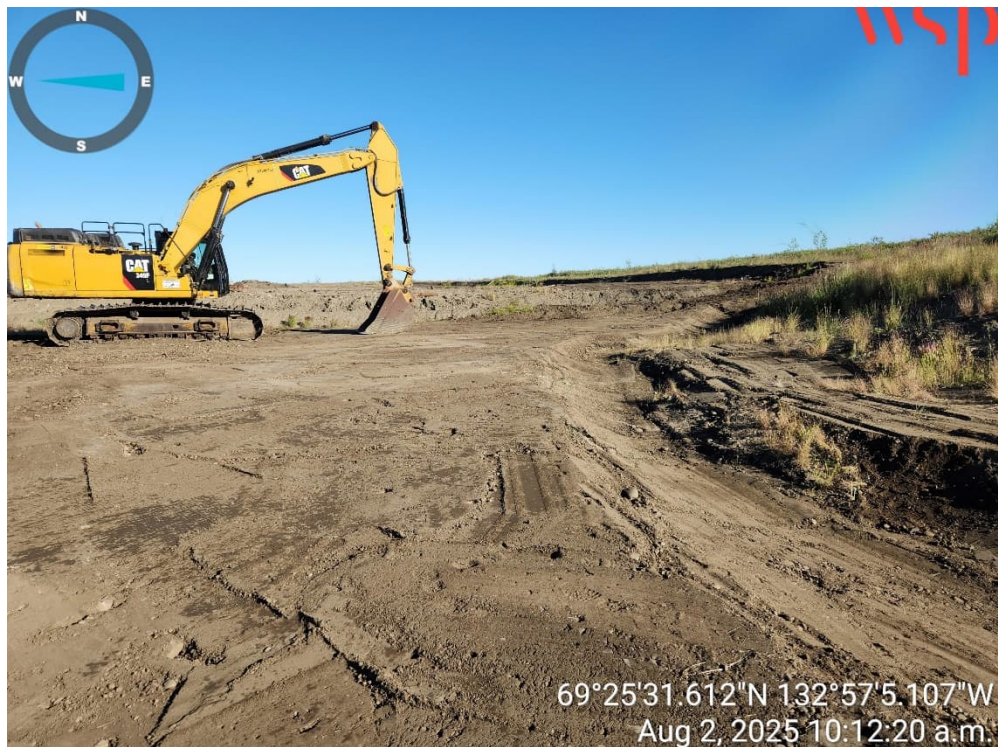
Photo 12 – CAT 349 excavator completing sloping away from the swale outside of the southeast corner of the South Landfill (2 August 2025).

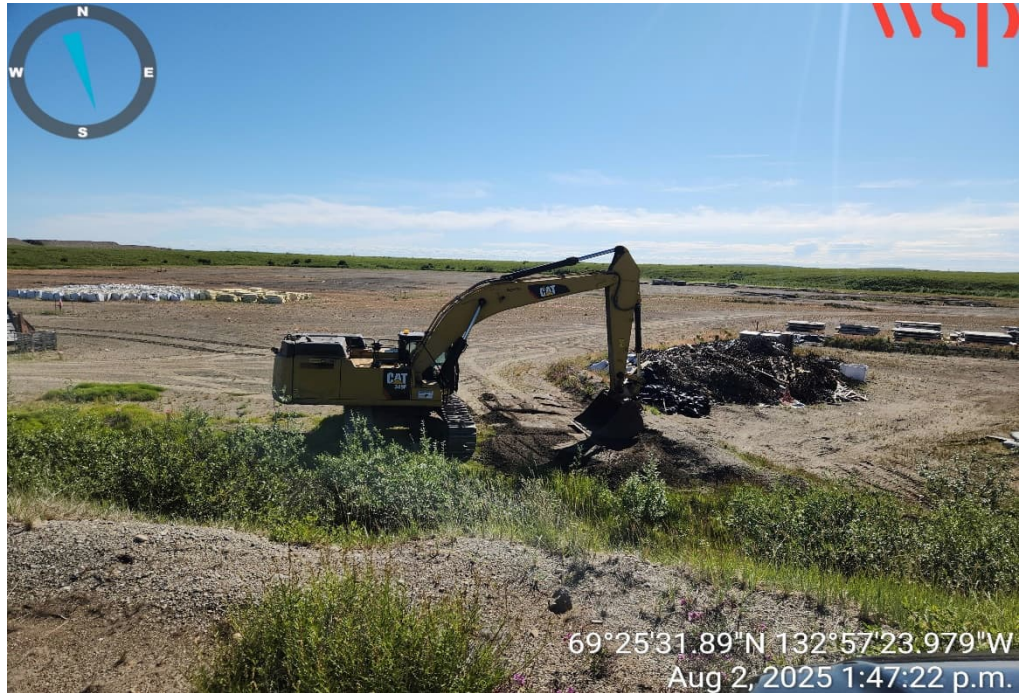
Photo 13 – CAT 349 excavator repairing swales and berms at the north entrance to the Metal & Debris stockpile (2 August 2025).

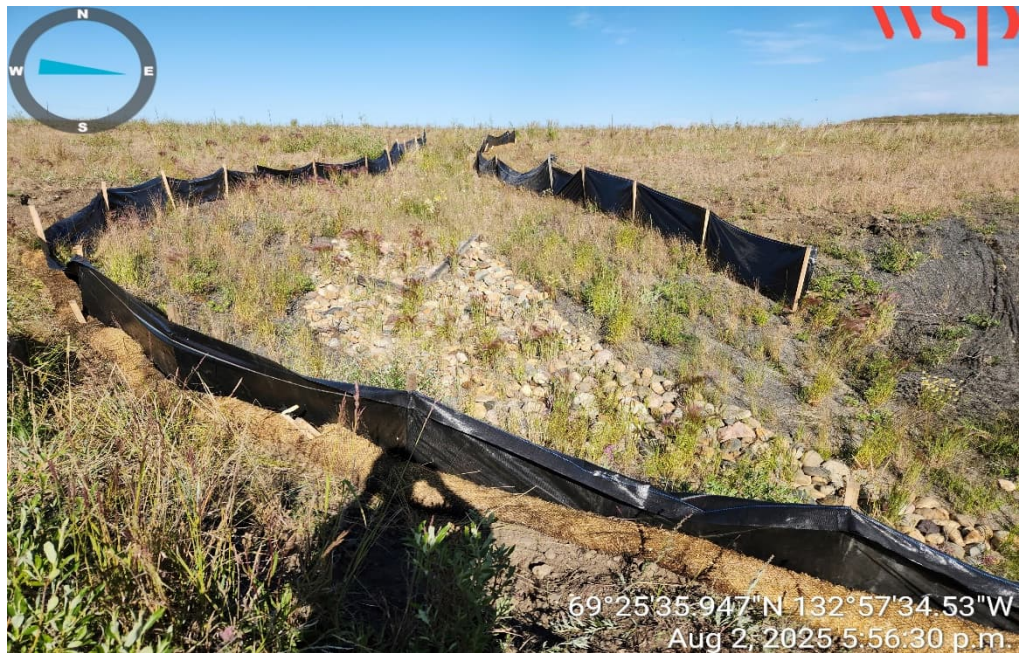
Photo 14 – New silt fence and wattles installed on each side of the ephemeral draw through former remediated excavation D2 (2 August 2025).

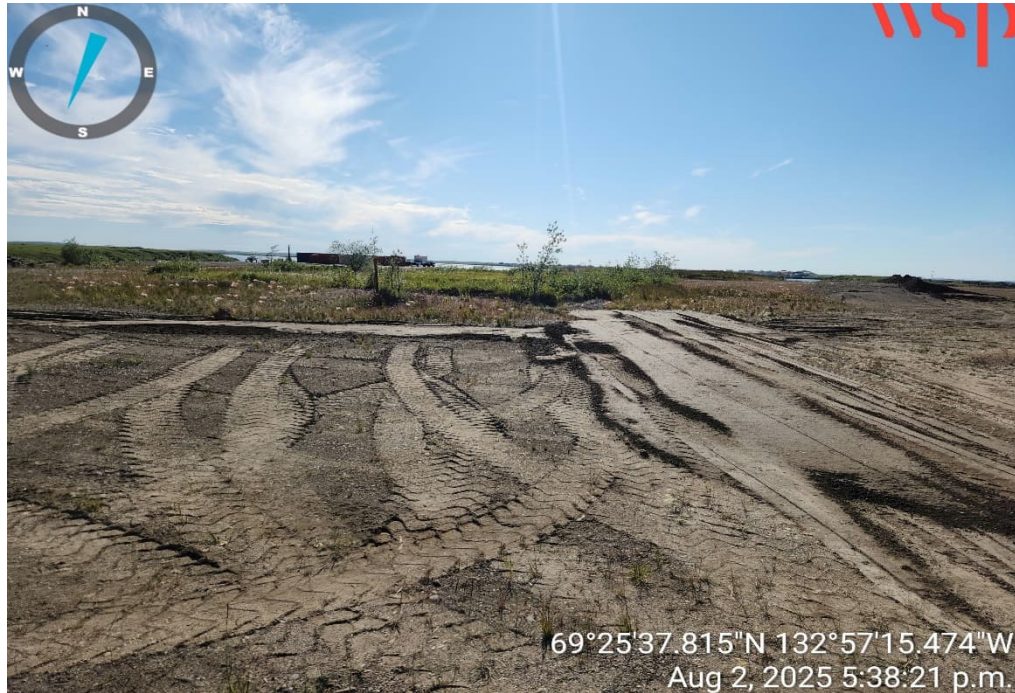
Photo 15 – Repaired soil subsidence on the Upper Terrace adjacent to a former remediated excavation (2 August 2025).

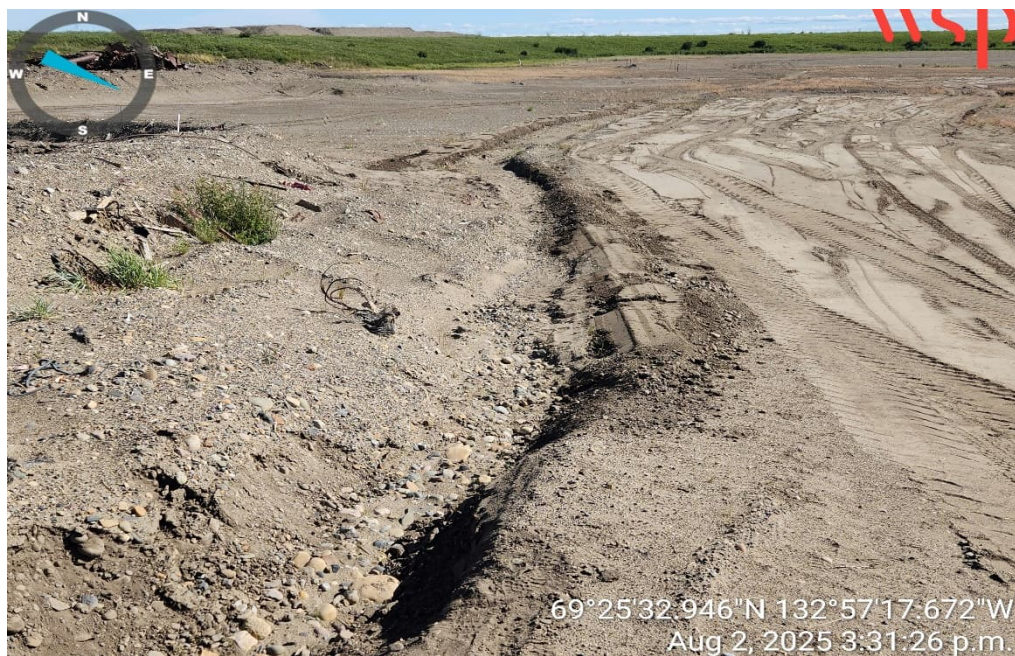
Photo 16 – Repaired swale along the west side of the South Landfill (2 August 2025).

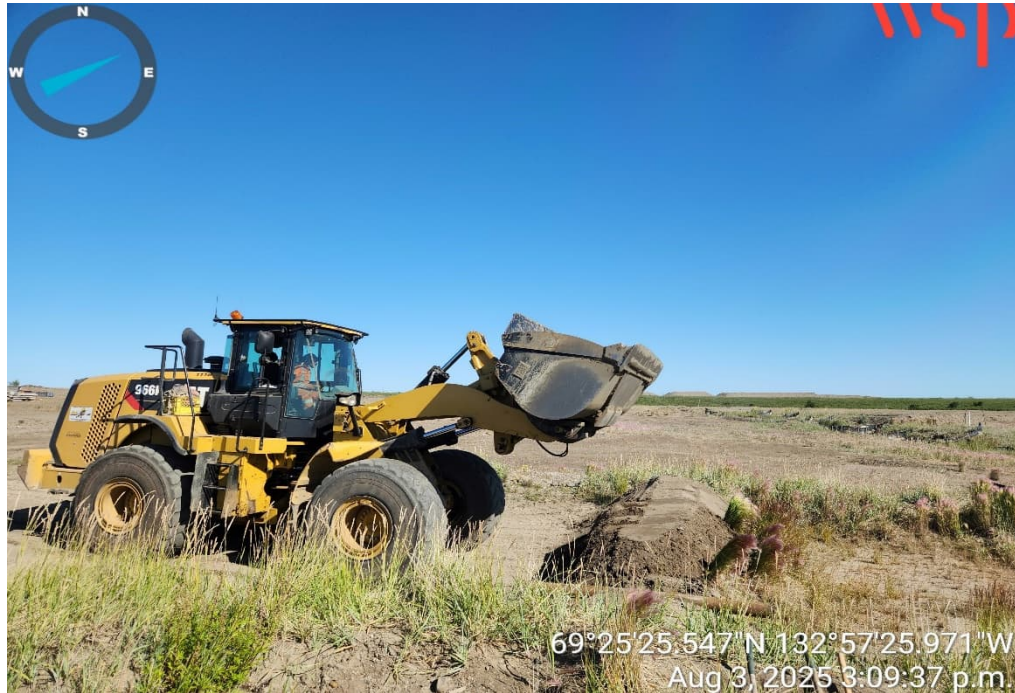
Photo 17 – Rebuilding berm surrounding the southwest settling pond for swales at the Metal & Debris Stockpile (3 August 2025).

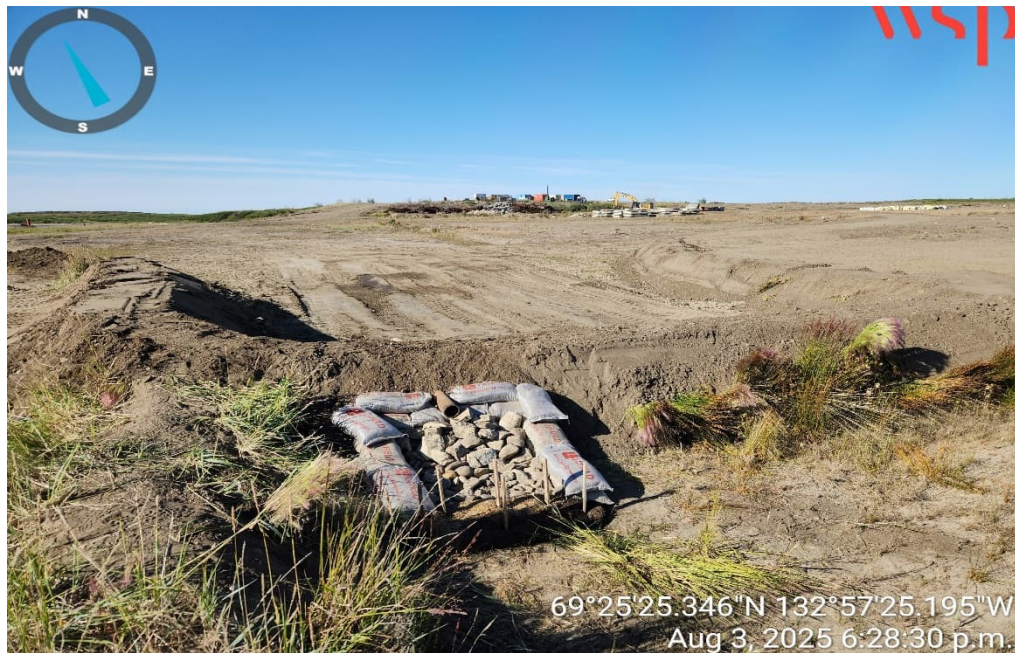
Photo 18 – Completed berm repairs with overflow pipe and splash pad for the southwest settling pond for swales from Metal & Debris Stockpile (3 August 2025).

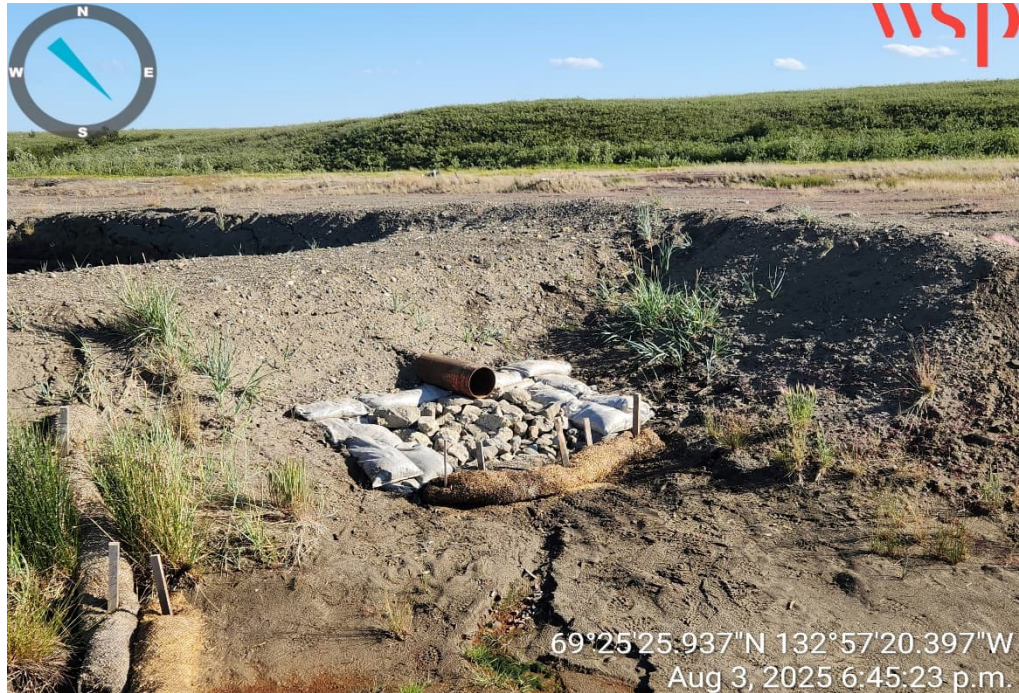
Photo 19 – Additional rip rap added to splash pad of overflow pipe from the main secondary settling pond (3 August 2025).

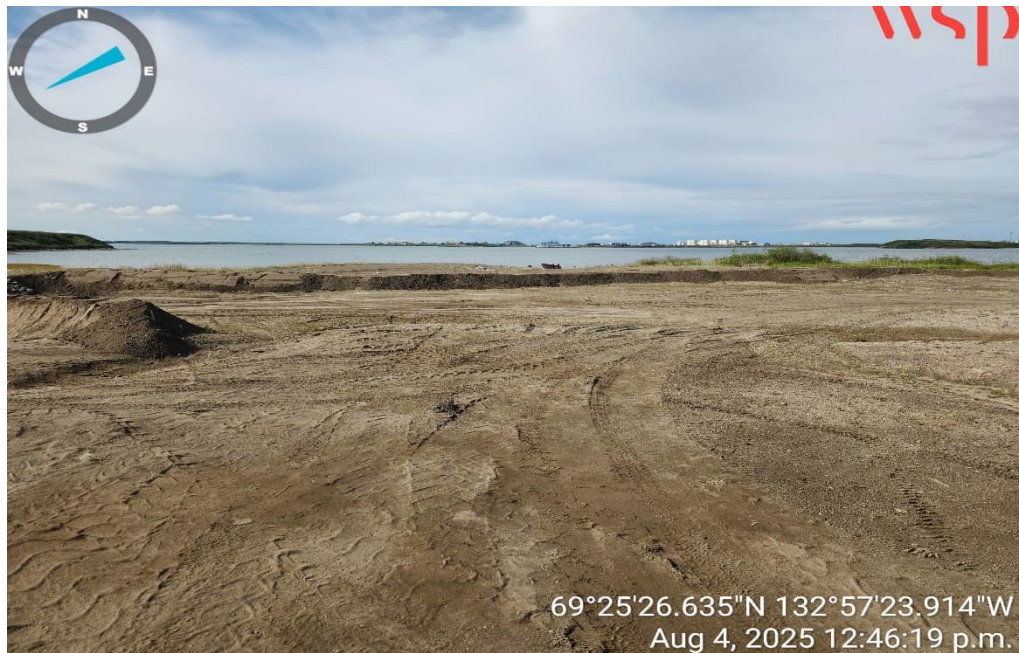
Photo 20 – Extended berm of the southwest settling pond for the swales originating at the Metal & Debris Stockpile (4 August 2025).

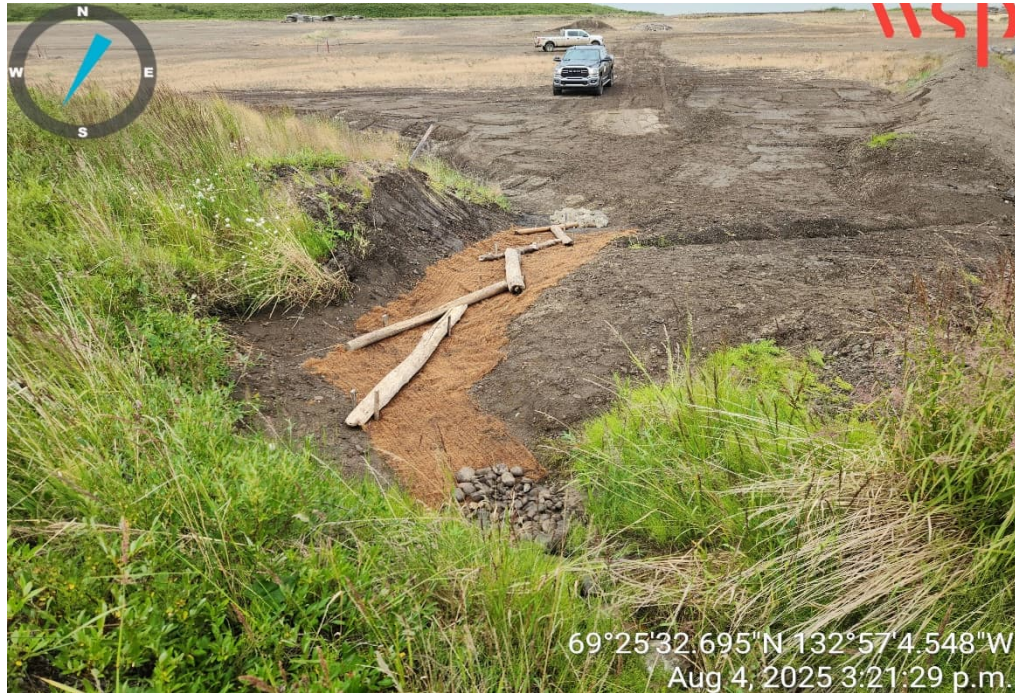
Photo 21 – Constructed erosion control coconut matting and driftwood within the water management swale at the southeast corner outside the South Landfill (4 August 2025).

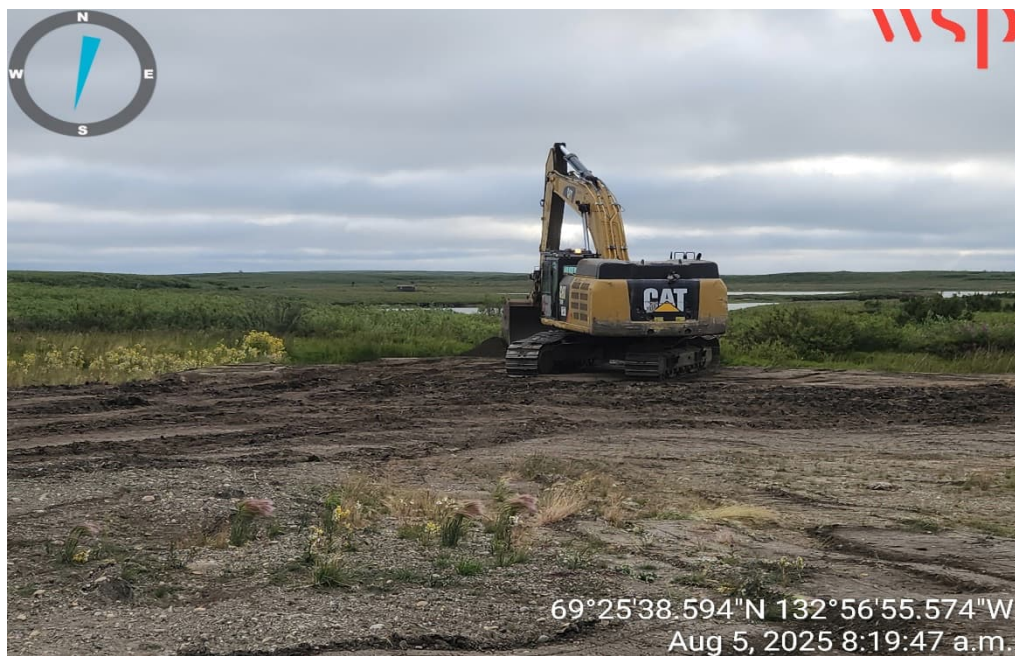
Photo 22 – Backfilled and graded to natural ground elevation at the Former Sewage Lagoon (5 August 2025).

On 4 and 5 August 2025 backfill and levelling were progressed in the subsidence and low-lying areas observed during the 2023 and 2024 seasons along the northeast side of the former Sewage Lagoon. The CAT 966K loader transported clean backfill stockpiled from the former northeast concrete pad on the upper terrace to the former Sewage Lagoon. Additional backfill from the on-site clean gravel stockpile was transported using the CAT 966K loader and placed for the CAT 349F excavator to distribute and fill remaining low-lying areas. The maintenance work at the former Sewage Lagoon was completed on 5 August 2025 (see photo 22, in Appendix A).

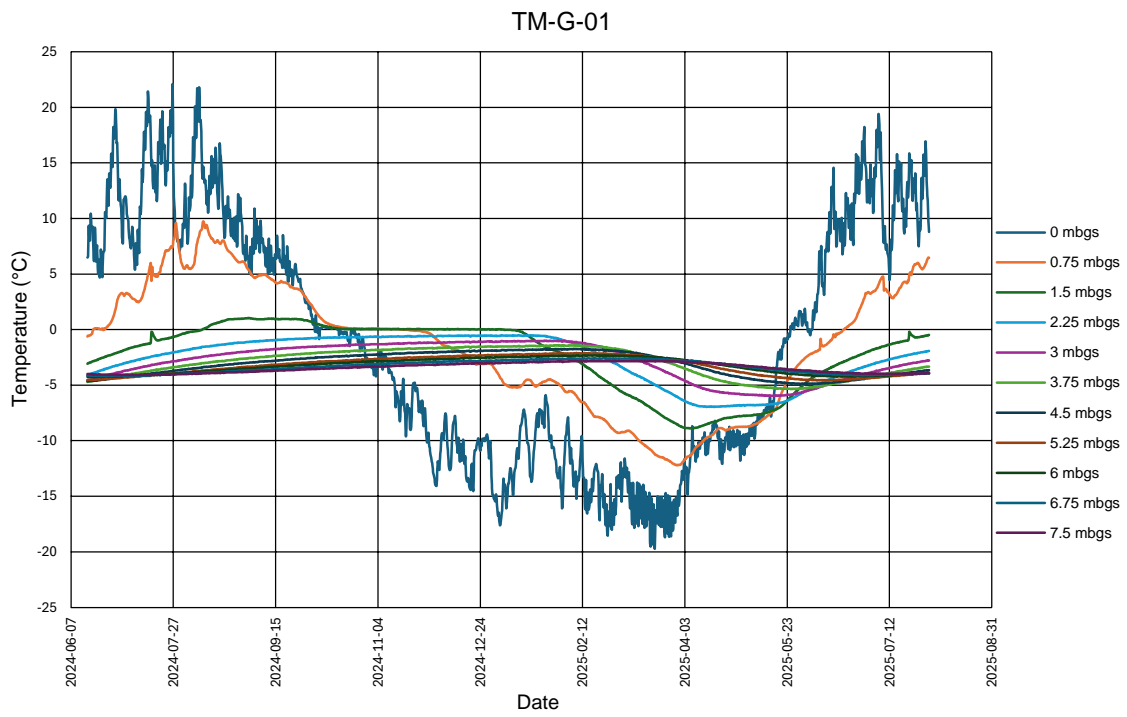
Figure E2: TM-G-01 temperature readings between 15 June 2024 and 31 July 2025

Inferred depth to the top of permafrost ranges from approximately 2.25mbgs to 2.7mbgs, as outlined in Table E. The depth of the active layer is considered as the depth at which ground temperatures have not remained consistently below 0 degrees (degree symbol) for a period of 2 or more consecutive years. The depth to permafrost as recorded by individual temperature sensors (Table E, second column) only provides a resolution of 0.75 m. The true depth to permafrost is between the sensor that records temperature below 0°C throughout the year and the next shallowest sensor. The depth of permafrost from thermistor location TM-N-01 in Table E was determined to be between 1.5 and 3.0 mbgs as there were no readings from the sensor installed at 2.25 mbgs. Based on historical data from Advisian, the TM-N-01 sensor installed at 2.25 mbgs has been malfunctioning intermittently since 2016. WSP attempted to troubleshoot but was unable to resolve the sensor malfunction. TM-N-01 and TM-L-01 stopped recording in March 2025 due to logger memory restrictions. In 2025, the memory settings on the TM-N-01 and TM-L-01 loggers were updated to allow for longer data logging. Hence, the six thermistors onsite are expected to continue collecting data through July 2026. Graphical presentation of the thermistor data is presented in Appendix E.

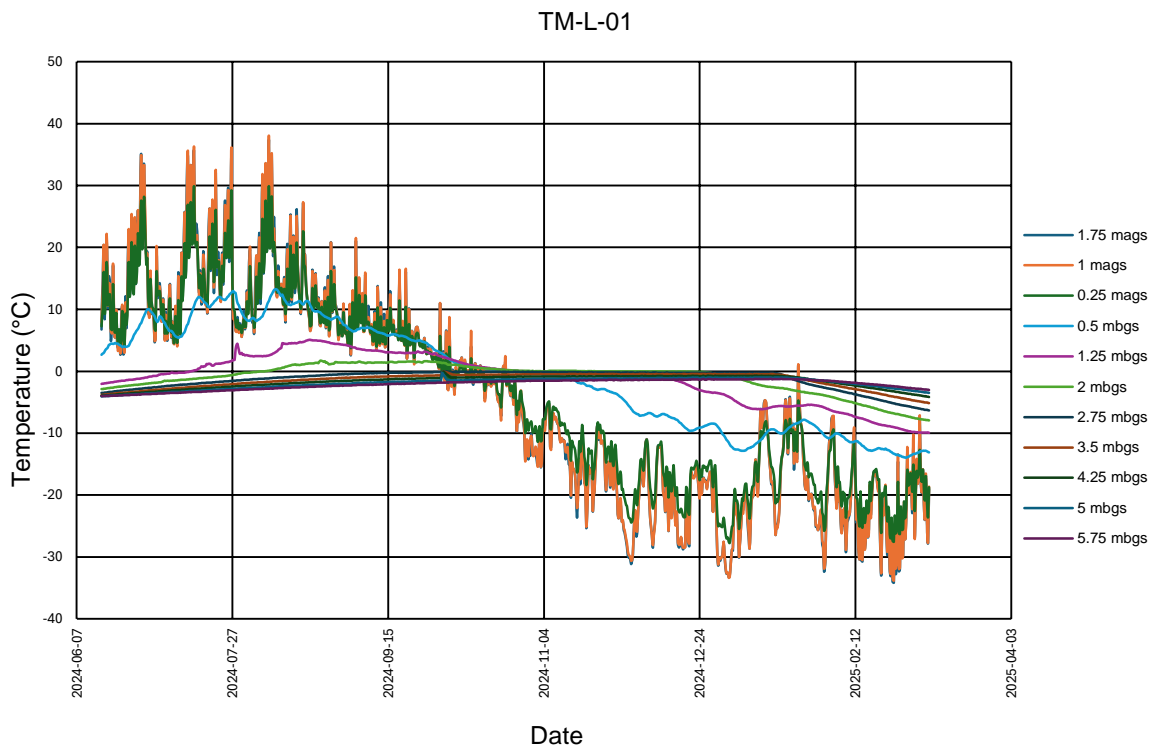
Figure E4: TM-L-01 temperature readings between 15 June 2024 and 7 March 2025

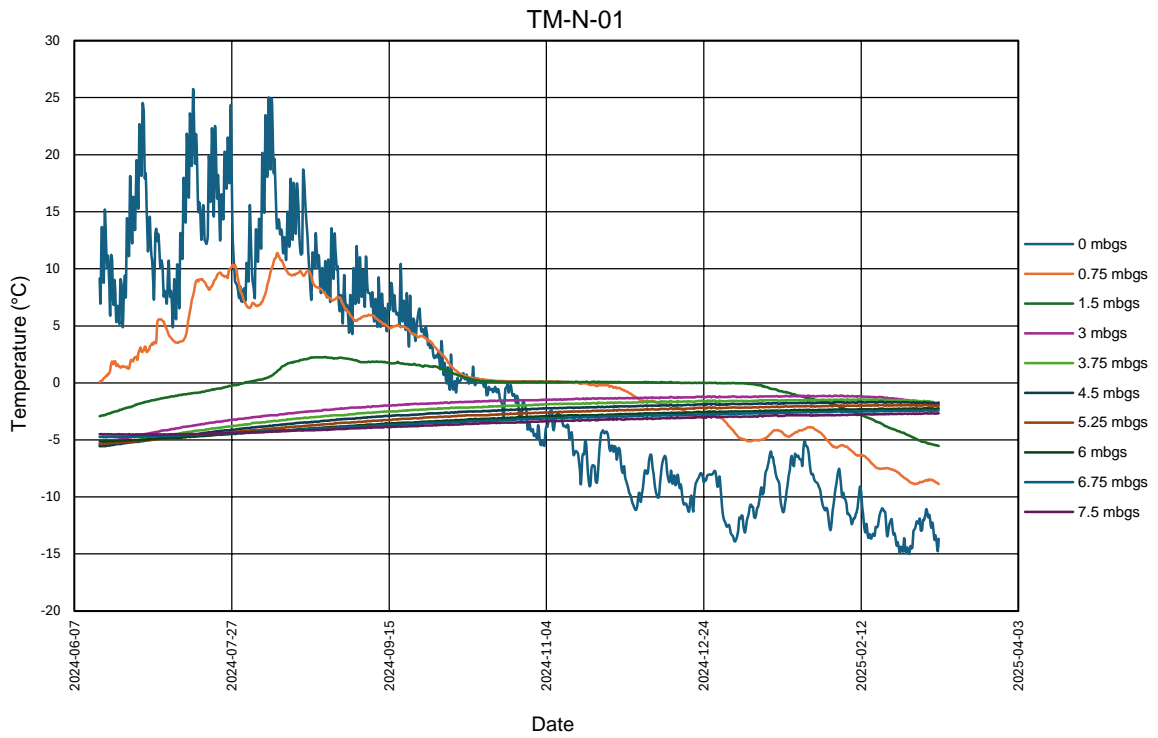
Figure E5: TM-N-01 temperature readings between 15 June 2024 and 8 March 2025

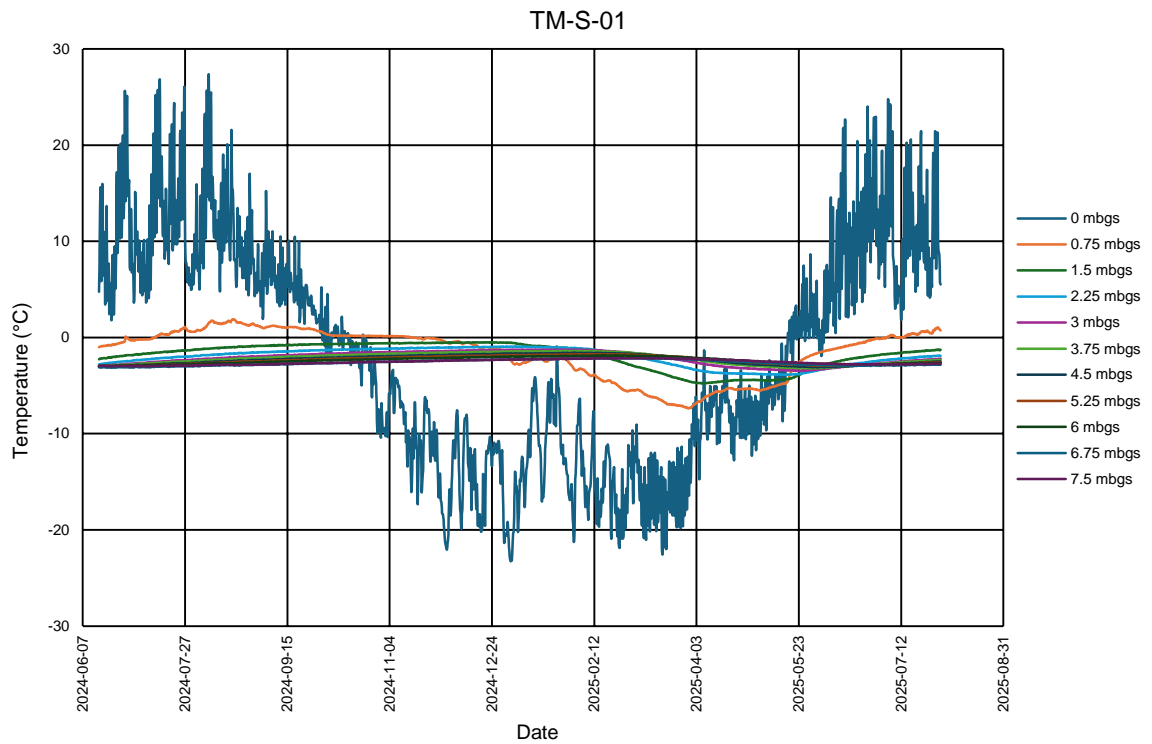
Figure E6: TM-S-01 temperature readings between 15 June 2024 and 31 July 2025
