## 2025 Annual Report

*Inuvialuit Water Board Water Licence, N5L8-1837  
Panarctic F-68 Abandoned Wellsite  
Satellite Bay, Prince Patrick Island, Northwest Territories*

**WSP Canada Inc.**

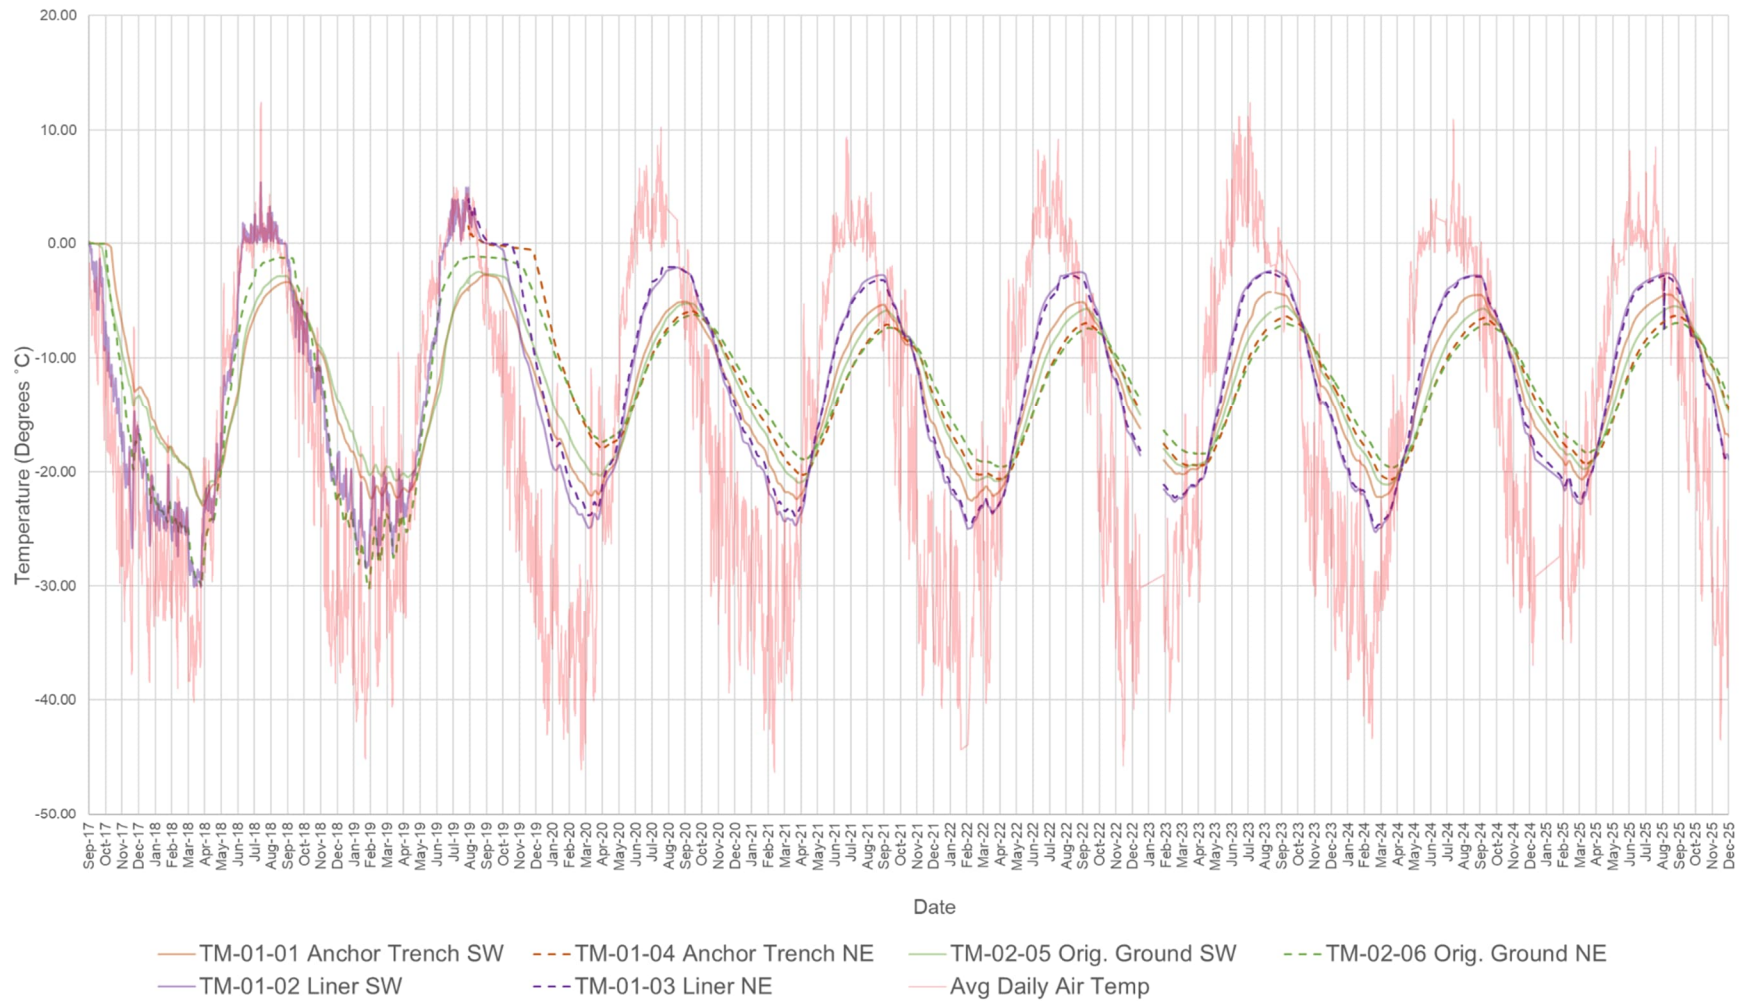
**Figure A: Containment Cell Temperatures**

The temperature monitoring system is working as designed. Battery voltages recovered following the battery replacement on 16 July 2025 and have remained functional to date. Despite the return to sub-optimal battery voltage between 2022 and July 2025, the system remained mostly operational throughout 2025, with the exception of 5 January to 20 February 2025 when battery voltages reduced below functional levels.

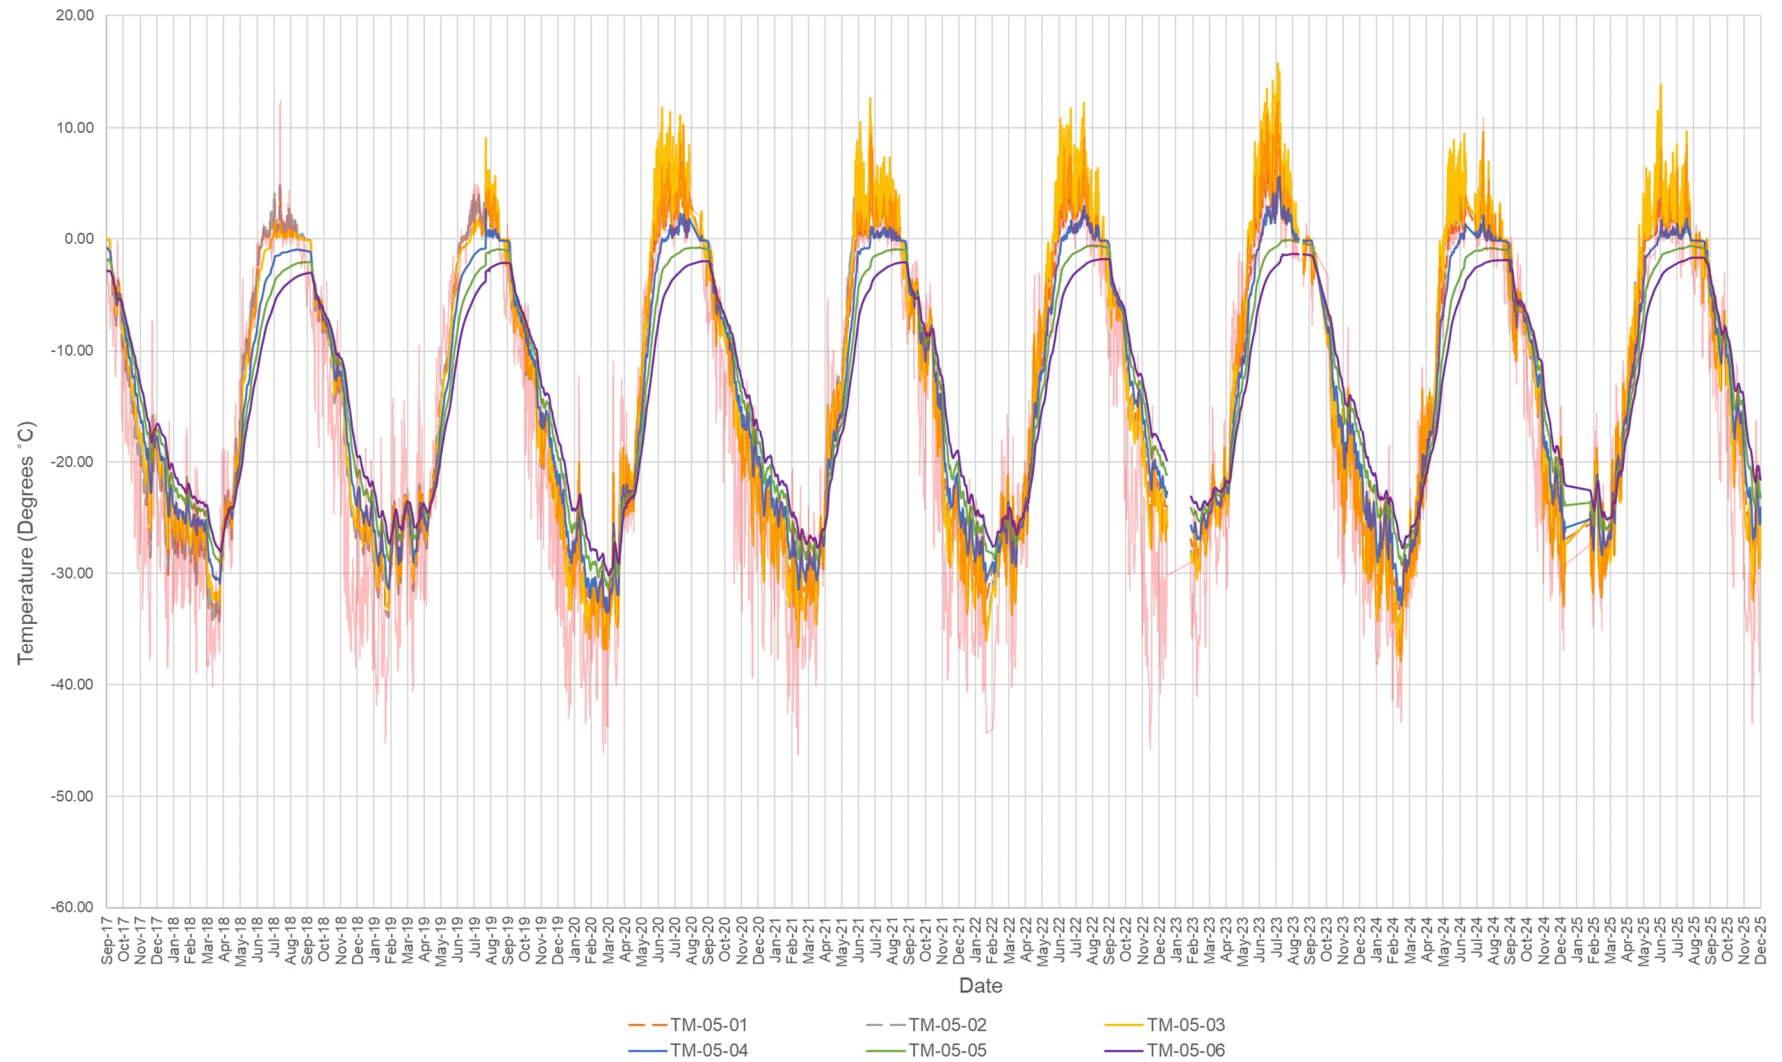
Figure B: Background Station Temperatures

- **Background Station (TM-05-01 through TM05-06):** This location represents the soil temperature conditions in an area removed from the effects of the Containment Structure and monitors changes in the active layer. Six thermistors are buried in a vertical borehole at depths of 0.27, 0.31, 0.61, 1.11, 1.61 and 2.11 m.

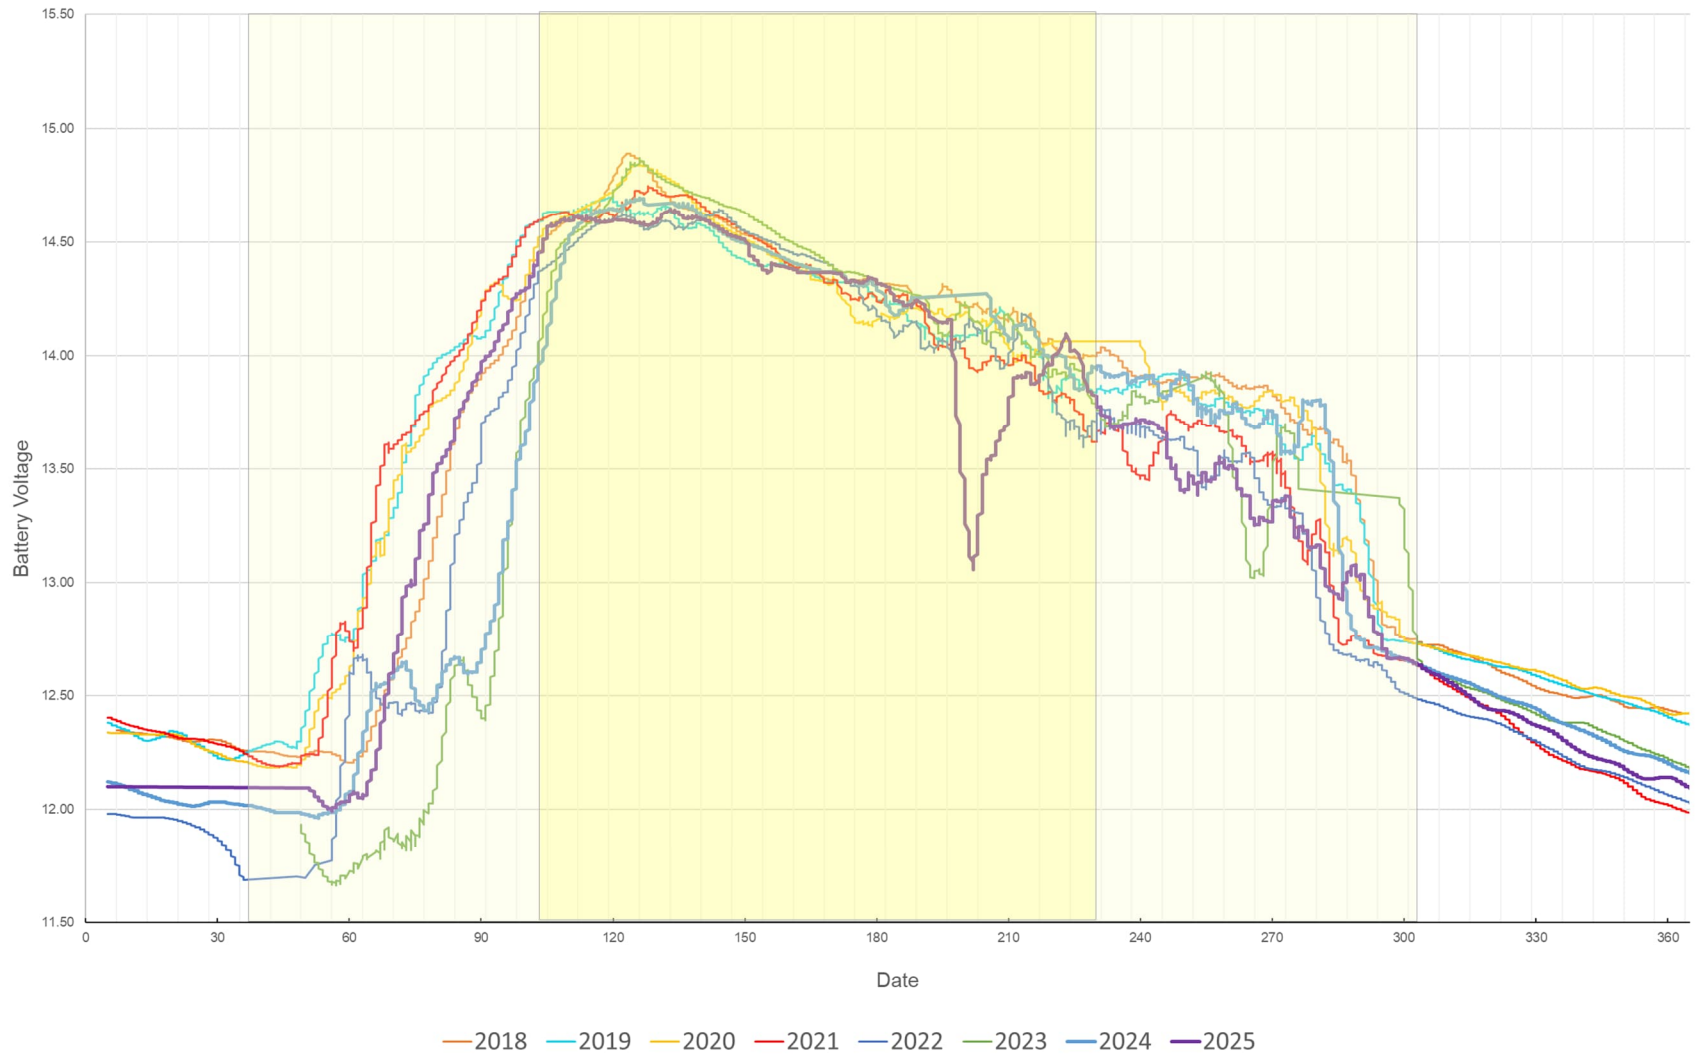
**Figure C: Annual Battery Voltages**

In December 2021, the voltage dropped below 12 volts, suggesting that the battery had begun to reach the end of its optimal service life. In the summer of 2022, the battery was replaced during a scheduled monitoring program. A subsequent voltage drop commencing in December 2022 was similar to that noted in 2021 and suggested the replacement battery was not operating as expected, and the battery was again replaced during the 2025 field season (on 16 July 2025). Data in 2025, prior to the battery replacement, indicated that some battery performance remained at functional levels, however, voltages remained lower than in the initial years of operation (more days with power below 12.5 volts) during low or no daylight periods. Following the 16 July 2025 battery replacement, voltages remained above 12 volts through to the end of 2025.

**Note:** Yellow shading in Figure C indicates daylight hours, darker yellow indicates 24 hour daylight.

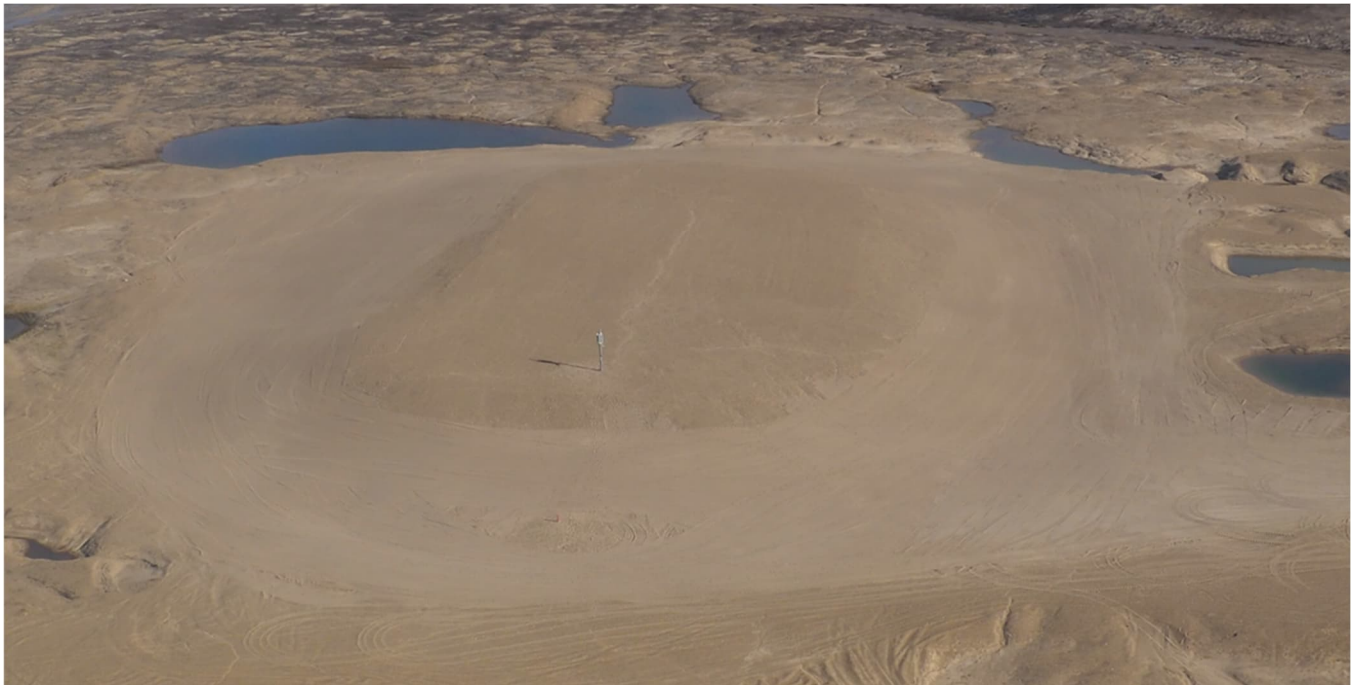
A final drone flight of the Containment Structure was completed by Clifton on 16 July 2025. During the drone flight, persistent high winds presented significant challenges, affecting a few sections of the photo orthomosaic (shown as blank areas on Drawings 5 and 9 in Appendix C). A final aerial photo (taken from a plane) of the Containment Structure is shown in Insert A below.

**Insert A: Aerial photo of Containment Structure after grading (Photo looking northeast, 9 August 2025)**

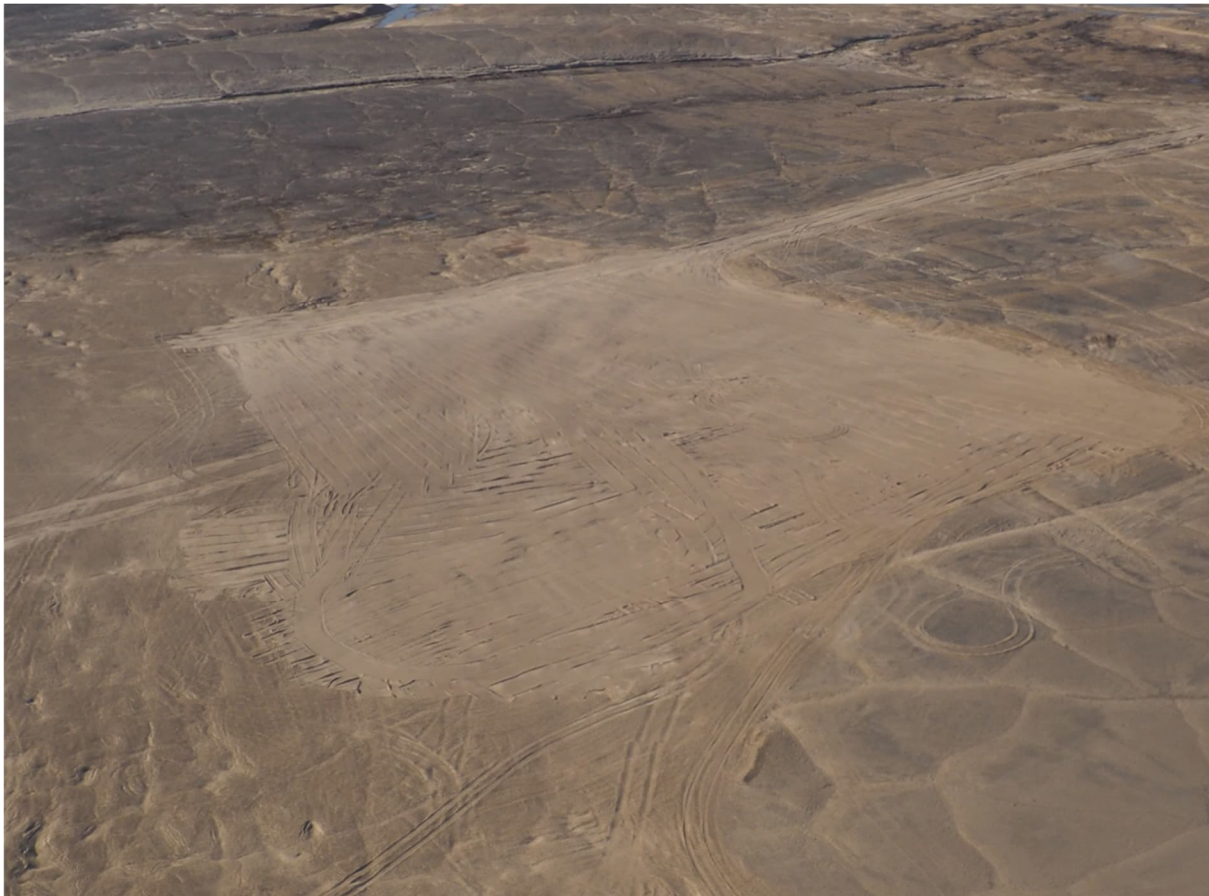
A drone flight of the Borrow Area was also attempted; however, due to unfavourable weather conditions including sustained high winds, a drone flight was not possible. Aerial photographs of the Borrow Area were taken on 9 August 2025 from a plane, as shown in Insert B.

**Insert B: Aerial photo of Borrow Area graded following use in 2025  
(Photo looking southwest, 9 August 2025)**

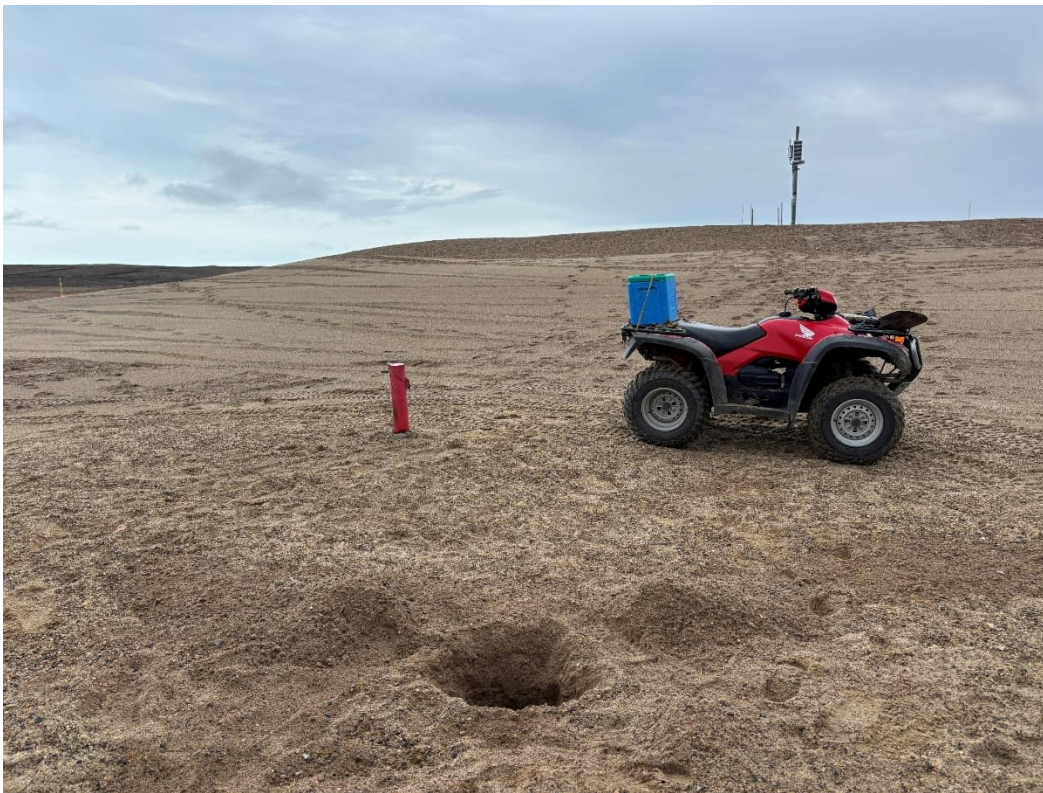
**Insert C: Photo of Soil Sampling at MW19-03SS (30 July 2025)**

Soil sampling was completed within approximately 3.0 m of each of the four monitoring wells; sampling locations are shown on Figure 4 and a photograph is provided in Insert C below. These locations are separated from those where the baseline soil samples were collected in 2019 and Year 1 samples collected in 2022.

The typical permafrost depth at the Site is approximately 0.70 to 0.80 m. Two samples, a shallow (between 0.10 and 0.2 m) and deep (between 0.50 and 0.60 m), were collected as grab samples within a hole excavated with a shovel. The holes were then backfilled with native material and the location relative to the monitoring well recorded.

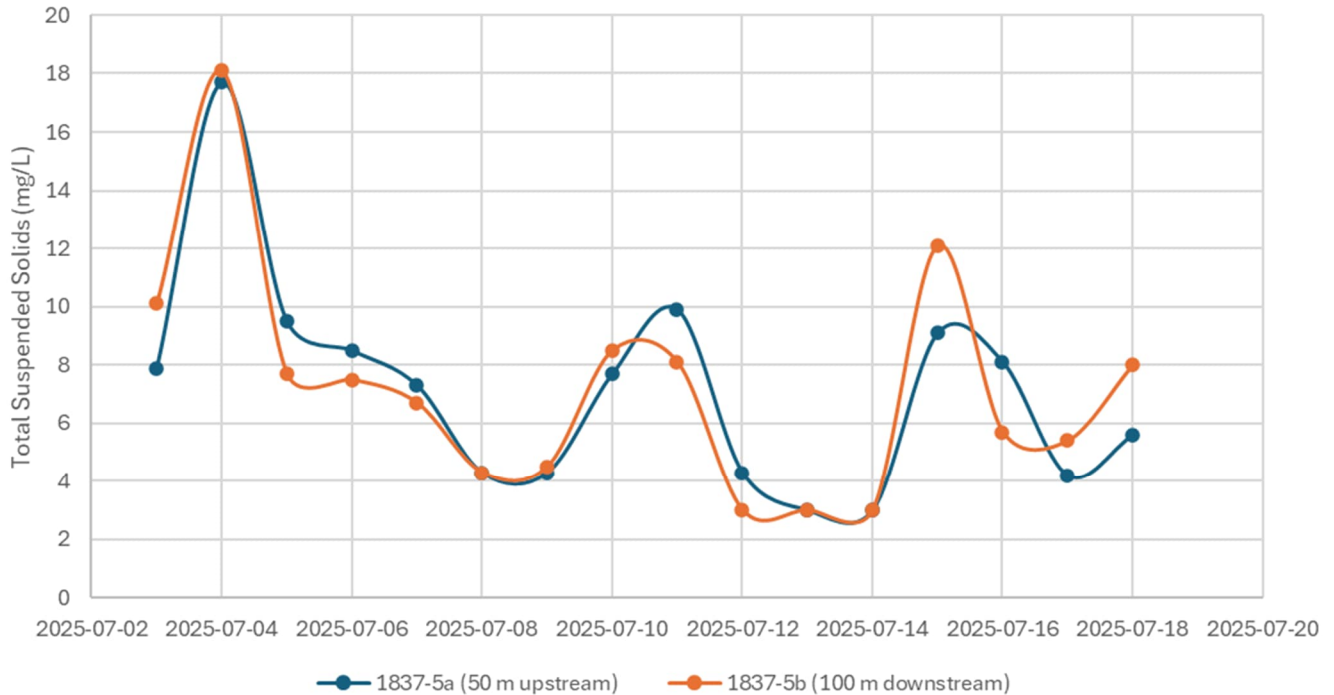
downstream TSS concentration were higher on the day the water course crossing was installed; however, both TSS concentrations decreased back to the pre-installation TSS concentrations within one day.

**Figure D: TSS Concentrations in the Surface Water Samples Collected from SNP Station 1837-5 in 2025**

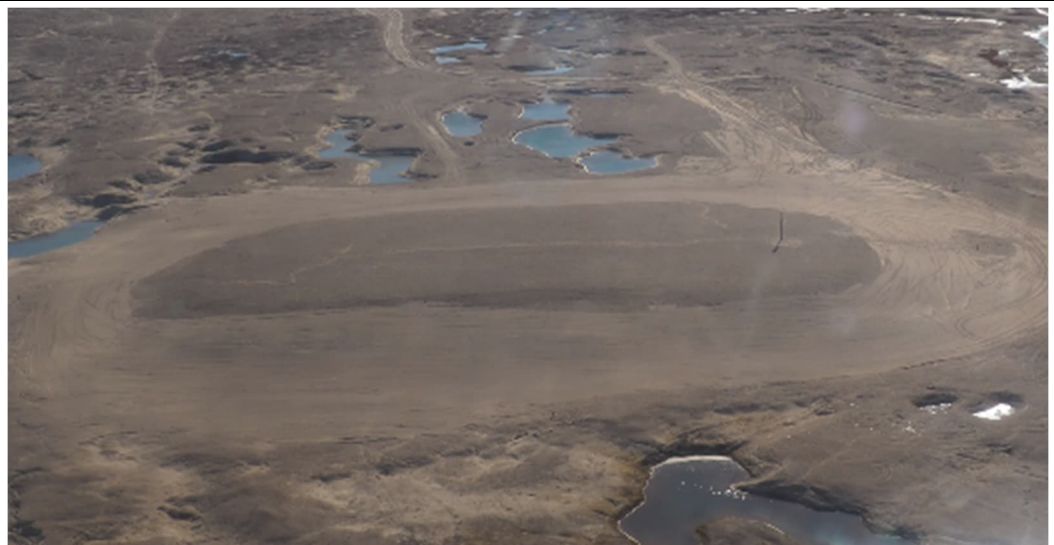
**Photograph 3:**

**2025 Post-Grading**

Communication tower visible on southwest (centre) in photo.

Ponds Q, R, P visible to east (top part of photo).

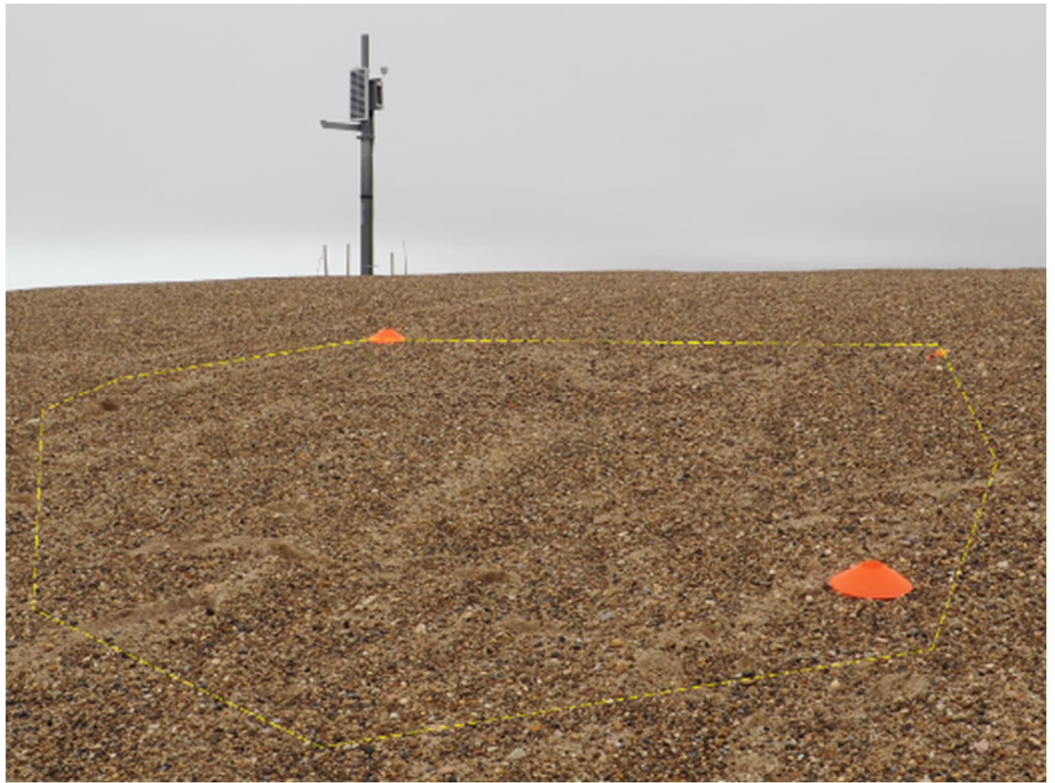
**Photograph 6:**

**Feature 1 – 2025  
Post-Grading  
Inspection**

Feature removed by  
regrading.

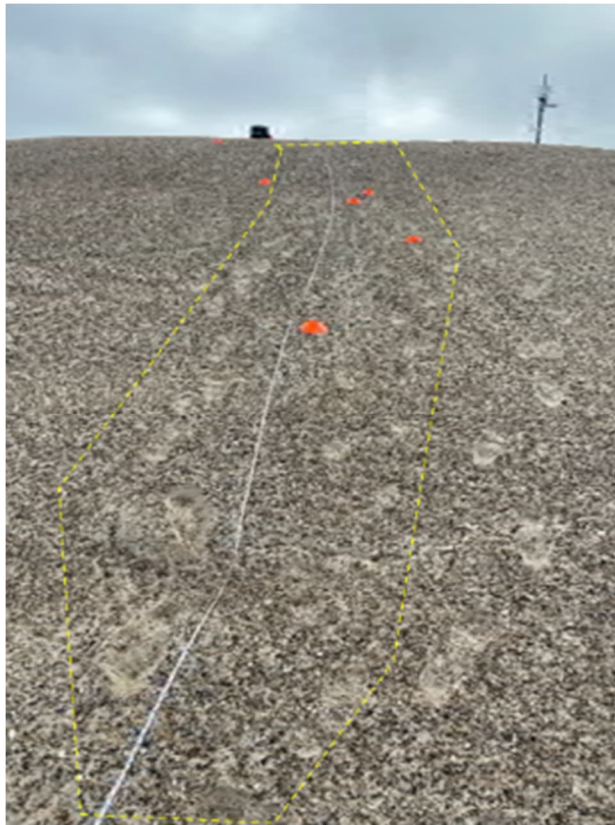
**Photograph 8:**

**Feature 2 – 2025**  
**Pre-Grading**  
**Inspection**

Similar to 2022 but  
deeper and more  
defined.

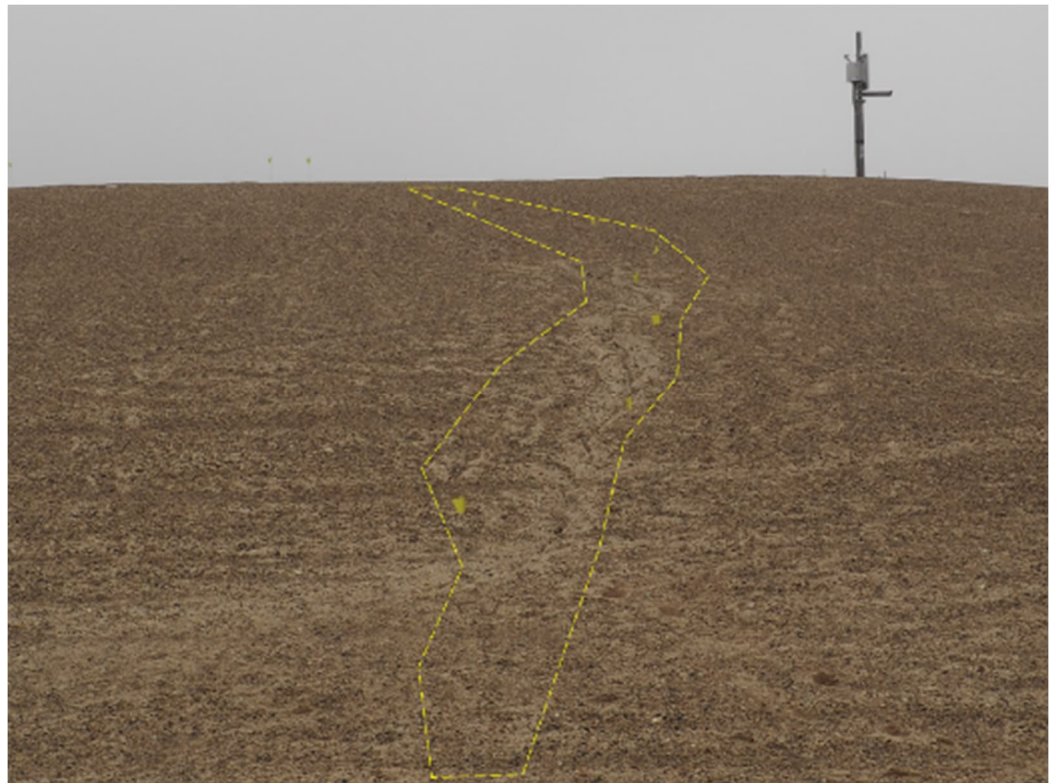
**Photograph 9:**

**Feature 2 – 2025  
Post-Grading  
Inspection**

Feature removed by  
grading.

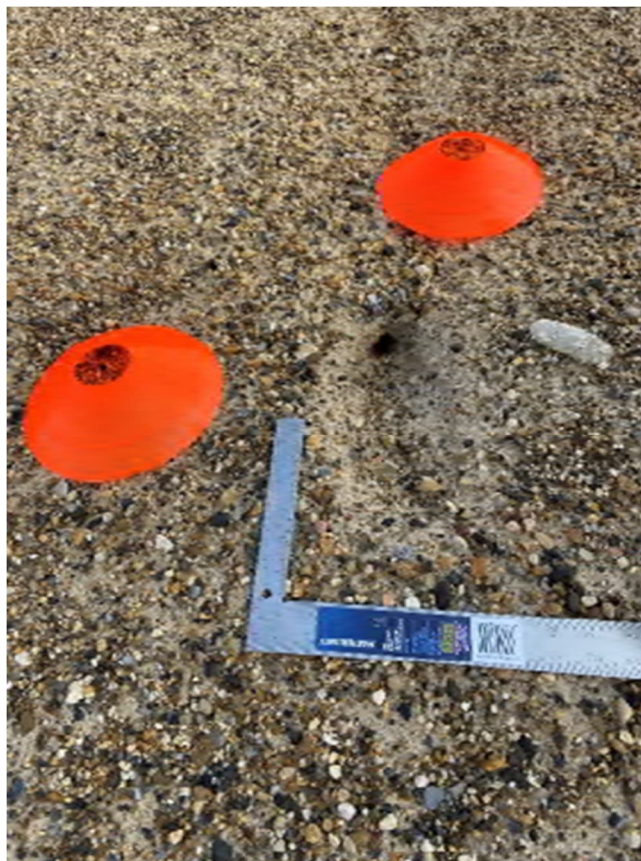
**Photograph 11:**

**Feature 3 – 2025  
Pre-Grading  
Inspection**

Noted depressions  
within the channel  
similar to earlier  
animal burrow  
feature.

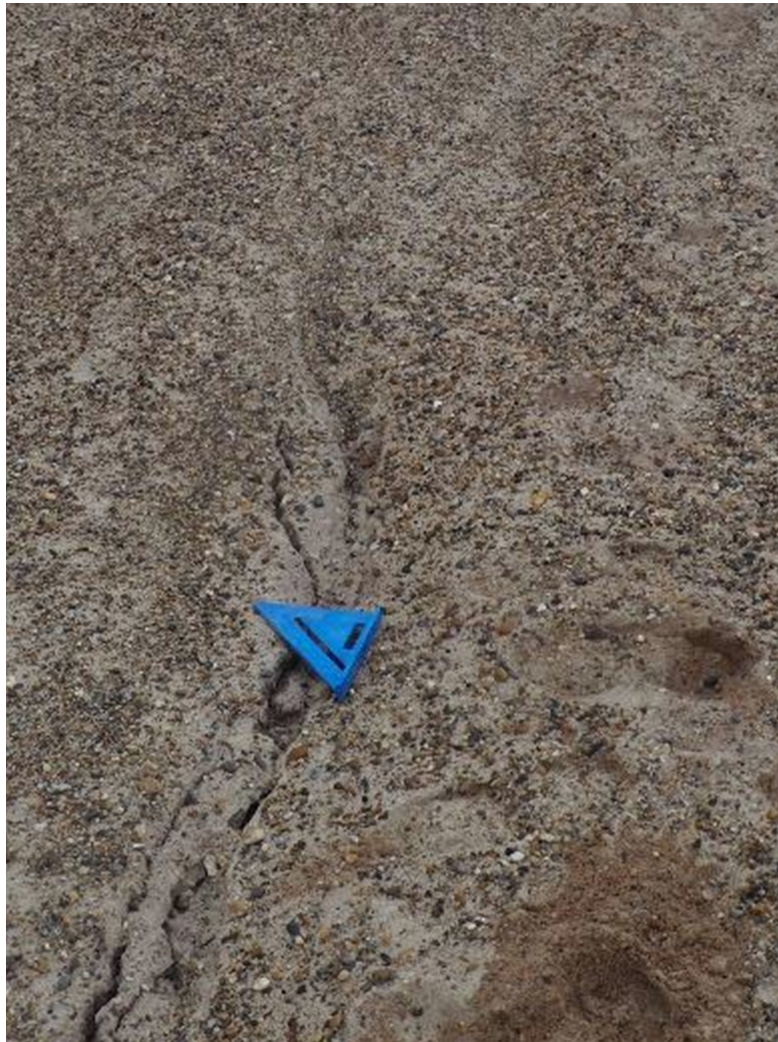
**Photograph 13:**

**Feature 3 – 2025  
Post-Grading  
Inspection**

Feature removed by  
grading.

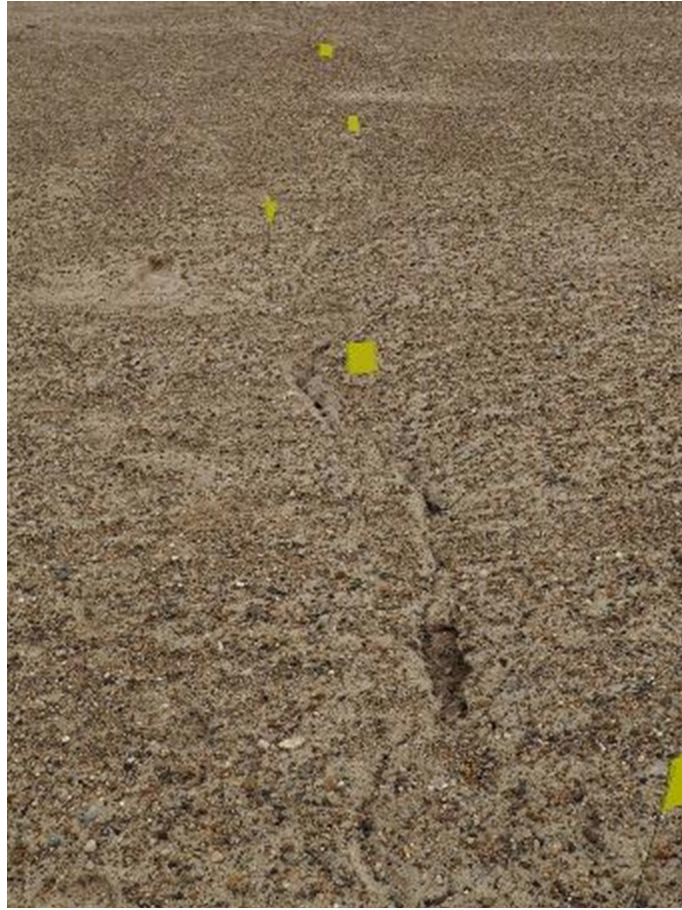
**Photograph 18:**

**Feature 4 – 2025  
Post-Grading  
Inspection**

Feature removed by  
regrading.

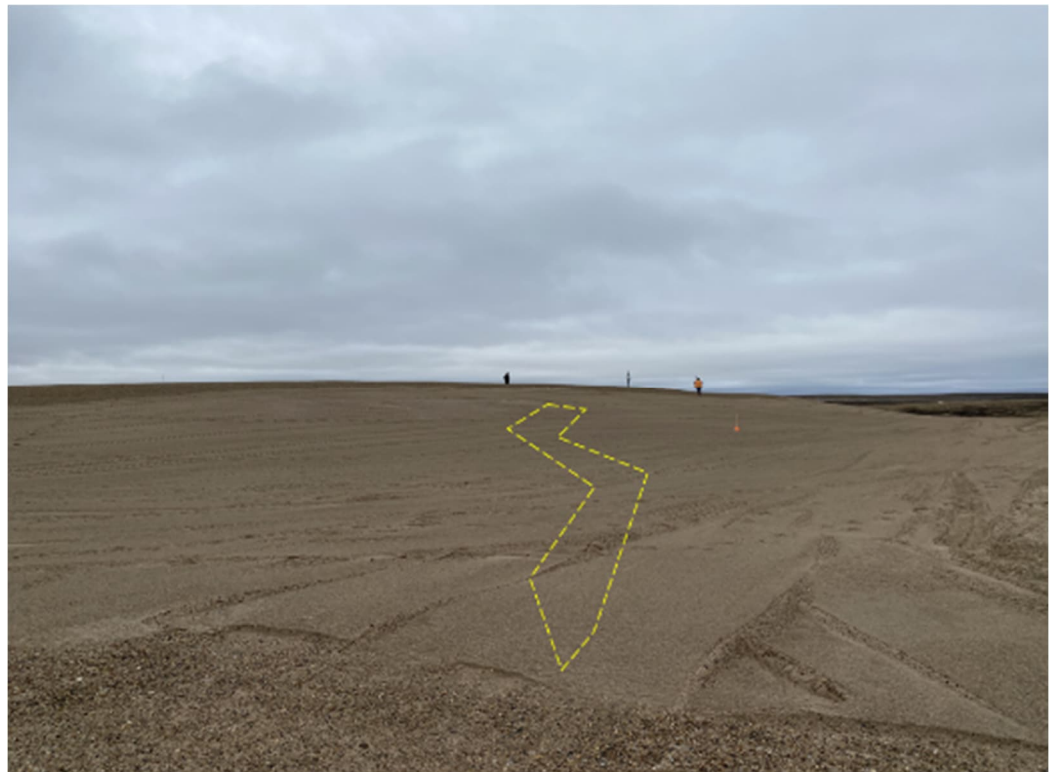
**Photograph 19:**  
**Feature 5 – 2022**  
**Visual Inspection**  
Drainage erosion channel on south corner sideslope (looking upslope).

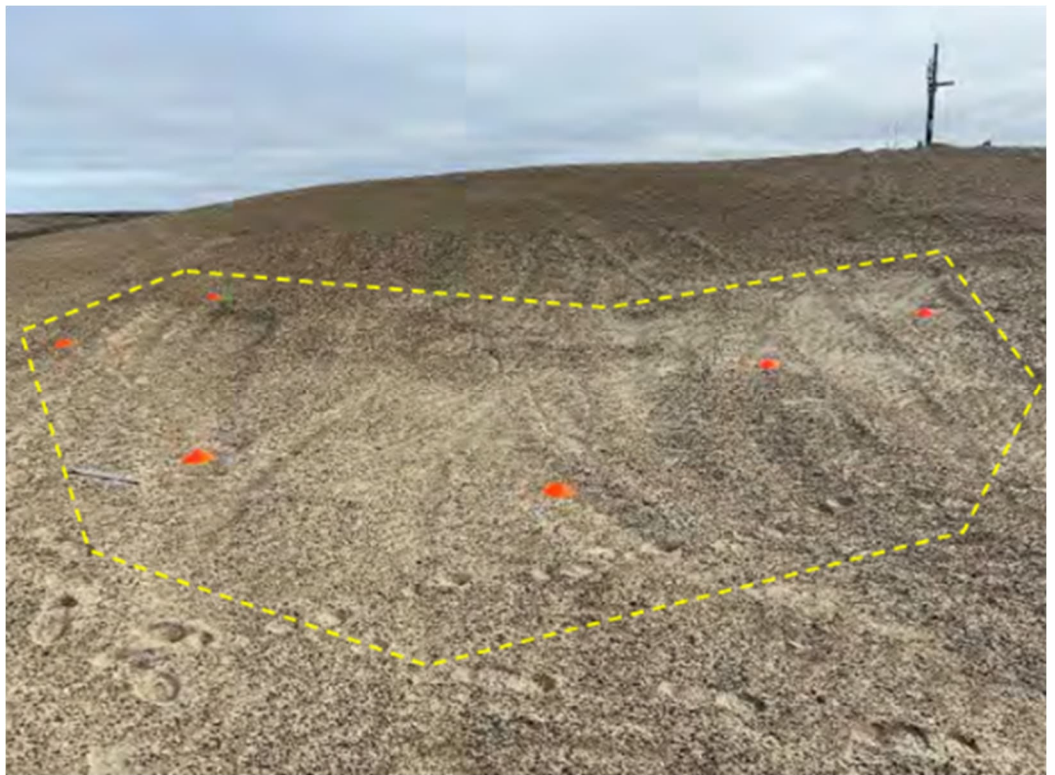
**Photograph 23:**

**Feature 6 – 2025  
Pre-Grading  
Inspection**

Similar to 2022.

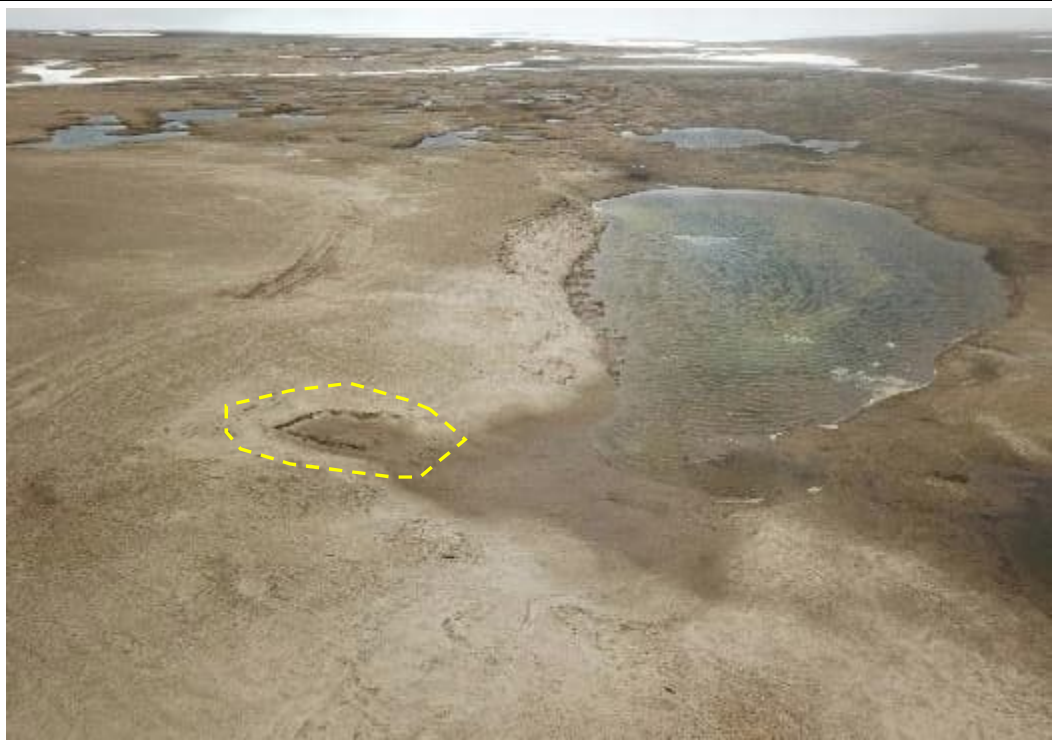
**Photograph 30:**

**Feature 8a – 2025  
Pre-Grading  
Inspection**

Similar to 2022.  
Drainage from low  
area to discharge  
point (bottom of  
photo) evident.

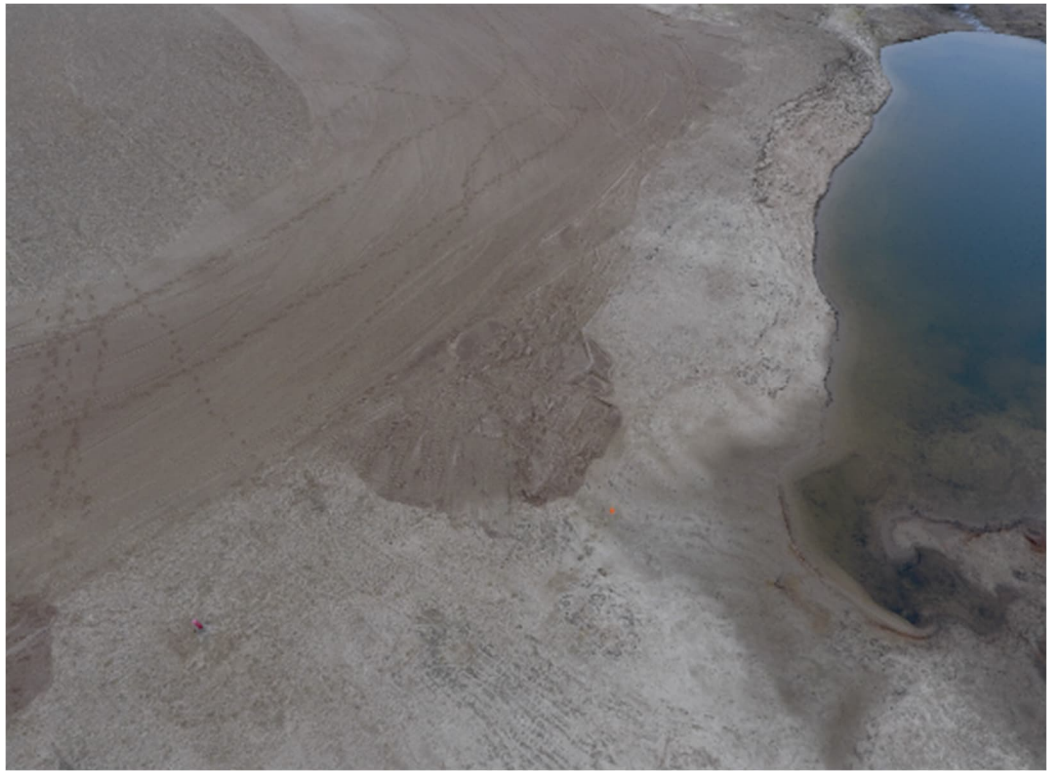
**Photograph 33:**

**Feature 8b – 2024 Site Visit**

Feature not identified in 2022 but noted in oblique air photo and ground photos completed in 2024.

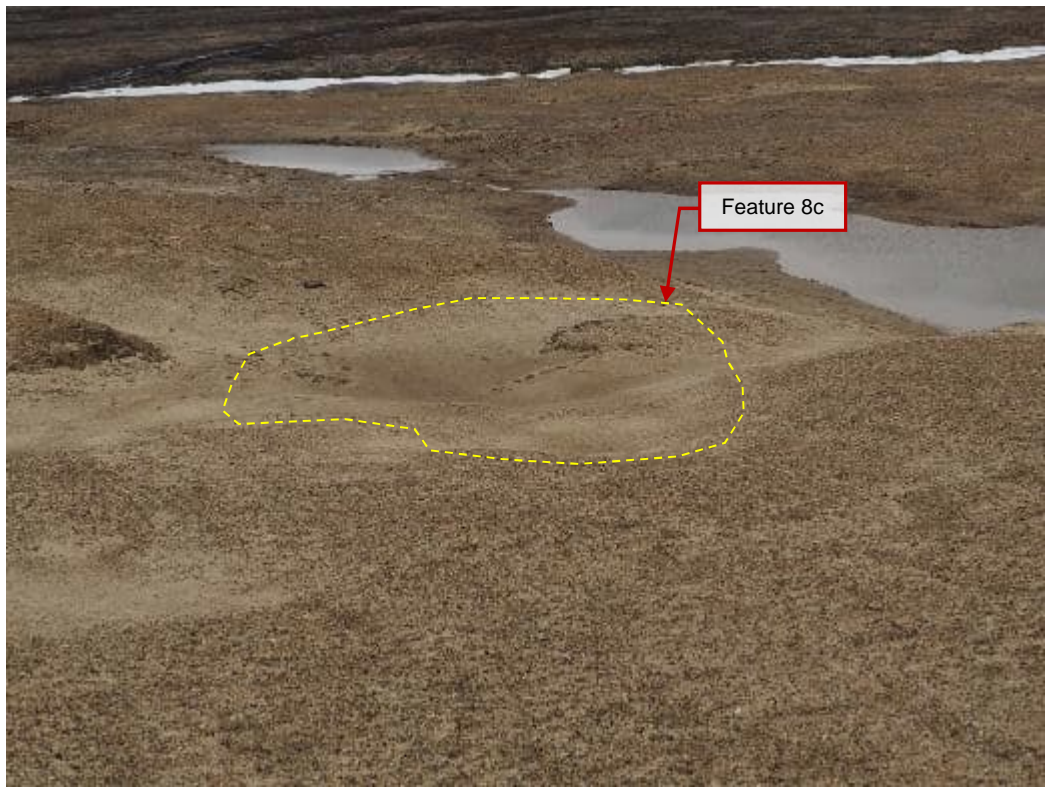
**Photograph 39:**

Photo looking east showing Feature 8c remaining post-grading due to the feature being outside of the buffer area and due to soft ground conditions in the area of Feature 8c.

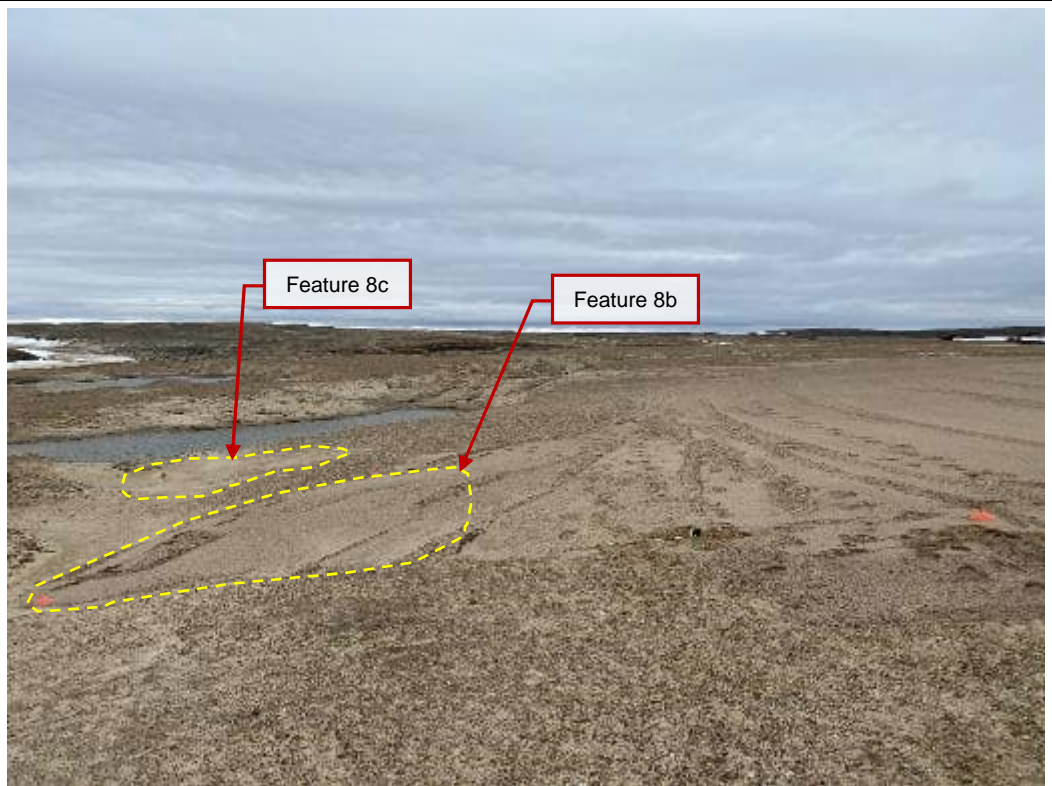
**Photograph 40:**

Photo looking west showing Feature 8c remaining post-grading due to the feature being outside of the buffer area and due to soft ground conditions in the area of Feature 8c.

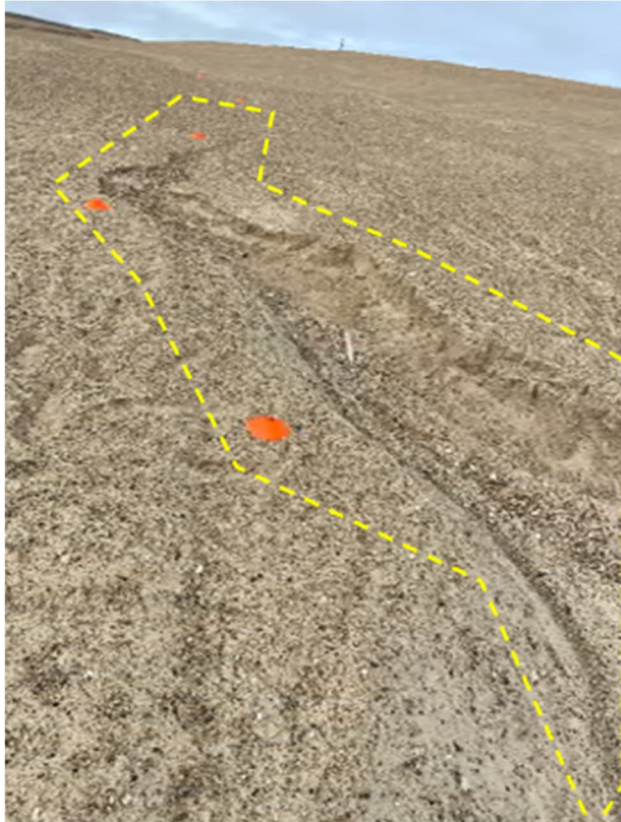
**Photograph 42:**

**Feature 9 – 2025  
Pre-Grading  
Inspection**

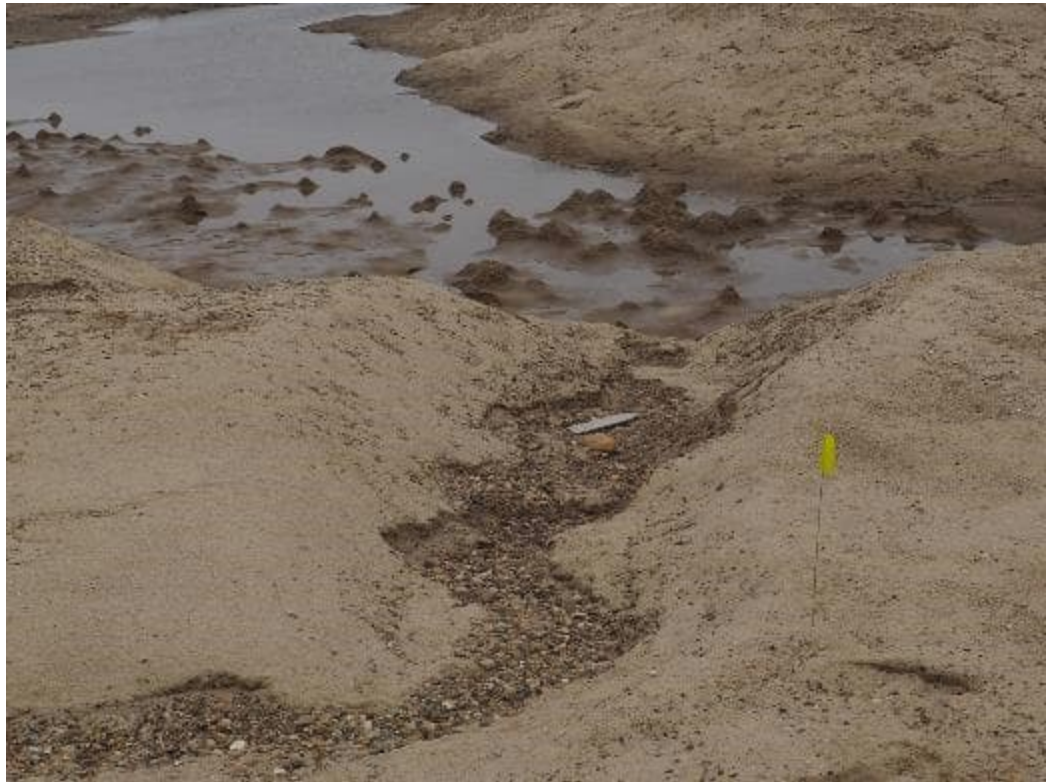
**Photograph 44:**

**Feature 9 – 2025  
Post-Grading  
Inspection**

Area from toe of slope to just beyond buffer area repaired by regrading.

Portion in far east leading to Pond P not filled.

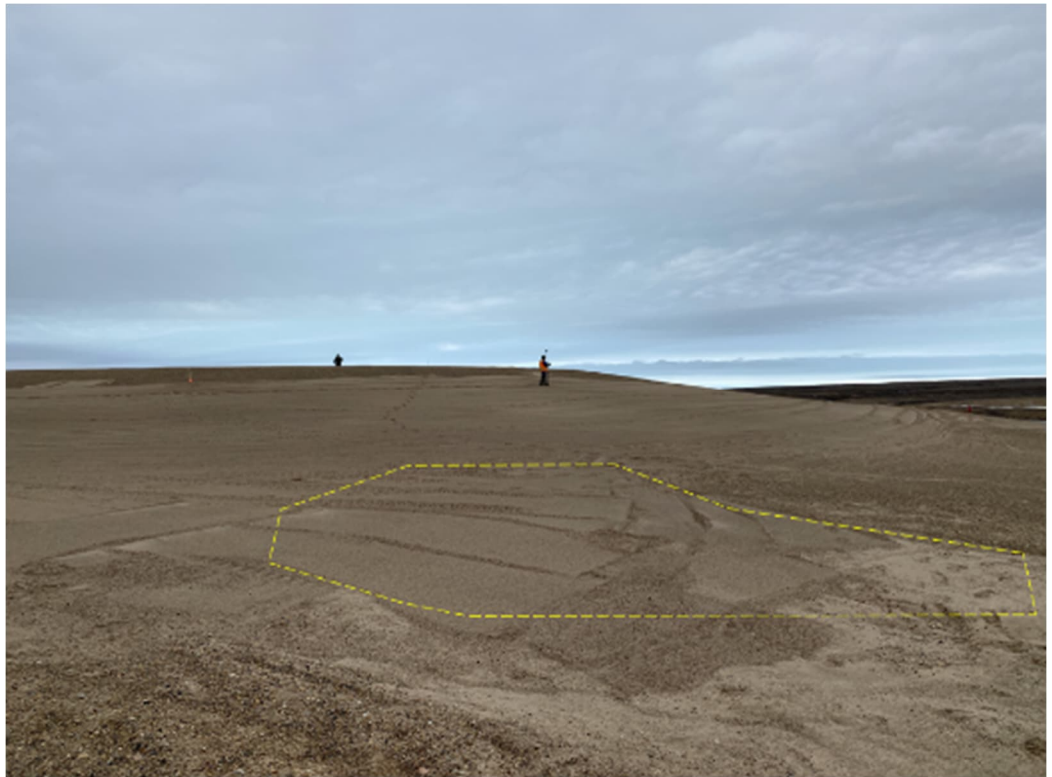
**Photograph 45:**

**Feature 9 – 2025  
Post-Grading  
Inspection**

Ungraded area to east leading to Pond P outlined in red.
