## 2025 Annual Report

*Inuvialuit Water Board Water Licence, N5L8-1837  
Panarctic F-68 Abandoned Wellsite  
Satellite Bay, Prince Patrick Island, Northwest Territories*

**WSP Canada Inc.**

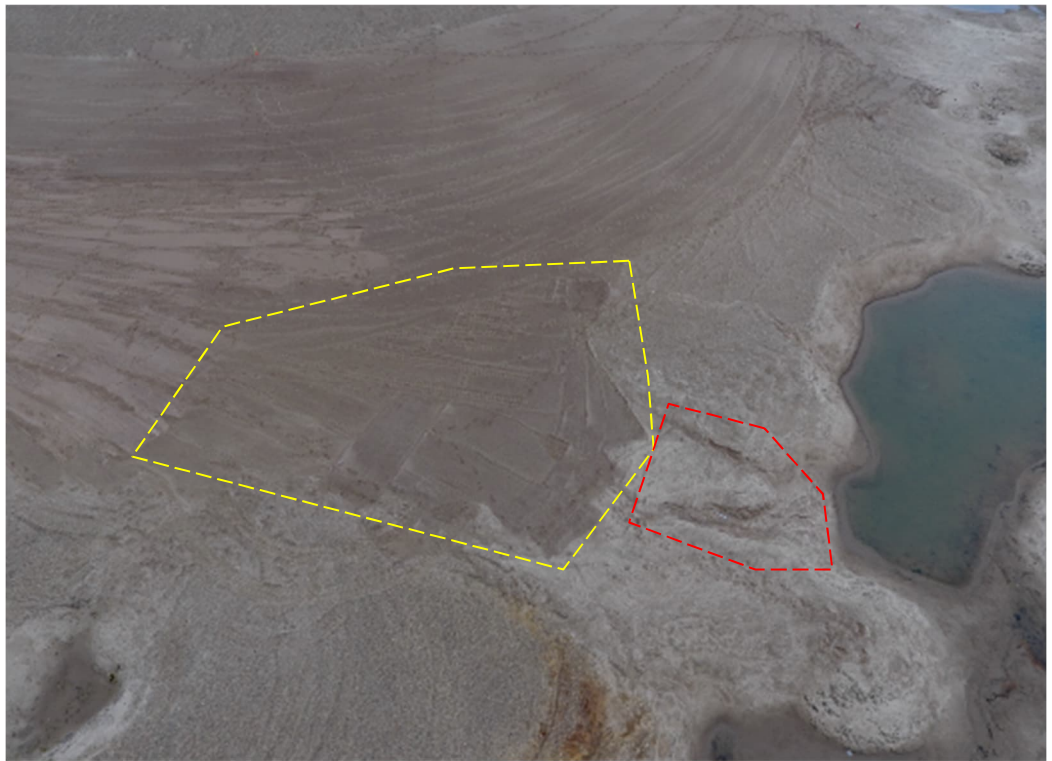
**Photograph 46:**

**Feature 10 – 2022  
Visual Inspection**

Settlement area with a diameter of approximately 3 metres (m), maximum depth of approximately 0.02 m.

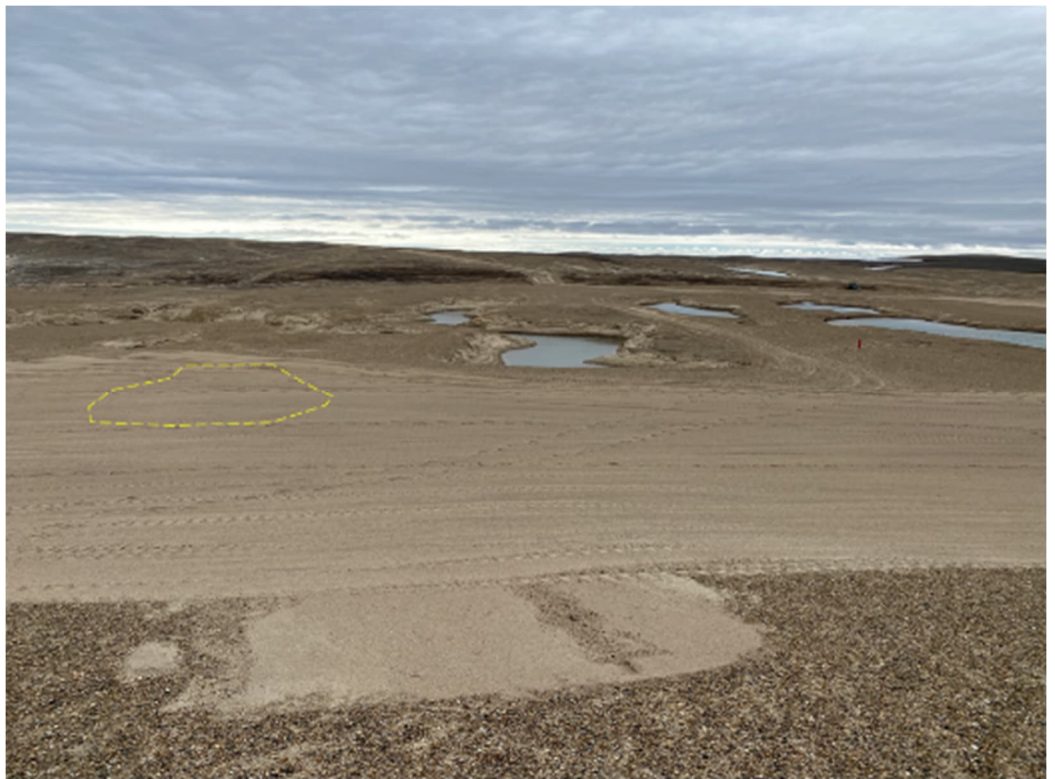
**Photograph 49:**

**Feature 11 – 2024  
Site Visit**

Crack extending across axis of the Containment Structure. Not clearly visible in 2022 Visual Inspection; however, closer examination of aerial photo indicates this feature was likely present.

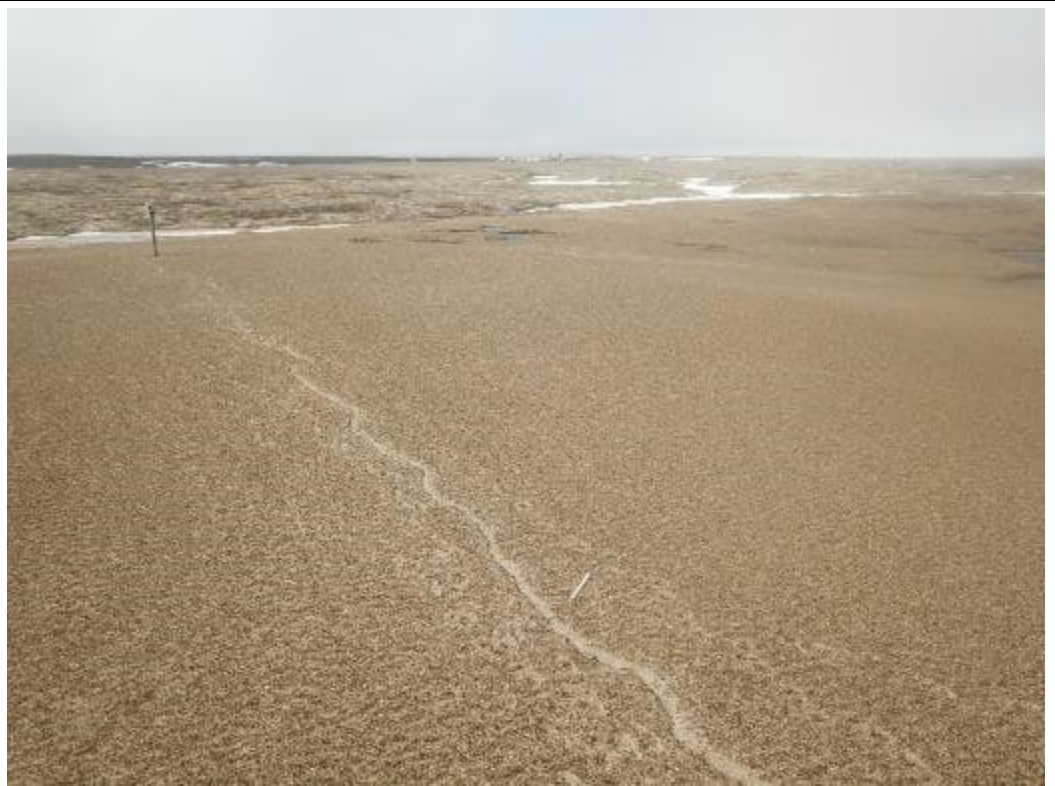
**Photograph 52:**

**Feature 11 – 2025  
Post-Grading  
Inspection.**

Feature was  
smoothened and  
tamped down by  
foot.

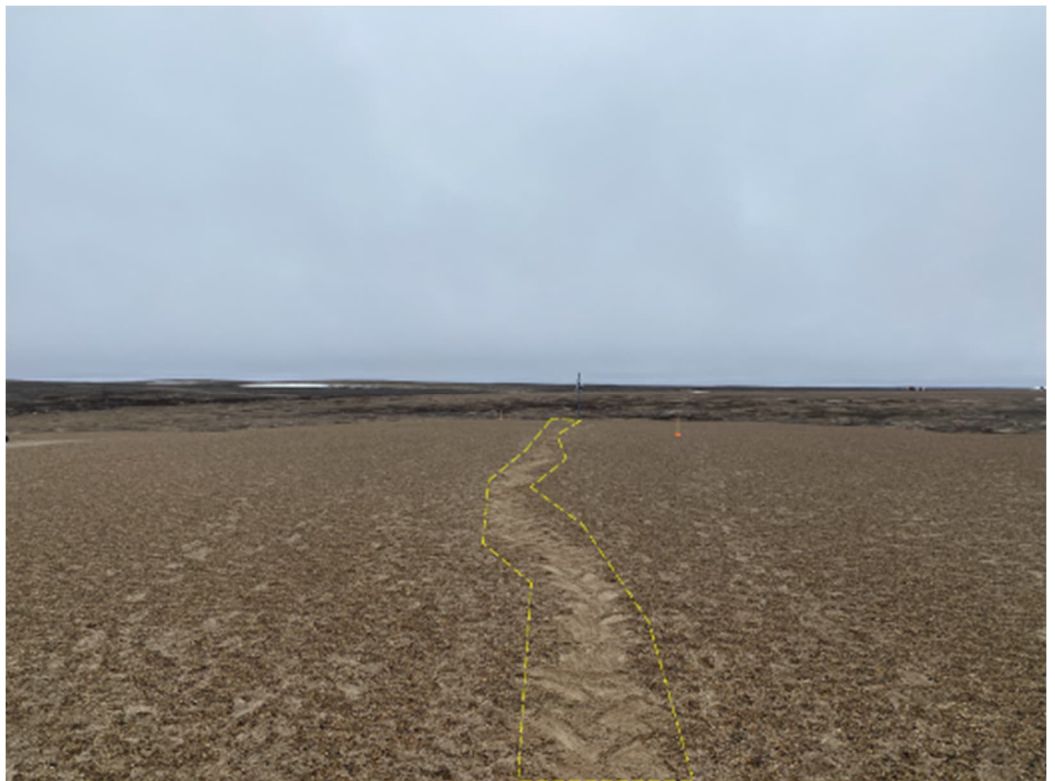
**Photograph 53:**

**Feature 12 – 2024  
Visual Inspection**

Feature not  
observed in 2022.

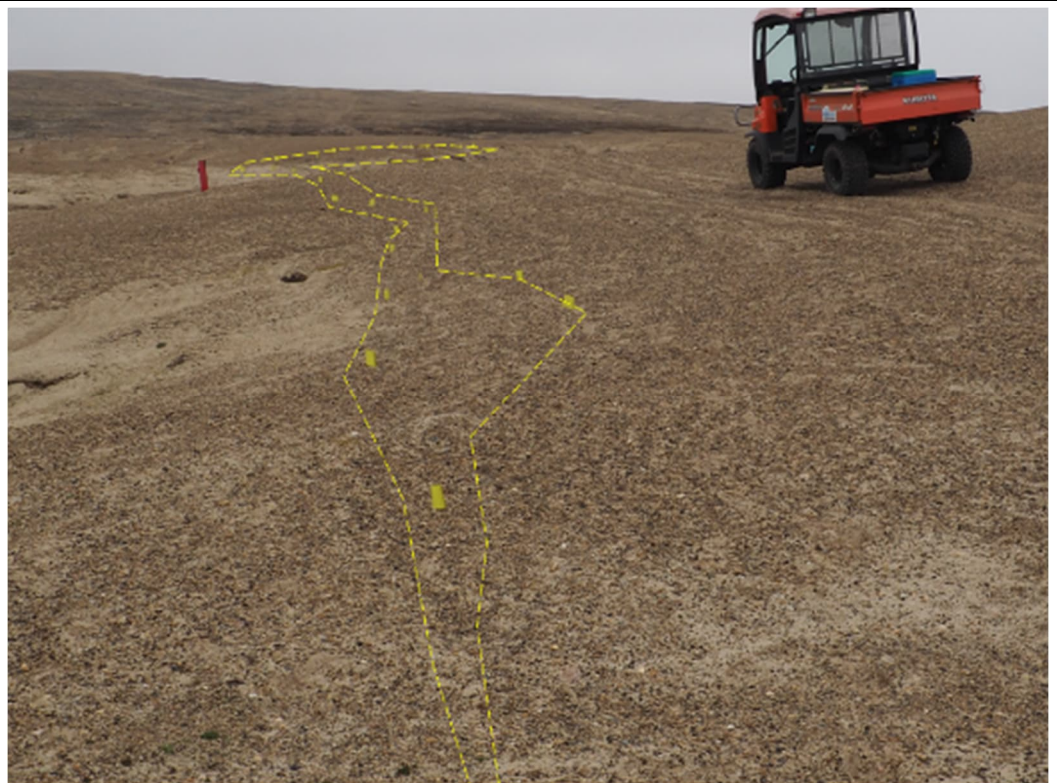
**Feature 12 – 2025  
Pre-Grading  
Inspection**

Extent and  
size/depth similar to  
2024.

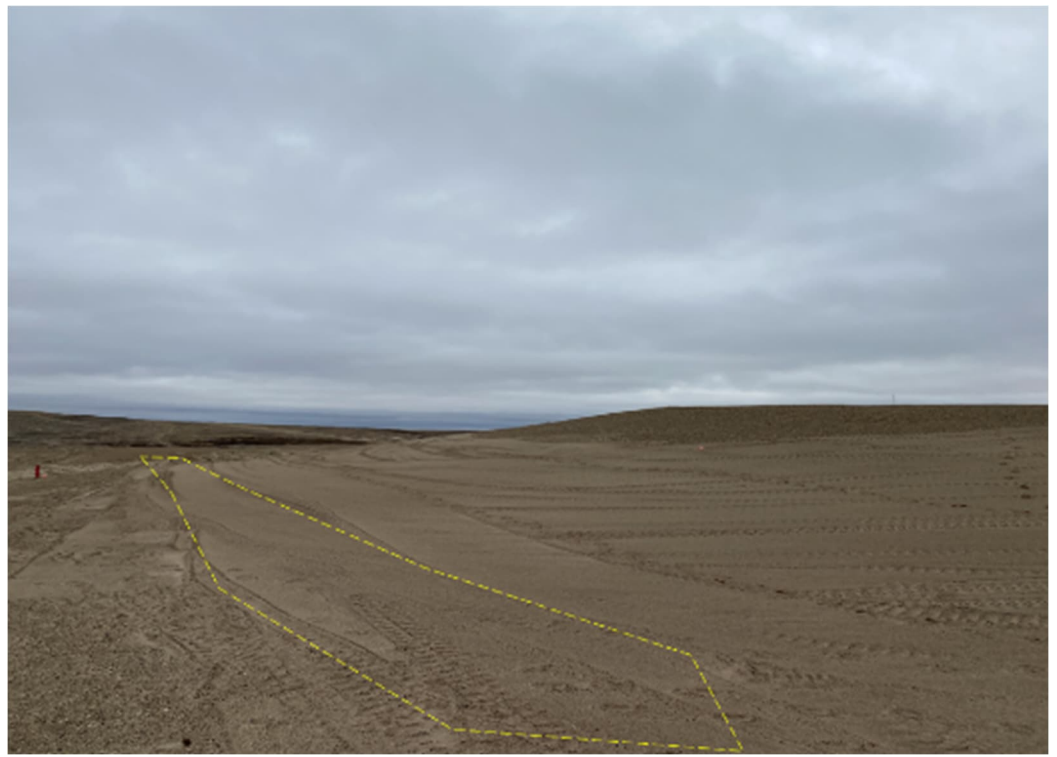
**Photograph 55:**

**Feature 12 – 2025  
Post-Grading  
Inspection**

Feature largely  
removed as part of  
regrading. The ends  
of the features  
outside of the  
regrading limits  
remain.

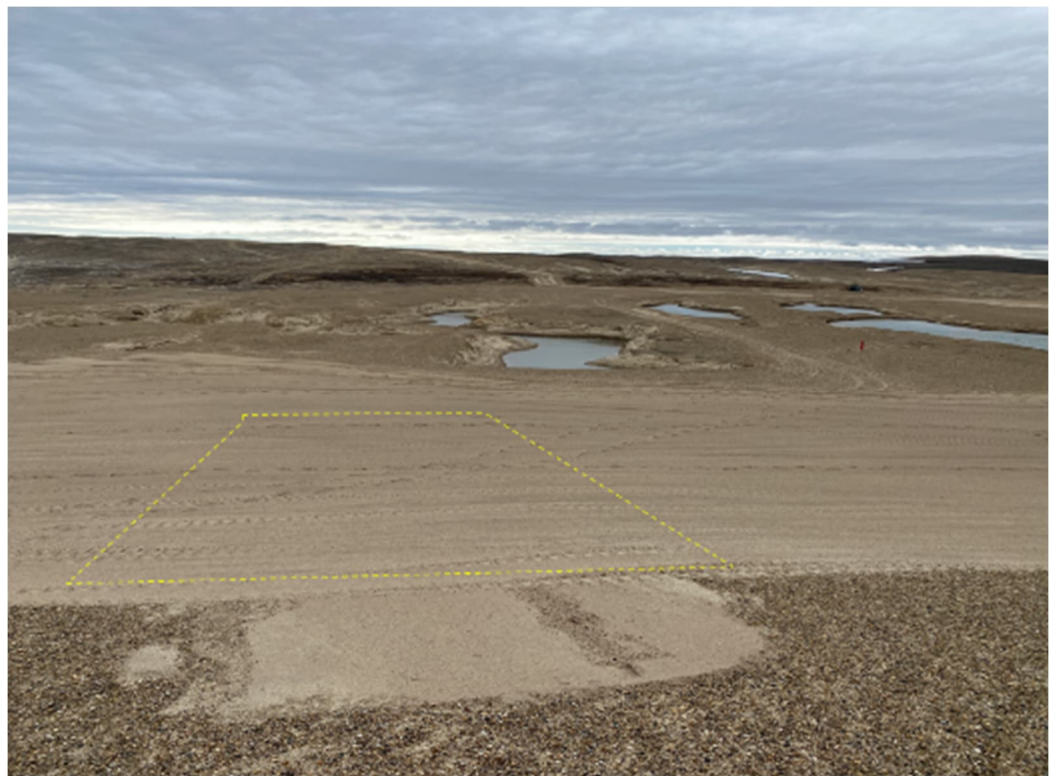
**Photograph 59:**  
**Feature 13 – 2025**  
**Post-Grading**  
**Inspection**

Feature removed as part of regrading.

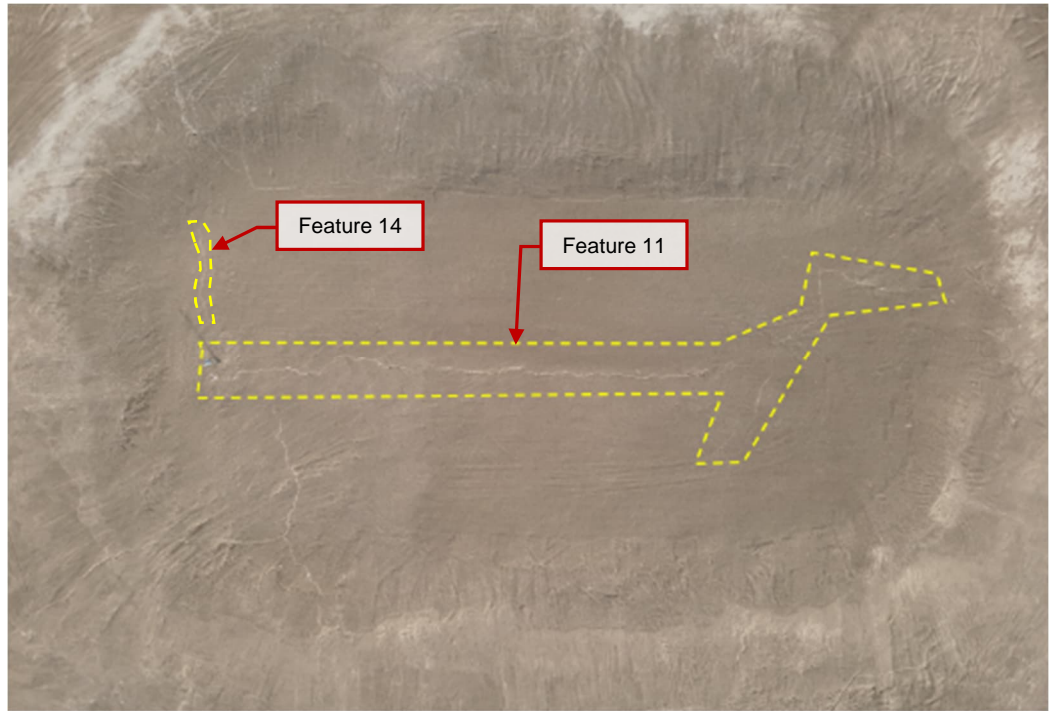
**Photograph 61:**

The Feature 14 crack was left as-is and was not filled in or smoothed post-grading.

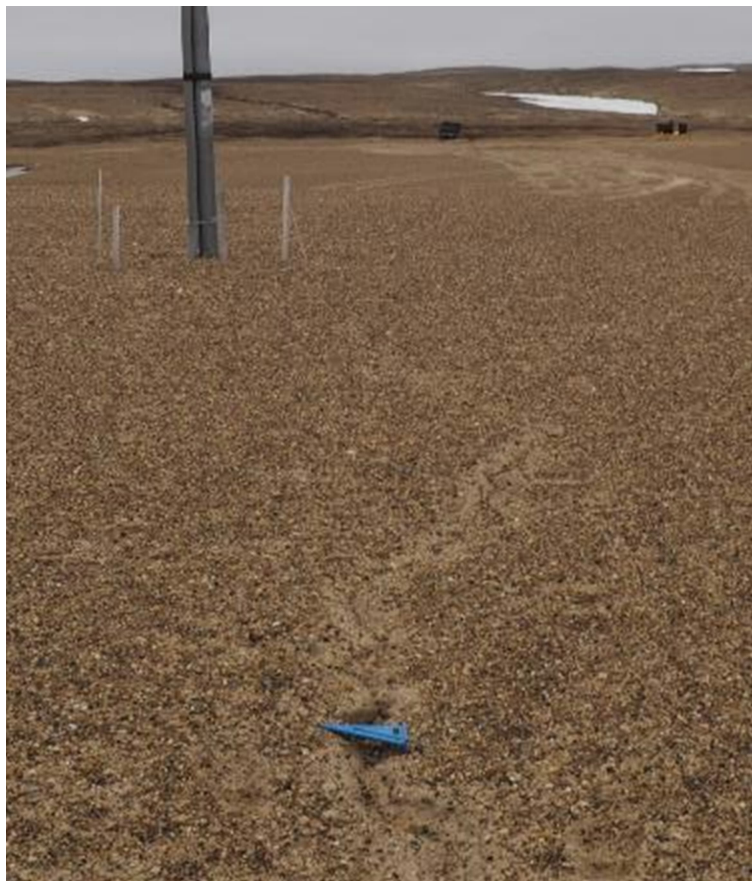
**Feature 14 – 2025 Visual Inspection**

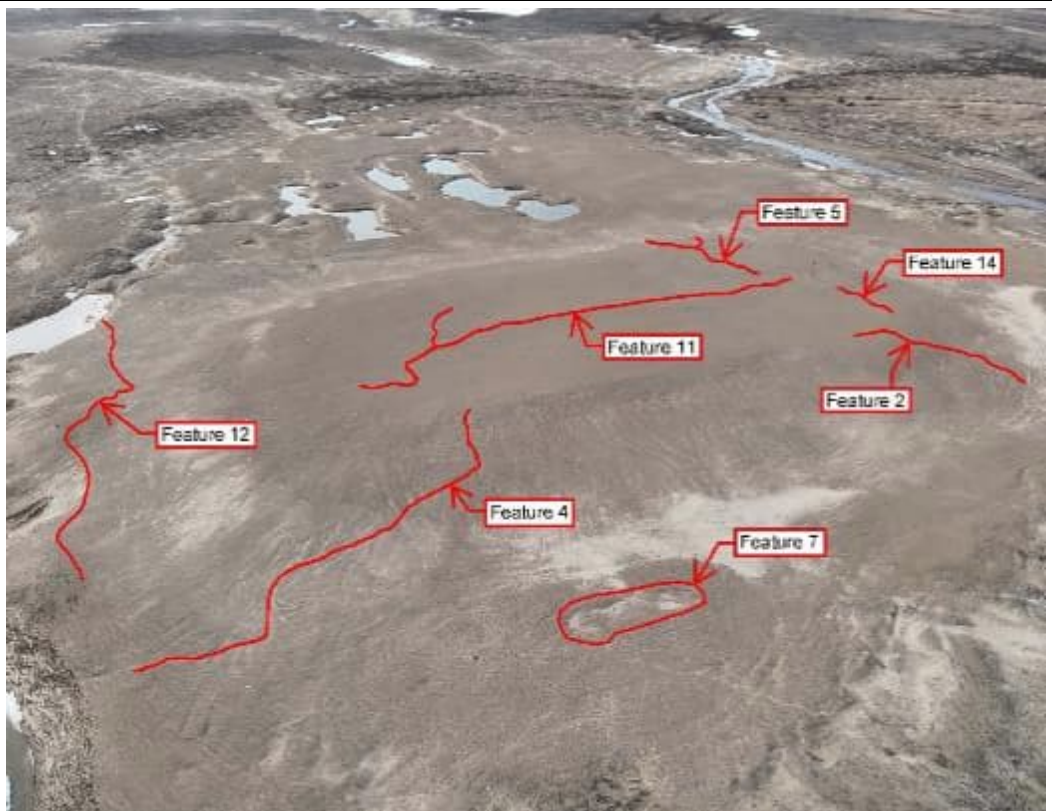
**Photograph 62:**

Oblique drone photo looking at the north side of Containment Structure showing some of the features identified in 2024.

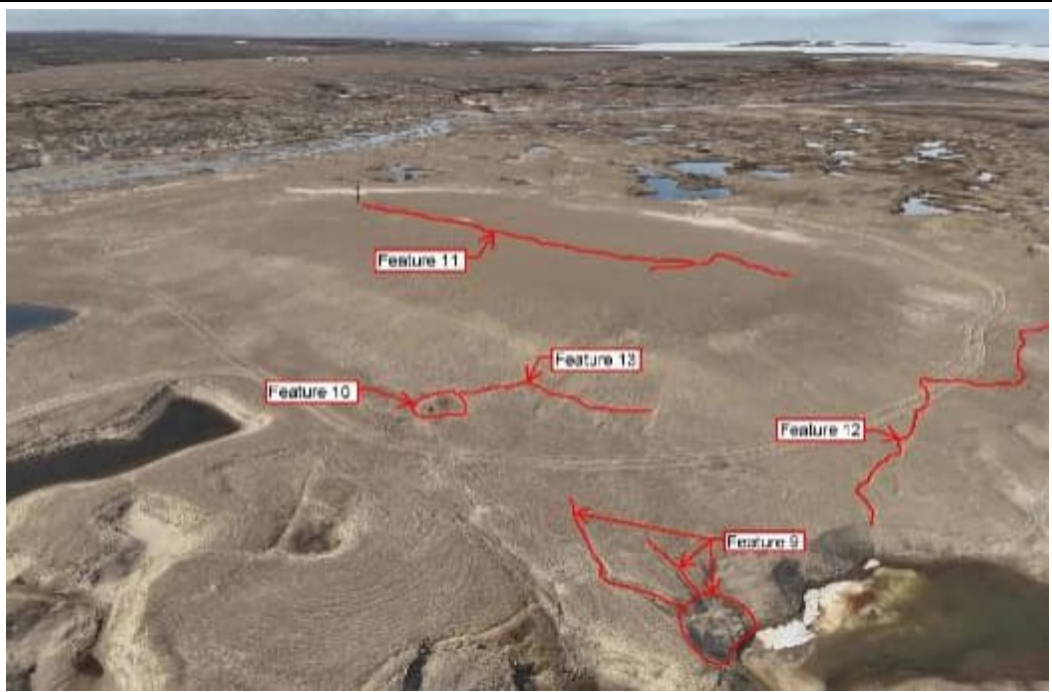
**Photograph 63:**

Oblique drone photo looking at the east side of Containment Structure showing some of the features identified in 2024.

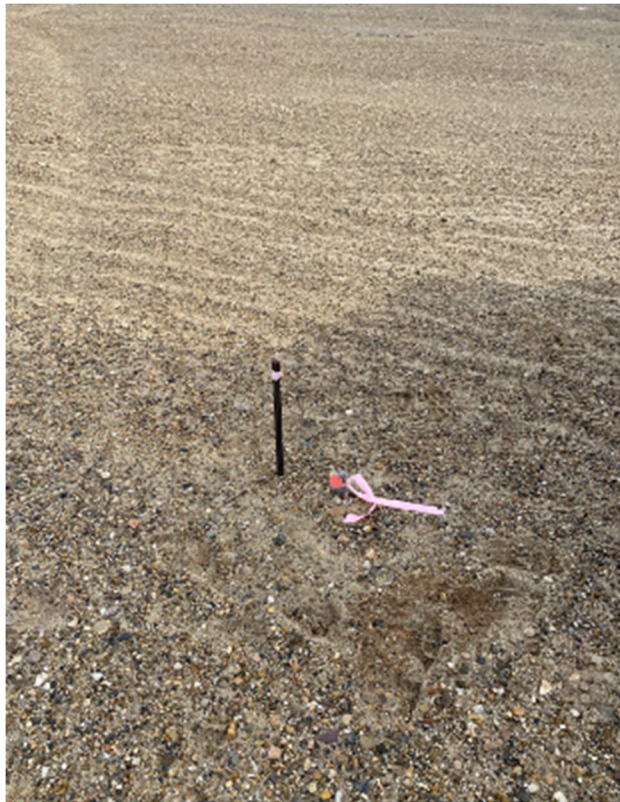
**Photograph 65:**

Soft soil conditions on top of Containment Structure. Photo shows a 100 millimetre deep footprint indentation.

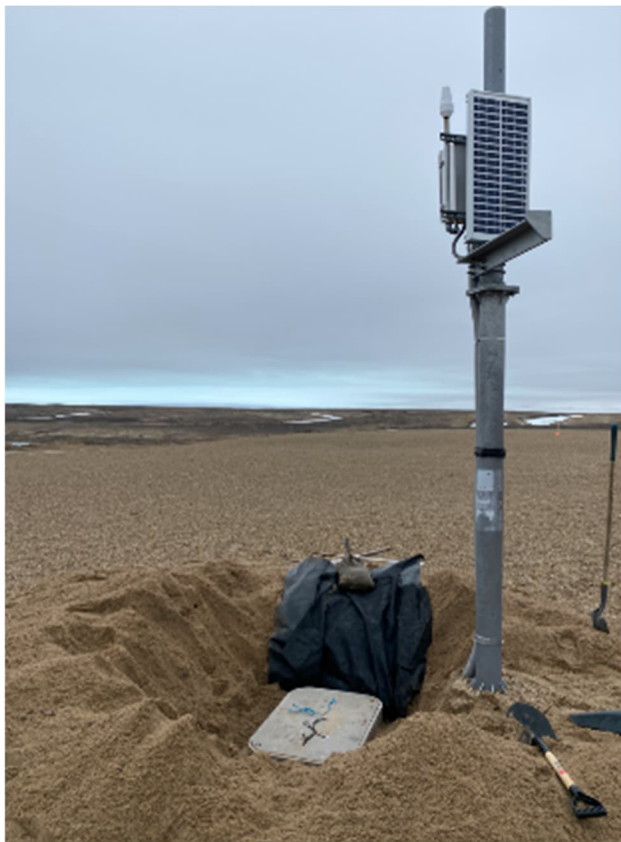
**Photograph 67:**

Battery Vault excavated.

The thermistor monitoring system consists of a tower, with solar panel and data logger/satellite connection modem in the chamber on the upper part of the tower, and a buried battery vault at the base of the tower. The battery vault contains the battery, battery management and cable connections. To extend the operating life of the thermistor monitoring system, the existing battery was replaced on 16 July 2025 with a new 12 volt battery. Prior to installation, the battery was tested to ensure that it was fully charged. After installation, data were remotely downloaded from the thermistor monitoring system to confirm that the battery was installed correctly, and the system was operating as designed. Photographs 67 to 69 in Appendix D illustrate the stages of the battery replacement procedure. Specifications of the replacement battery are provided in Table N.

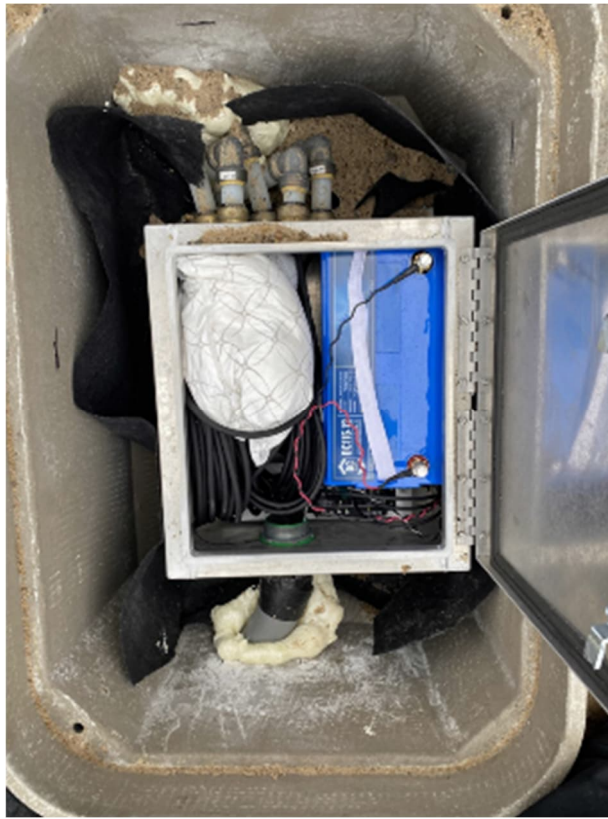
**Photograph 68:**

New battery placed in vault.

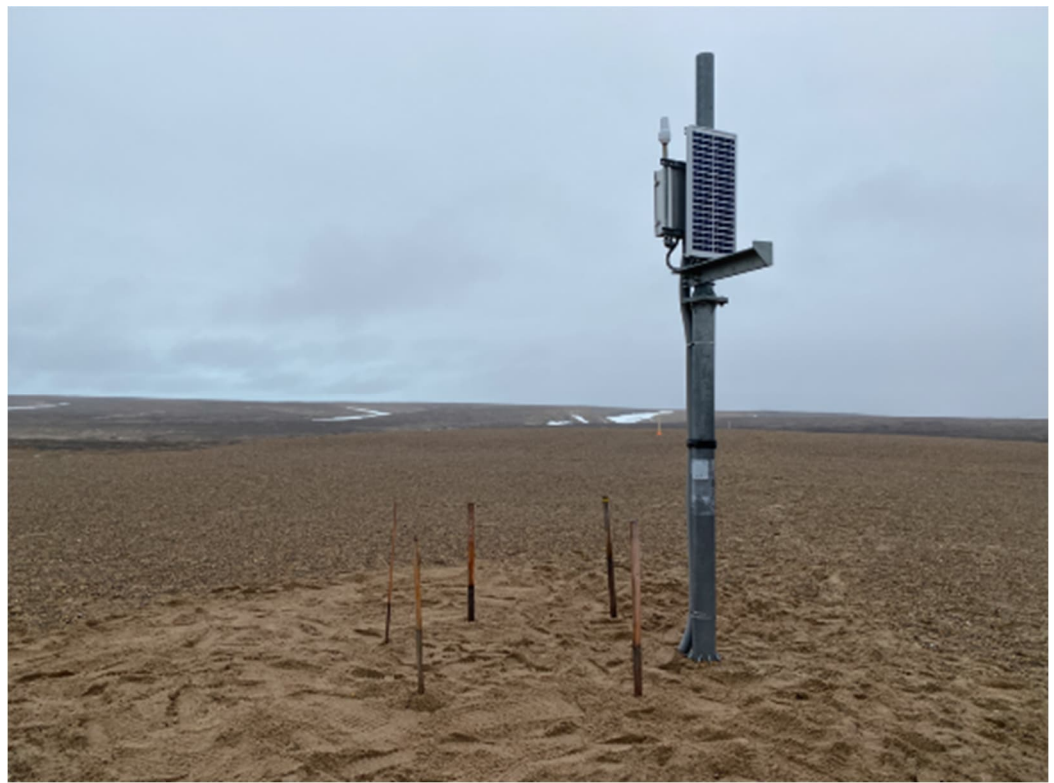
**Photograph 69:**

Battery Vault backfilled.

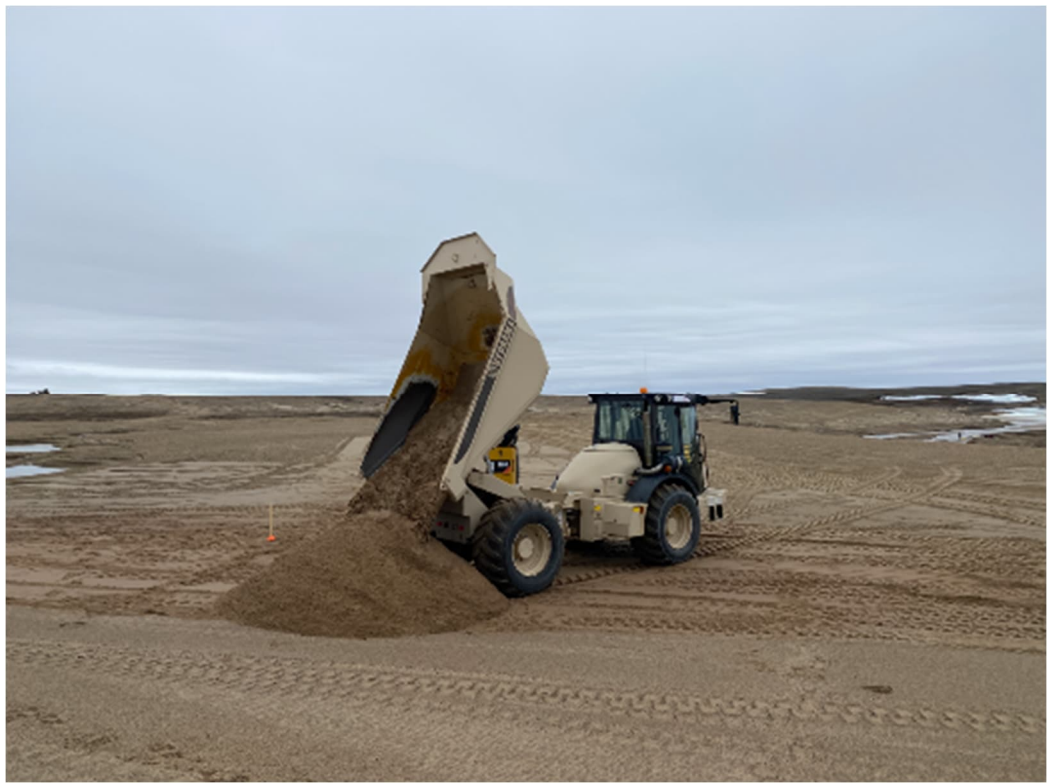
**Photograph 70:**

Soil hauled from Borrow Area to Containment Structure using Hydrema trucks.

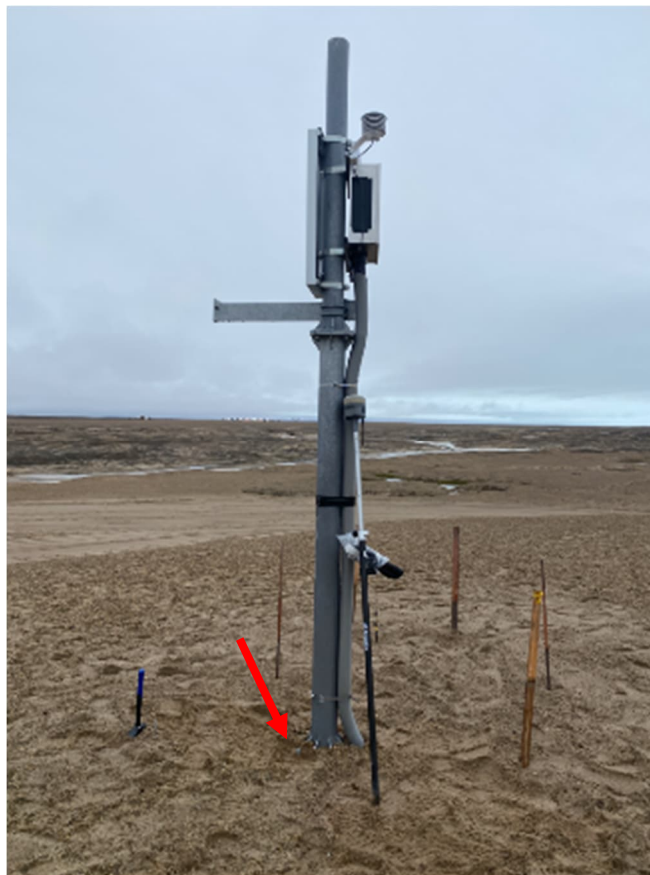
**Photograph 71:**

Location of Communication Tower Benchmark – Base plate bolt. See next photograph for detail.

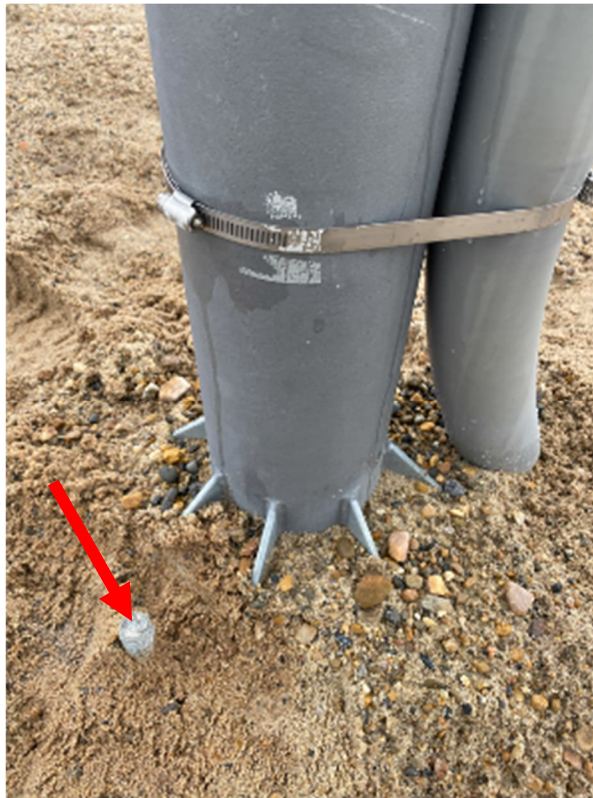
**Photograph 72:**  
**2025 Post-Grading**  
Location of  
Communication  
Tower Benchmark –  
Base plate bolt.

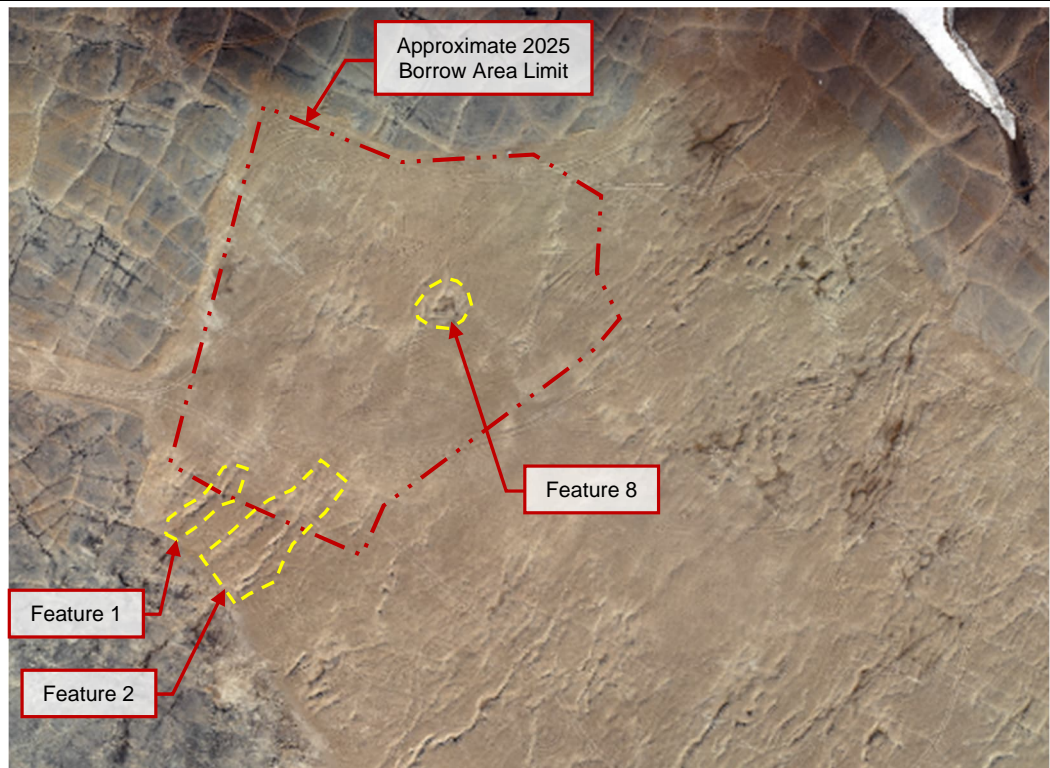
**Photograph 74:**

Polygonal ground structure consistent with natural permafrost features visible, notably in right part of photo.

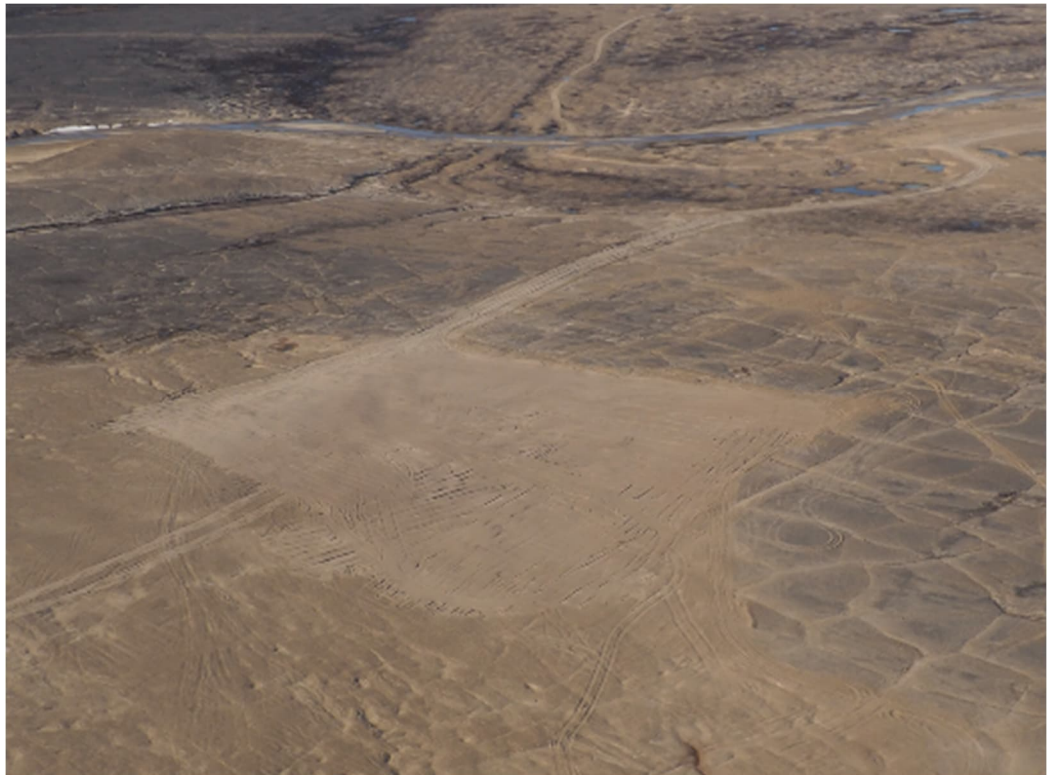
**Photograph 75:**

Polygonal ground structure consistent with natural permafrost features visible, notably in bottom part of photo.
