HAMLET OF PAULATUK

PAULATUK SEWAGE LAGOON UPGRADES

PAULATUK
SEWAGE AND SOLID WASTE SITE ASSESSMENT

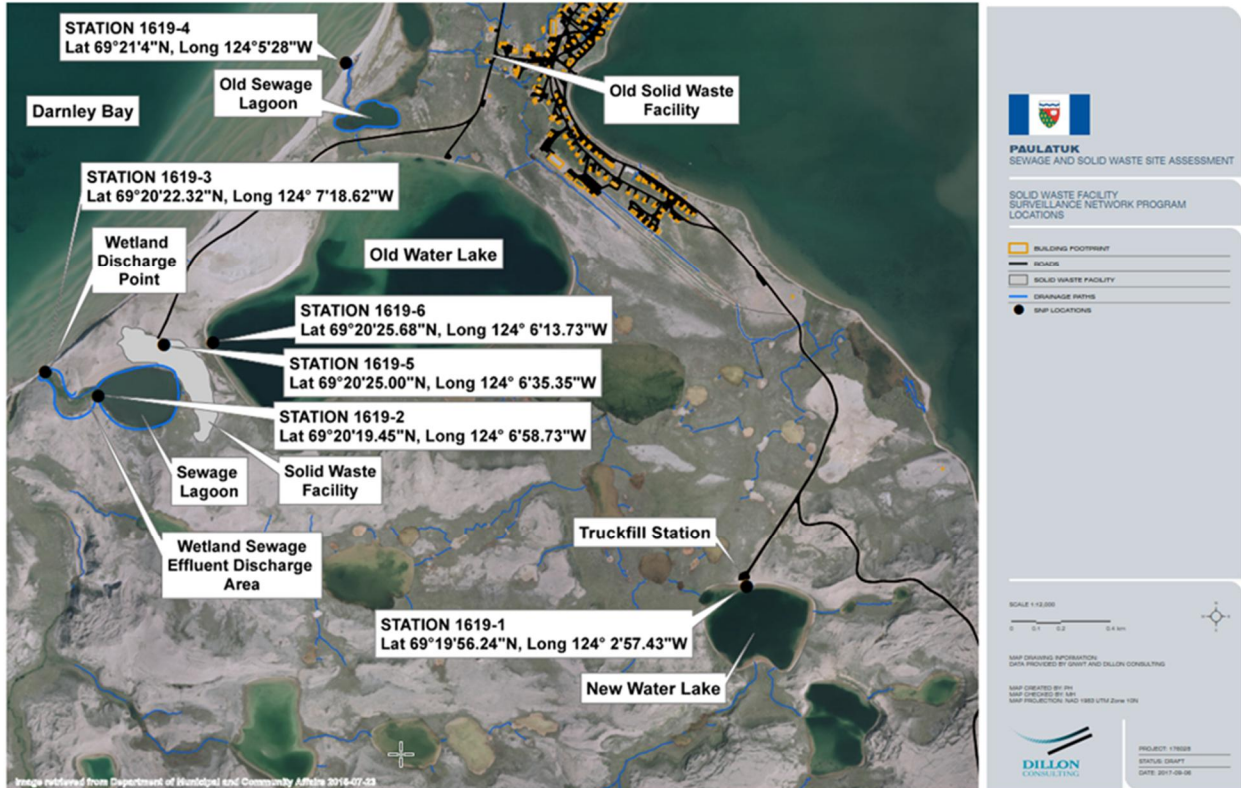
Figure 2: Active and abandoned Sewage and Solid Waste Facilities

There is an abandoned solid waste disposal facility and wastewater discharge lagoon approximately 350 m west from the existing municipal area as shown in Figure 2. Odour issues and the construction of a new airport in 1993 led to the landfill and wastewater discharge being relocated to a site 2 km south of the abandoned site (Dillon Consulting Limited, 2009). The abandoned and active facilities both fall within the municipal boundaries of the Hamlet of Paulatuk. The abandoned facilities are not included in this plan, which focuses on the abandonment and restoration of the currently active facilities.
