# Hamlet of Tuktoyaktuk

# **Tuktoyaktuk Sewage Lagoon**

## **Condition Assessment Report – Fall 2004**

Prepared 2005 07 19

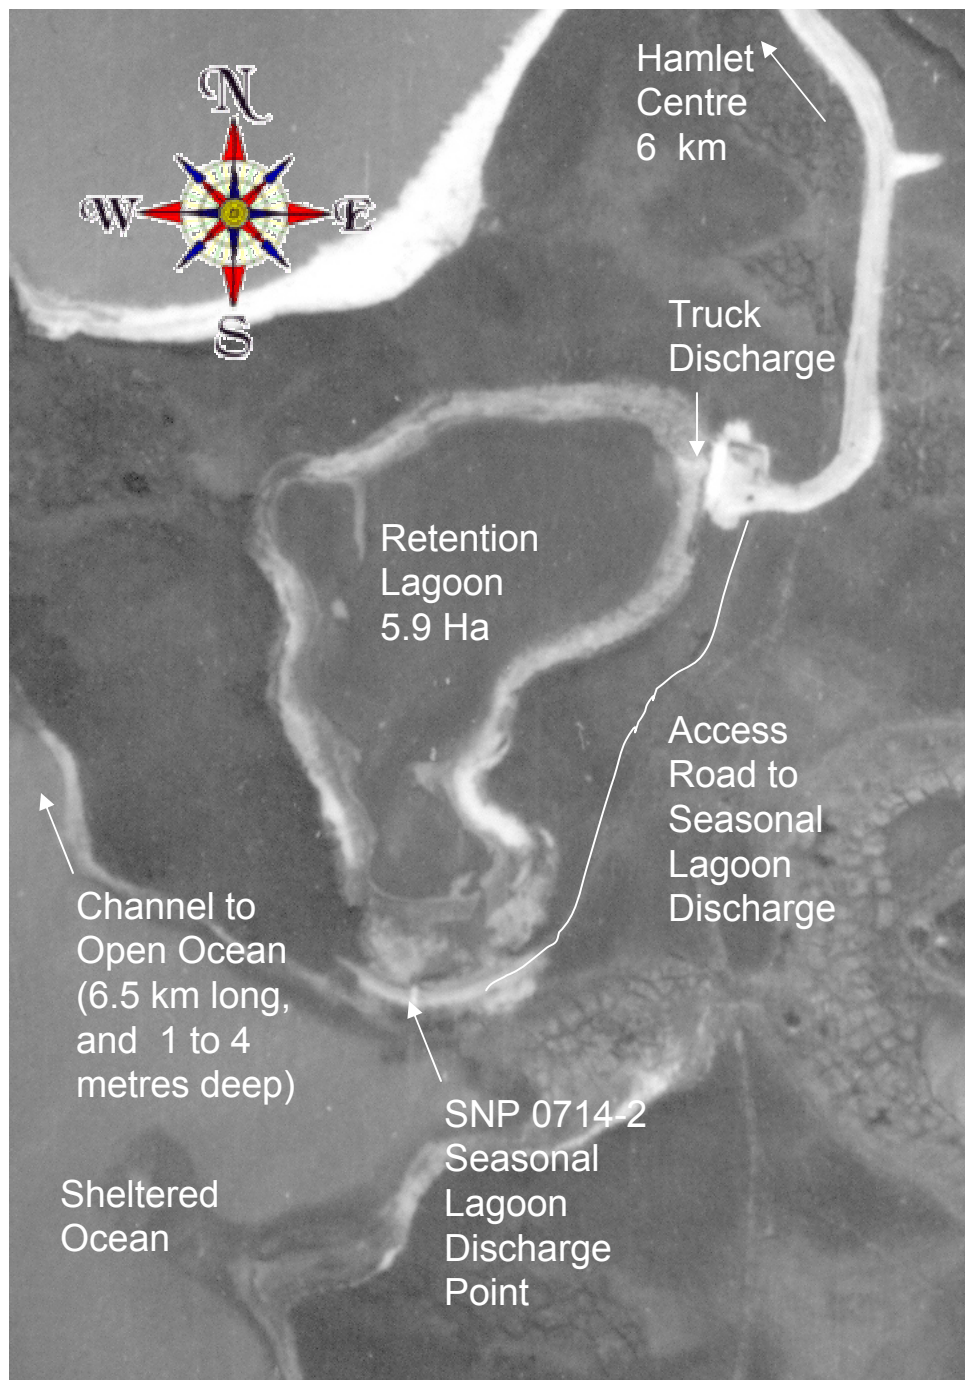
**Figure 2. Site Plan**

The area surrounding the lagoon is influenced by winds primarily from a northwesterly direction, and tides of 30 to 60 centimetres. The lagoon is discharged in the mid to late fall of each year to a saltwater inlet. The lagoon is 3.0 kilometres southeast from the open ocean, and approximately 6.5 kilometres from the ocean by way of several channels, which vary in depth from 1 metre to 4 metres (See Figure 2, Site Plan).
