Re: Devon Itiginkpac F-29 Sump Assessment

ITGINKPAK F-29 SUMP REMEDIATION PLAN

**KIGGIAK-EBA CONSULTING LTD.
CALGARY, ALBERTA**

OCTOBER 2006

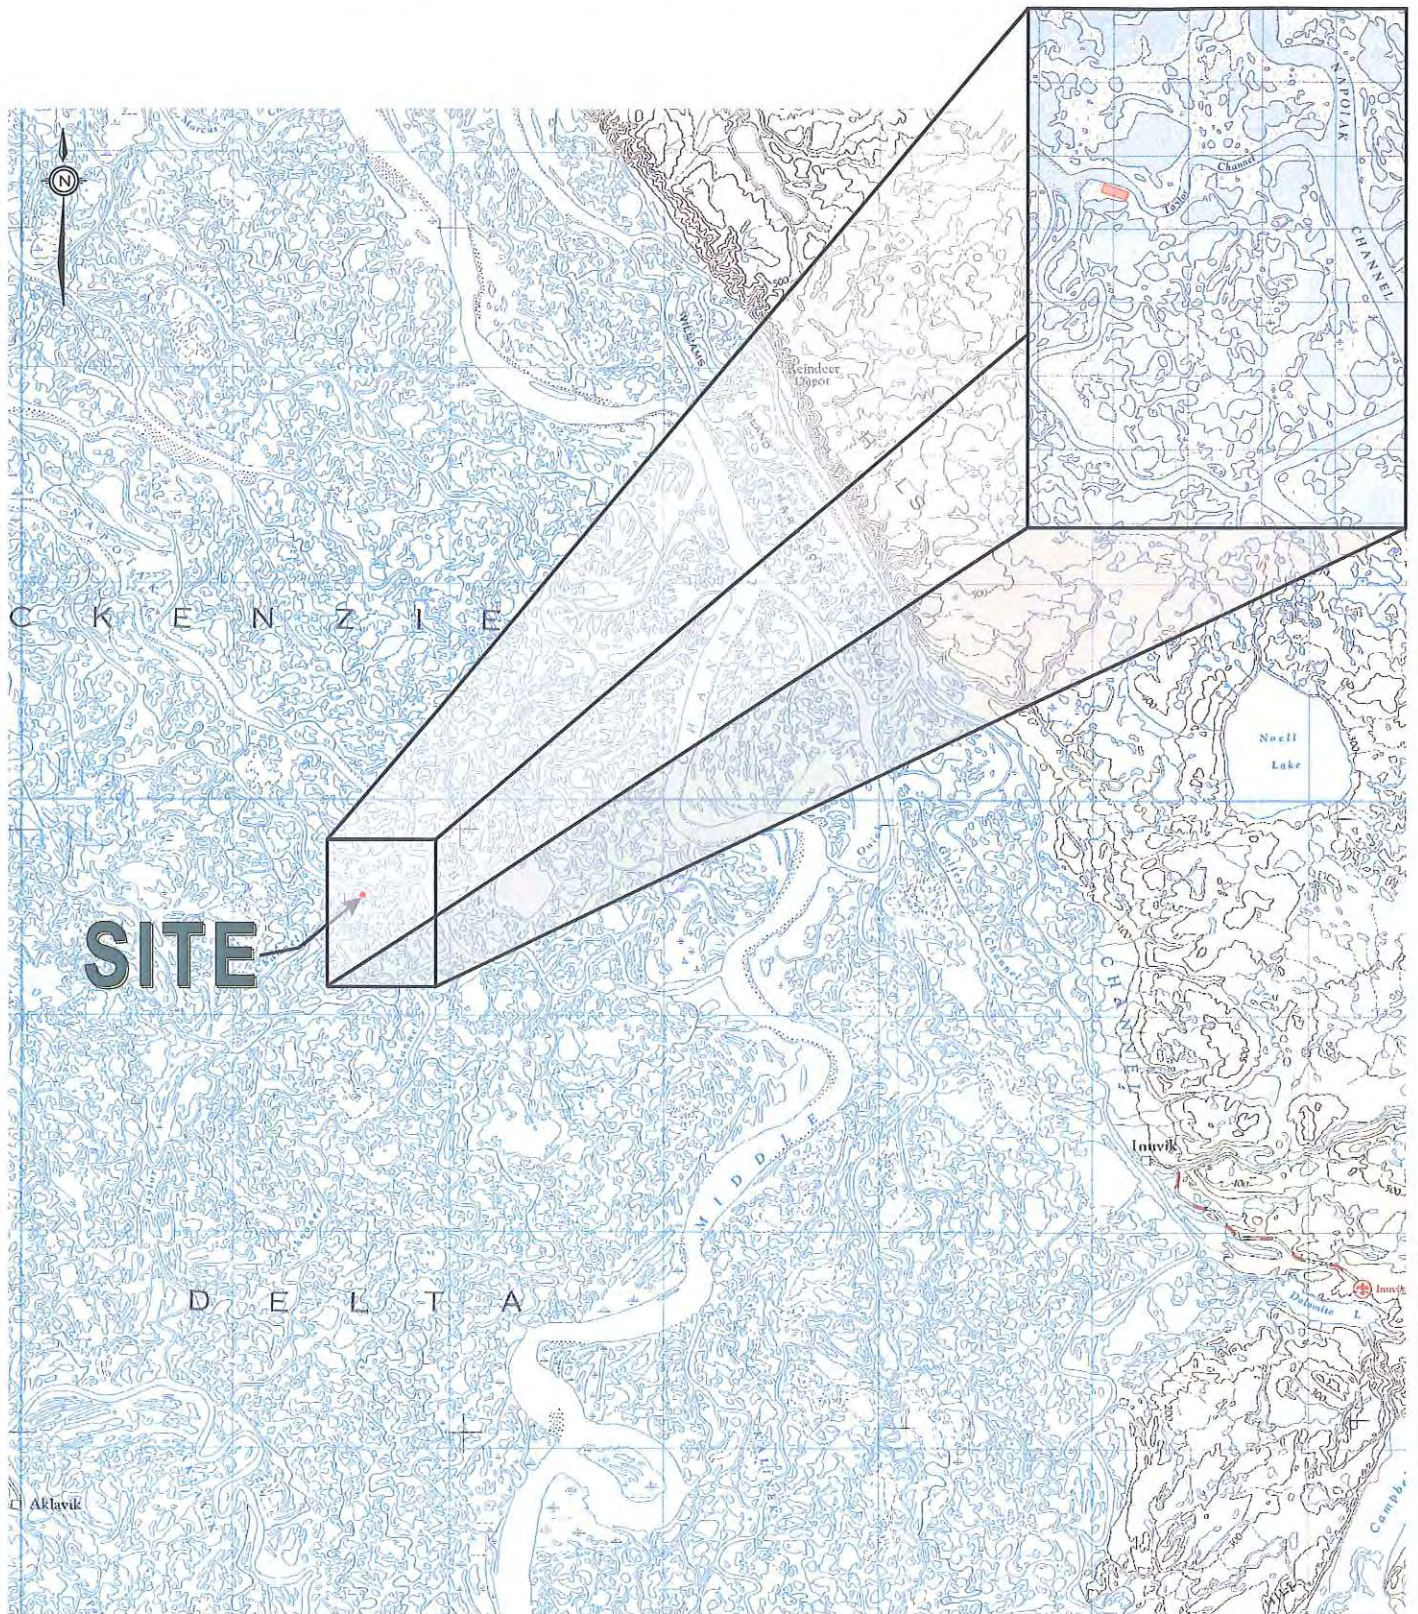
Figure 1

The Itiginkpak F-29 site is located, as indicated on Figure 1, approximately 38 km west-northwest of Inuvik, in the Mackenzie Delta. This location is approximately 7.5 km off of the winter road route between Aklavik and Inuvik, and about 71 km by ice-road from Inuvik (the winter road route is subject to change due to early season ice conditions). Figure 2 provides a recent topographic survey of the site area showing the sump at the west end of the lease. The sump is approximately 70 m from the nearest channel bank, and a similar distance from a small lake to the south.
