**Re: N7L3-1619 – Modifications to Sewage Lagoon**

HAMLET OF PAULATUK

# **Sewage Lagoon and Solid Waste Assessment**

November 29, 2017

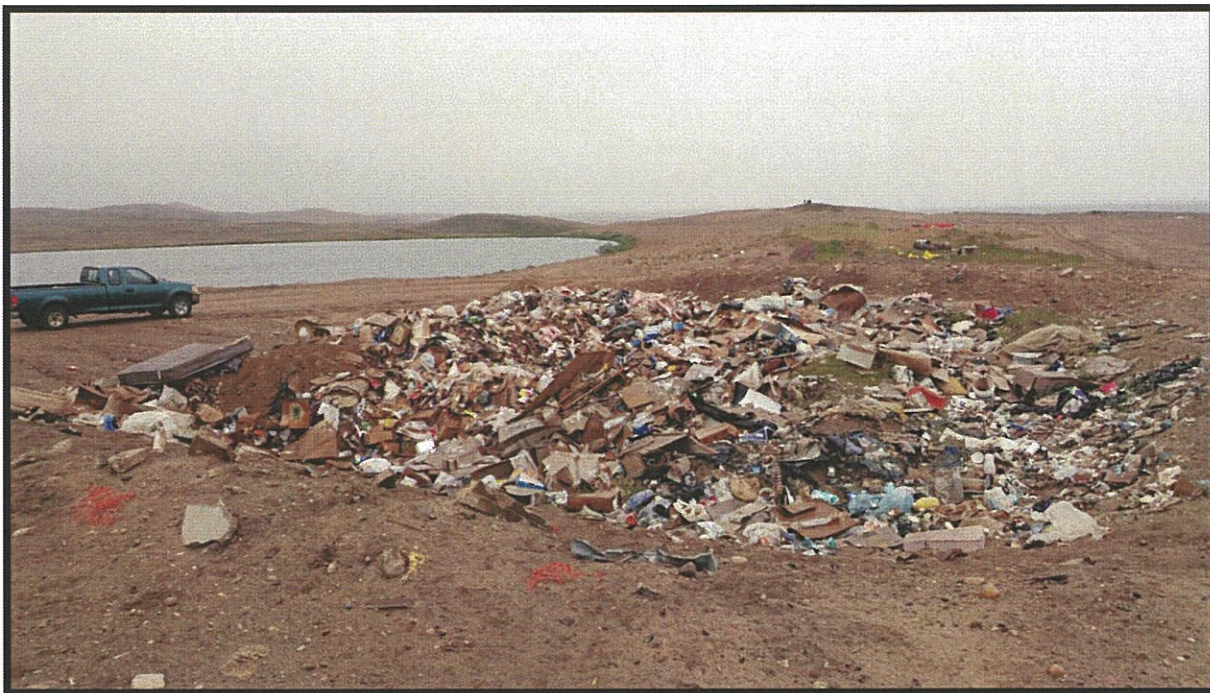
Photo 11: Northern Store Cell, Looking Southwest

Burning permissible wastes reduces the volume of waste that requires landfilling. Part D, Item 11 of the water licence details that paper products, paperboard packaging, untreated wood, and animal carcasses may be burned. Significant amounts of paper based products are visible in the Northern Store cell (Photo 11). Typical waste compositions in the Northwest Territories suggest that approximately 27% of waste by weight is cardboard, newsprint, or other paper products, with wood accounting for an additional 9.9% by weight (Kent et al., 2003). Volume reduction of 80 – 90% may be achieved by incineration (The World Bank, 1999). Safe burning practices and the risk of air pollution as a result of burning would require consideration. Additionally, as with recycling, the involvement of the community would be necessary to achieve the separation of these items at the source for burning. Paper products in the landfill were noted by the Hamlet Council to be a primary source of windblown litter in the community, and the separation and burning of these items may result in a reduction in windblown litter. Any disposal by burning is subject to the conditions of the Municipal Solid Wastes Suitable for Open Burning guidelines<sup>2</sup> from the Department of Environment and Natural Resources (Environmental Protection Division, 1993). Conditions for burning include, but are not limited to, applying the principles of reduce, reuse, recycle, burning in a controlled manner when conditions are favourable (no or low wind blowing away from the community), receiving applicable permits and abiding by permit conditions, removal of all non-burnable material, and compliance with any other site specific conditions.

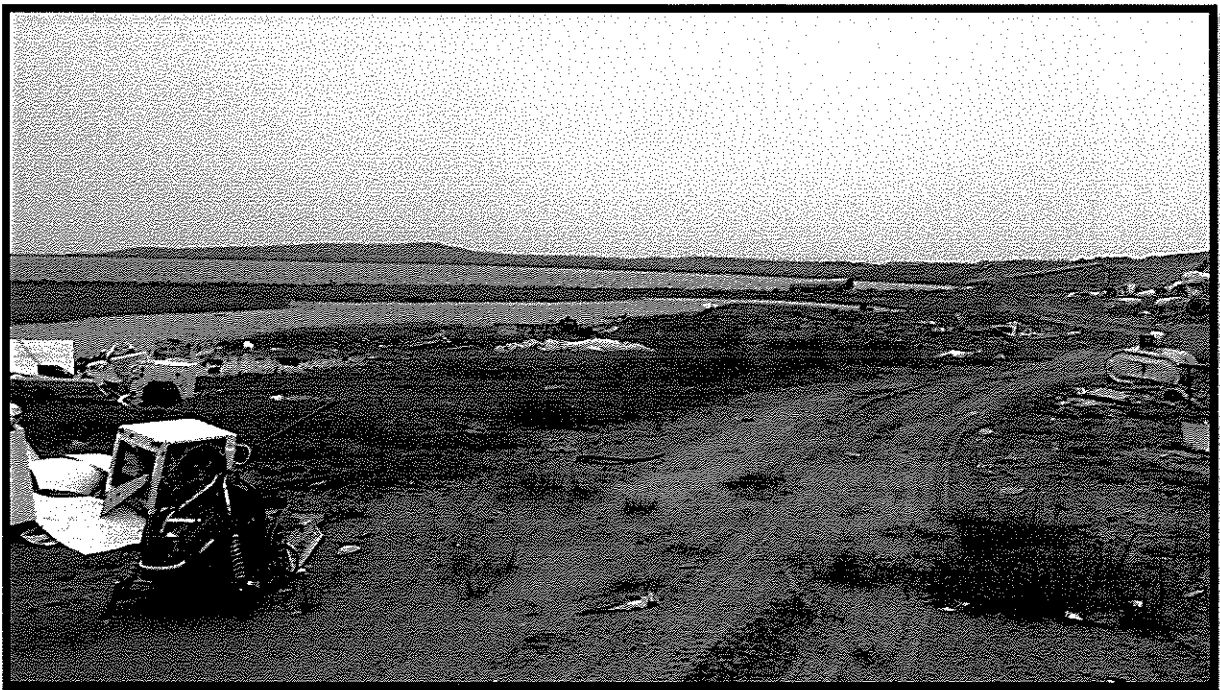
Photo 15: SNP Station 1619-5 (Ponded Water Adjacent to 'Lake A' and White Goods)
