Hamlet of Aklavik

Background Report for Water Licence Renewal

May 2019

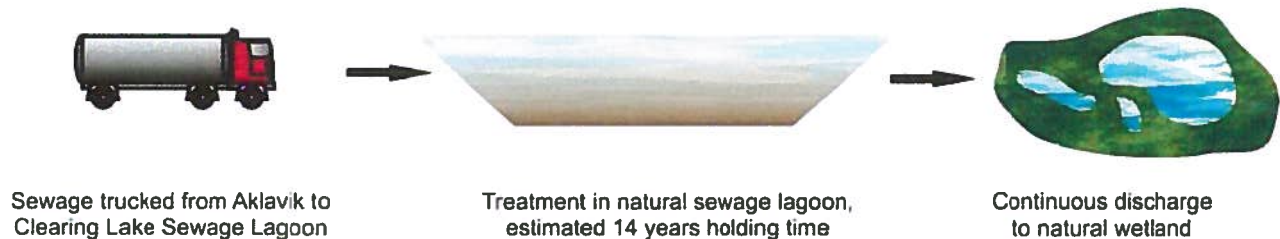
Figure 3-1: Aklavik Sewage Treatment Schematic

The Clearing Lake Sewage Lagoon is a natural lagoon that operates with continuous discharge into the adjacent natural wetland. **Figure 3-1** below illustrates the sewage treatment process. Freeze-up of the lagoon typically happens in early October, and break-up is in late May or early June.

The lagoon covers an area of approximately 290,000 m² and is about 1.5 m (5 ft) deep. The lagoon can therefore hold roughly 435,000 m³ of sewage. For an average sewage input of 87 m³/day (with sewage production assumed equal to potable water use), the lagoon theoretically provides a retention time of 5018 days (14 years).

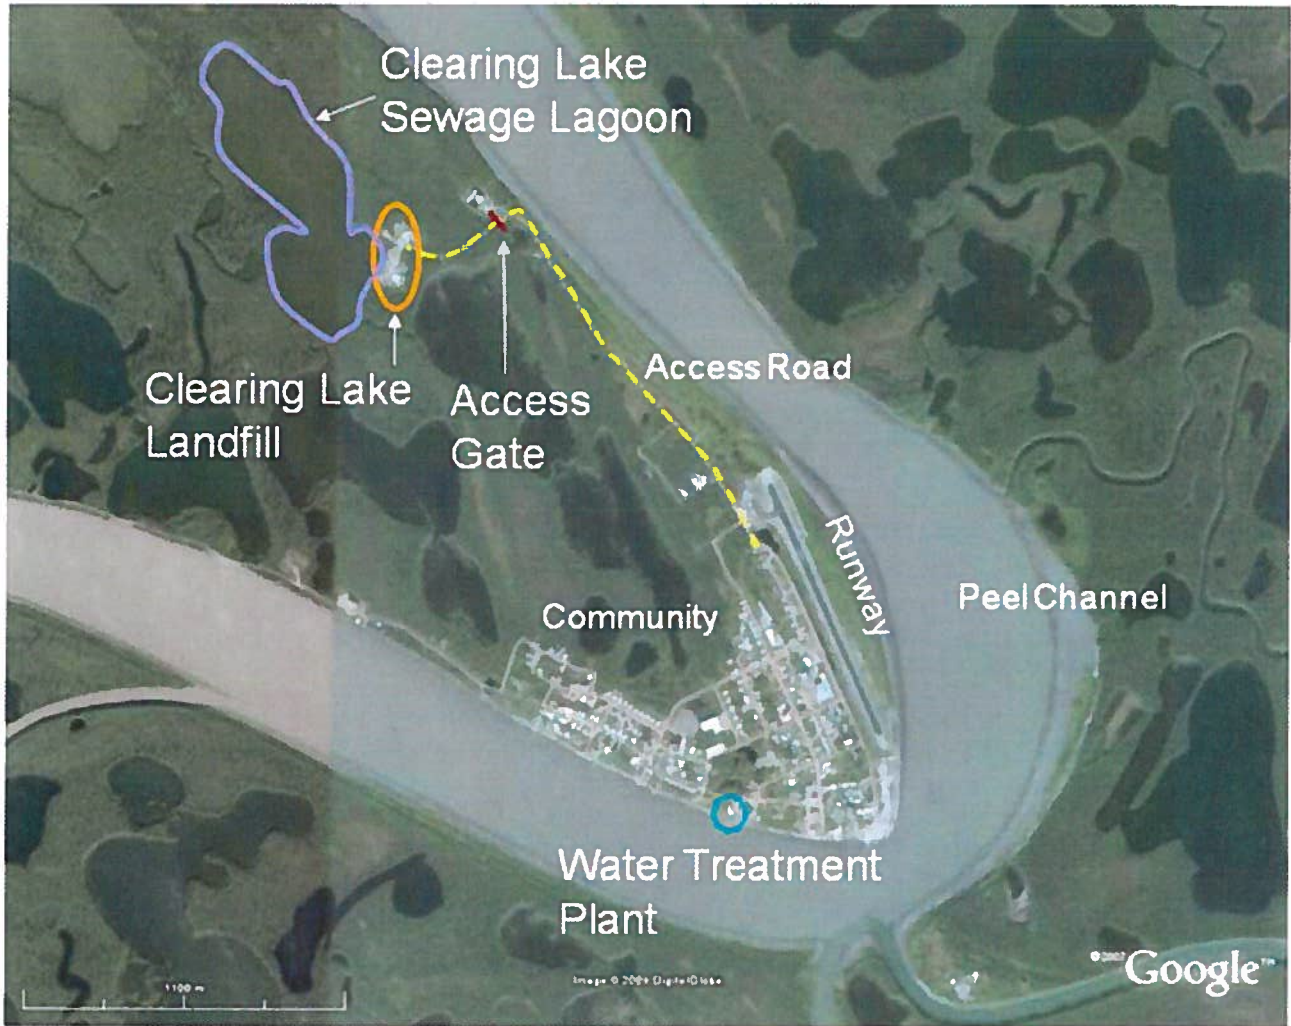
Figure 3-2: Infrastructure Locations

This section provides an overview of Aklavik's sewage and solid waste disposal systems. See **Figure 3-2** for the locations of the infrastructure described below.

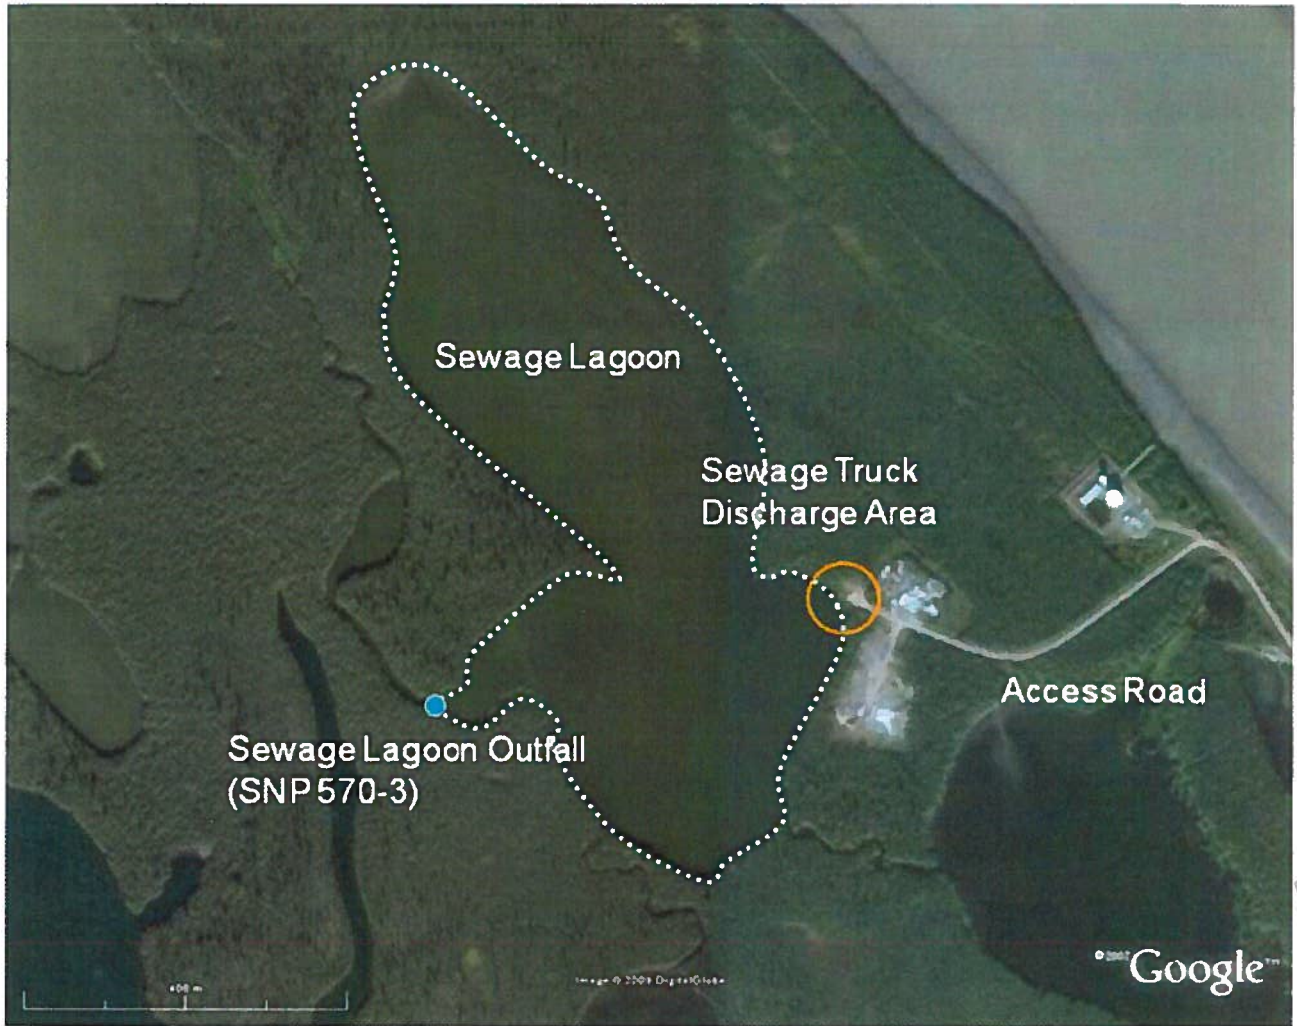
Figure 3-3: Sewage Lagoon Site Plan

Aklavik's sewage is collected using trucked pump-out services. The sewage is treated at the Clearing Lake Sewage Lagoon approximately 2 km northwest of the community. See **Figure 3-3** for a site plan of the sewage lagoon.

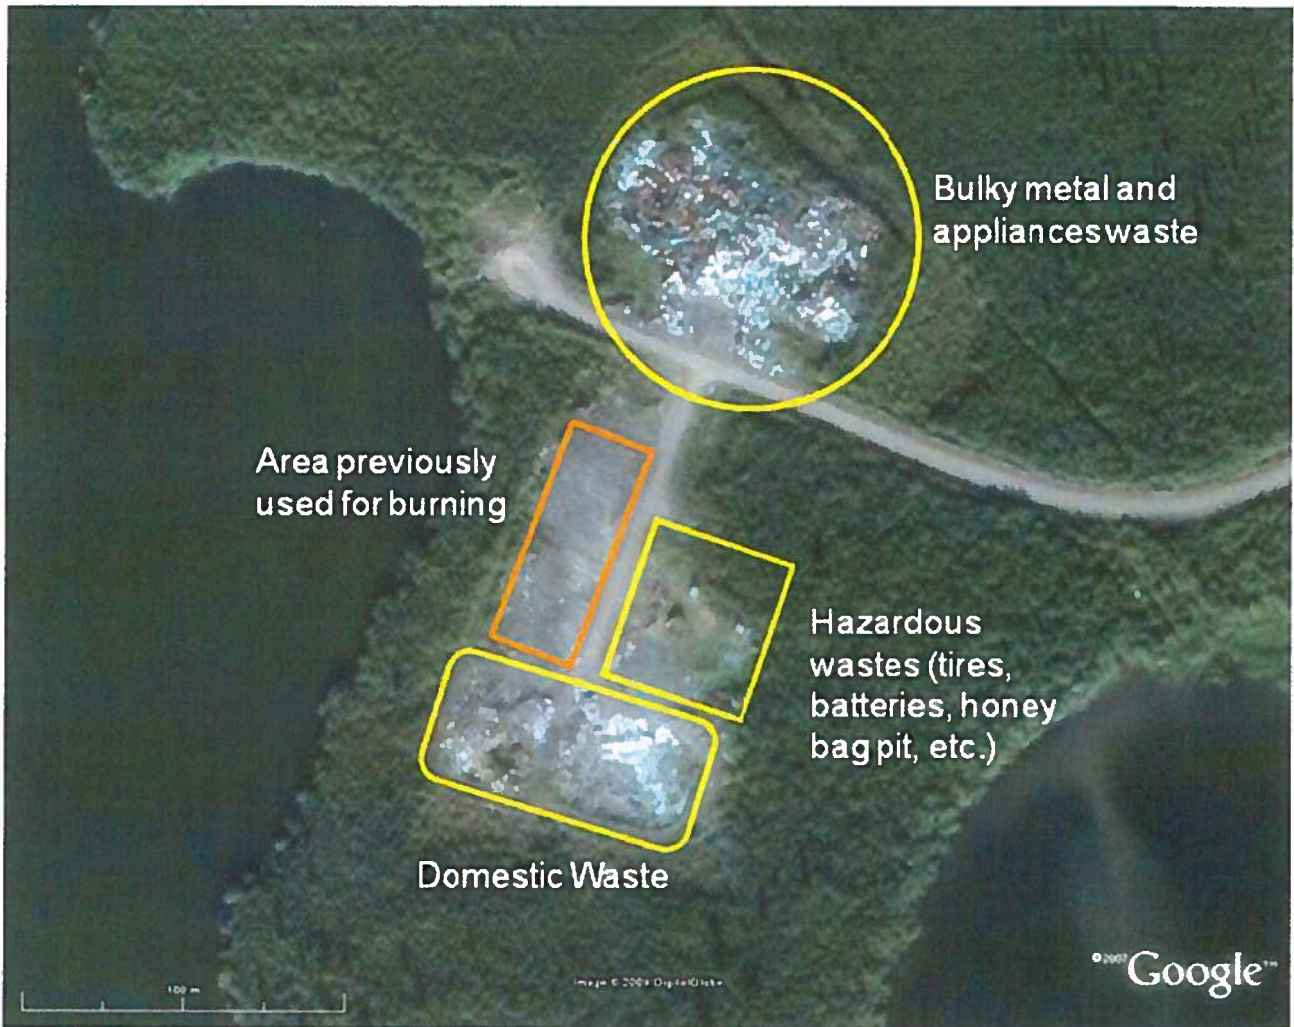
Figure 3-4: Landfill Site Plan

the Sewage Lagoon. See **Figure 3-4** for a site plan of the landfill. There are no existing engineering

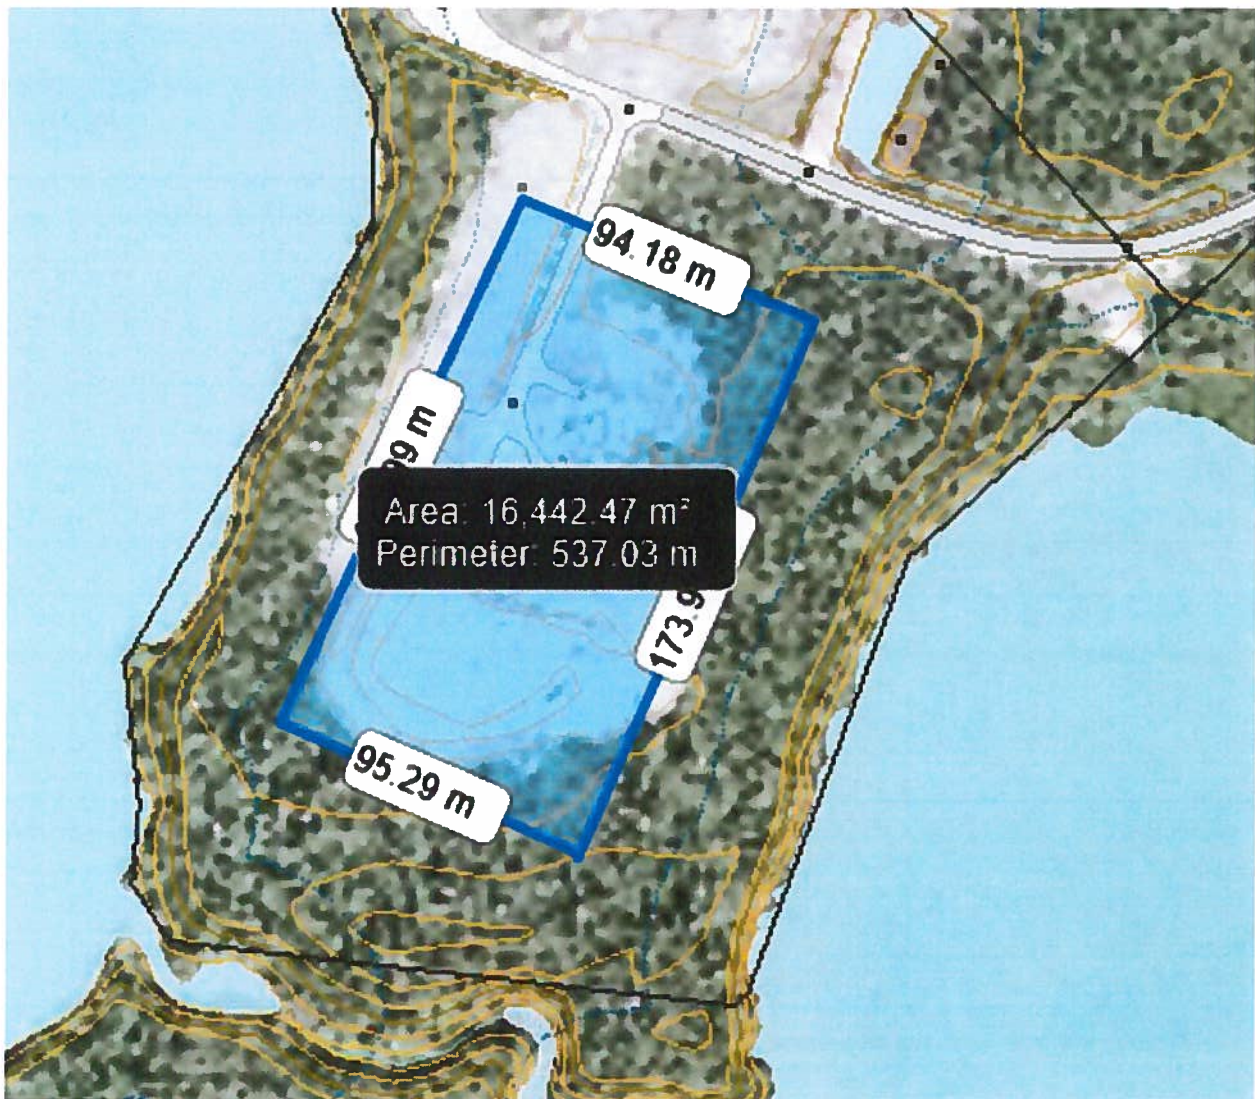
Figure 1: GNWT ATLAS image with a proposed landfill footprint of Est. 95 m x 175m

The current site appears to have nearly extended laterally as much as possible. It is constrained by water on three sides and a road to the North. It may be possible to clear some tree's to the South and

Northeast in order to develop a footprint of approximately 16,000 square meters. The dimensions of this footprint are approximately 175 m x 95 m. This is outlined in Figure 1.

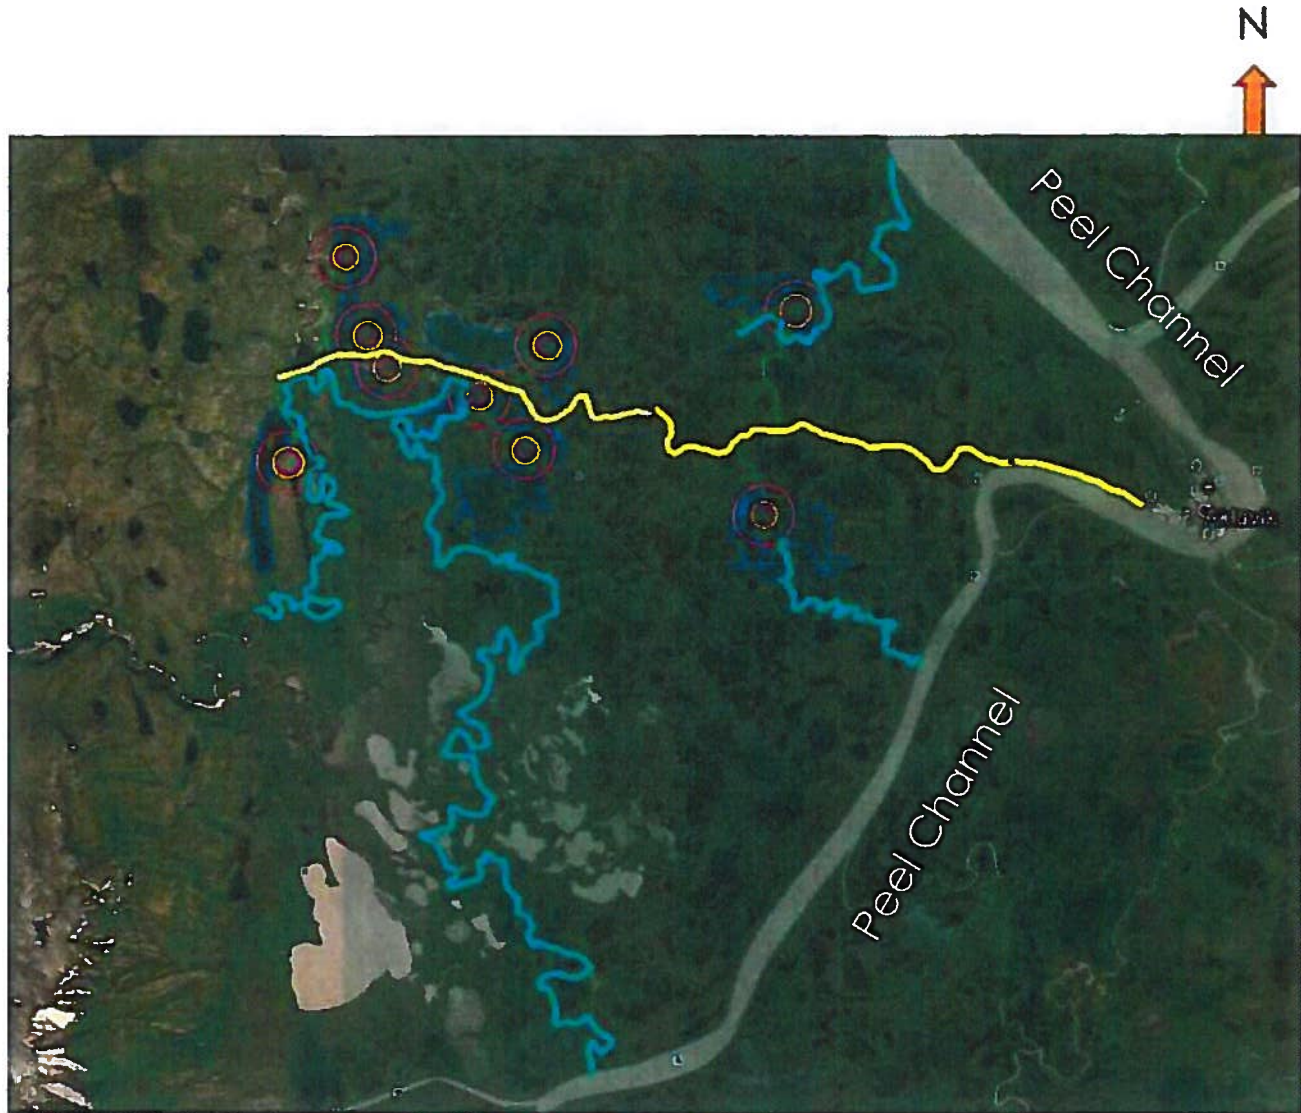
1. Landfill area includes 50 meter setback from site boundary (pink circle)
2. 500 m radius around site area showing lagoon access limit (red circle)
3. Flow drainage path (light blue)
4. Lagoon (dark blue)

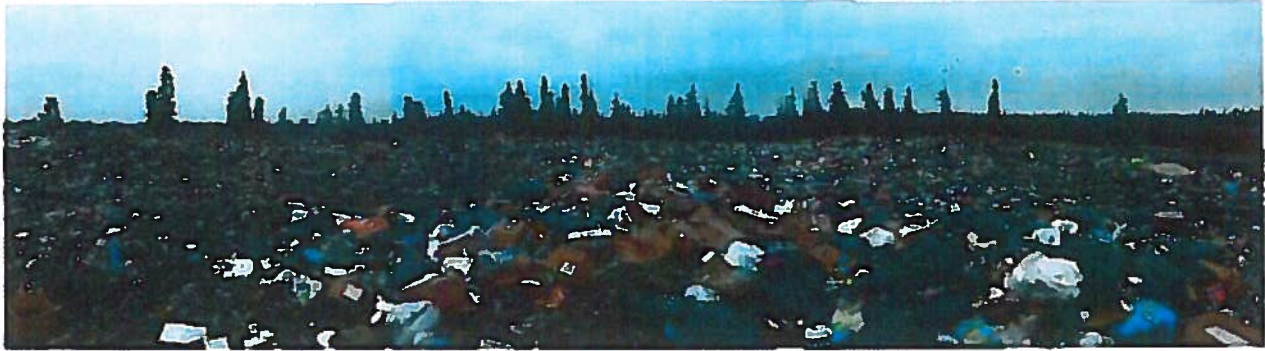
Active Area for Municipal Solid Waste – View to South (2016 09 28)

Hamlet of Aklavik, NT
Solid Waste Planning Study
FIGURE 3. EXISTING SITE PHOTOGRAPHS
Prepared by Ken Johnson, RPP, P.Eng. 2016 11 07

The municipal waste area (See Figure 2 and Figure 3) is approximately 4600 m², and currently operates as a large single cell for municipal solid waste disposal. Smaller cells within the area have been used in the past as evident with several internal perimeter berms. The current operating configuration does not accommodate efficient waste compaction, fire protection and animal attraction control by periodic waste covering, and allows for blowing debris to easily occur.

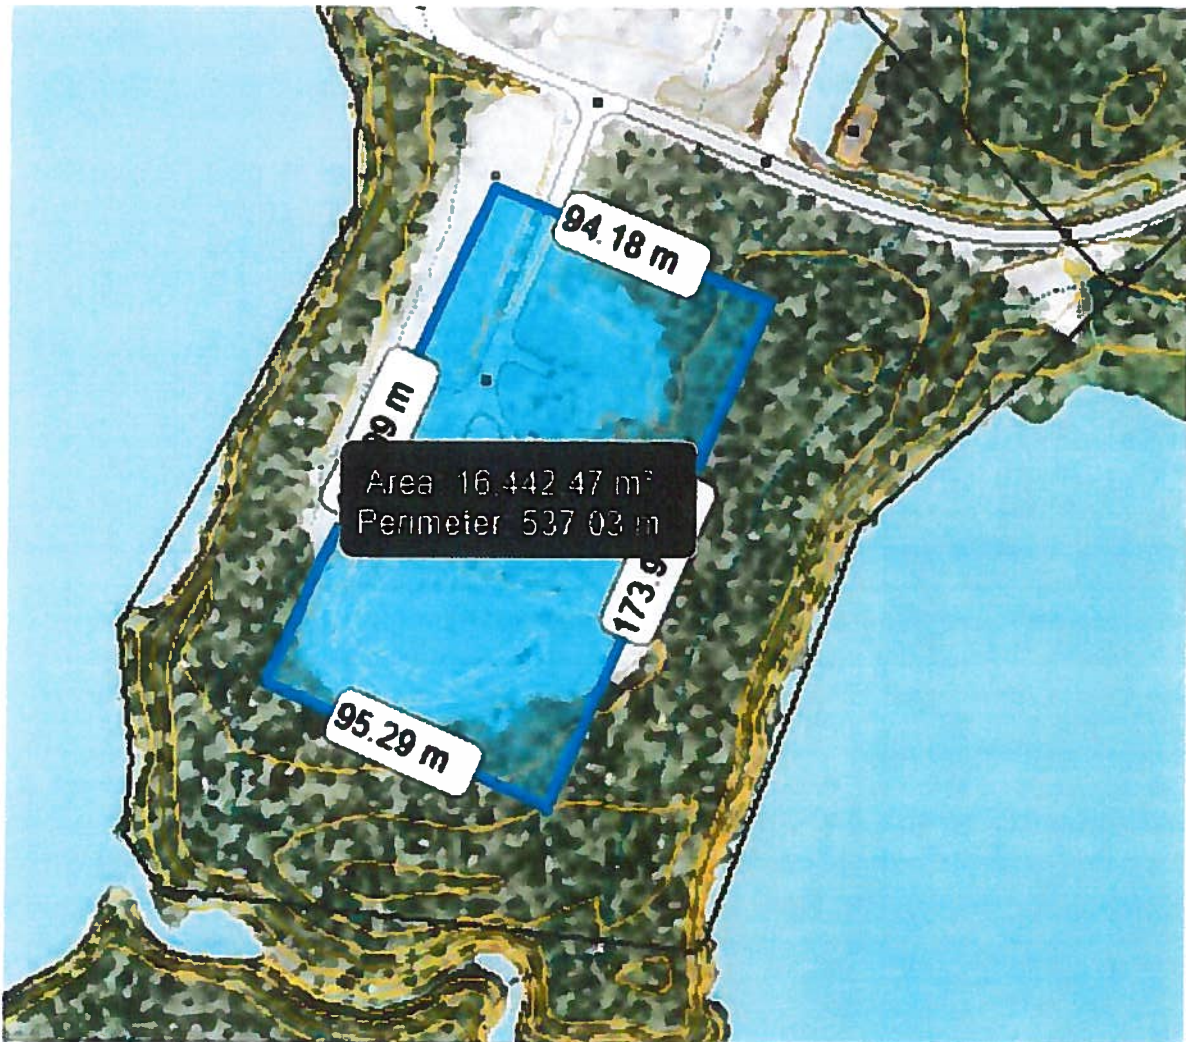
Figure 1: GNWT ATLAS image with a proposed landfill footprint of Est. 95 m x 175m

The current site appears to have nearly extended laterally as much as possible. It is constrained by water on three sides and a road to the North. It may be possible to clear some tree's to the South and

Northeast in order to develop a footprint of approximately 16,000 square meters. The dimensions of this footprint are approximately 175 m x 95 m. This is outlined in Figure 1.
